HISTORIC AND DESIGN REVIEW COMMISSION

HDRC CASE NO: 2021-585
ADDRESS: 1502 BUENA VISTA ST
LEGAL DESCRIPTION: NCB 2340 BLK 7 LOT N 101.25 FT OF 1
ZONING: C-2
CITY COUNCIL DIST.: 5
APPLICANT: Alberto Mejia
OWNER: Alberto Mejia
TYPE OF WORK: Historic Tax Certification
APPLICATION RECEIVED: November 05, 2021
60-DAY REVIEW: Not applicable due to City Council Emergency Orders
CASE MANAGER: Rachel Rettaliata
REQUEST:

The applicant is requesting Historic Tax Certification for the property at 1502 Buena Vista.

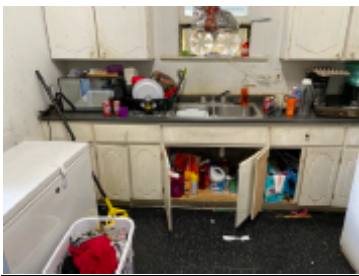
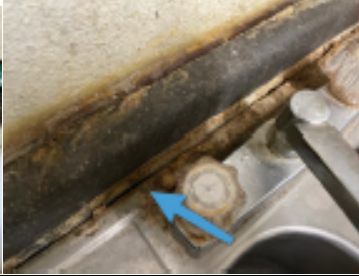
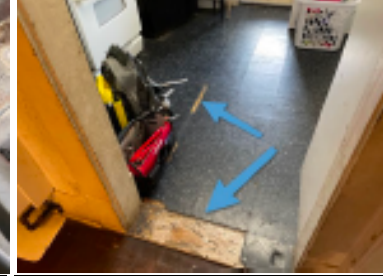
Kitchen is in need of a complete remodel. Work will include installation of new sink, cabinetry and stove. Mudroom will need new washer/dryer unit and new drywall.

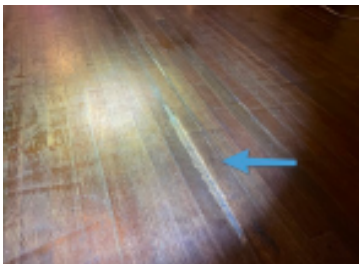
If possible, original wood flooring will be repaired and refinished throughout all rooms in the home.

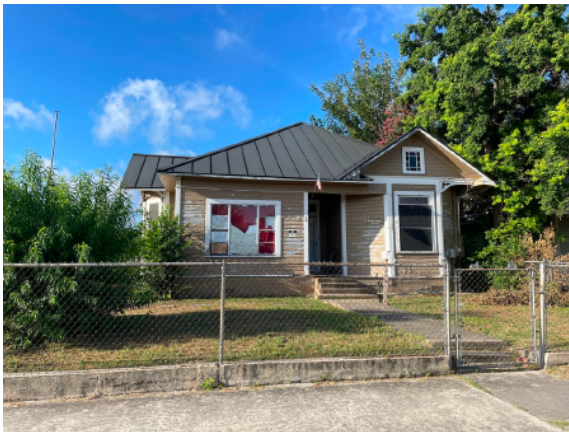
The rolling gate facing east toward Las Moras St. may need some repair. The remaining perimeter is currently a chain link iron fence, this will likely be replaced with a wood picket fence more fitting to the folk Victorian architecture/character of the home.
