HISTORIC AND DESIGN REVIEW COMMISSION

HDRC CASE NO: 2021-606
ADDRESS: 130 E ROSEWOOD AVE
LEGAL DESCRIPTION: NCB 6458 BLK 9 LOT 56 AND 57
ZONING: R-5
CITY COUNCIL DIST.: 1
DISTRICT: Monte Vista Historic District
APPLICANT: James MacMillan
OWNER: James MacMillan
TYPE OF WORK: Fenestration modifications
APPLICATION RECEIVED: November 16, 2021
60-DAY REVIEW: Not applicable due to City Council Emergency Orders
CASE MANAGER: Katie Totman
REQUEST:

The applicant is requesting a Certificate of Appropriateness for approval to modify one (1) window opening to install steel casement windows on the west elevation of the main house.

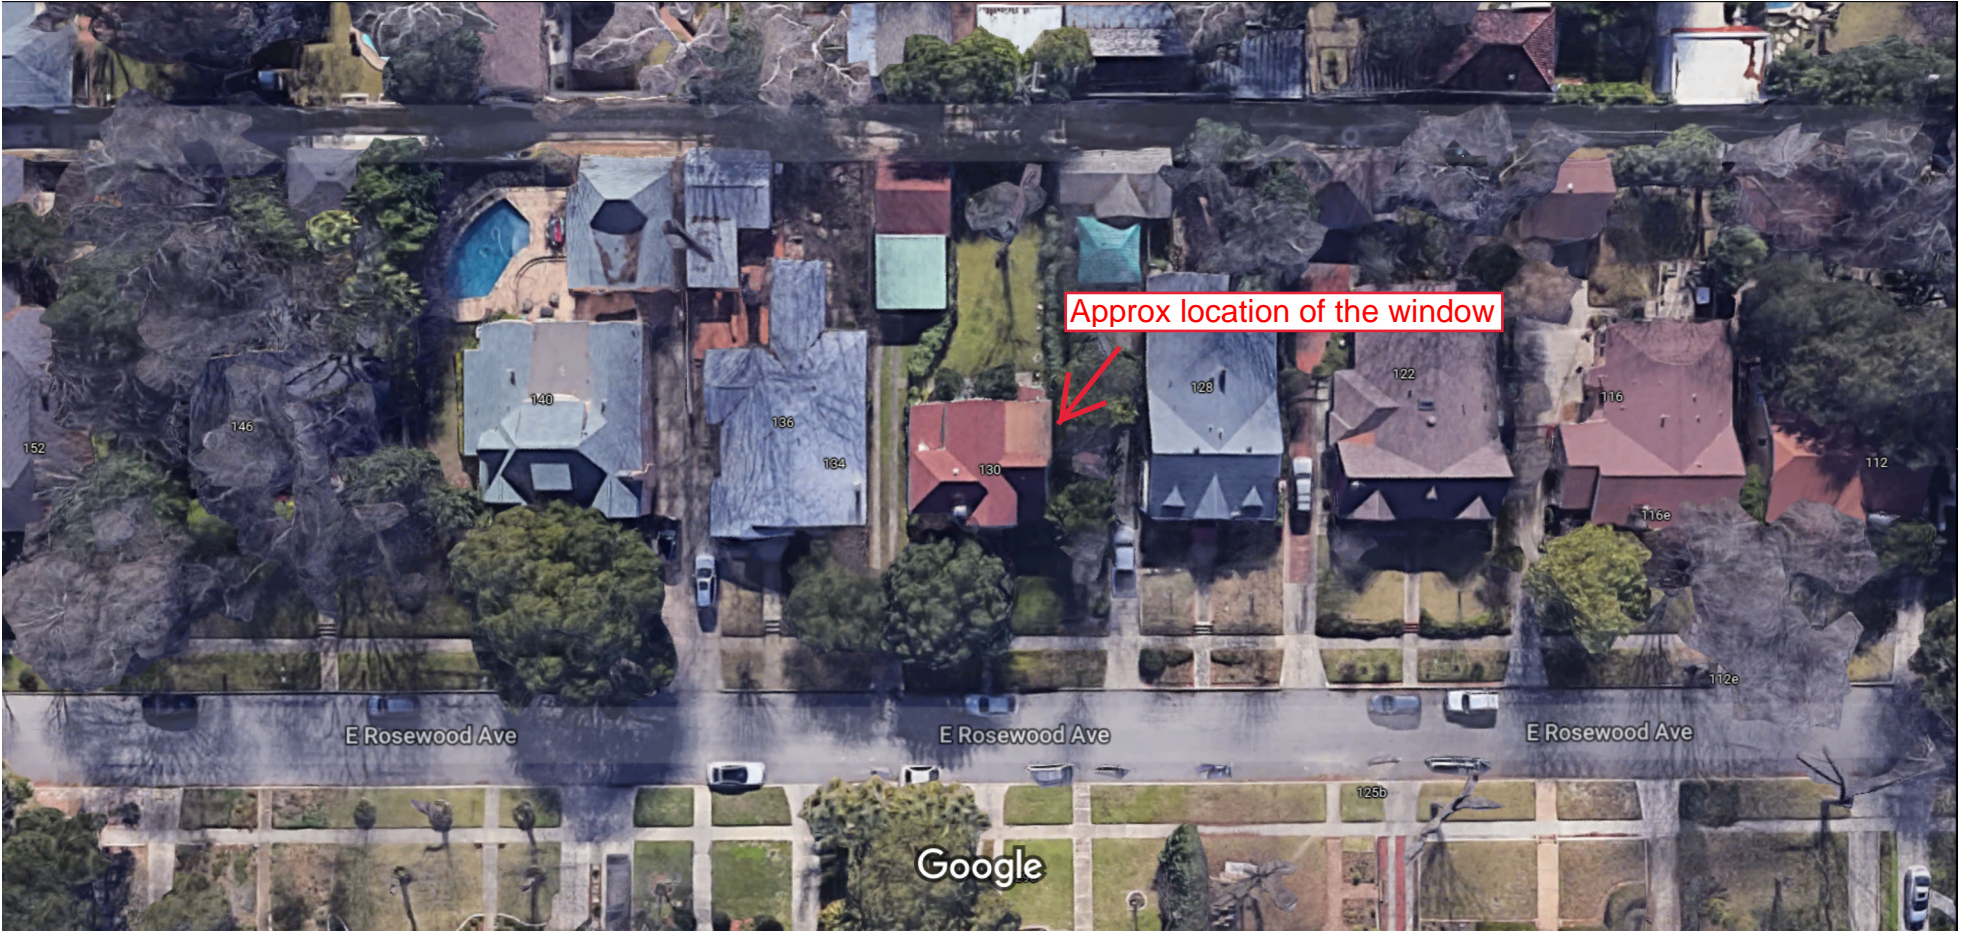
Approx location of the window

b. WINDOW REPLACEMENT (FIRST FLOOR) – The applicant is proposing to replace one (1) existing wood one over one window located on the west elevation of the house with a salvaged steel casement window. The existing wood window has a smaller proportion relative to the majority of the historic window openings on the primary facade of the home and is located on what staff finds to be a later rear addition based on Sanborn map evidence. The modification will not be easily visible from the public right-of-way. According to the Historic Design Guidelines, new elements should not significantly alter or destroy historic building character. Opening modifications should be compatible and should be appropriate for the building style. The proposed casement window system echoes the rhythm and proportions on the existing structure and will utilize a portion of the existing window frame opening. Staff finds the request acceptable with the stipulations listed in the recommendation.
