HISTORIC AND DESIGN REVIEW COMMISSION

January 19, 2022

HDRC CASE NO: 2021-636
ADDRESS: 345 E SUMMIT AVE
LEGAL DESCRIPTION: NCB 6882 BLK LOT 31, 32 & E 20 FT OF 30
ZONING: R-5, H
CITY COUNCIL DIST.: 1
DISTRICT: Monte Vista Historic District
APPLICANT: TERRY KRUEGER
OWNER: TERRY KRUEGER
TYPE OF WORK: Window replacement and front door replacement
APPLICATION RECEIVED: November 30, 2021
60-DAY REVIEW: Not applicable due to City Council Emergency Orders
CASE MANAGER: Rachel Rettaliata

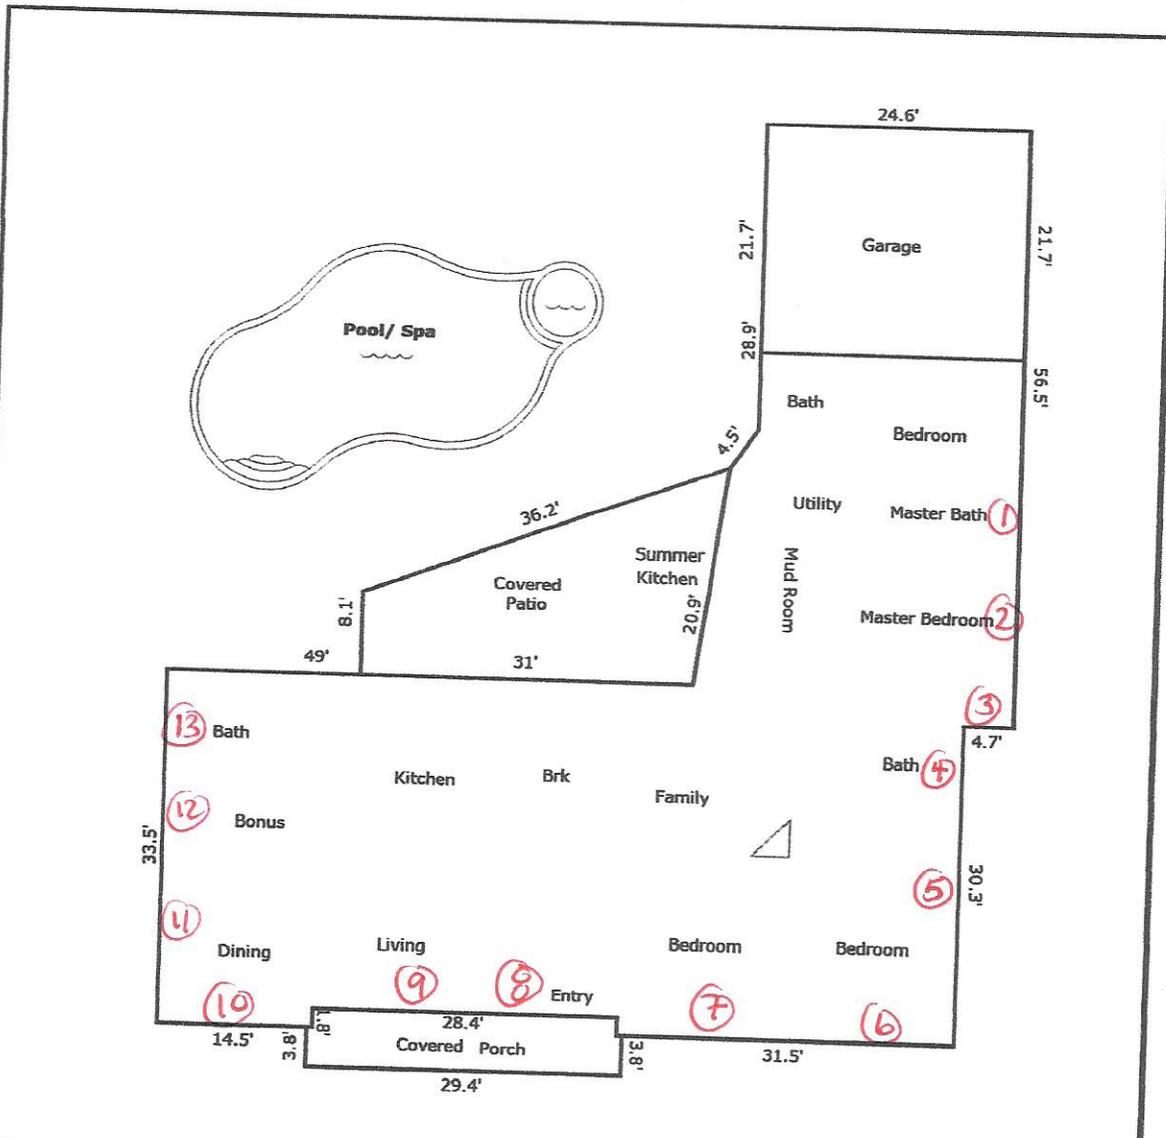
Building Sketch

Living Area	Area	Calculation Details
First Floor	3856 Sq ft	$33.5 \times 14.5 = 485.8$ $31.7 \times 28.4 = 900.3$ $33.5 \times 6.1 = 204.4$ $0.5 \times 20.7 \times 2.9 = 30.2$ $33.5 \times 2.9 = 97.8$ $0.5 \times 3.7 \times 2.6 = 4.8$ $54.2 \times 2.6 = 139.9$ $86.8 \times 19.9 = 1727.3$ $56.5 \times 4.7 = 265.6$
2 Car Attached	-533.8 Sq ft	$21.7 \times 24.6 = 533.8$
Total Living Area (Rounded):	3322 Sq ft	
Non-living Area	458.4 Sq ft	$31 \times 8.1 = 251.1$ $0.5 \times 1.1 \times 8.1 = 4.6$ $0.5 \times 32.1 \times 12.6 = 202.7$
Patio	162.8 Sq ft	$29.4 \times 3.8 = 111.7$ $28.4 \times 1.8 = 51.1$
Open Porch	162.8 Sq ft

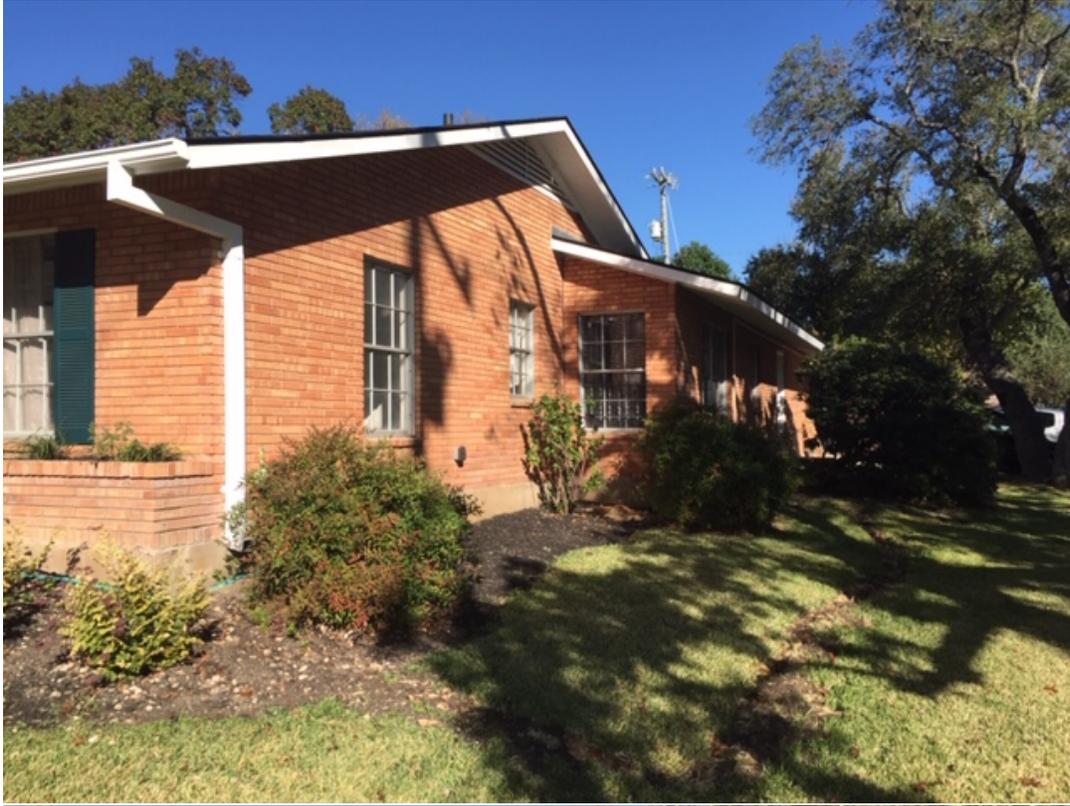
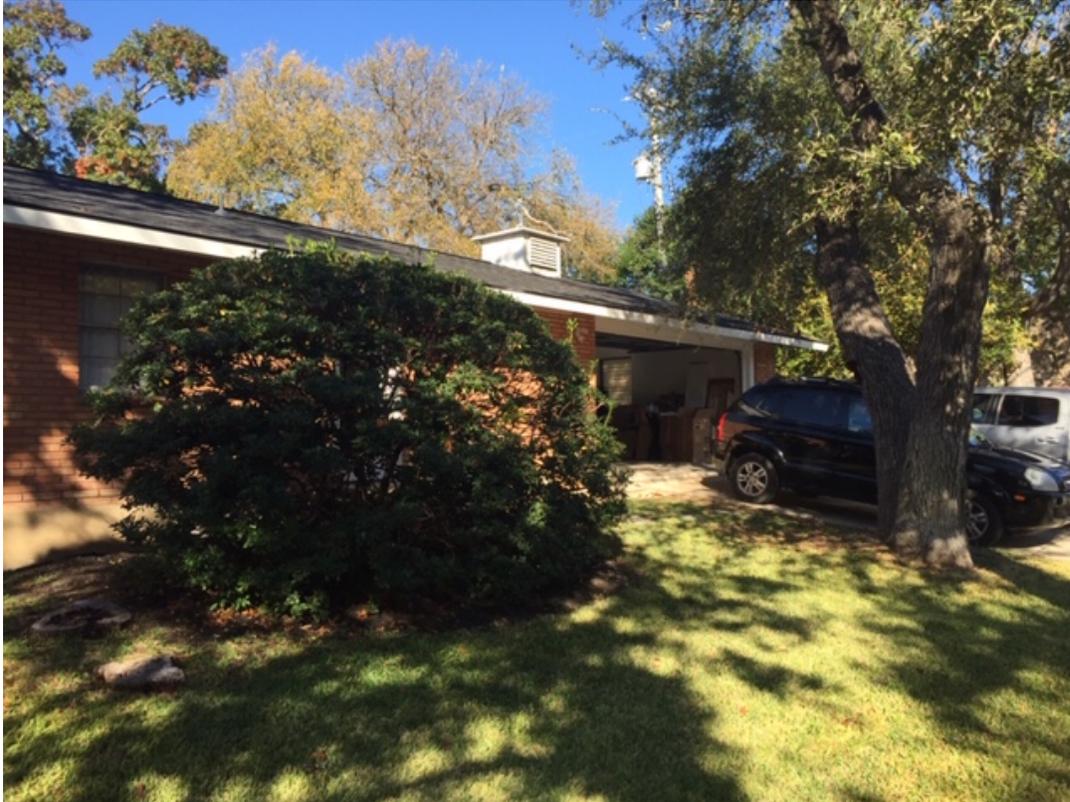
East side of 345 E Summit Ave

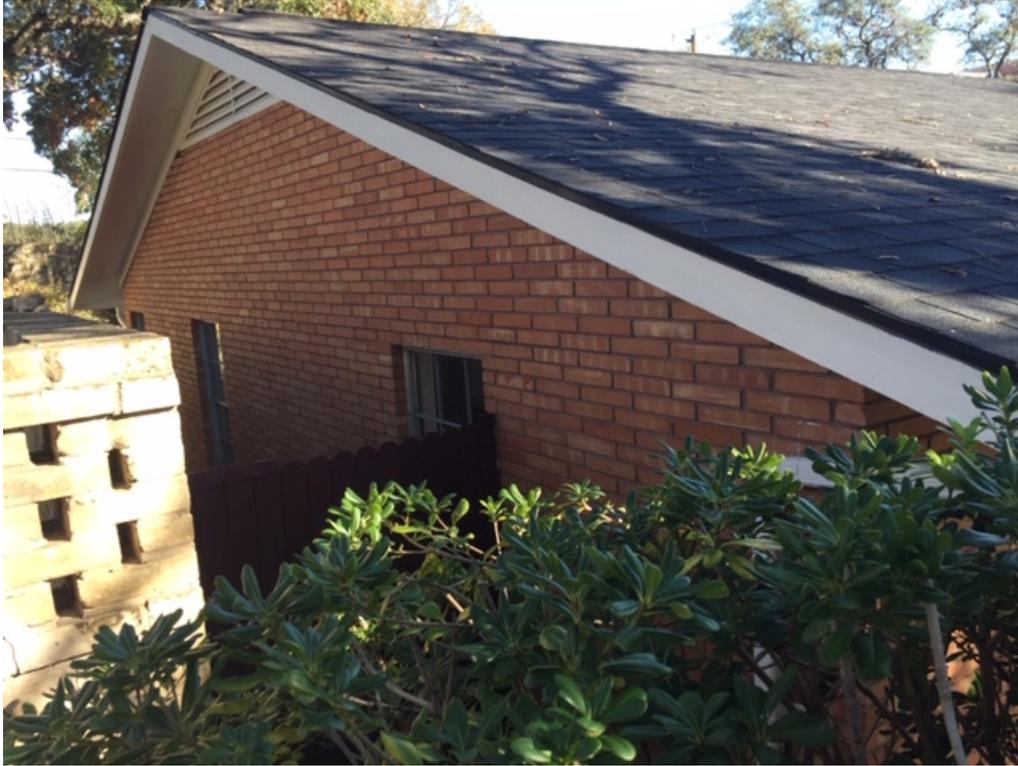
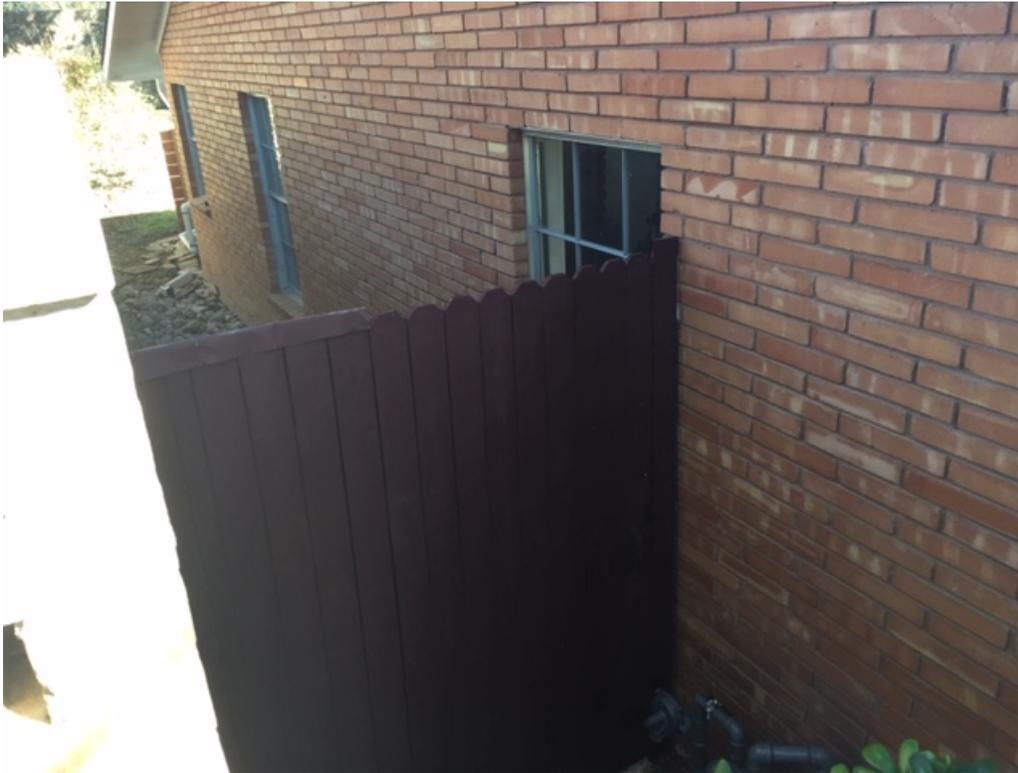
West side of 345 E Summit Ave

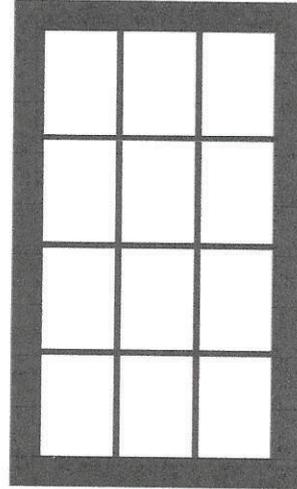
100 SERIES PICTURE WINDOW

Product ID#	100REC3050
Unit Width	35 1/2"
Unit Height	59 1/2"
Interior Color	White
Glass	SmartSun™ Glass
Grille Pattern	Colonial
Grille Width	3/4"
Exterior Color	Dark Bronze

- i. That the applicant installs aluminum windows that match the existing windows in size, type, configuration, material, form, appearance, and detail. The windows should feature an inset that matches the inset of the existing windows. White manufacturer's color is not allowed, and color selection must be presented to staff. There should be a minimum of two inches in depth between the front face of the window trim and the front face of the top window sash. This must be accomplished by recessing the window sufficiently within the opening. The applicant is required to submit final material specifications to staff for review and approval prior to the issuance of a Certificate of Appropriateness.
