HISTORIC AND DESIGN REVIEW COMMISSION

HDRC CASE NO: 2022-033
ADDRESS: 125 W GRAMERCY PLACE
LEGAL DESCRIPTION: NCB 6382 BLK 2 LOT 6,7 & 8
ZONING: R-5, H
CITY COUNCIL DIST.: 1
DISTRICT: Monte Vista Historic District
APPLICANT: Alan Hicks/HICKS DALE & THERESA ERIN
OWNER: Alan Hicks/HICKS DALE & THERESA ERIN
TYPE OF WORK: Rear fence and wall modifications
APPLICATION RECEIVED: November 08, 2021
60-DAY REVIEW: Not applicable due to City Council Emergency Orders
CASE MANAGER: Rachel Rettaliata

1. Remove the existing chain link fencing on top of the stone wall at the rear of the east property line and increase the height of the 3-foot-tall rock wall to 6 feet in height with in-kind materials.
2. Remove the existing stone wall along the north (rear) property line and install a 6-foot-tall wood privacy fence with a pedestrian gate.

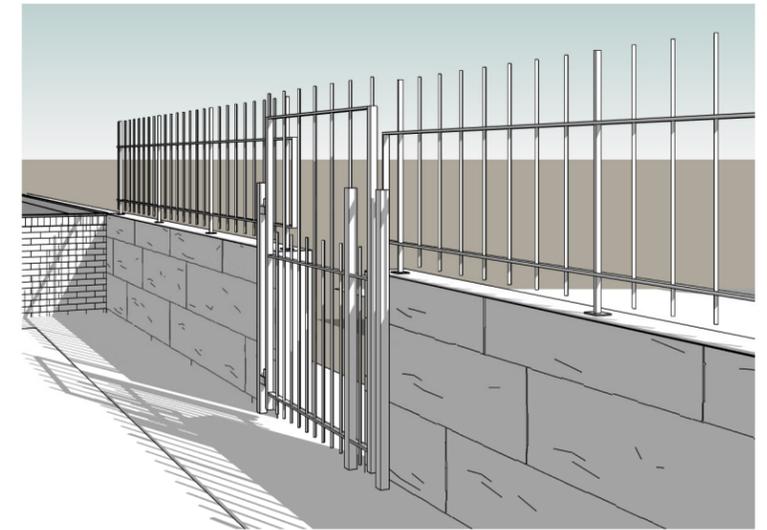
1 NORTH WALL - ELEVATION EXISTING

- c. **The North Fence** line, abuts the rear alley. The existing fence here is a combination of a rock wall, approximately 4' in height, topped by a decorative wrought iron addition of approximately another 3'. See Old Elevation North Wall, 21.04.02 A1.2 and Photos 6261, 6262, and 6264.

- c. WALL MODIFICATION – NORTH – The applicant has proposed to remove the existing stone wall along the north (rear) property line and install a 6-foot-tall wood privacy fence with a pedestrian gate. Guideline 2.A.i for Site Elements states that historic fences and walls should be retained. Guideline 2.A.ii recommends that only the deteriorated sections of historic fences and walls that are deteriorated beyond repair should be replaced. Replacement materials should match the color, texture, size, profile, and finish of the original. Staff finds that the removal of the existing stone wall along the north (rear) property line is not consistent with the Guidelines. Extending the stone wall to match the proposed modification on the east property line would be appropriate.

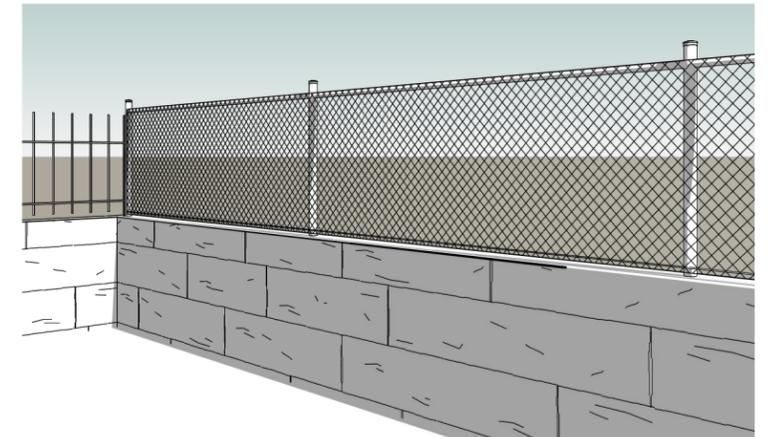
2 EAST WALL - ELEVATION - EXISTING

- a. **The East fence** line contains a low rock wall that extends from the street to the drive gates for both 125 West and the adjacent property., 117 West. See Photos 6267 and 6260. See Old Elevation drawing for East side, 21.04.02 A1.2.

- i. Behind the Drive Gates , the rock wall extends to the rear (north) property line at an elevation of about 3 feet on the west Side (the 125 side), but is substantially lower on the 117 side. See Photos 6267 and 6260. An ugly chain link fence was added to the top of the rock wall behind the drive gates at some point., most likely for safety and security because pets or small children could scale the fence from the 117 side of the fence.

- b. WALL MODIFICATION: EAST – The applicant has proposed to remove the existing chain link fencing on top of the stone wall at the rear of the east property line and increase the height of the 3-foot-tall stone wall to 6 feet in height with in-kind materials. Guideline 2.B.i for Site Elements states that new fences and walls should appear similar to those used historically within the district in terms of their scale, transparency, and character. Guideline 2.A.ii for Site Elements states that replacement materials (including mortar) should be matched to the color, texture, size, profile, and finish of the original. Design of fence should respond to the design and materials of the house or main structure. The existing chain link fencing mounted to the stone wall is a non-compliant condition and staff finds that the removal of the chain link fencing and the extension of the stone wall to 6 feet in height with in-kind material is appropriate.

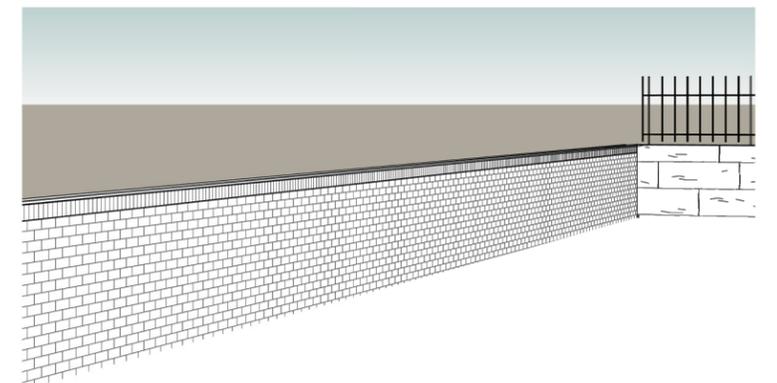
3 WEST WALL ELEVATION - EXISTING

- b. **The West Fence** line, abutting the property designated as 135 West Gramercy, contains a low brick wall, See Photos 6265 and 6266 and Old Elevation Drawing for the West Fence, 21.04.02 A1.2.

- i. This fence technically sits on the property of 117 West, based on the survey of 125 West accomplished at purchase. The brick , while resembling the brick of 135 West is not a true match and is a later addition, though the timing is not known. This

fence terminates at the West corner of the structure at 125 West and a wrought Iron gate which matches the drive gate exists. Behind the gate , the first 10' of the fence is a wooden structure. After that the brick section of the wall begins. See Photo 6266 and Old West elevation, 21.04.02 A1.2.

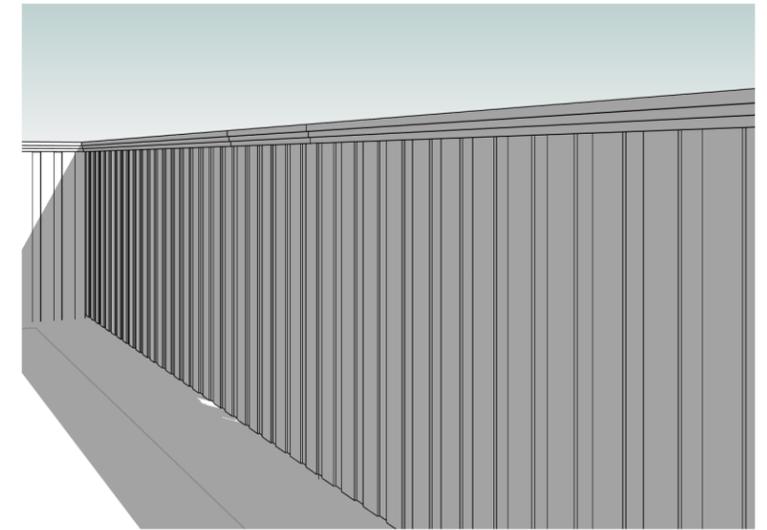
4 NORTH WALL - ELEVATION - New

BOARD ON BOARD WOOD FENCE

- i. **The Proposal for the North fence** envisions removing the wrought iron and with matching materials and construction techniques, raising the height of the fence behind the drive gates to 6', as measured from the 125 West side. This would allow a 6' high perimeter fence that would eliminate the ability of anyone in the alley from gazing into the back yard and thus completing the goal of privacy, and would aesthetically tie the back fence to the east fence. See New elevation North side. 21.04.18 A1.2

Item 2, staff does not recommend approval of the wall removal and replacement on the north (rear) property line based on finding c. Staff recommends that the existing stone wall is retained.

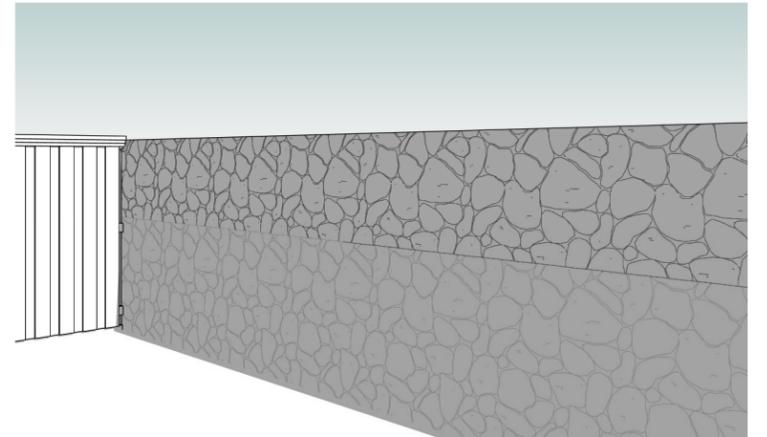
5 EAST WALL - ELEVATION - New

NEW STONE PRIVACY FENCE

- ii. **The Proposal** for the East side envisions removing the chain link and with matching materials and construction techniques, raising the height of the fence behind the drive gates to 6', as measured from the 125 West side. See New Elevation East Side. 21.04.18 A1.2

- i. That the wall extension, including the mortar, matches the color, texture, size, profile, and finish of the original stone wall.
- ii. That the final construction height of the approved wall may not exceed the maximum height of 6 feet as approved by the HDRC at any portion of the fence. Additionally, the wall modification must be permitted and meet the development standards outlined in UDC Section 35-514.

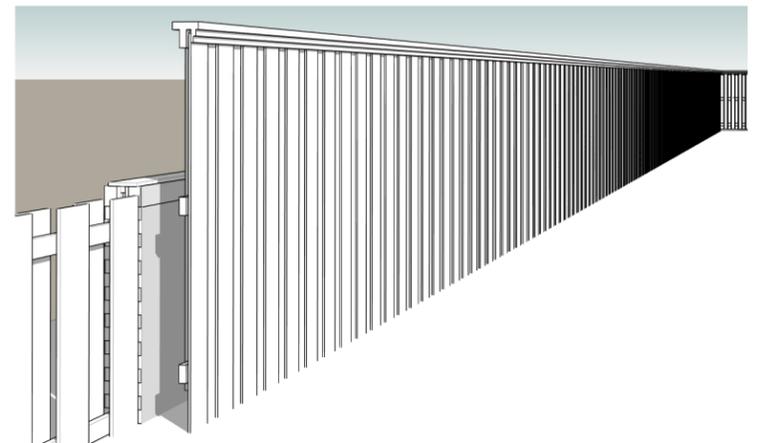
6 WEST WALL ELEVATION - New

BOARD ON BOARD WOOD PRIVACY FENCE

- ii. **The Proposal** for the West side envisions installing a 6' wood on wood fence, on the 125 West side of the wall, which would be installed flush against the existing brick wall. The pickets on the 135 West side would terminate at the top of the brick wall, giving it a finished look. The neighbors at 135 West have a large Rotweiller who has scaled the existing low wall on occasion. The elevated fence will protect small children in the backyard by keeping the aggressive dog out. The neighbors at 135 West are in complete agreement with this proposal.

- d. ADMINISTRATIVE APPROVAL – The applicant has proposed to install a 6-foot-tall wood privacy fence on the west property line flush against the existing contemporary brick wall, which is located on the neighboring property. This scope of work is eligible for administrative approval and does not require HDRC review.
