HISTORIC AND DESIGN REVIEW COMMISSION

HDRC CASE NO: 2022-126
ADDRESS: 615 AUGUSTA
LEGAL DESCRIPTION: NCB 806 BLK 23 LOT 10 & W 3.71 FT OF 11
ZONING: FBZ T5-1, H
CITY COUNCIL DIST.: 1
LANDMARK: Individual Landmark
APPLICANT: Patrick Christensen/Patrick Christensen, Attorney at Law
OWNER: RESIDENCES AT MADISON SQUARE PARK LLC
TYPE OF WORK: Demolition of a landmark
APPLICATION RECEIVED: January 10, 2022
60-DAY REVIEW: Not applicable due to City Council Emergency Orders
CASE MANAGER: Rachel Rettaliata

The applicant is requesting a Certificate of Appropriateness for approval to demolish the primary structure.

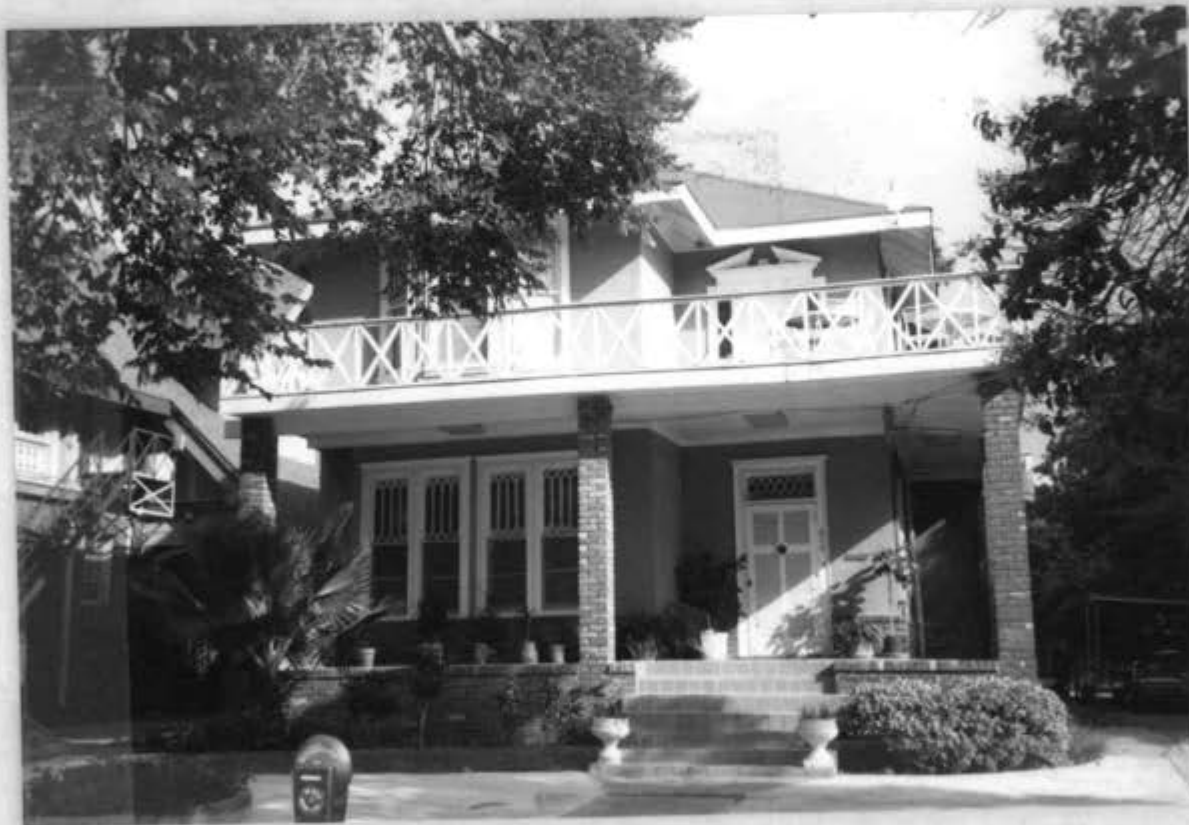
SAN ANTONIO HISTORIC SURVEY

2-story L-plan stuccoed dwelling with low-pitched shingled hipped roof. First-floor porch supported by thin brown brick columns. At right, steps lead to entrance door with transom set within recessed wing of building. To left, band of four 1/1 double-hung sash windows with ornamental screens. Thin brick piers support second floor porch with decorative rail with X-shaped wood trim. To right, door with broken pediment above. To left, bay window with double-hung windows. Prominent roof overhang.

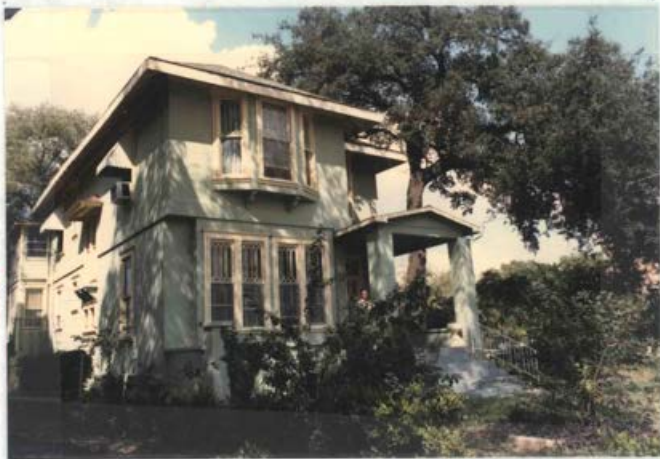
1. Walls-stucco (painted light green)
2. Roof Form-moderate pitch, hipped with ridge
3. Roof-Wall Junction-slight eave overhang with wide band of trim below and multiple supports
4. Dormers-NONE
5. Other Roof Elaborations-Material used-shingle (green)
6. Doors-transom lights
7. Fenestration-2nd story, left side of facade there is an oriel type of structure for three windows, but without top cone
8. Chimneys-NONE
9. Porch Supports-brick, plain-squared pilasters

10. Porches-entry type with simple pediment
11. Other Decorative Details-simple beltcourse
emphasizing the division of the two stories
12. NOTE: Possibly the bracketted tops over the
windows on the second floor were added
recently.
