HISTORIC AND DESIGN REVIEW COMMISSION

HDRC CASE NO: 2022-057
ADDRESS: 133 E HUISACHE AVE
LEGAL DESCRIPTION: NCB 1702 BLK 6 LOT 22 & E 25 FT OF 21
ZONING: R-4
CITY COUNCIL DIST.: 1
DISTRICT: Monte Vista Historic District
APPLICANT: Maria del Carmen Drury/DRURY MARIA DEL CARMEN
OWNER: Maria del Carmen Drury/DRURY MARIA DEL CARMEN
TYPE OF WORK: Rear wall replacement
APPLICATION RECEIVED: January 10, 2022
60-DAY REVIEW: Not applicable due to City Council Emergency Orders
CASE MANAGER: Katie Totman
REQUEST:

The applicant is requesting a Certificate of Appropriateness for approval to remove the existing rear stone wall and construct a CMU block wall.

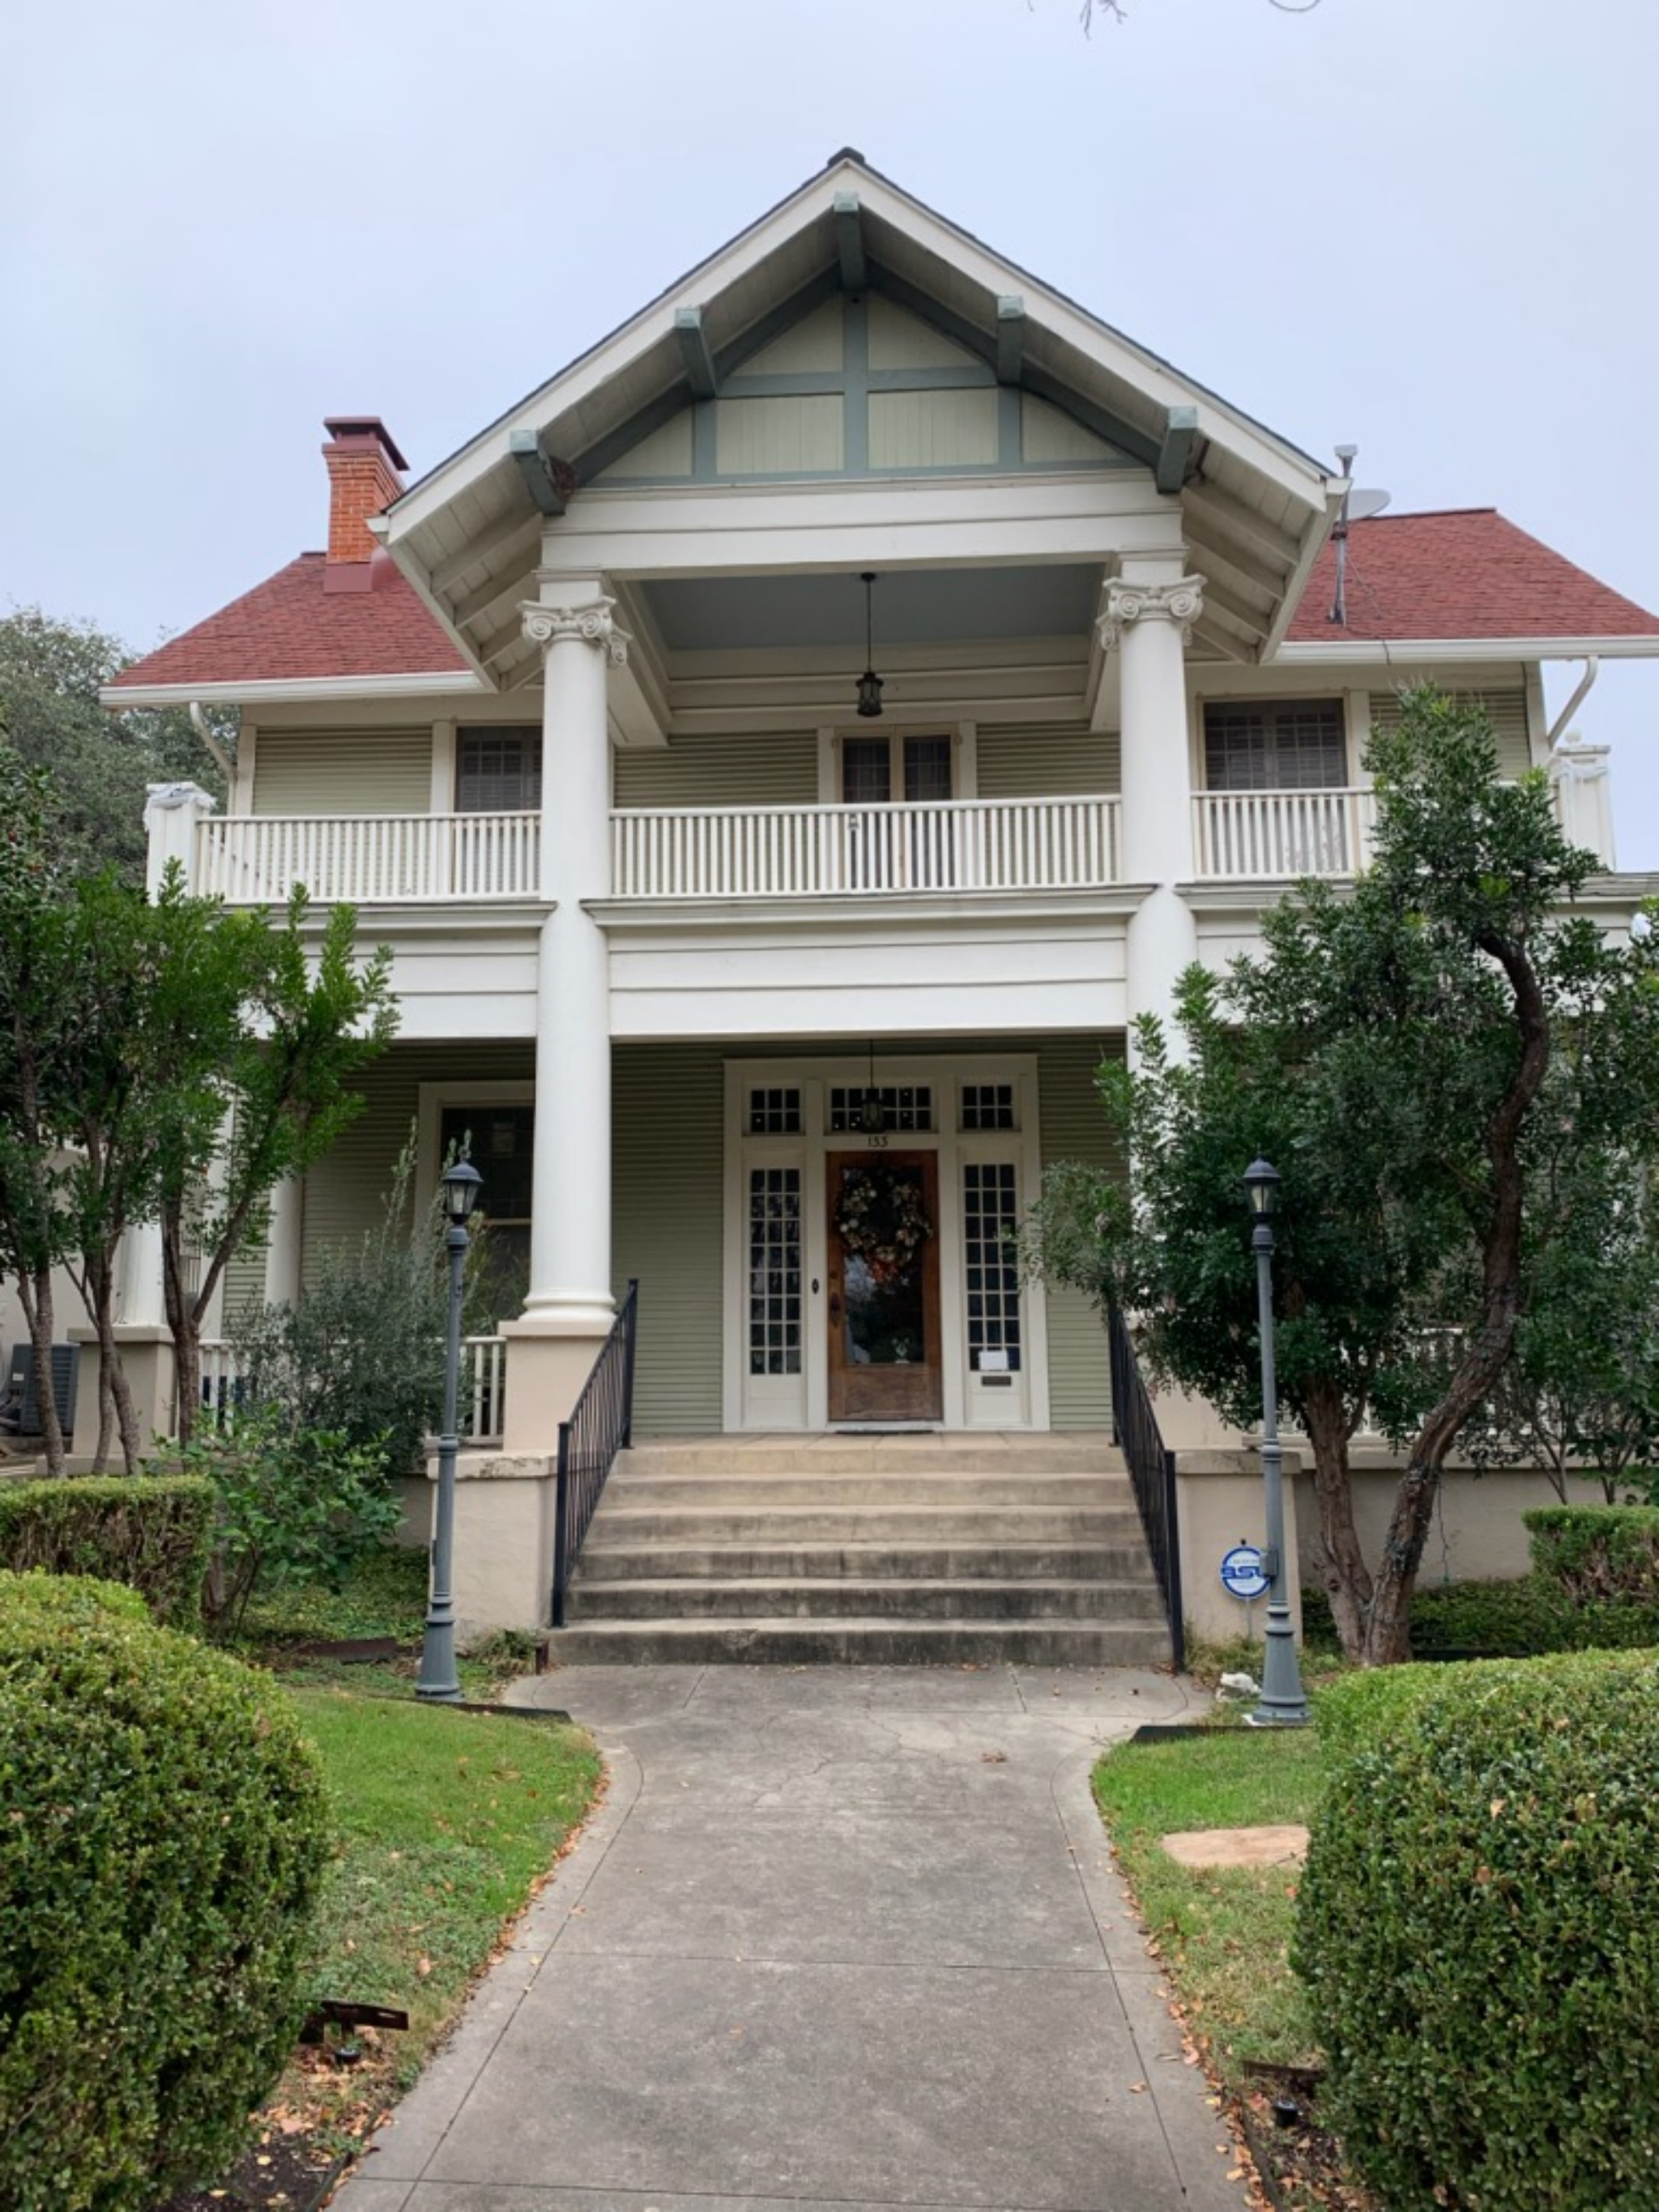
- a. REMOVAL AND REPLACEMENT OF REAR ROCK/STONE WALL - The applicant has proposed to remove the existing rock/stone wall along the north (rear) property line and install a 6-foot-tall CMU wall. Guideline 2.A.i for Site Elements states that historic fences and walls should be retained. Guideline 2.A.ii recommends that only the deteriorated sections of historic fences and walls that are deteriorated beyond repair should be replaced. Replacement materials should match the color, texture, size, profile, and finish of the original. Staff finds that the removal of the existing stone wall along the north (rear) property line is not consistent with the Guidelines. Repairing and/or re-building the stone wall in kind would be consistent with the Guidelines.

Staff does not recommend approval of the removal of the rock wall and the replacement CMU wall based on finding b. Staff recommends that the existing rock wall be maintained and repaired using in kind materials.
