HISTORIC AND DESIGN REVIEW COMMISSION

HDRC CASE NO: 2022-065
ADDRESS: 202 MARY LOUISE
LEGAL DESCRIPTION: NCB 6699 BLK 8 LOT 21
ZONING: R-6, H
CITY COUNCIL DIST.: 7
DISTRICT: Monticello Park Historic District
APPLICANT: Benjamin & Jennifer Rosas
OWNER: Benjamin & Jennifer Rosas
TYPE OF WORK: Historic Tax Verification
APPLICATION RECEIVED: January 21, 2022
60-DAY REVIEW: Not applicable due to City Council Emergency Orders
CASE MANAGER: Rachel Rettaliata

The applicant is requesting Historic Tax Verification for the property at 202 Mary Louise.

HISTORIC REHABILITATION APPLICATION PART 2 | JANUARY 2022

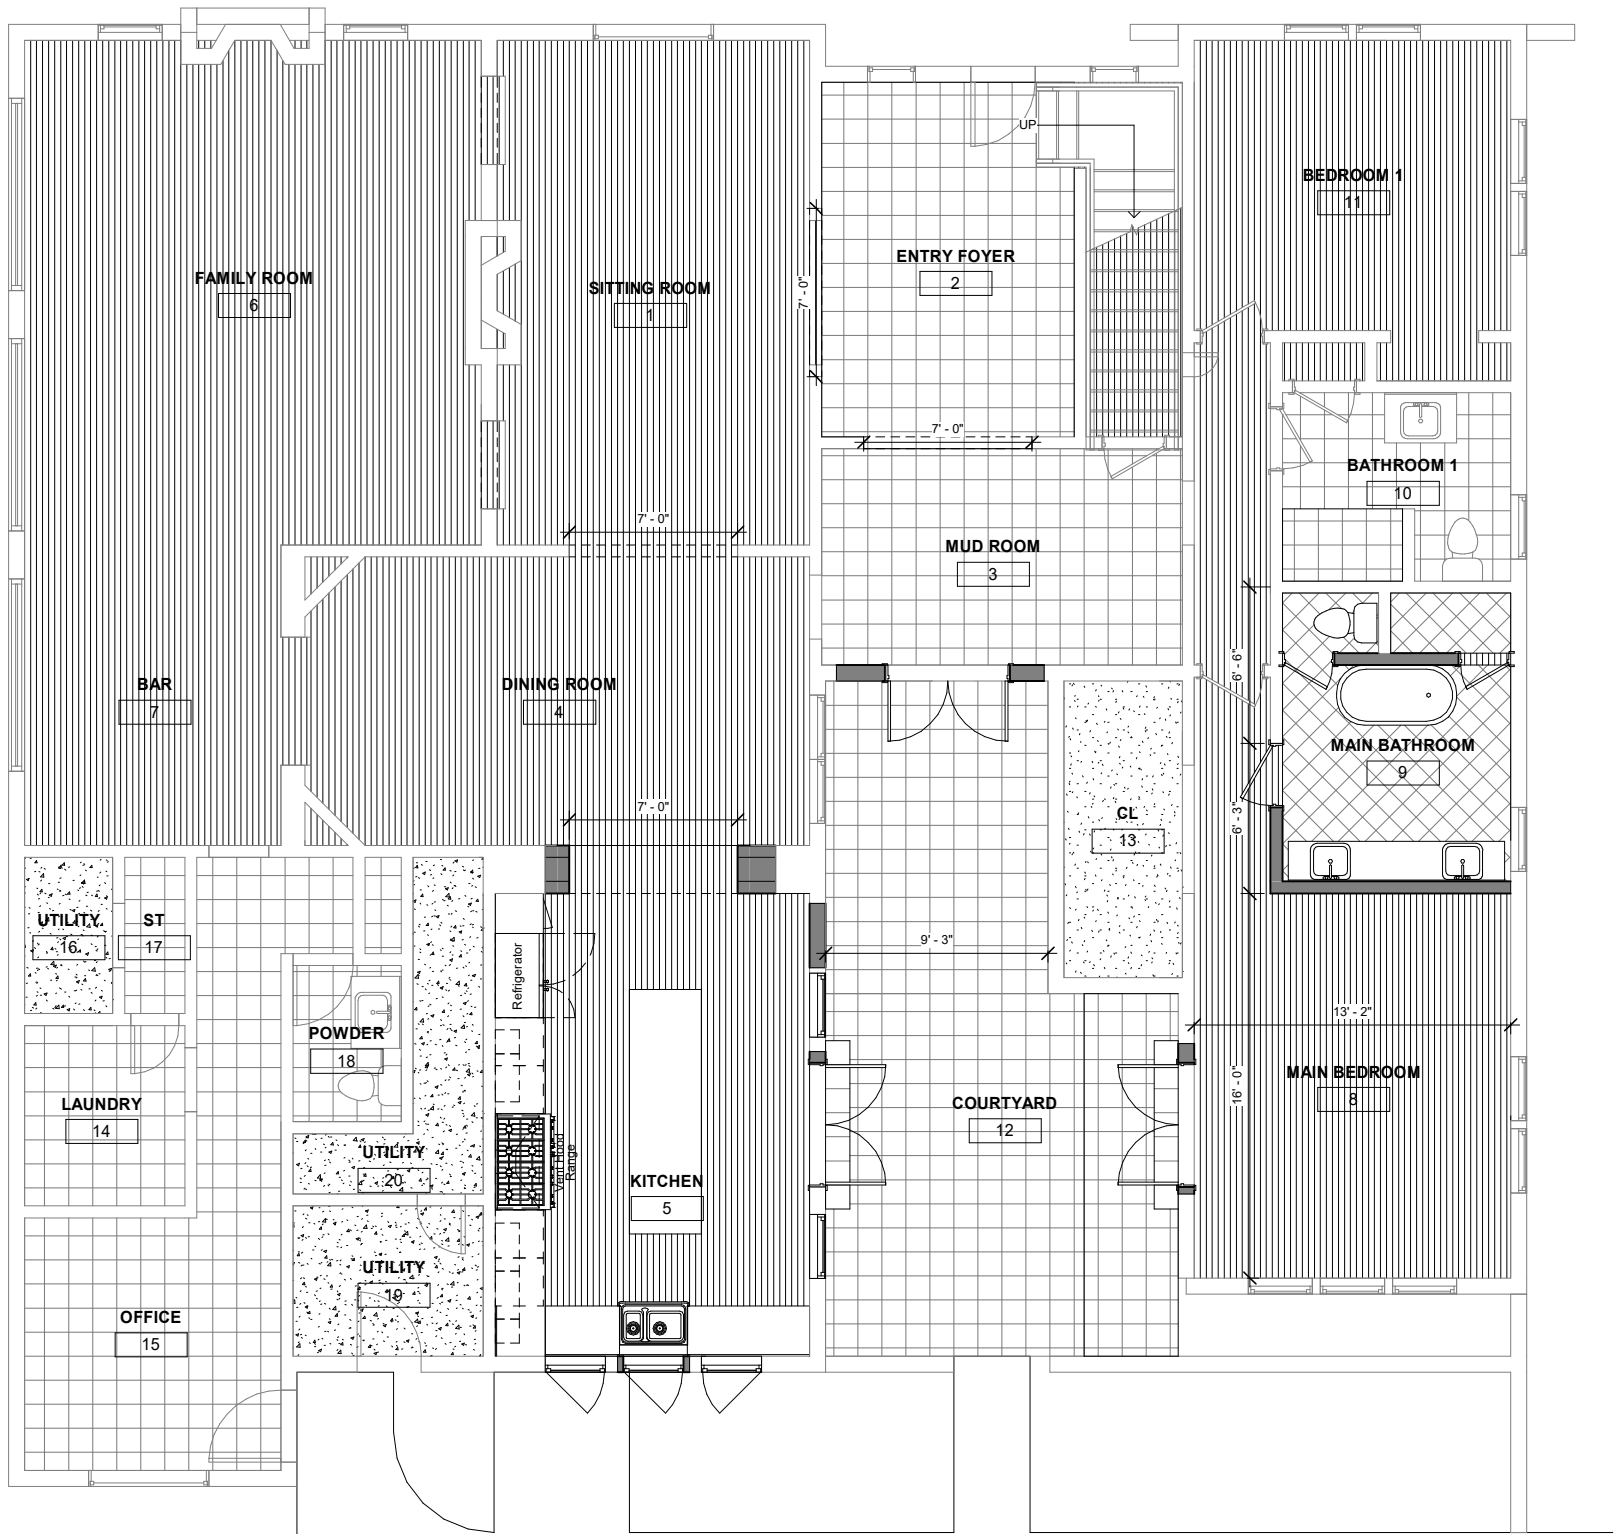
NEW FLOOR PLAN

- Repair Stucco finish throughout and repaint with same white color
- Reseal Windows and Doors
- Rehabilitate Leaking Windows: Carpenter to rebuild in same historic likeness and wood construction methodology
- Repair existing leaking modified bitumen roofing membrane
- Reseal flat roof joints and seams
- Landscape front yard with drought tolerant vegetation

- Repair and level Foundation
- Repair and replace broken, rotted, and/or damaged framing
- Replace rotted wood flooring
- Repair and Restore and historic wood flooring: sand, seal, replace broken/rotting/missing boards
- Remove period inappropriate interventions and replace with contemporary complimentary interventions: remove fiberglass columns and arches and replace with simple archways. Remove dark stained particle board kitchen cabinetry and replace with solid wood kitchen cabinetry and countertops.
- Update/Renovate Main Bathroom layout, tile, electrical, and plumbing fixtures
- Paint and finish throughout

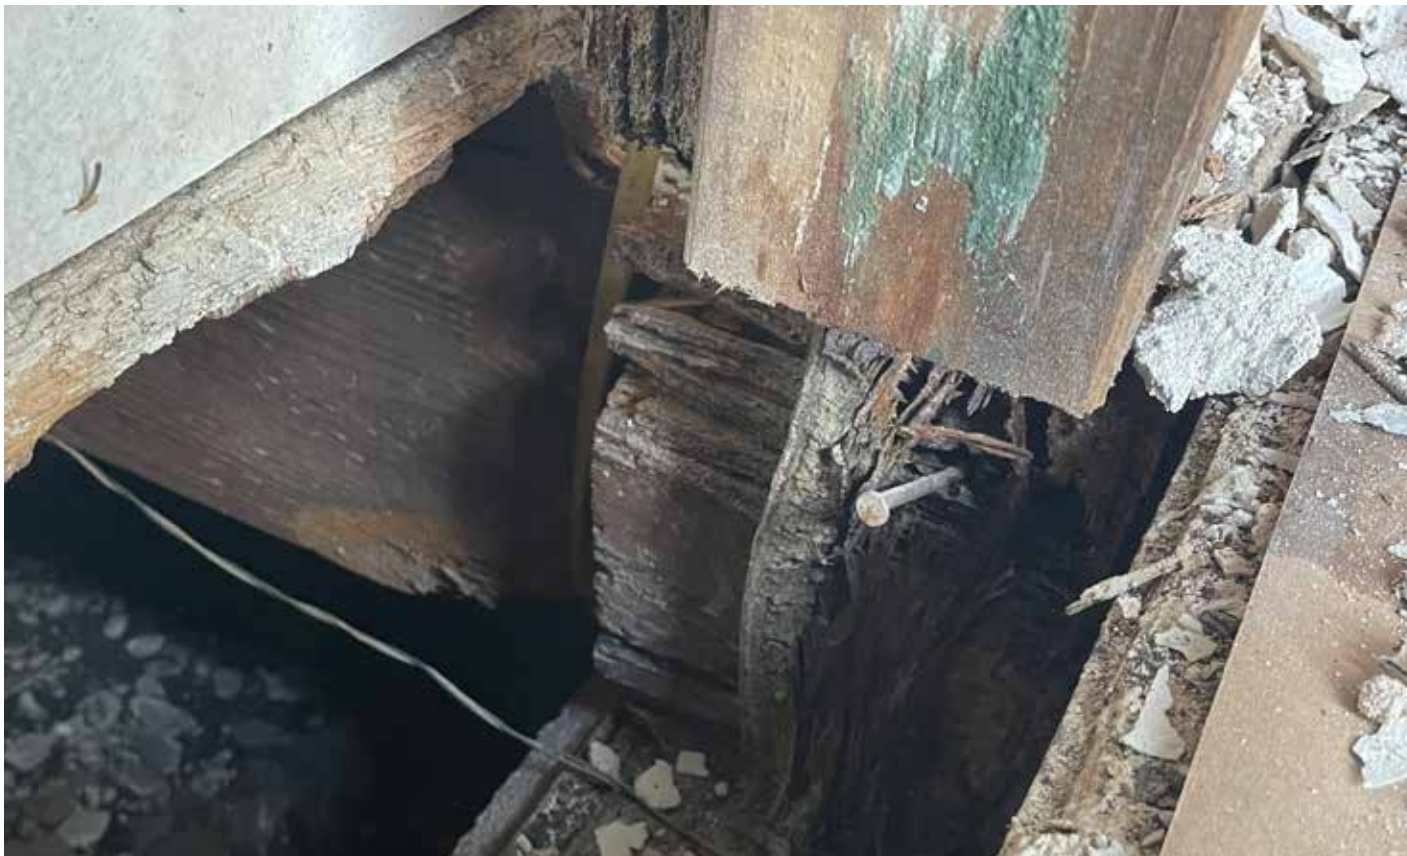
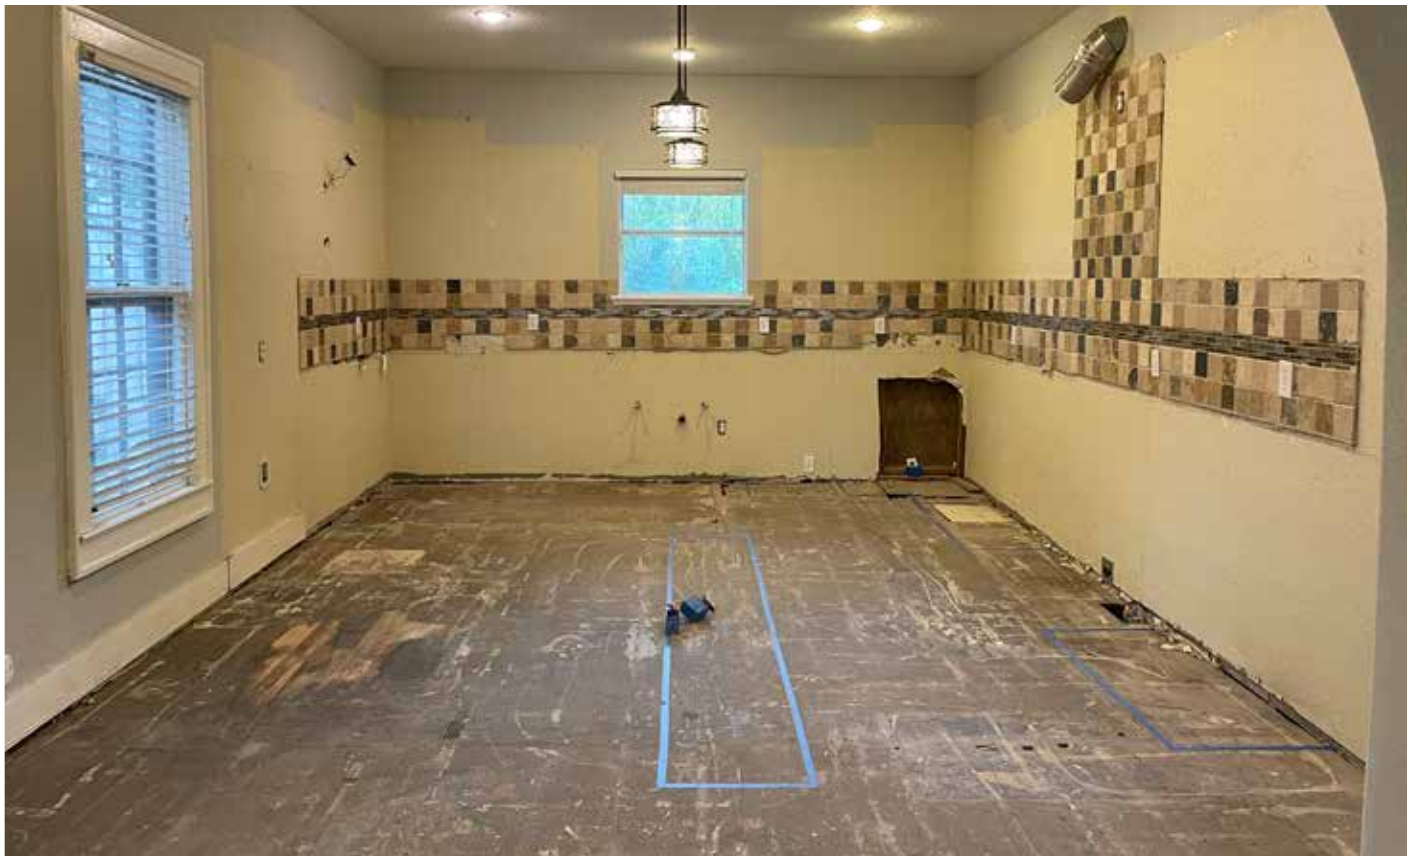
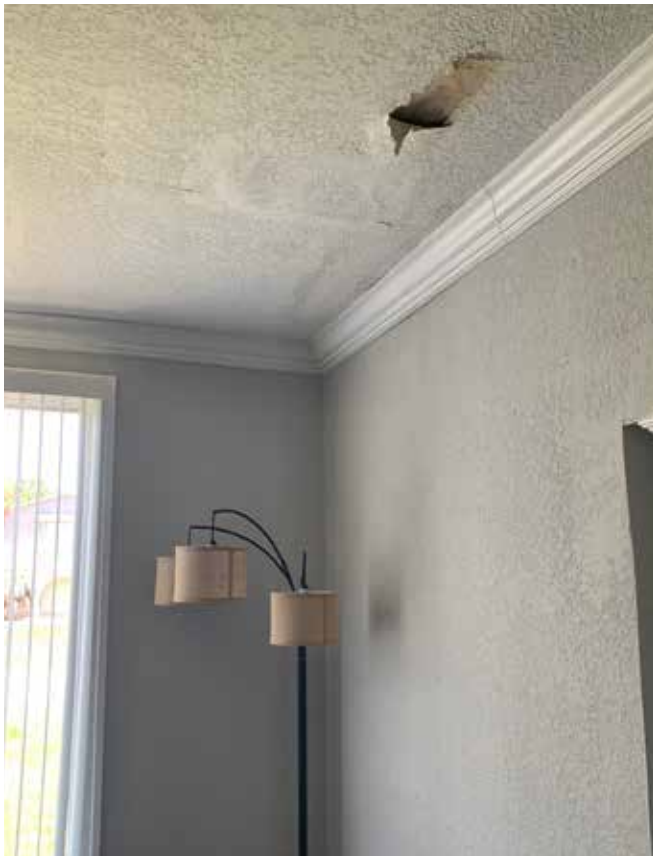
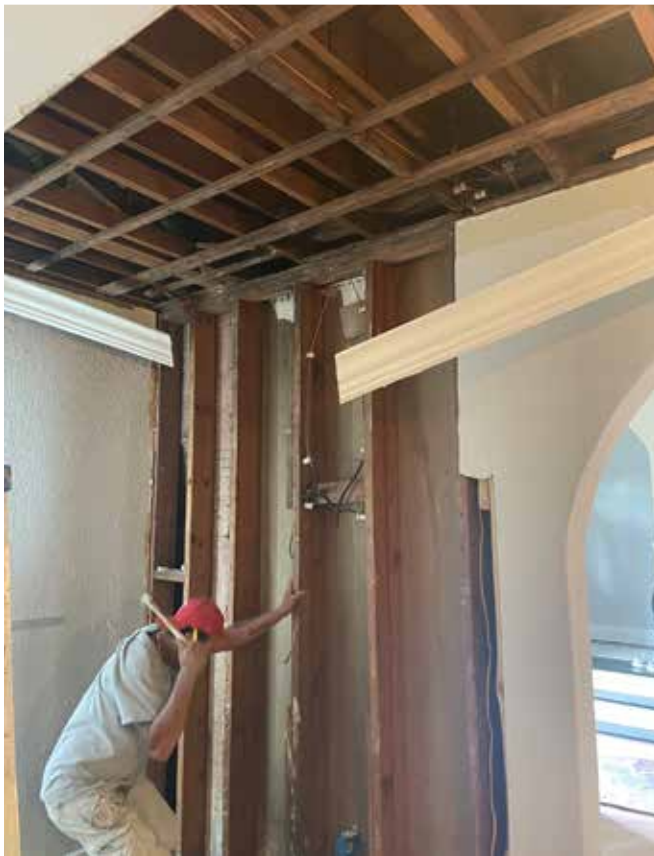
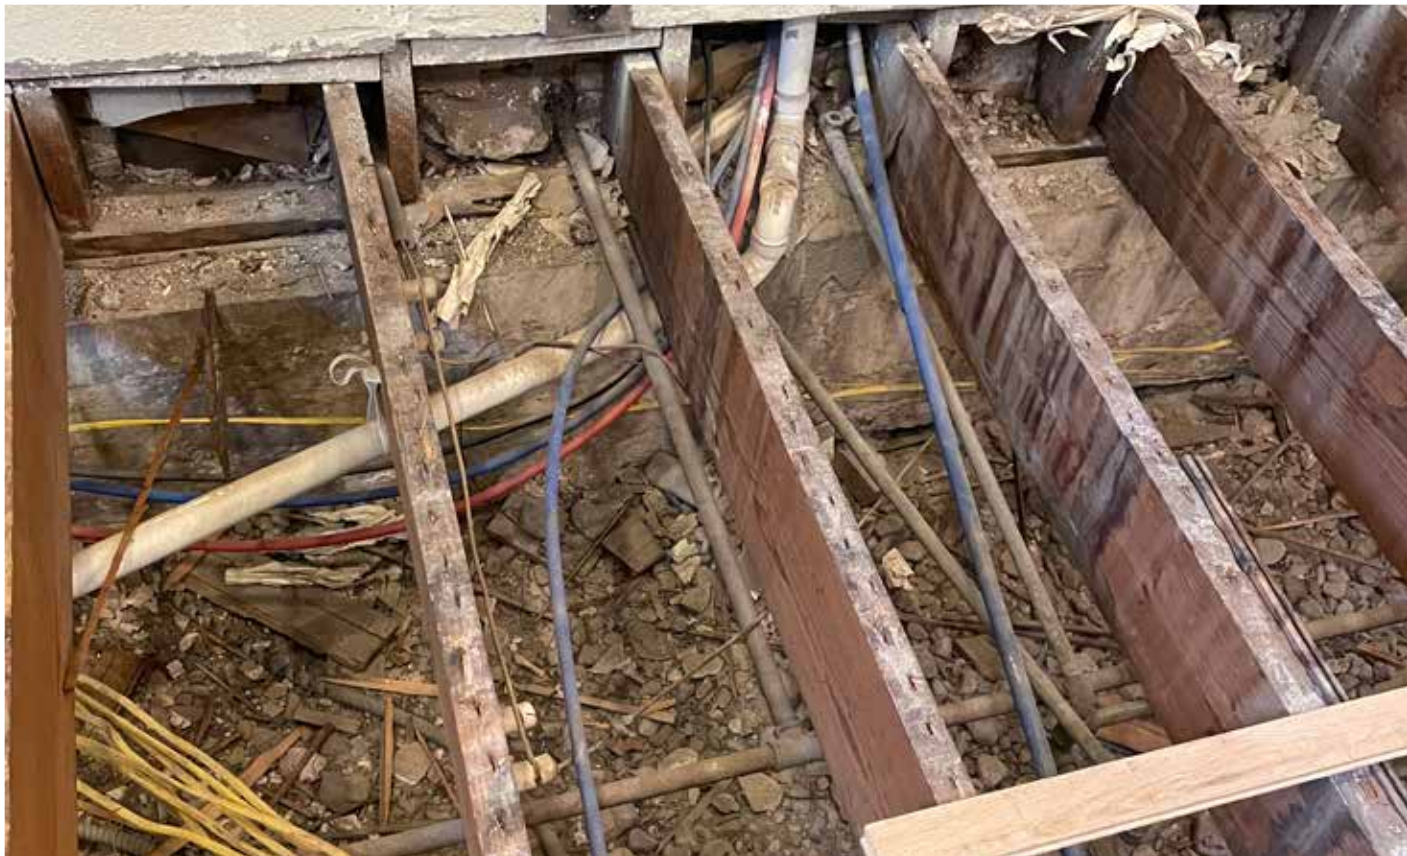
TERMITE DAMAGE, WATER DAMAGE, AND ROTTED FOUNDATIONS

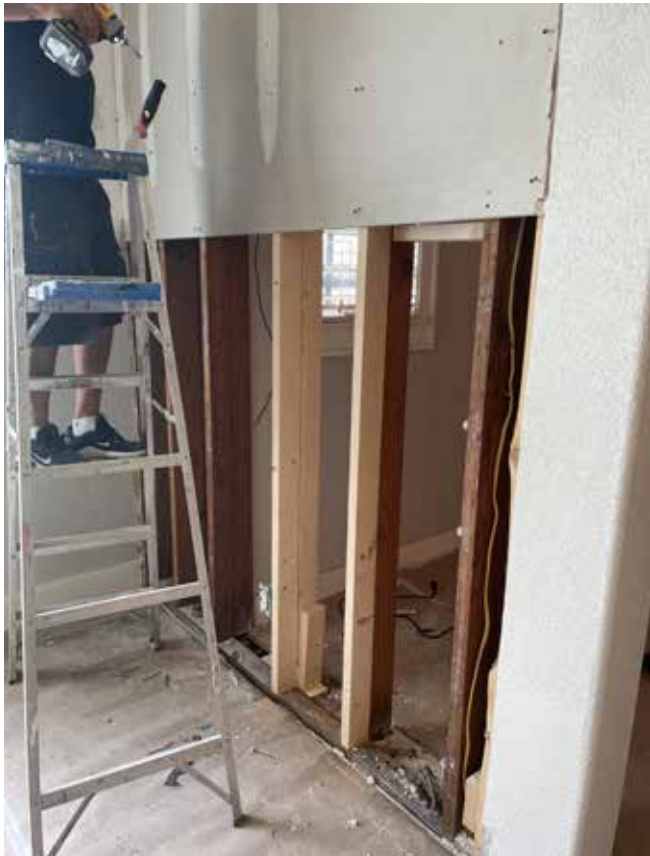
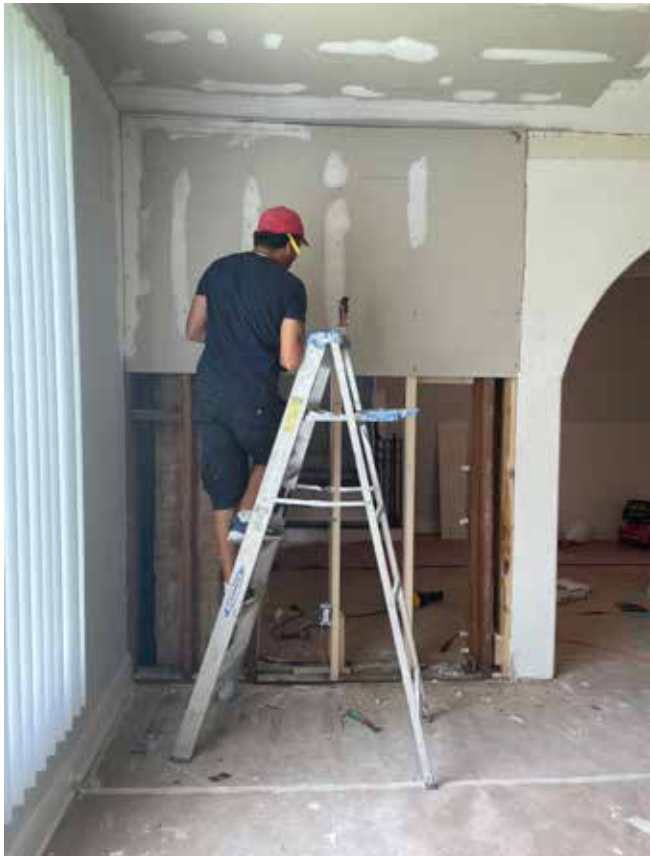
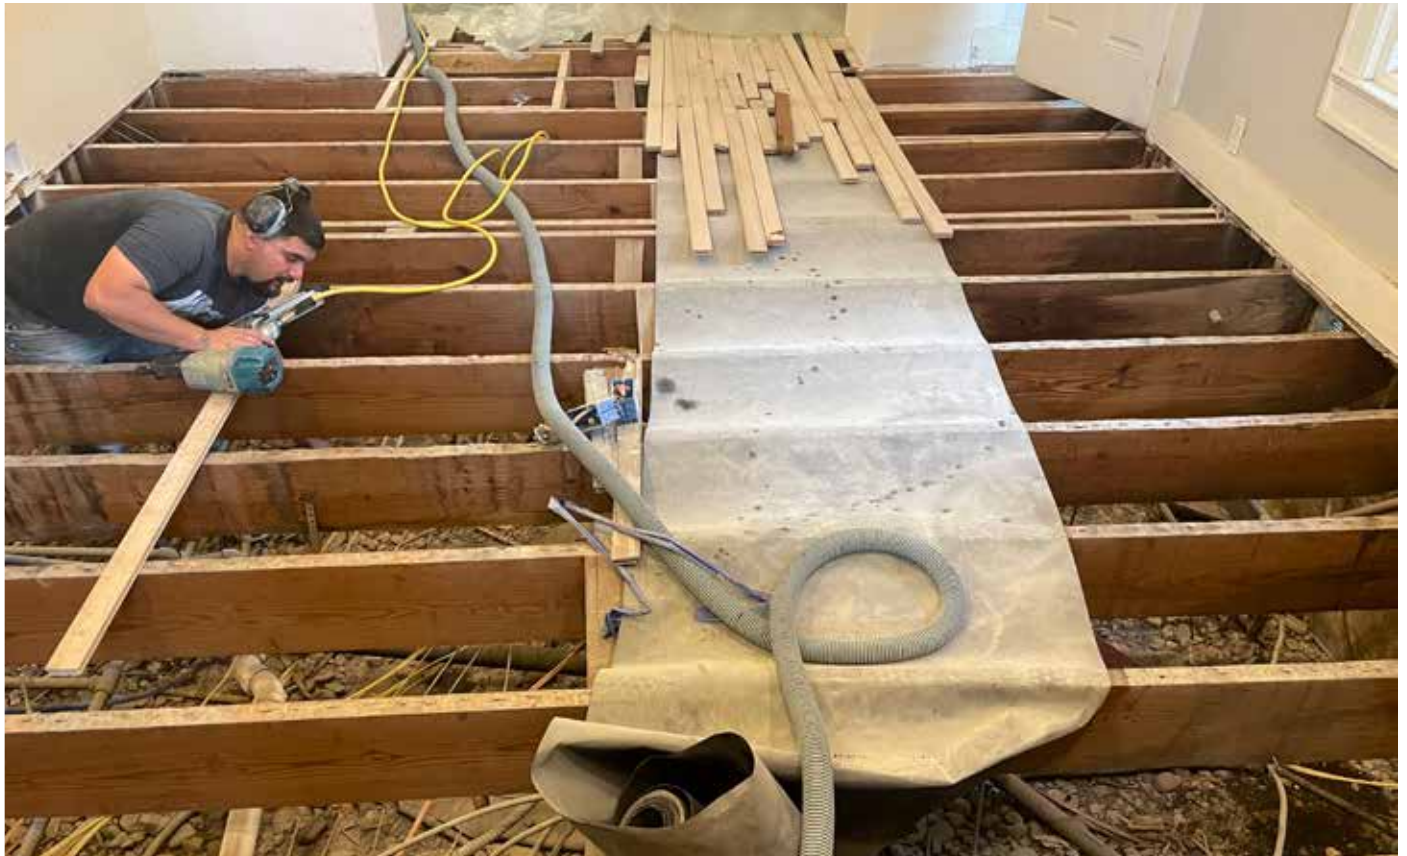
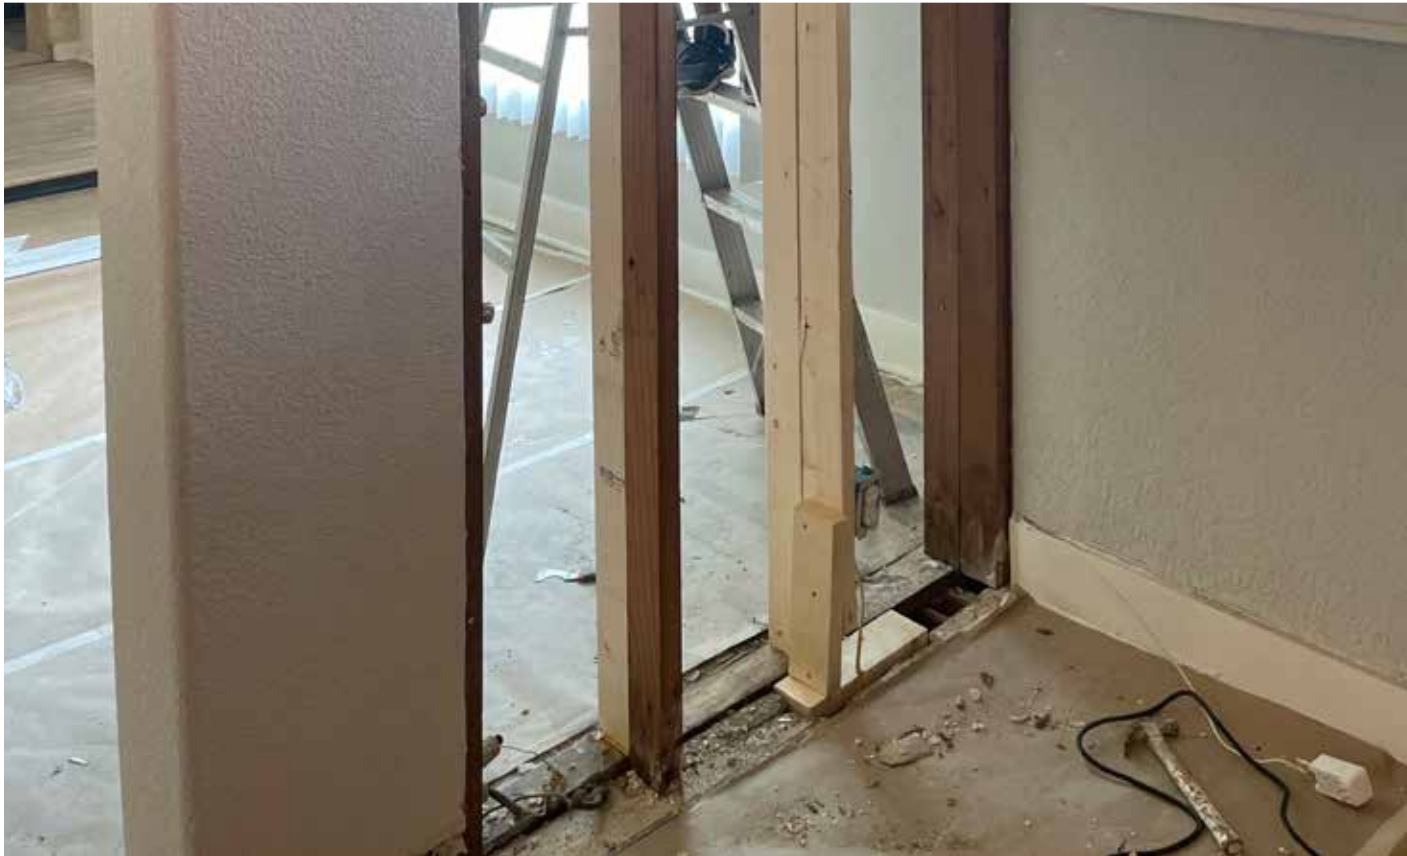
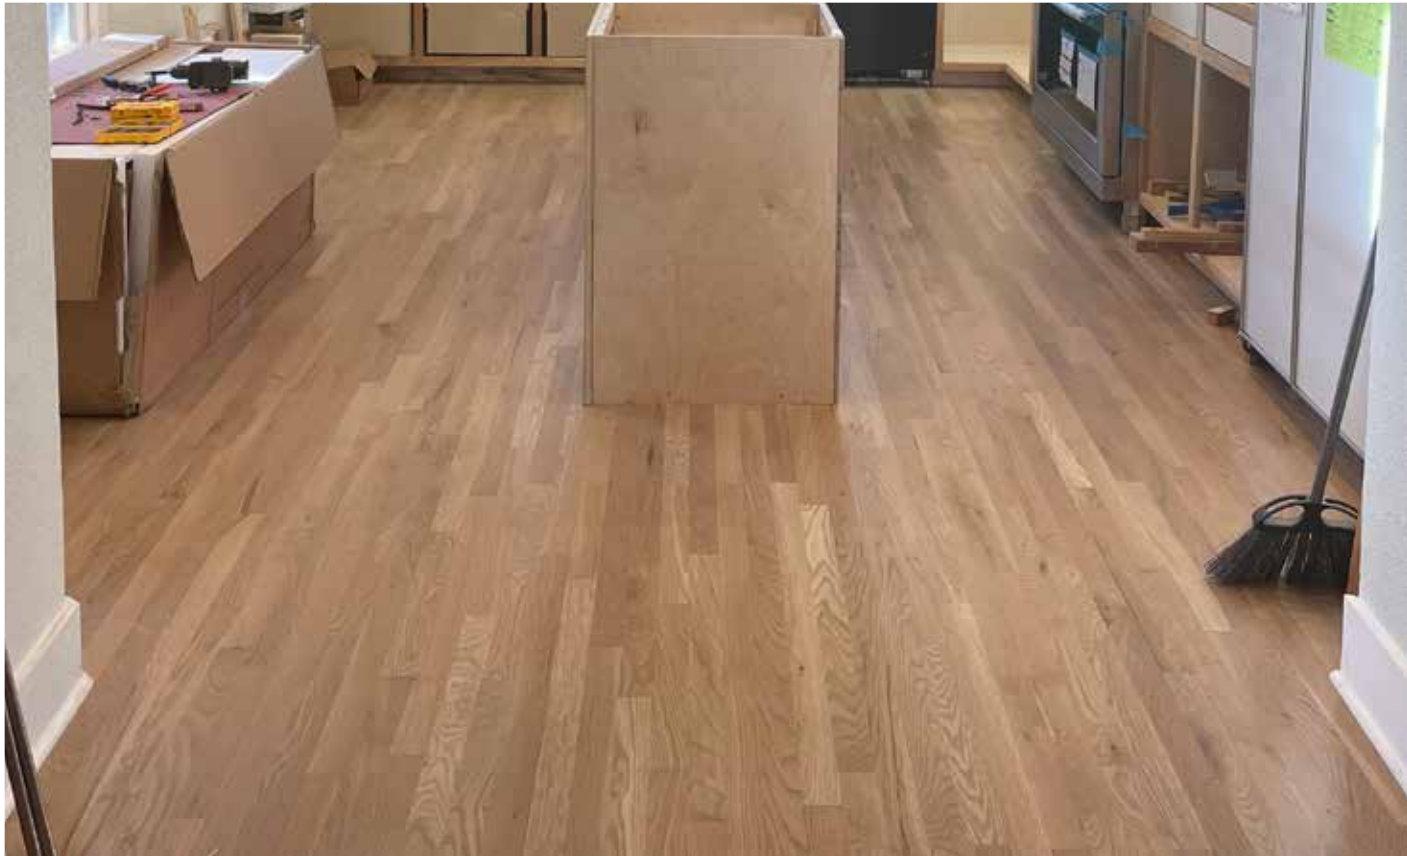
NEW FRAMING, REPAIRED FOUNDATIONS, NEW FLOORING TO MATCH EXISTING

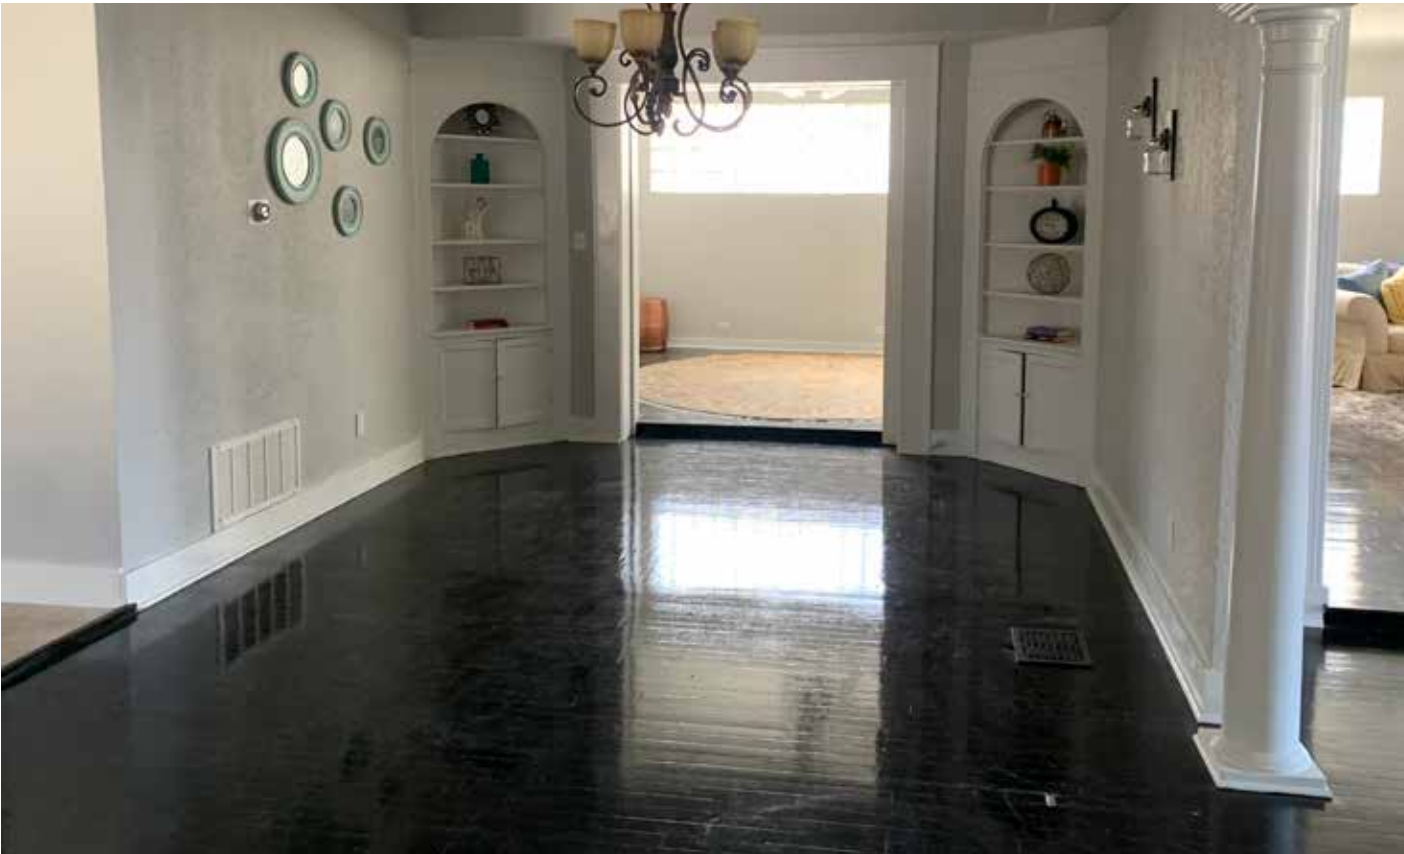
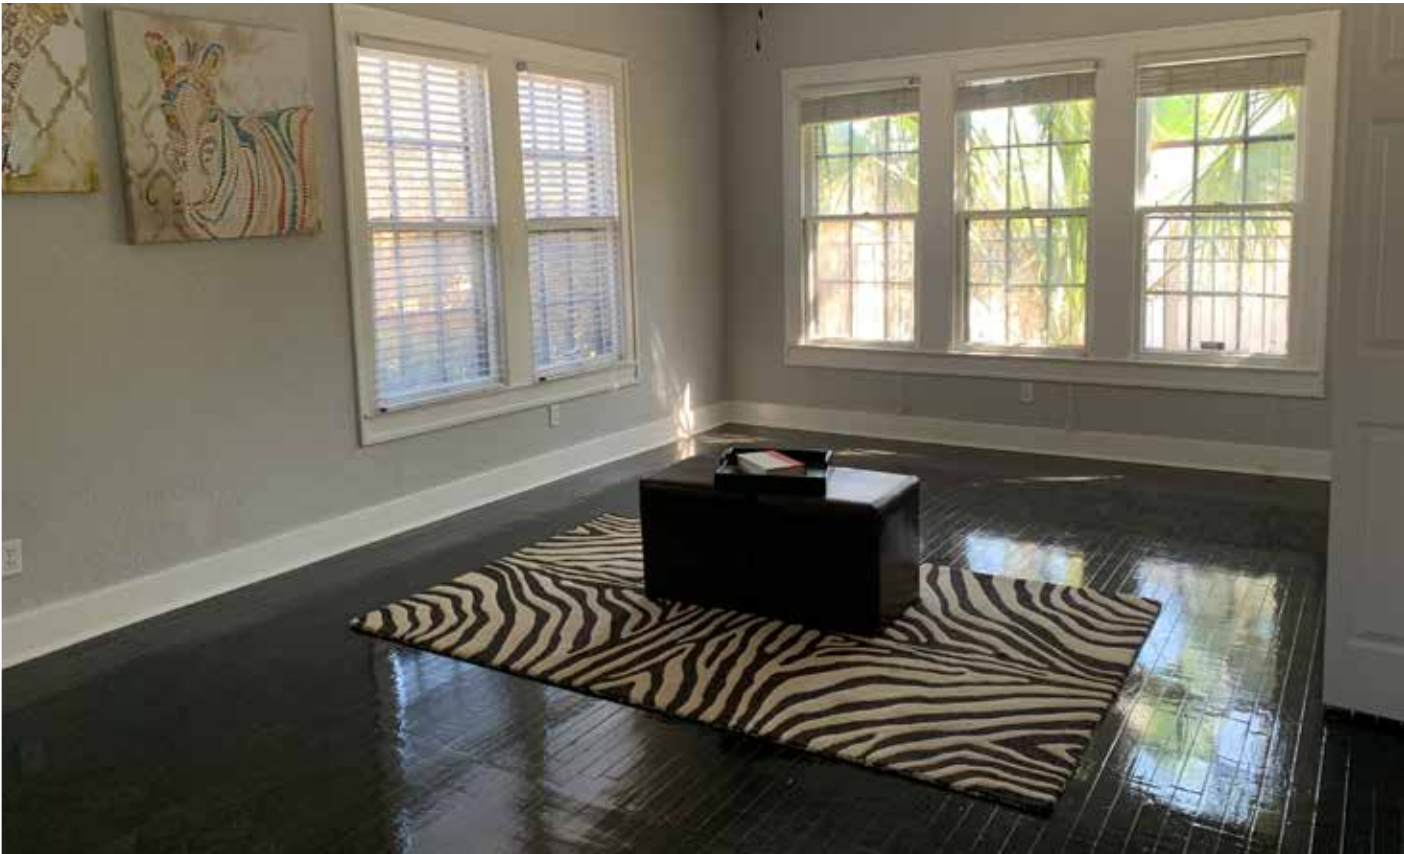
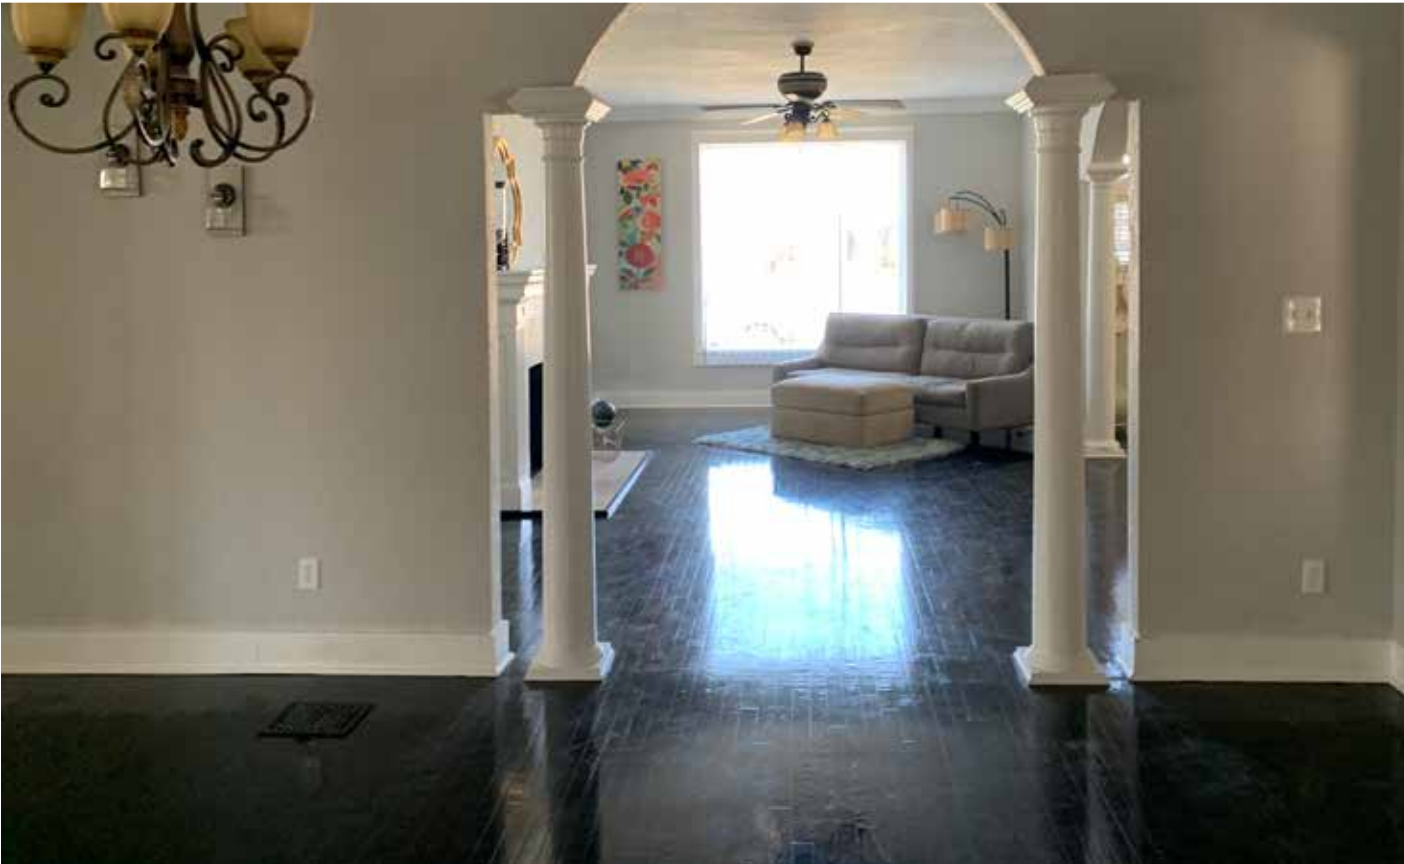
PAINTED ORIGINAL FLOORING

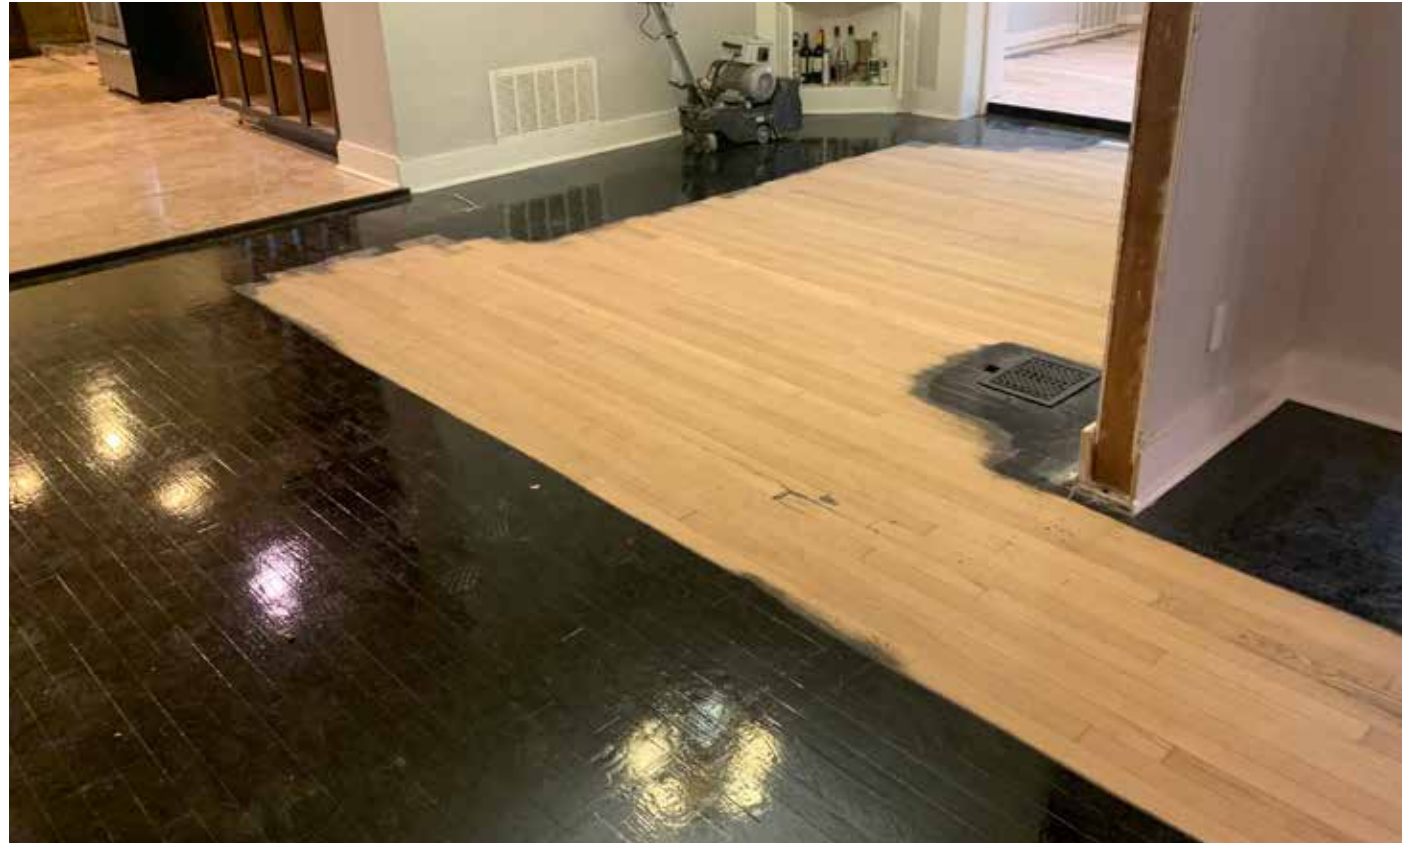
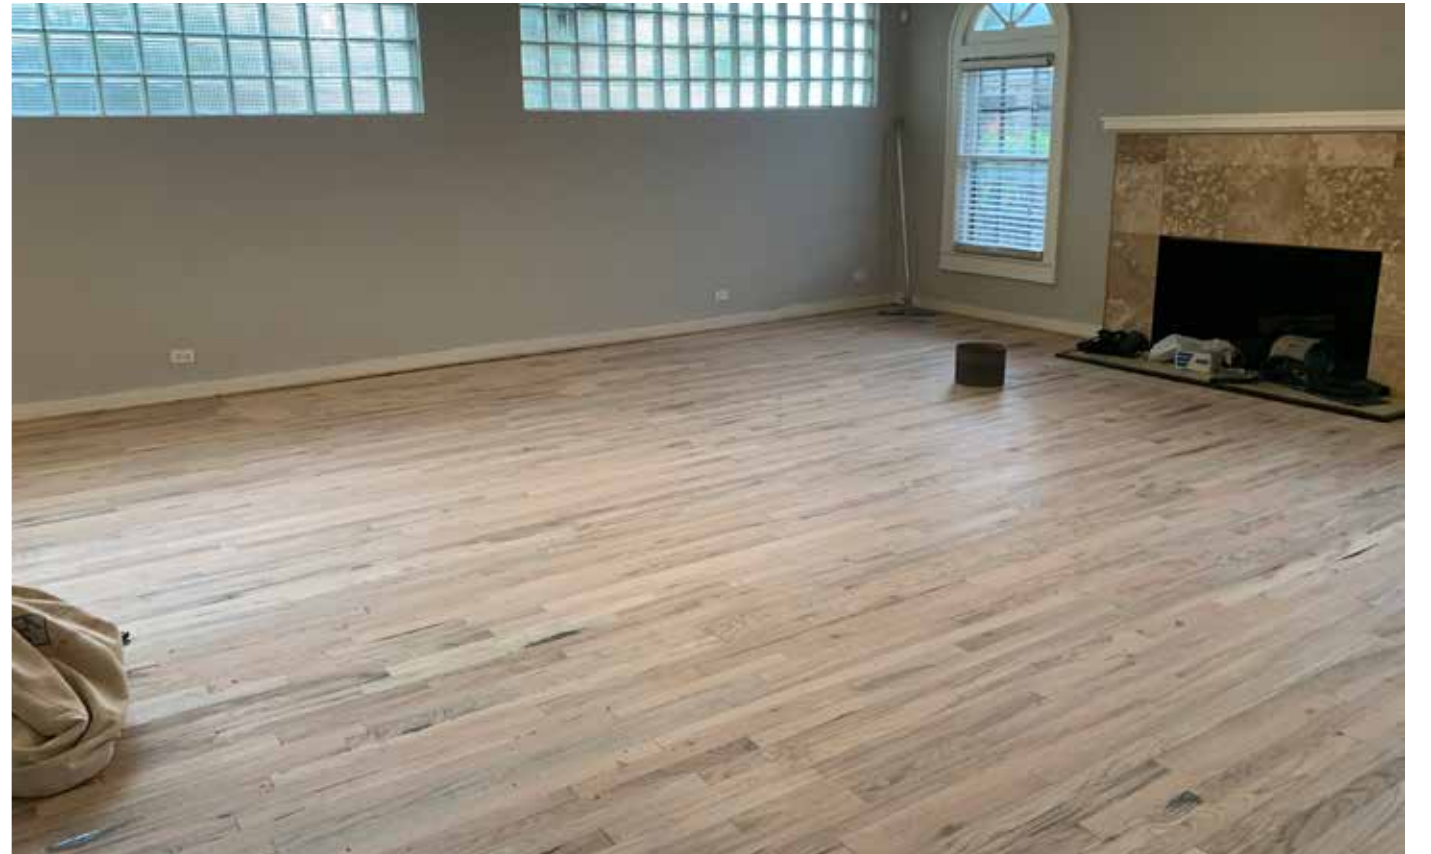
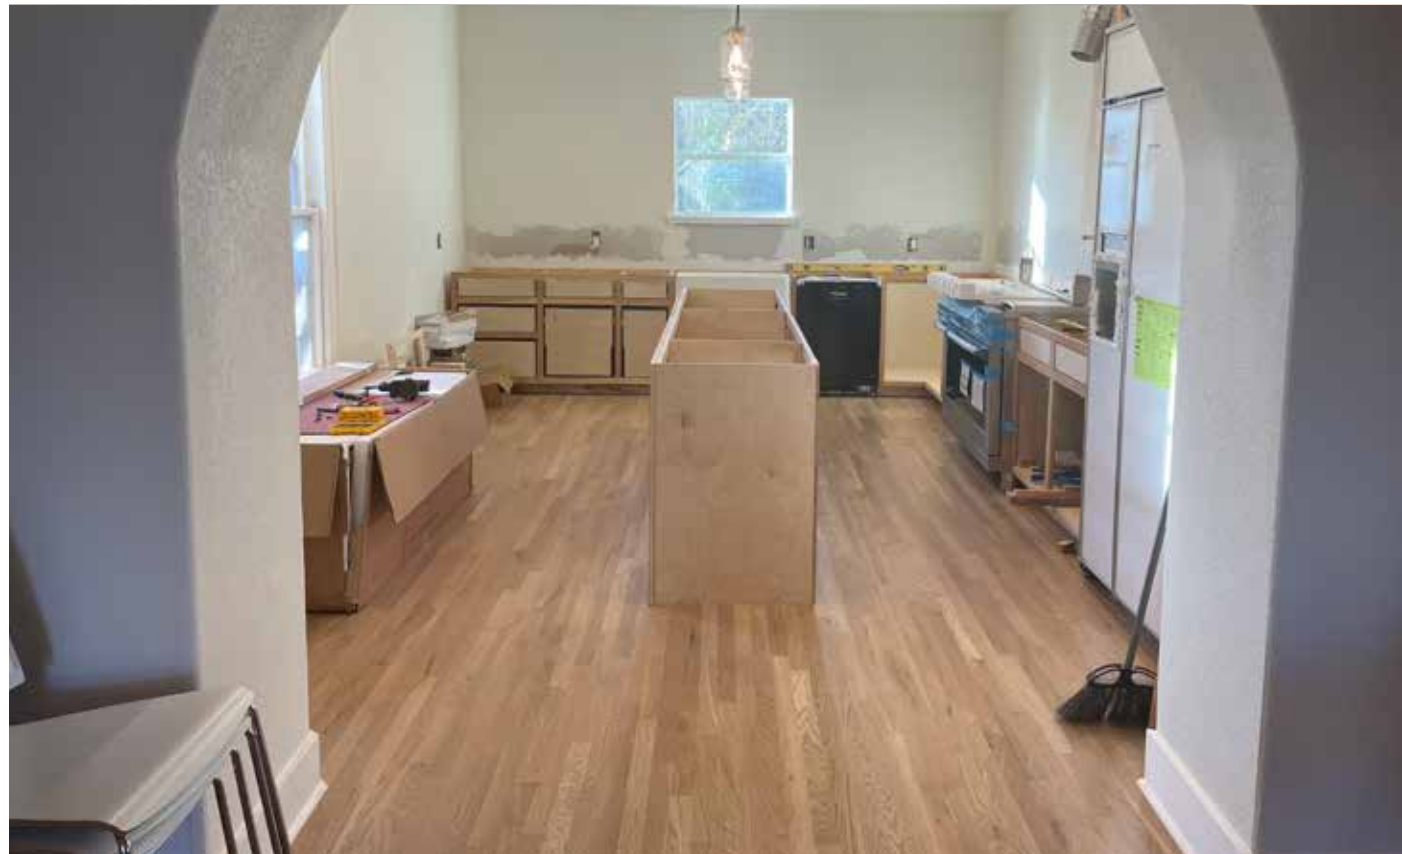
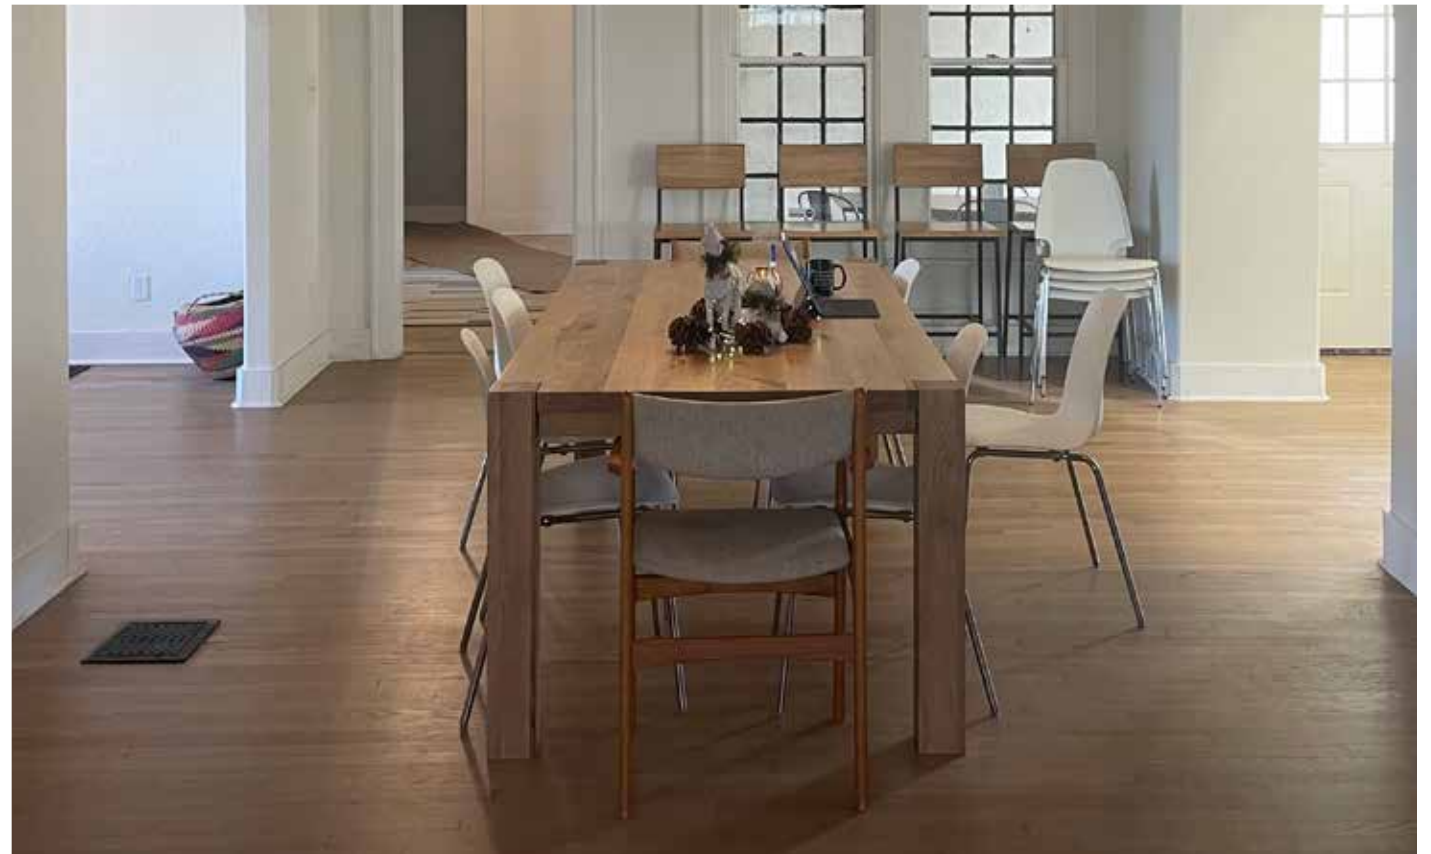
REFINISHED AND RESTORED ORIGINAL FLOORING THROUGHOUT
