HISTORIC AND DESIGN REVIEW COMMISSION

HDRC CASE NO: 2022-065
ADDRESS: 202 MARY LOUISE
LEGAL DESCRIPTION: NCB 6699 BLK 8 LOT 21
ZONING: R-6, H
CITY COUNCIL DIST.: 7
DISTRICT: Monticello Park Historic District
APPLICANT: Benjamin & Jennifer Rosas
OWNER: Benjamin & Jennifer Rosas
TYPE OF WORK: Historic Tax Verification
APPLICATION RECEIVED: January 21, 2022
60-DAY REVIEW: Not applicable due to City Council Emergency Orders
CASE MANAGER: Rachel Rettaliata

The applicant is requesting Historic Tax Verification for the property at 202 Mary Louise.

HISTORIC REHABILITATION APPLICATION PART 2 | JANUARY 2022

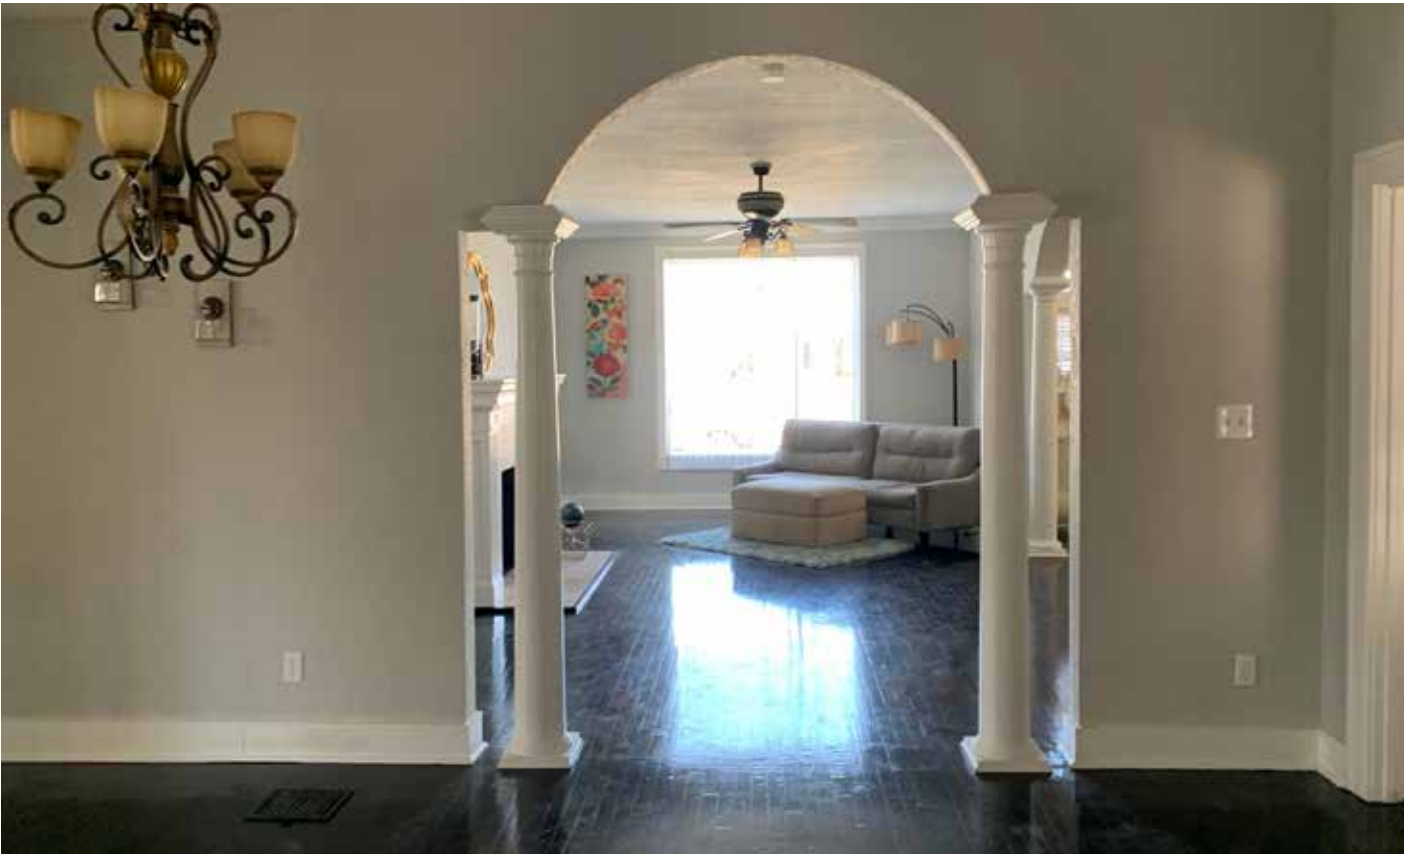
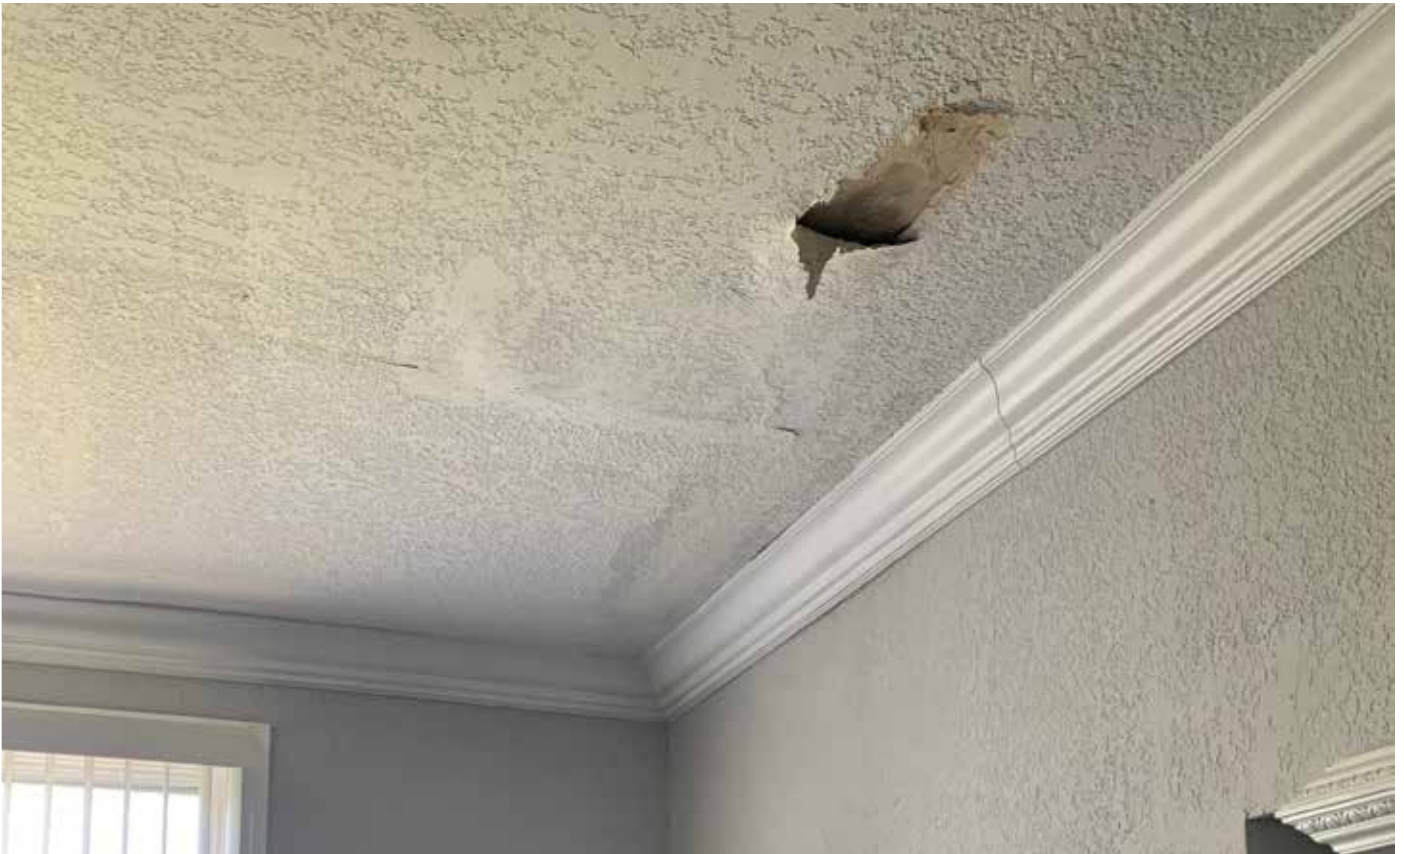
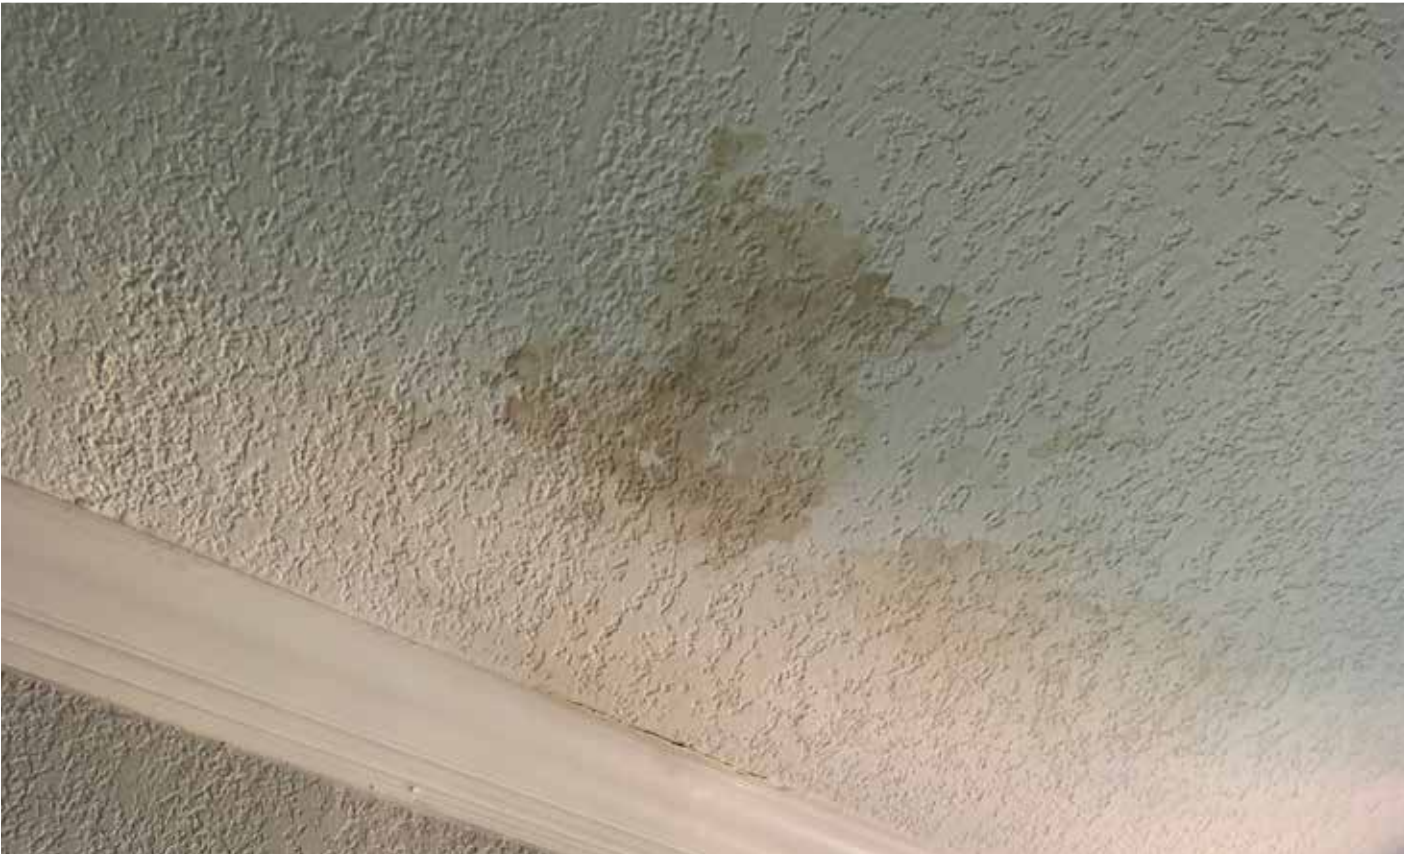
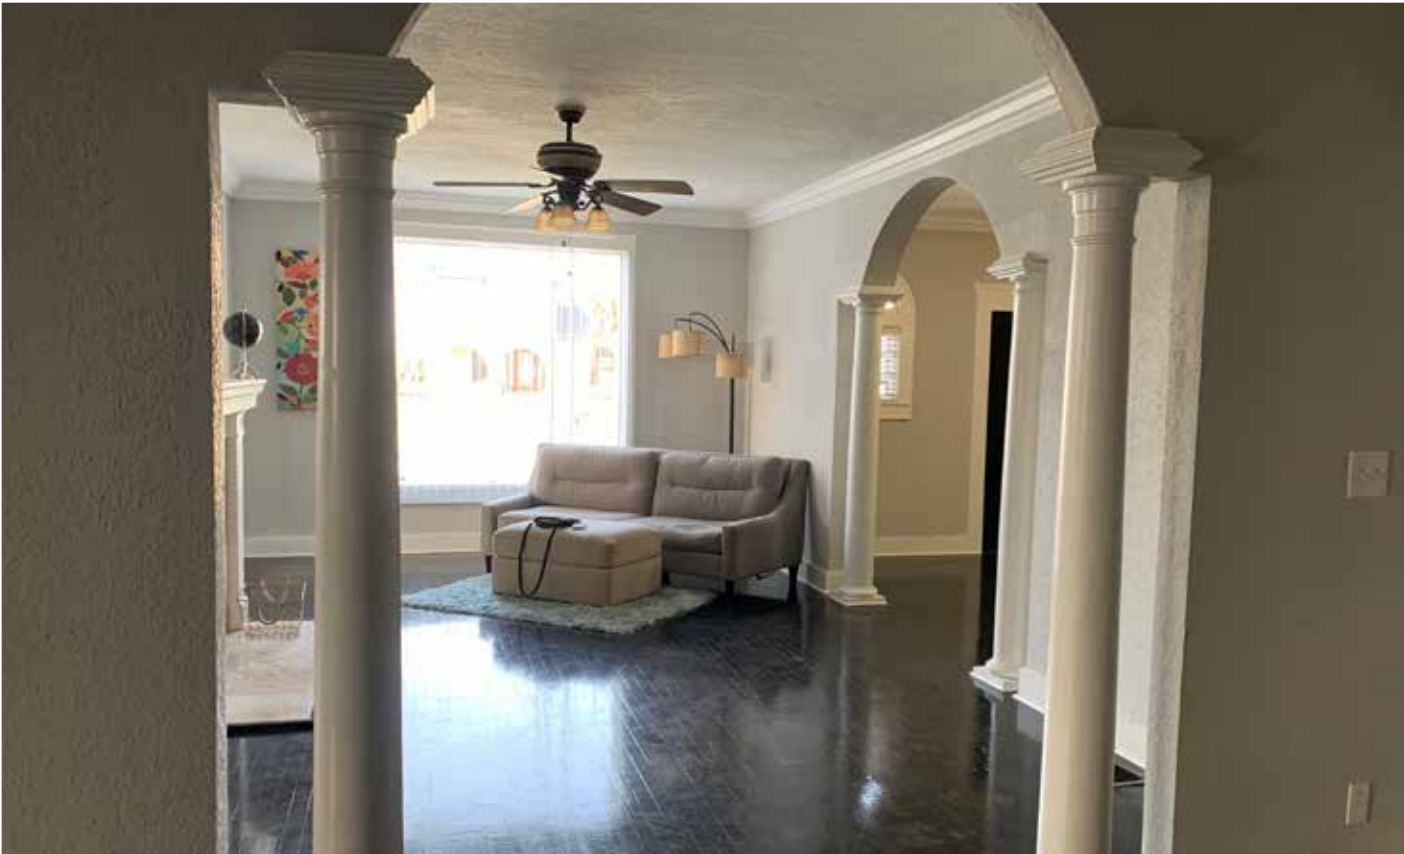
PREVIOUS ARCHES AND ROOF LEAK WATER DAMAGE

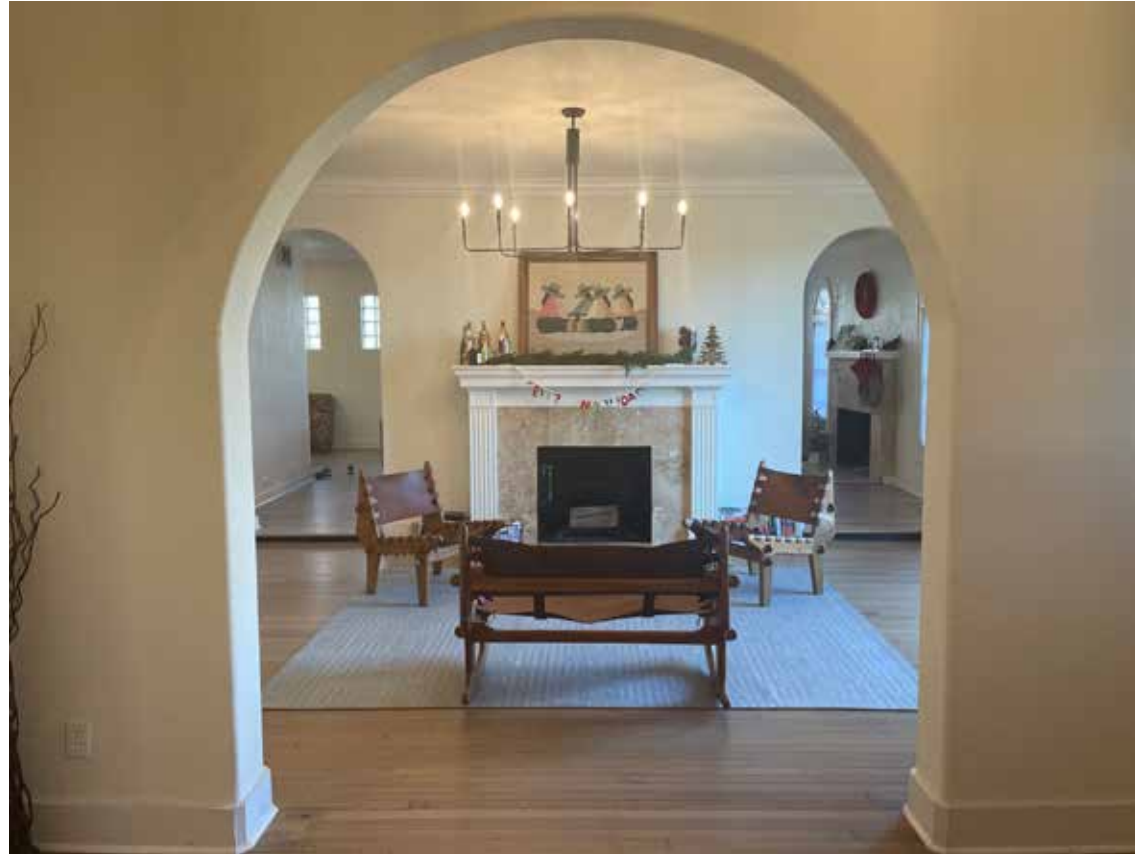
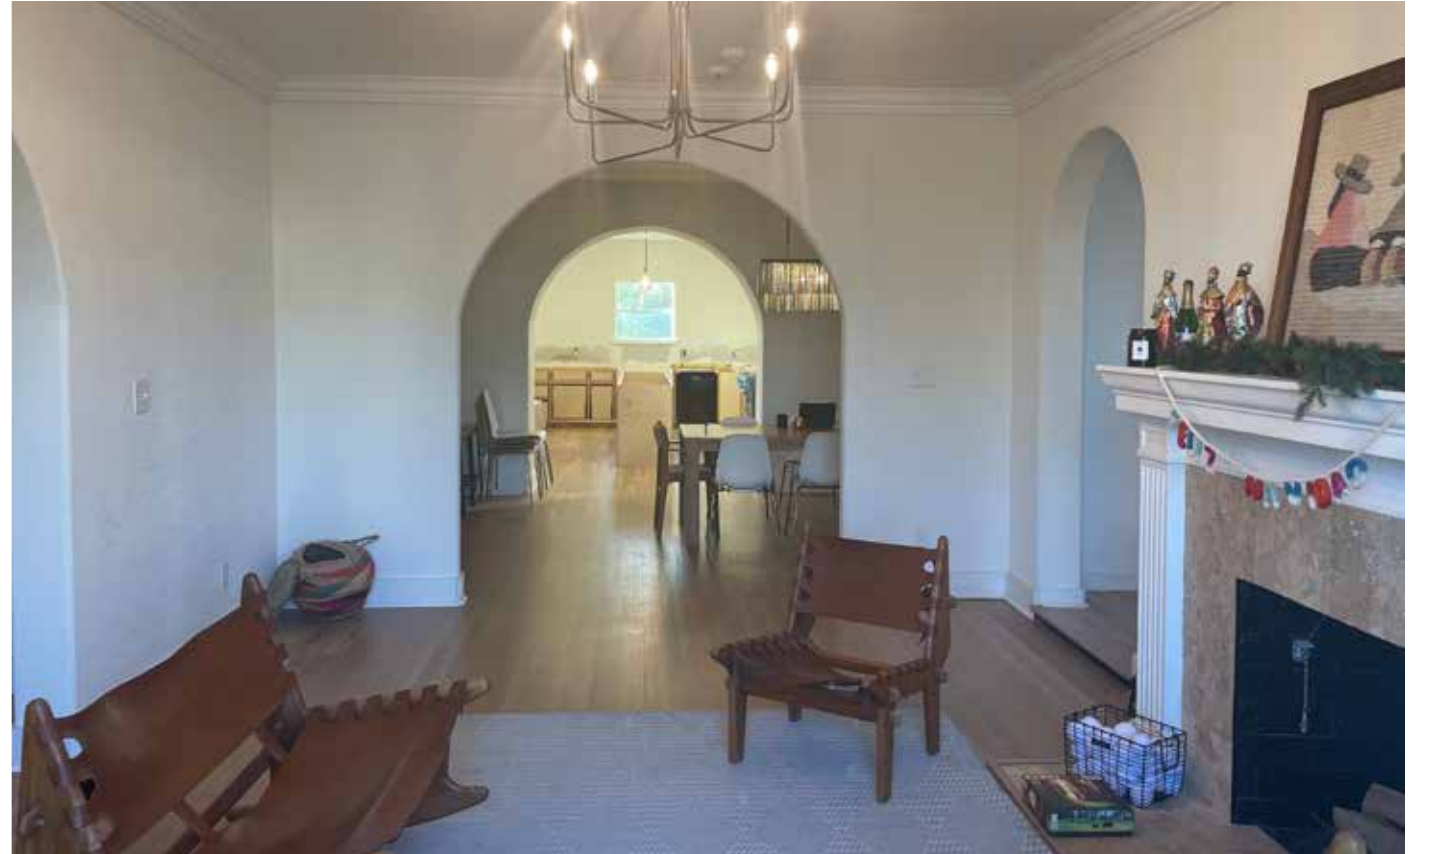
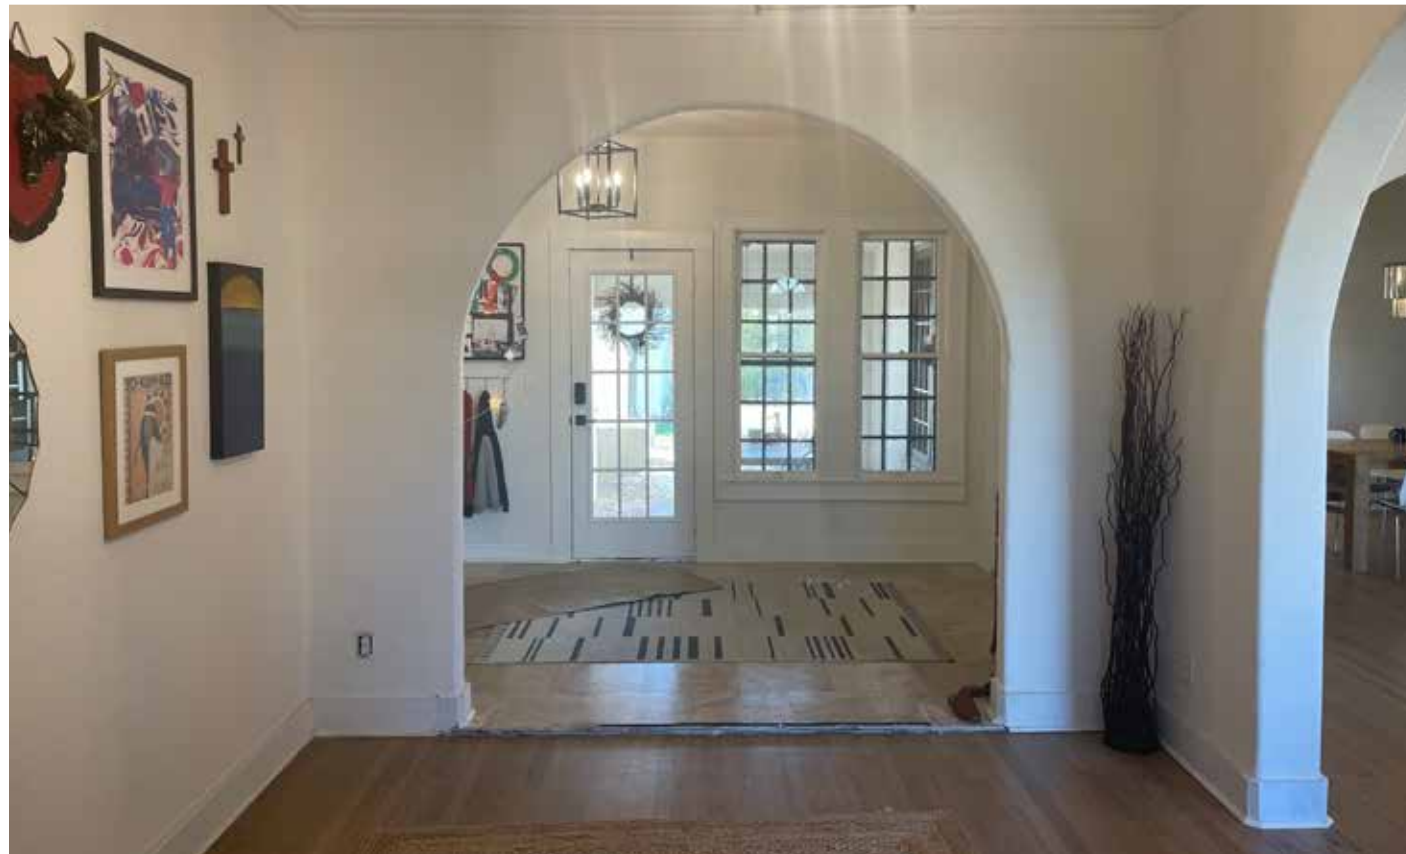
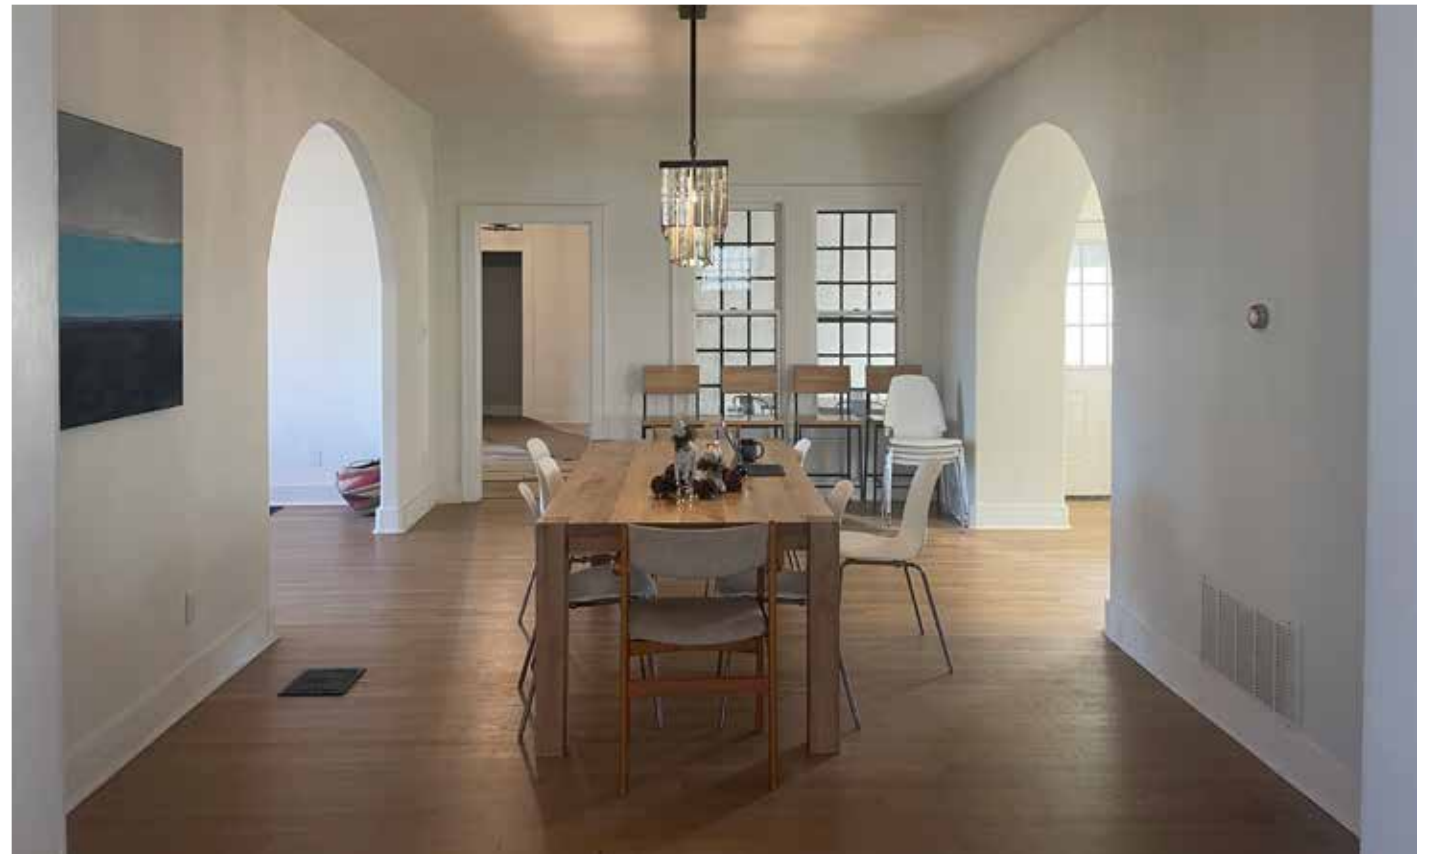
NEW ARCHES AND REPAIRED WATER DAMAGE

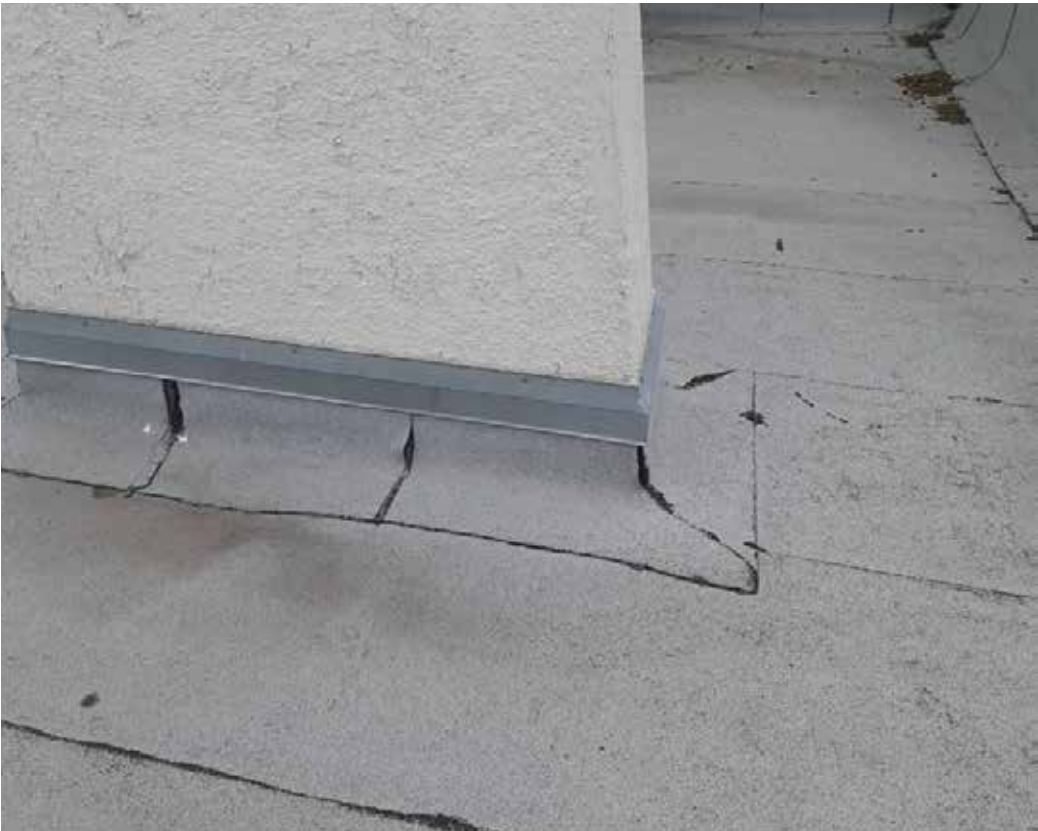
PREVIOUS ROOFING TO BE RESTORED AND REPAIRED

The area with the blisters and openings.

- Repair Stucco finish throughout and repaint with same white color
- Reseal Windows and Doors
- Rehabilitate Leaking Windows: Carpenter to rebuild in same historic likeness and wood construction methodology
- Repair existing leaking modified bitumen roofing membrane
- Reseal flat roof joints and seams
- Landscape front yard with drought tolerant vegetation

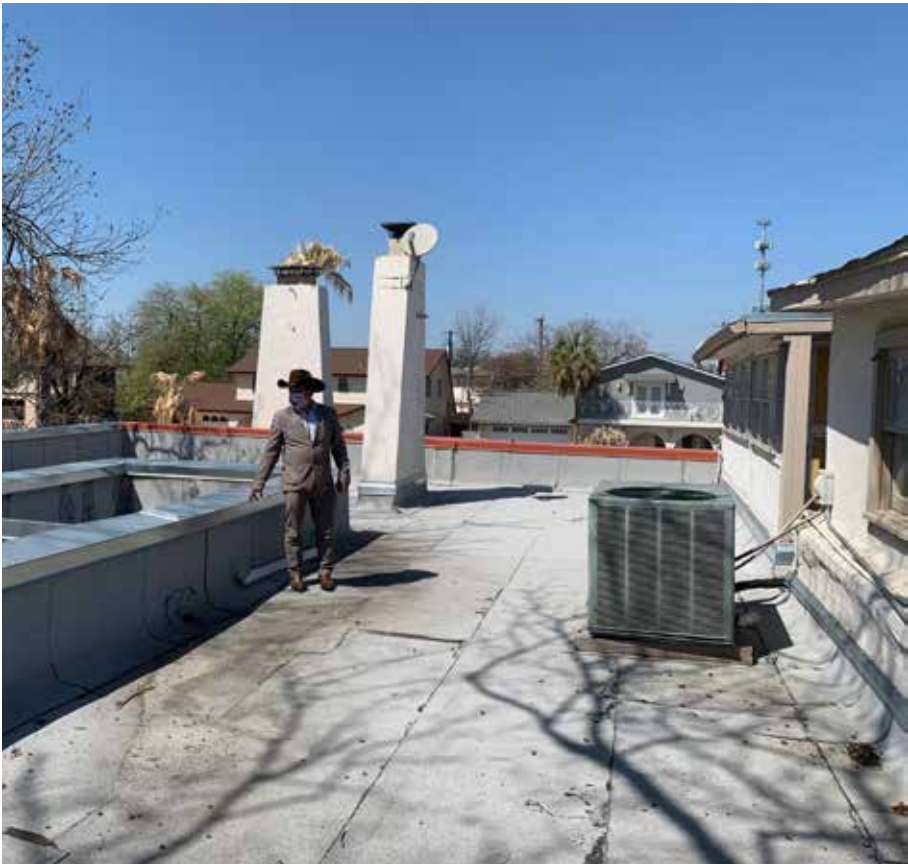
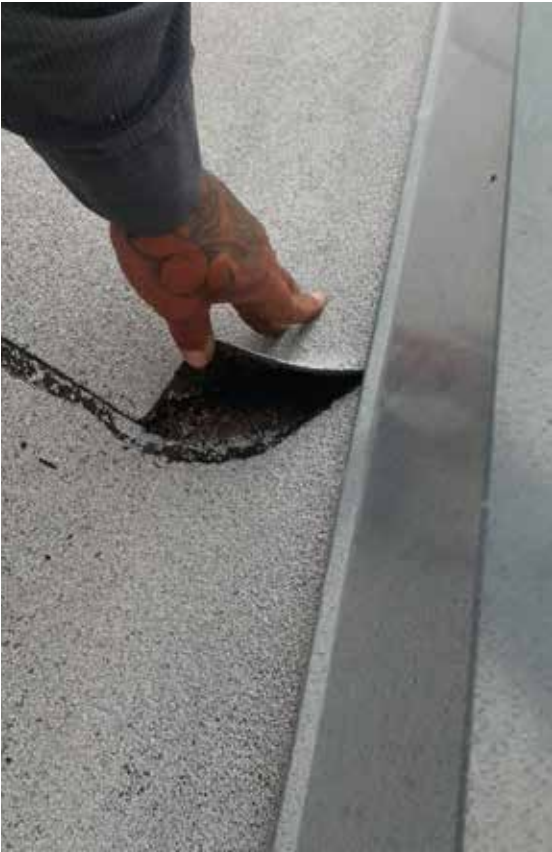
An opening in the SBS

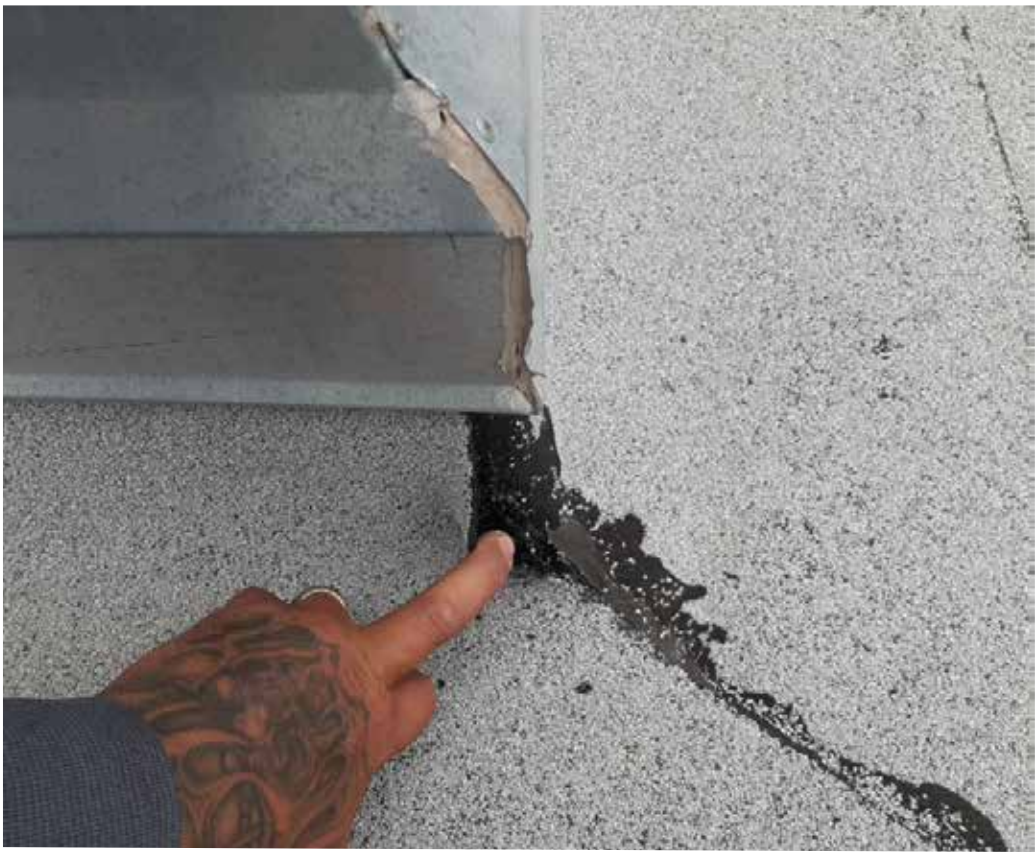
An opening in the SBS

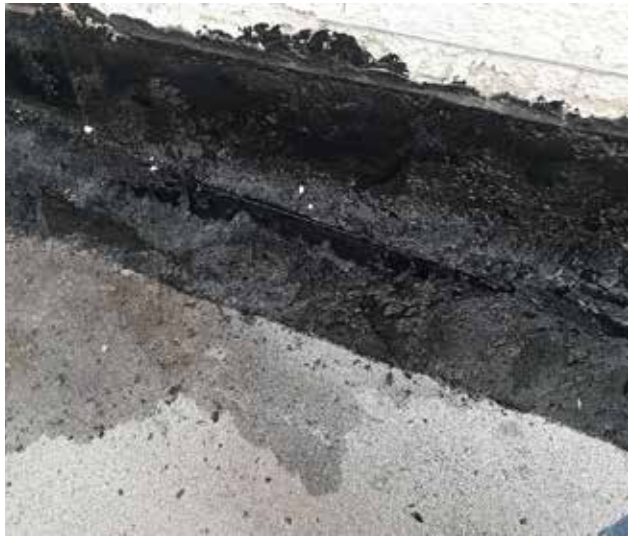
The removed base flashing.

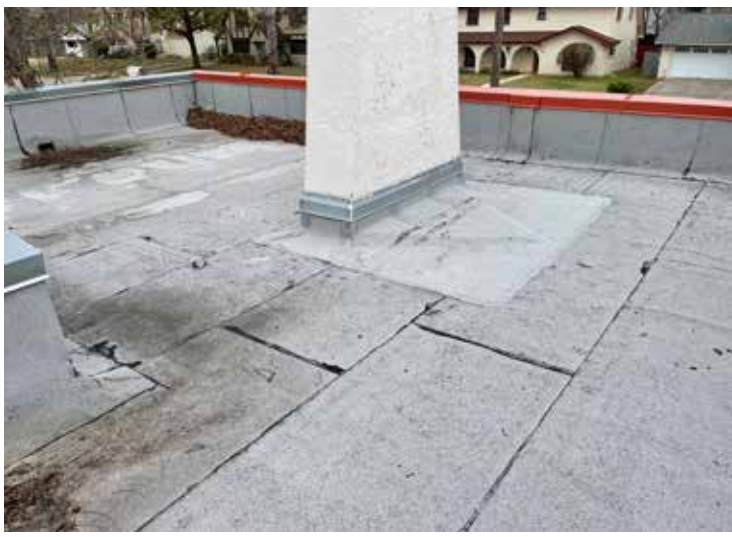
new sbs coating applied

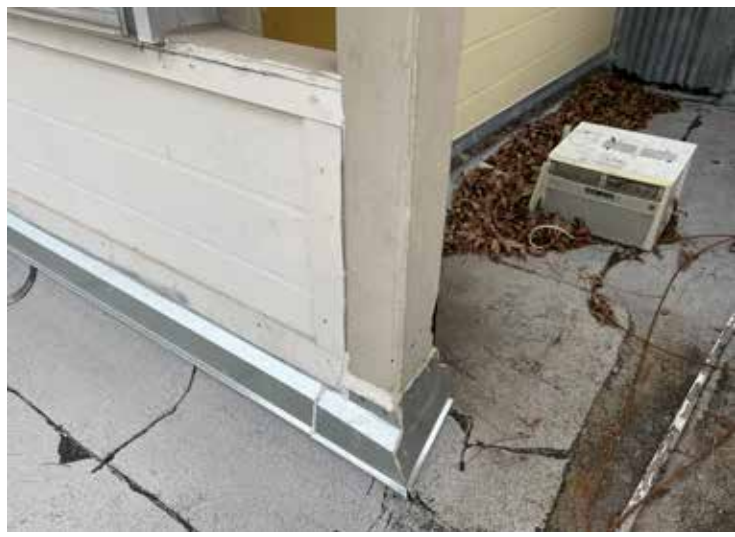
new flashings and sealants applied

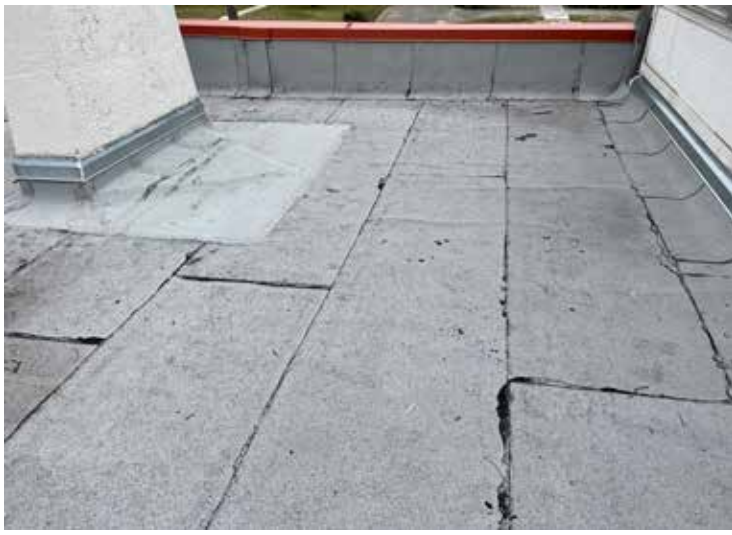
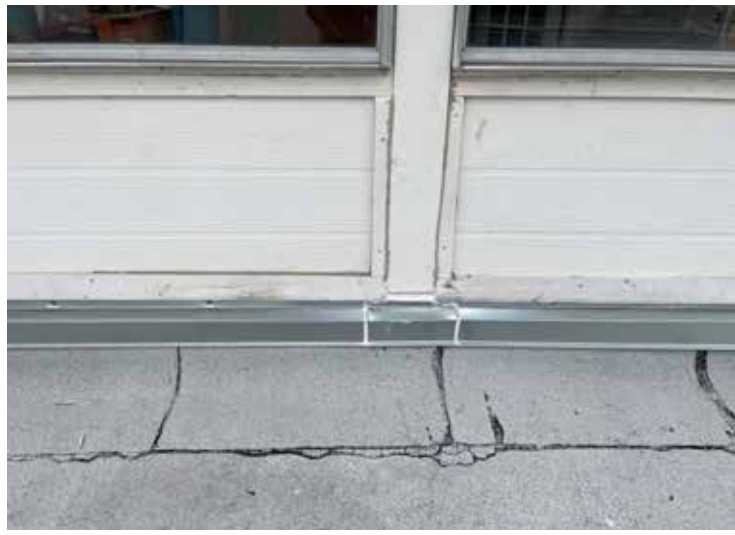
Cricket constructed.

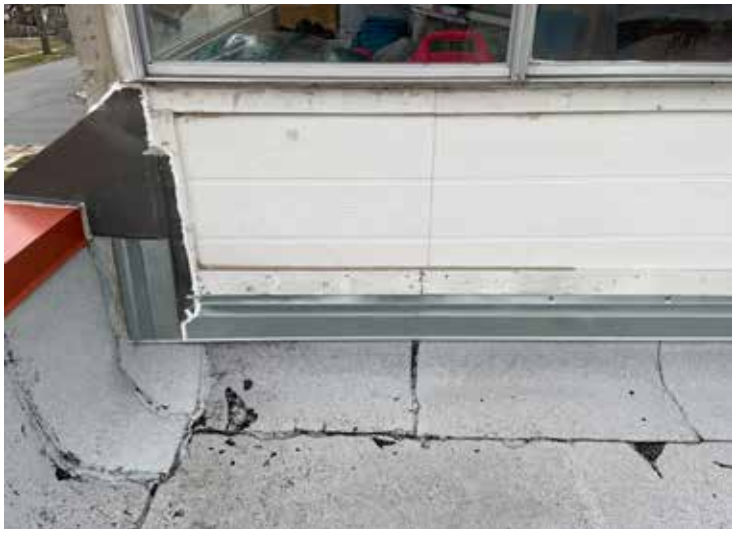
new flashings and sealants applied

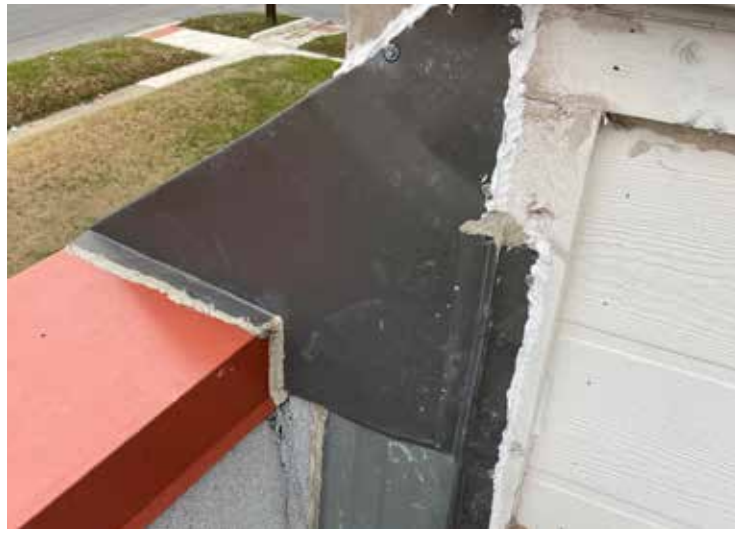
new flashings and sealants applied

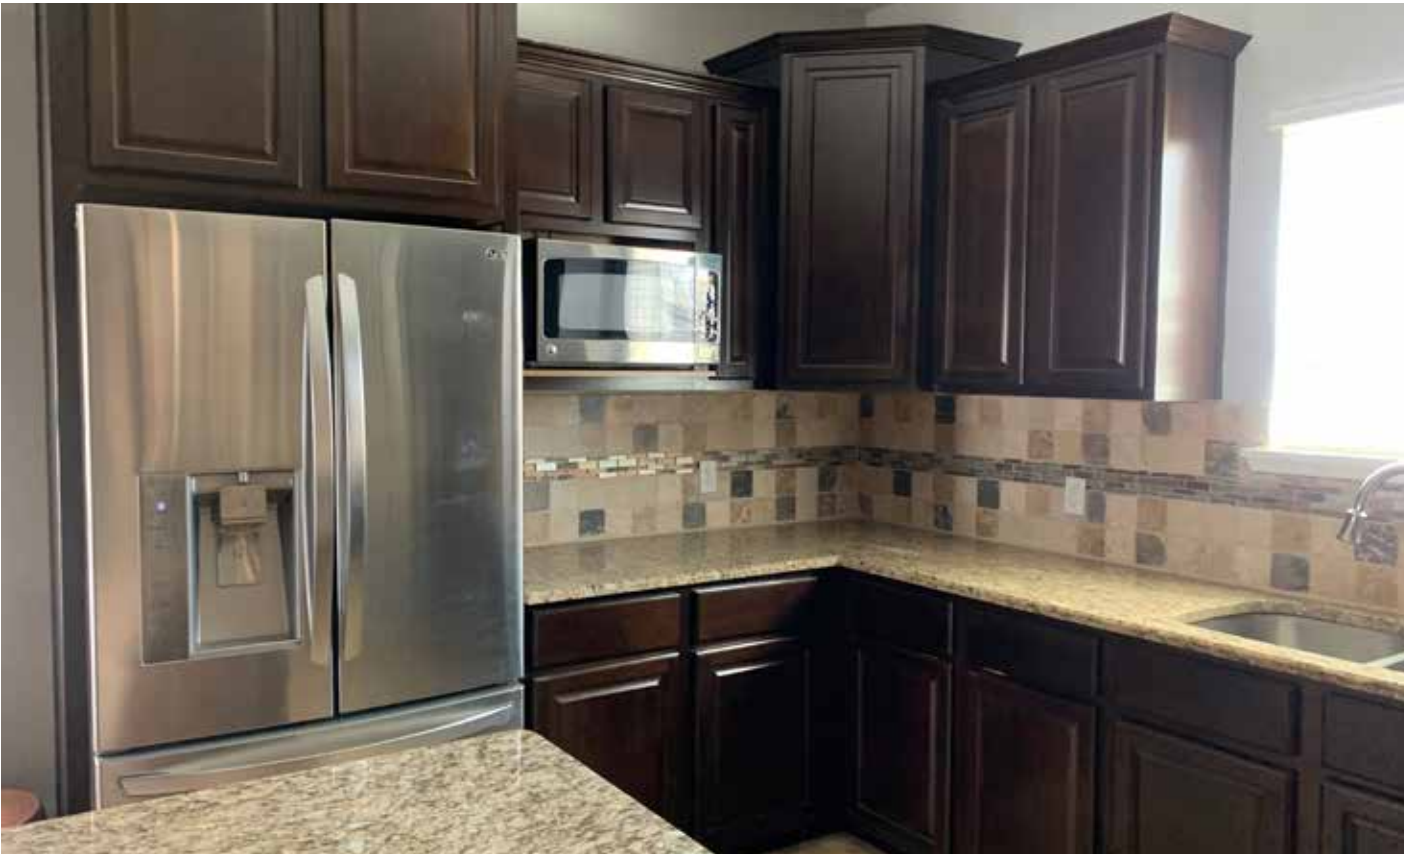
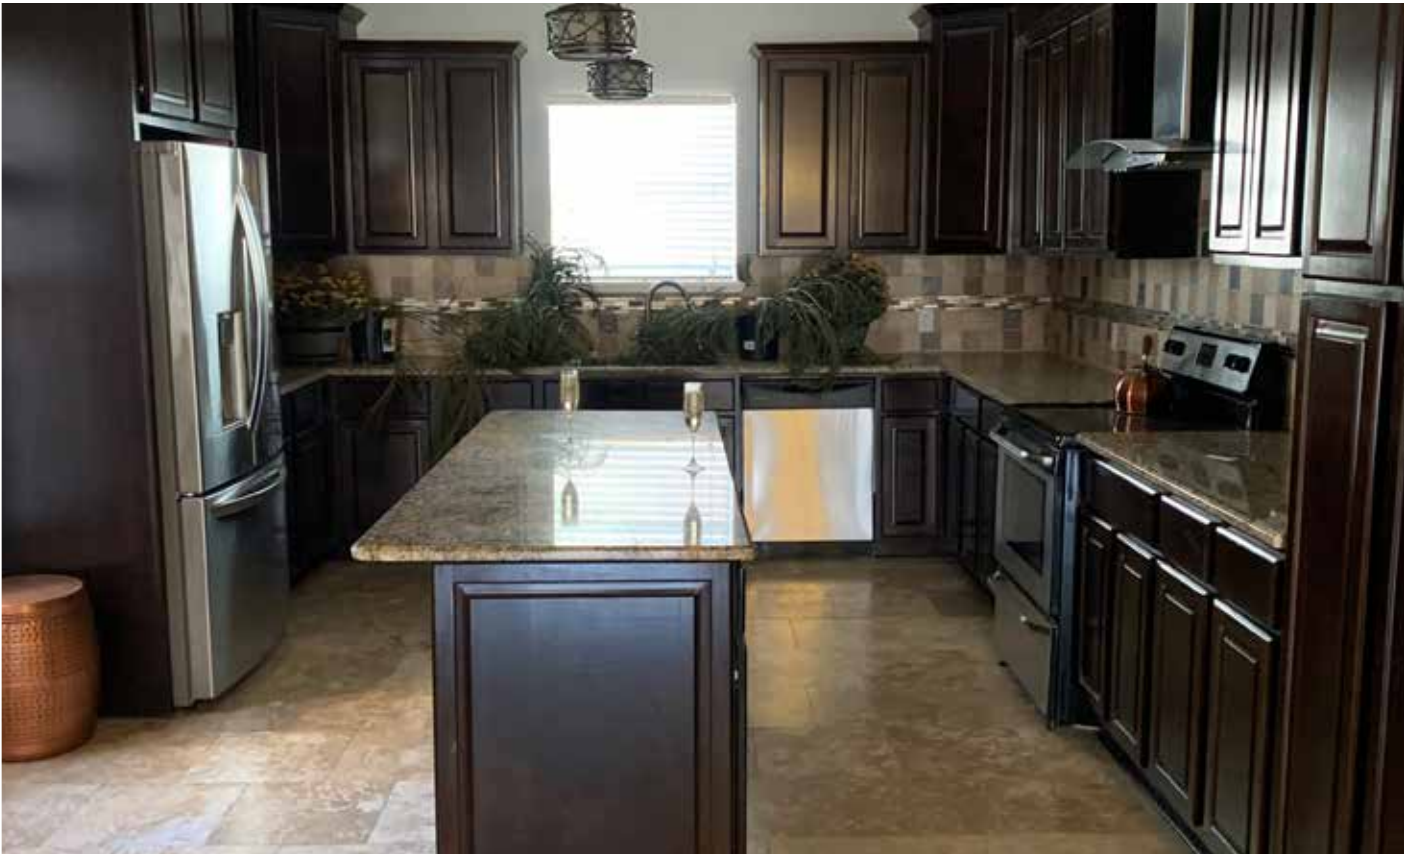
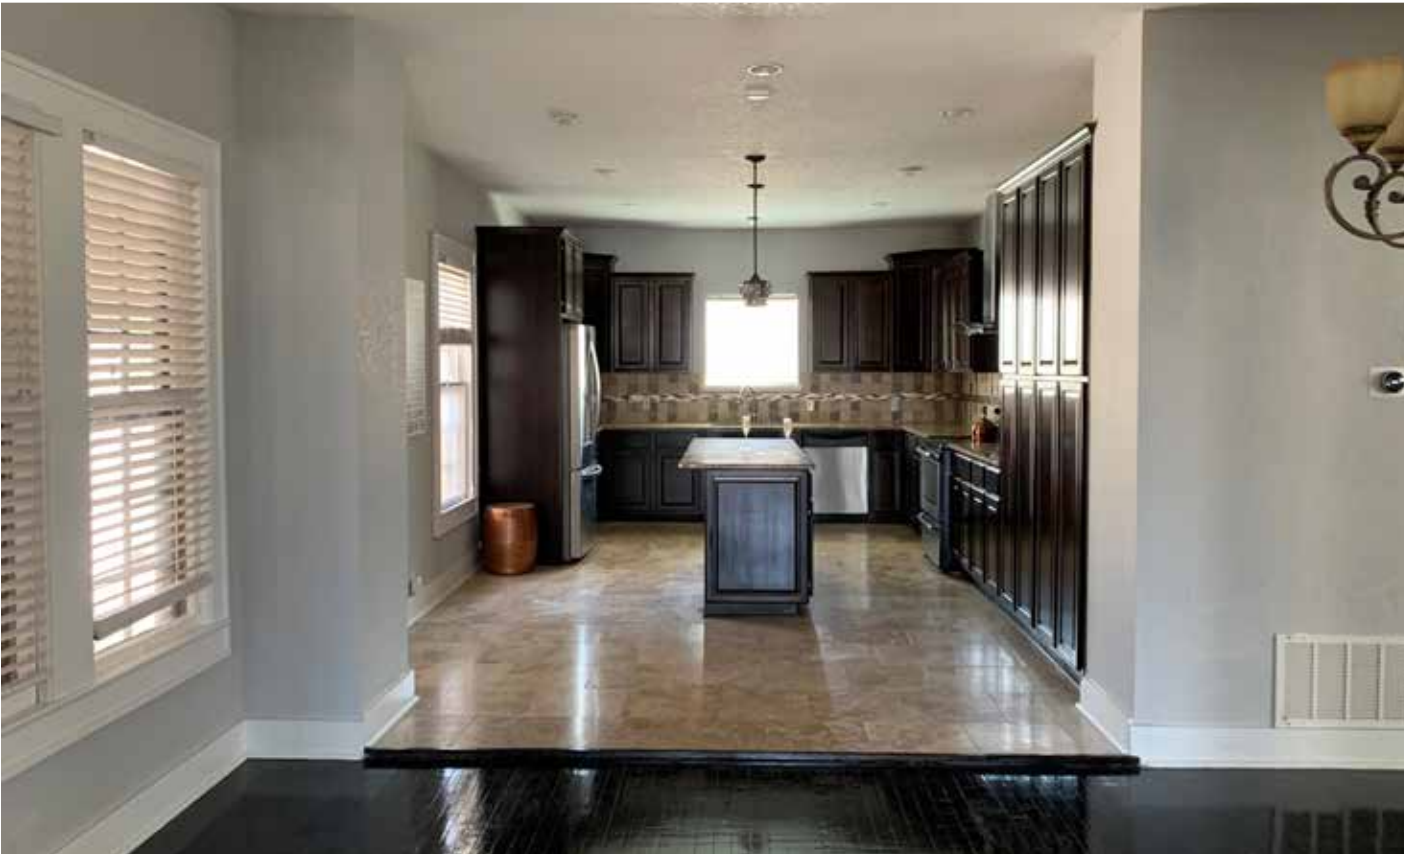
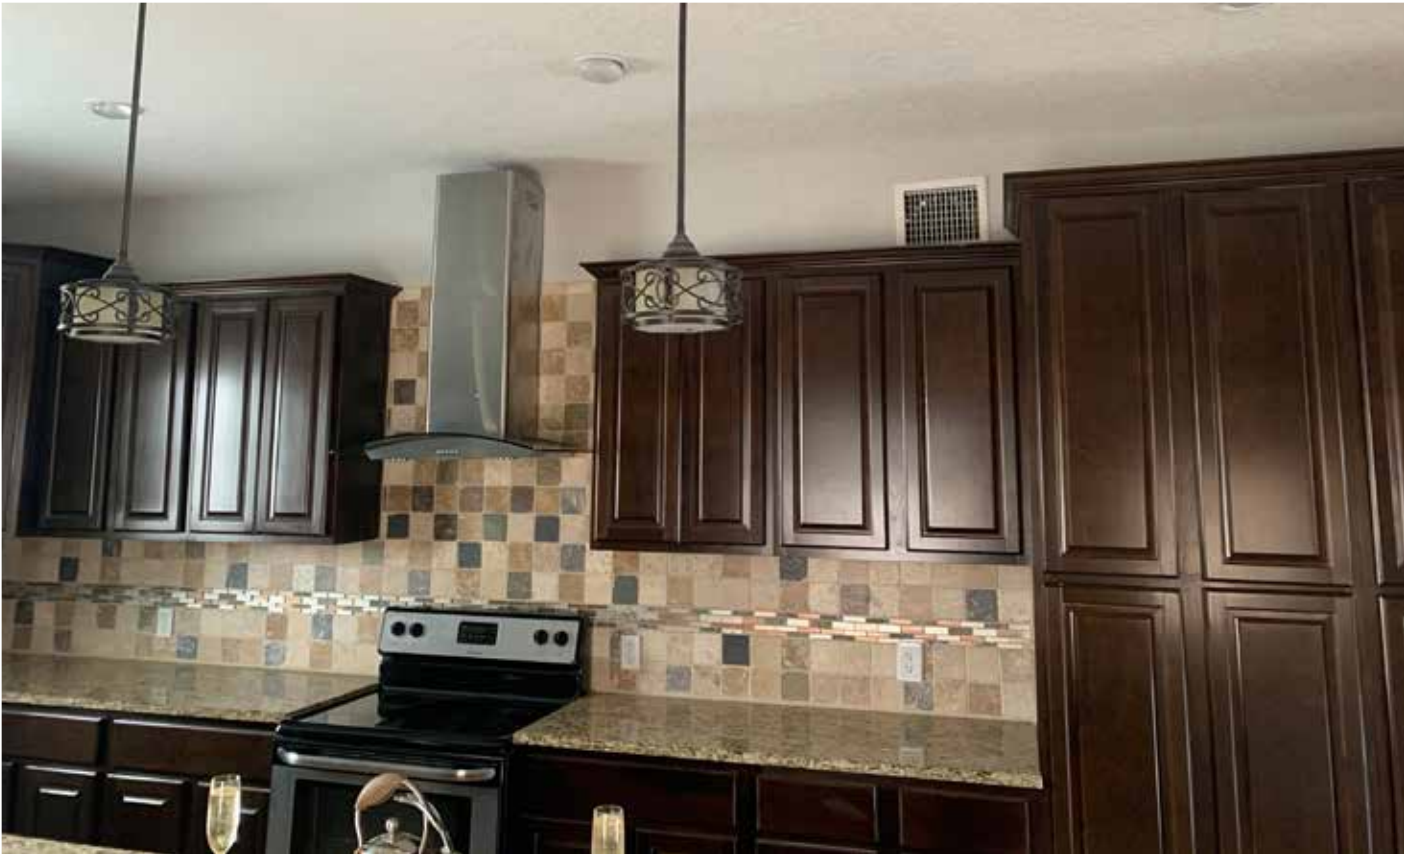
EXISTING KITCHEN WITH ROTTED, BUG INFESTED CABINETS
