HISTORIC AND DESIGN REVIEW COMMISSION

HDRC CASE NO: 2022-065
ADDRESS: 202 MARY LOUISE
LEGAL DESCRIPTION: NCB 6699 BLK 8 LOT 21
ZONING: R-6, H
CITY COUNCIL DIST.: 7
DISTRICT: Monticello Park Historic District
APPLICANT: Benjamin & Jennifer Rosas
OWNER: Benjamin & Jennifer Rosas
TYPE OF WORK: Historic Tax Verification
APPLICATION RECEIVED: January 21, 2022
60-DAY REVIEW: Not applicable due to City Council Emergency Orders
CASE MANAGER: Rachel Rettaliata

The applicant is requesting Historic Tax Verification for the property at 202 Mary Louise.

HISTORIC REHABILITATION APPLICATION PART 2 | JANUARY 2022

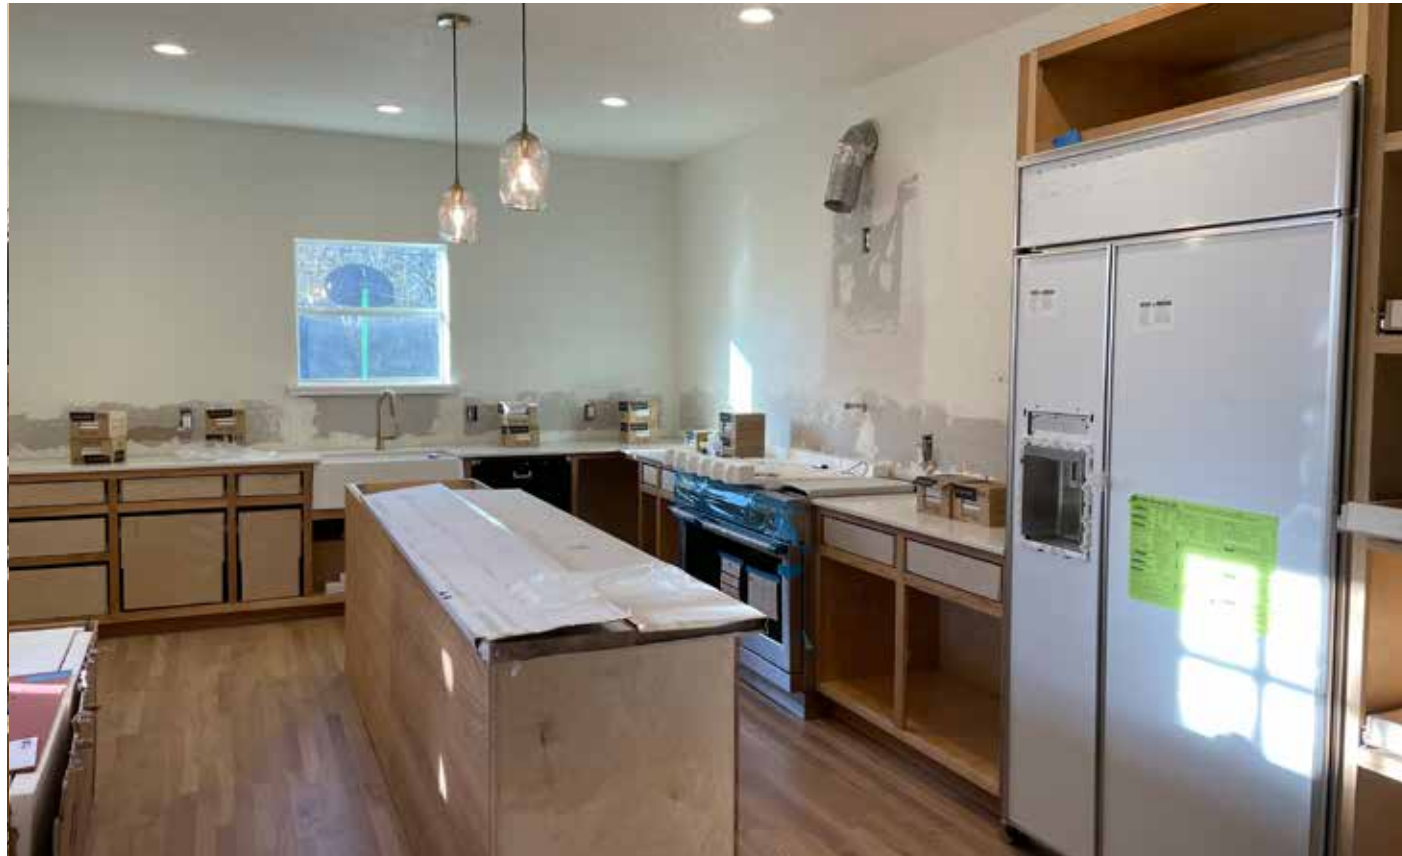
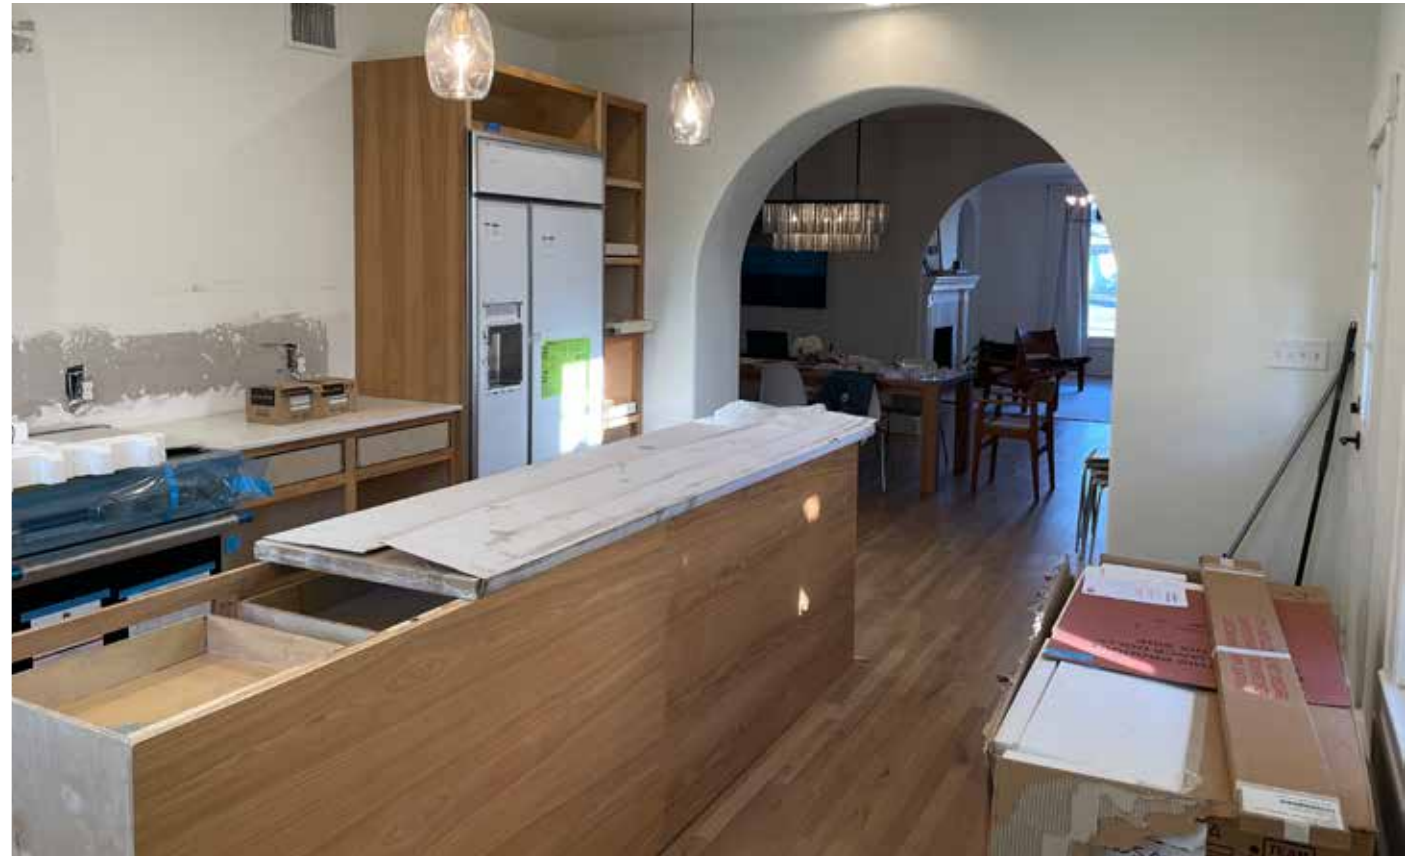
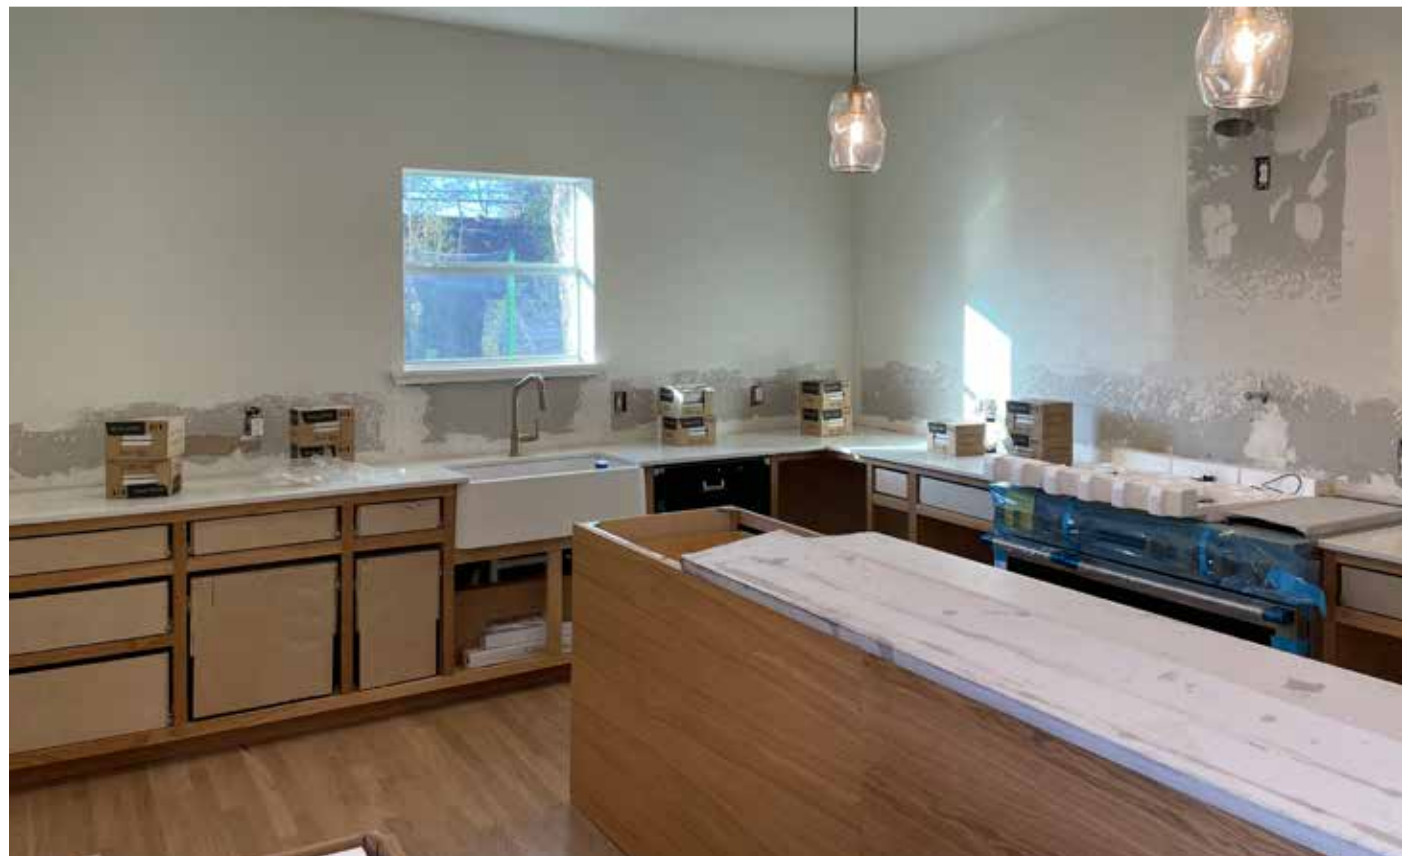
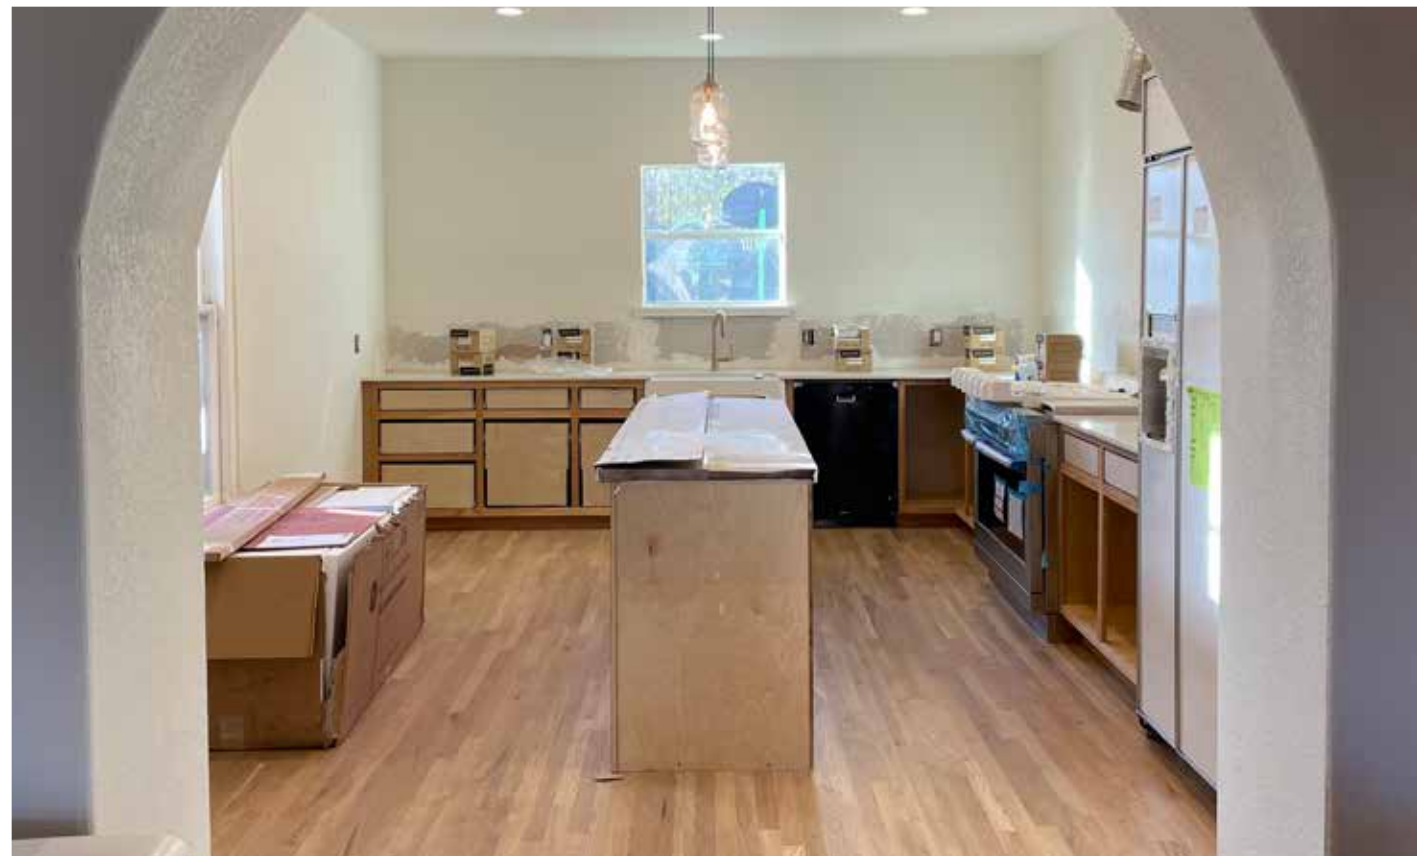
NEW KITCHEN (ESTIMATED COMPLETION AT THE END OF JANUARY)

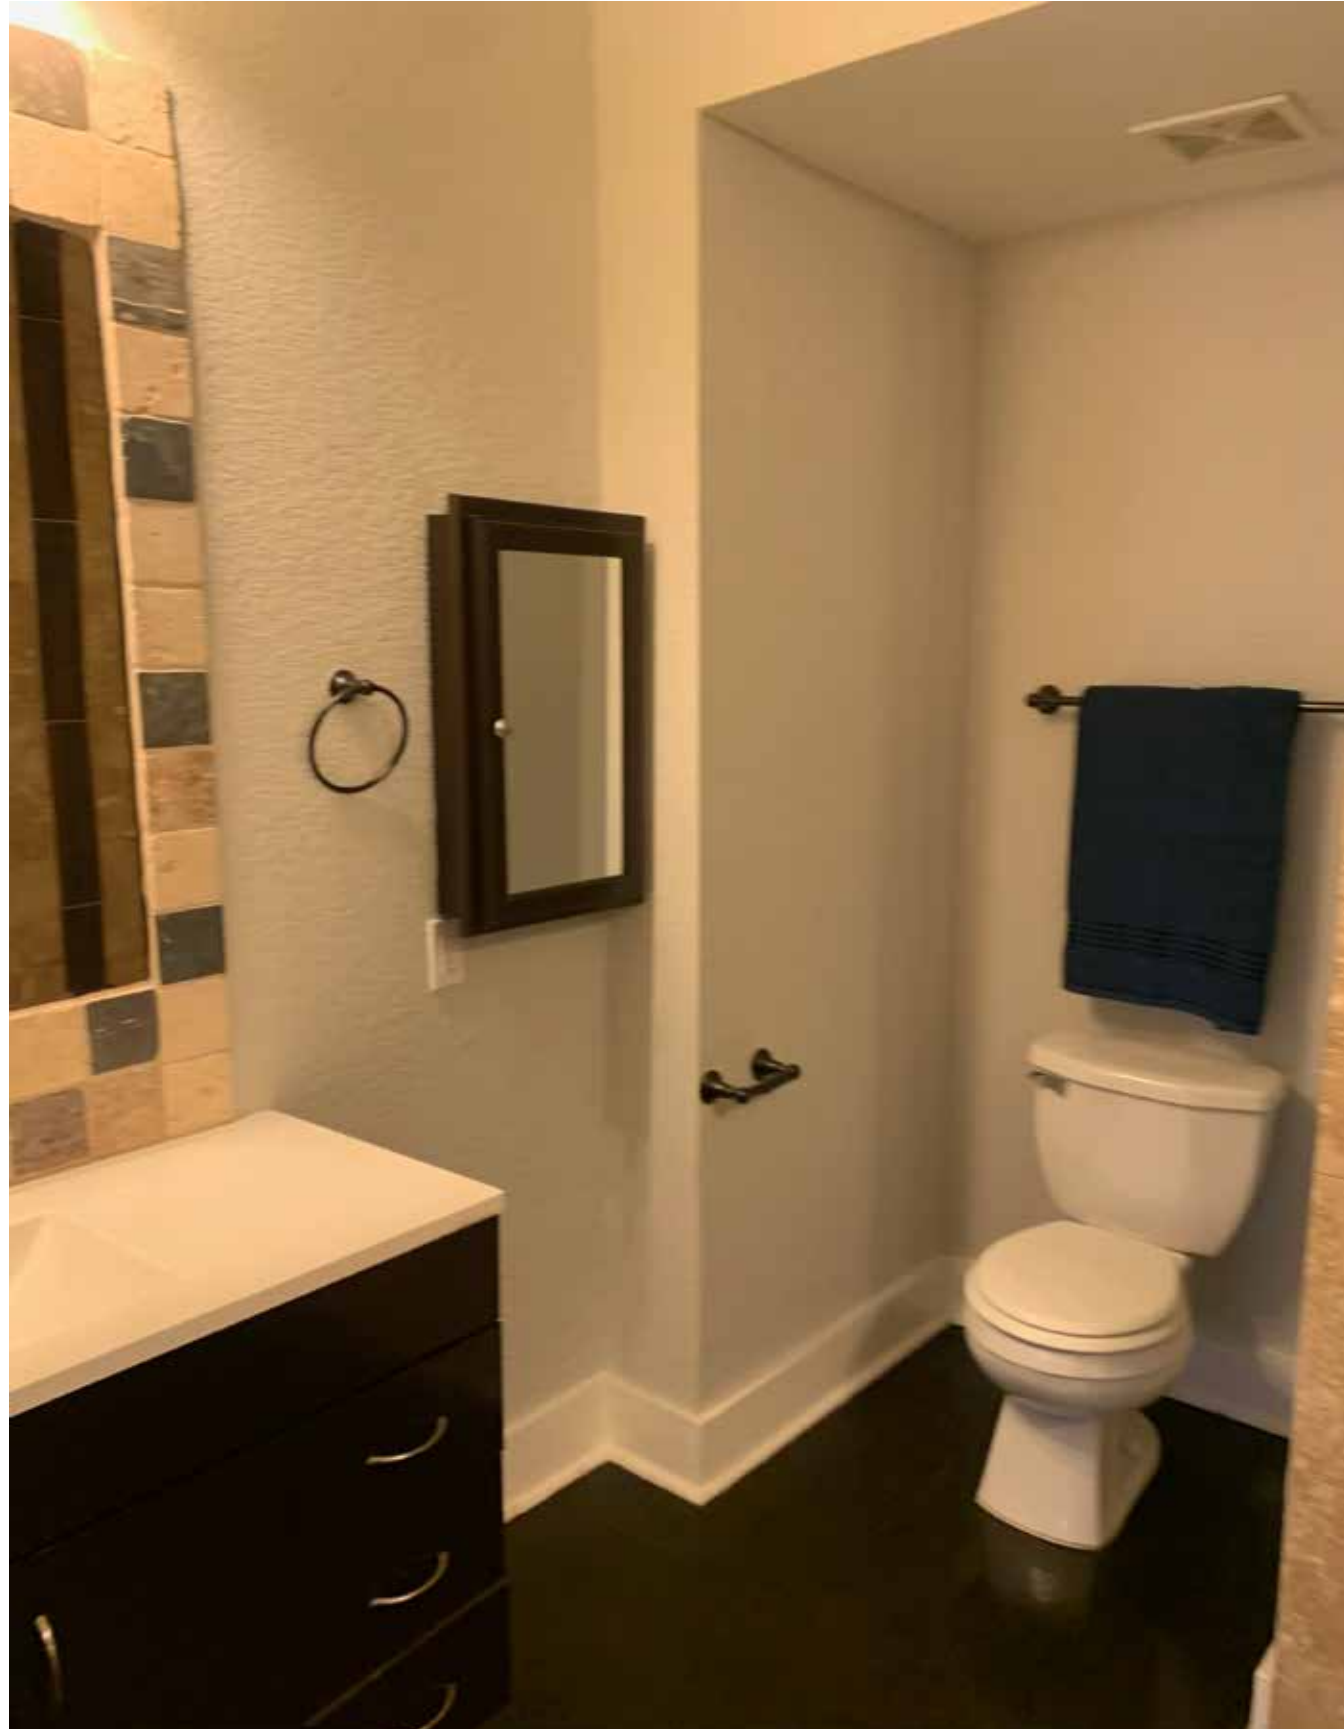
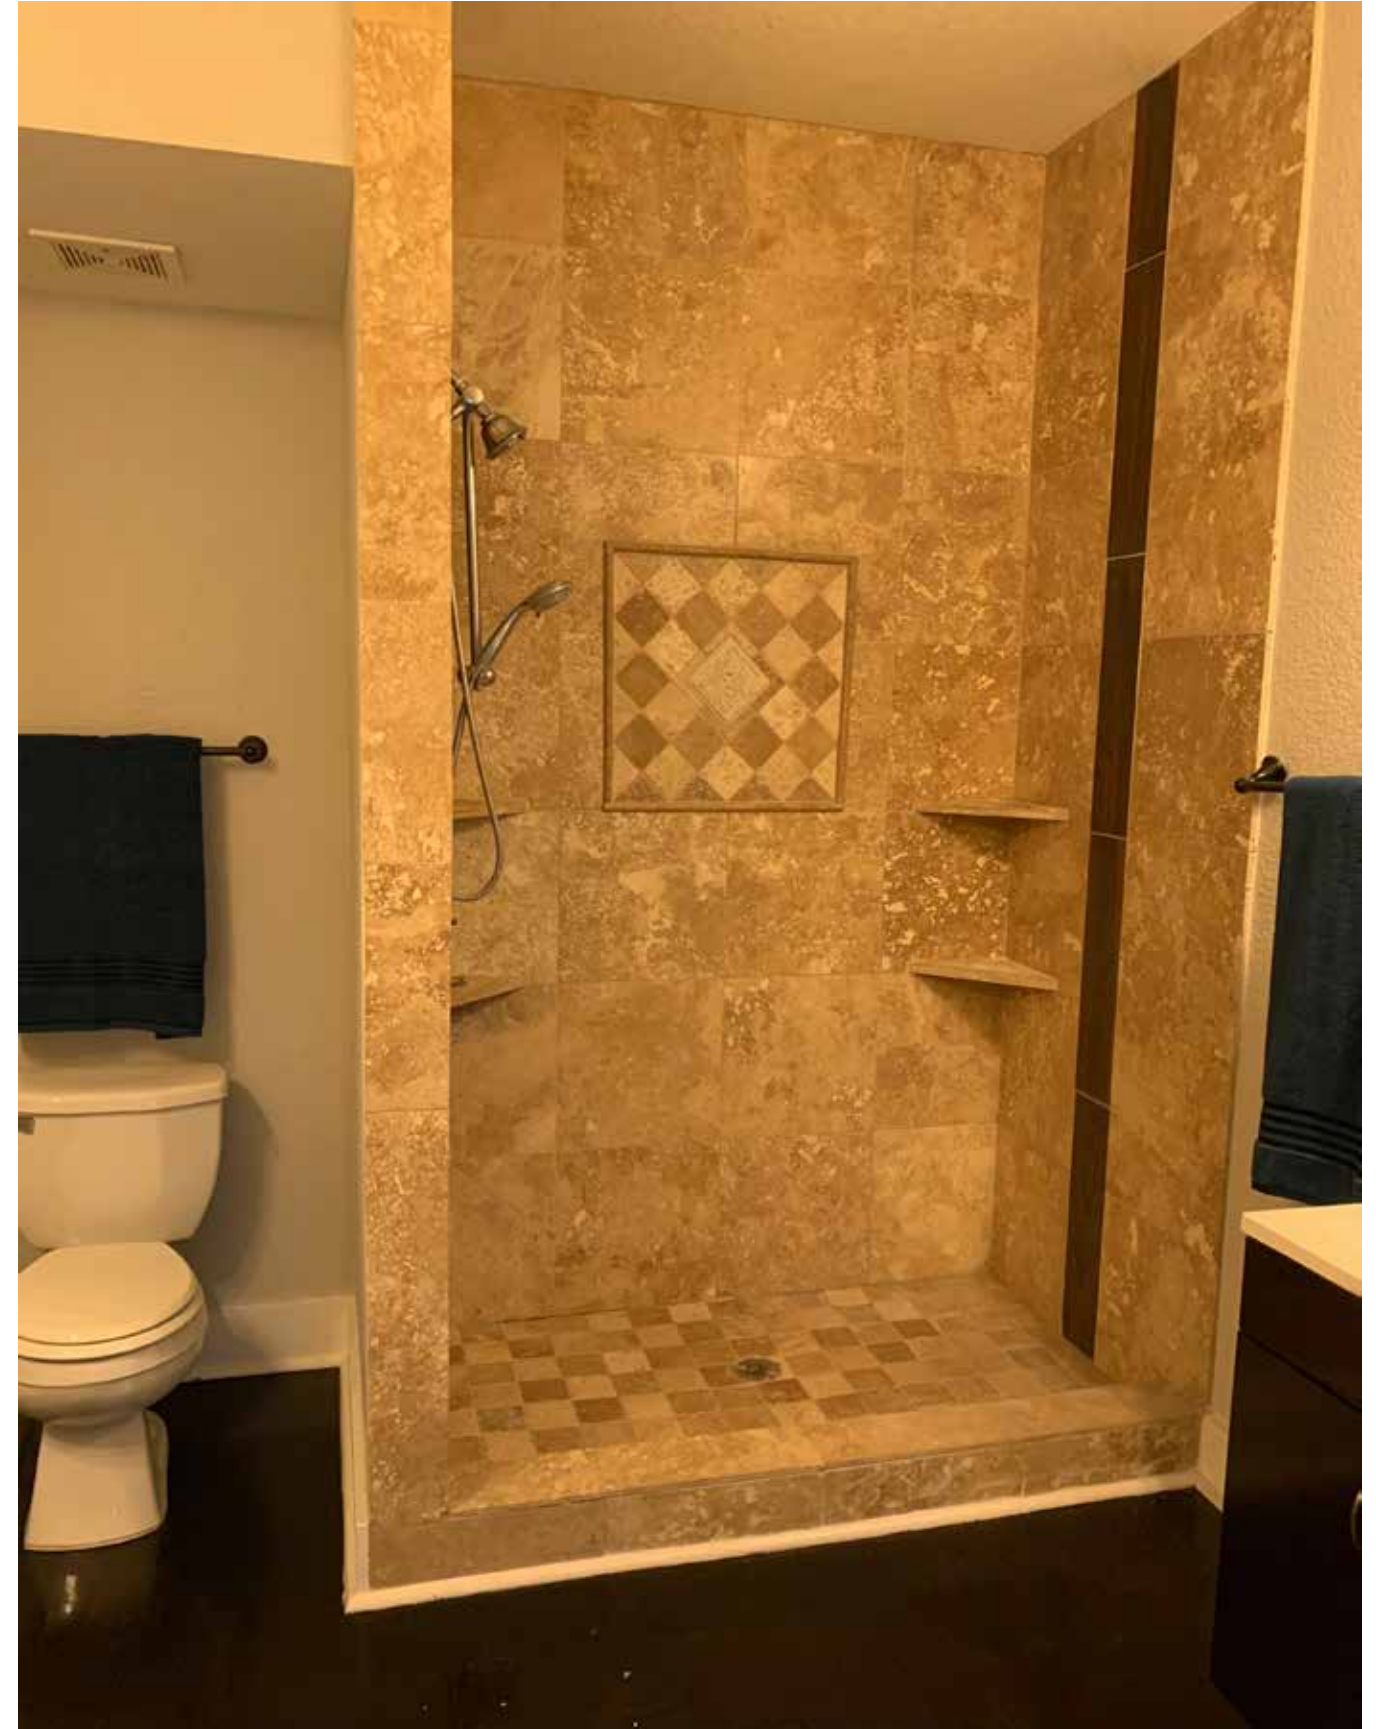
EXISTING MAIN BATHROOM WITH BROKEN AND DAMAGED PLUMBING/CABINETS

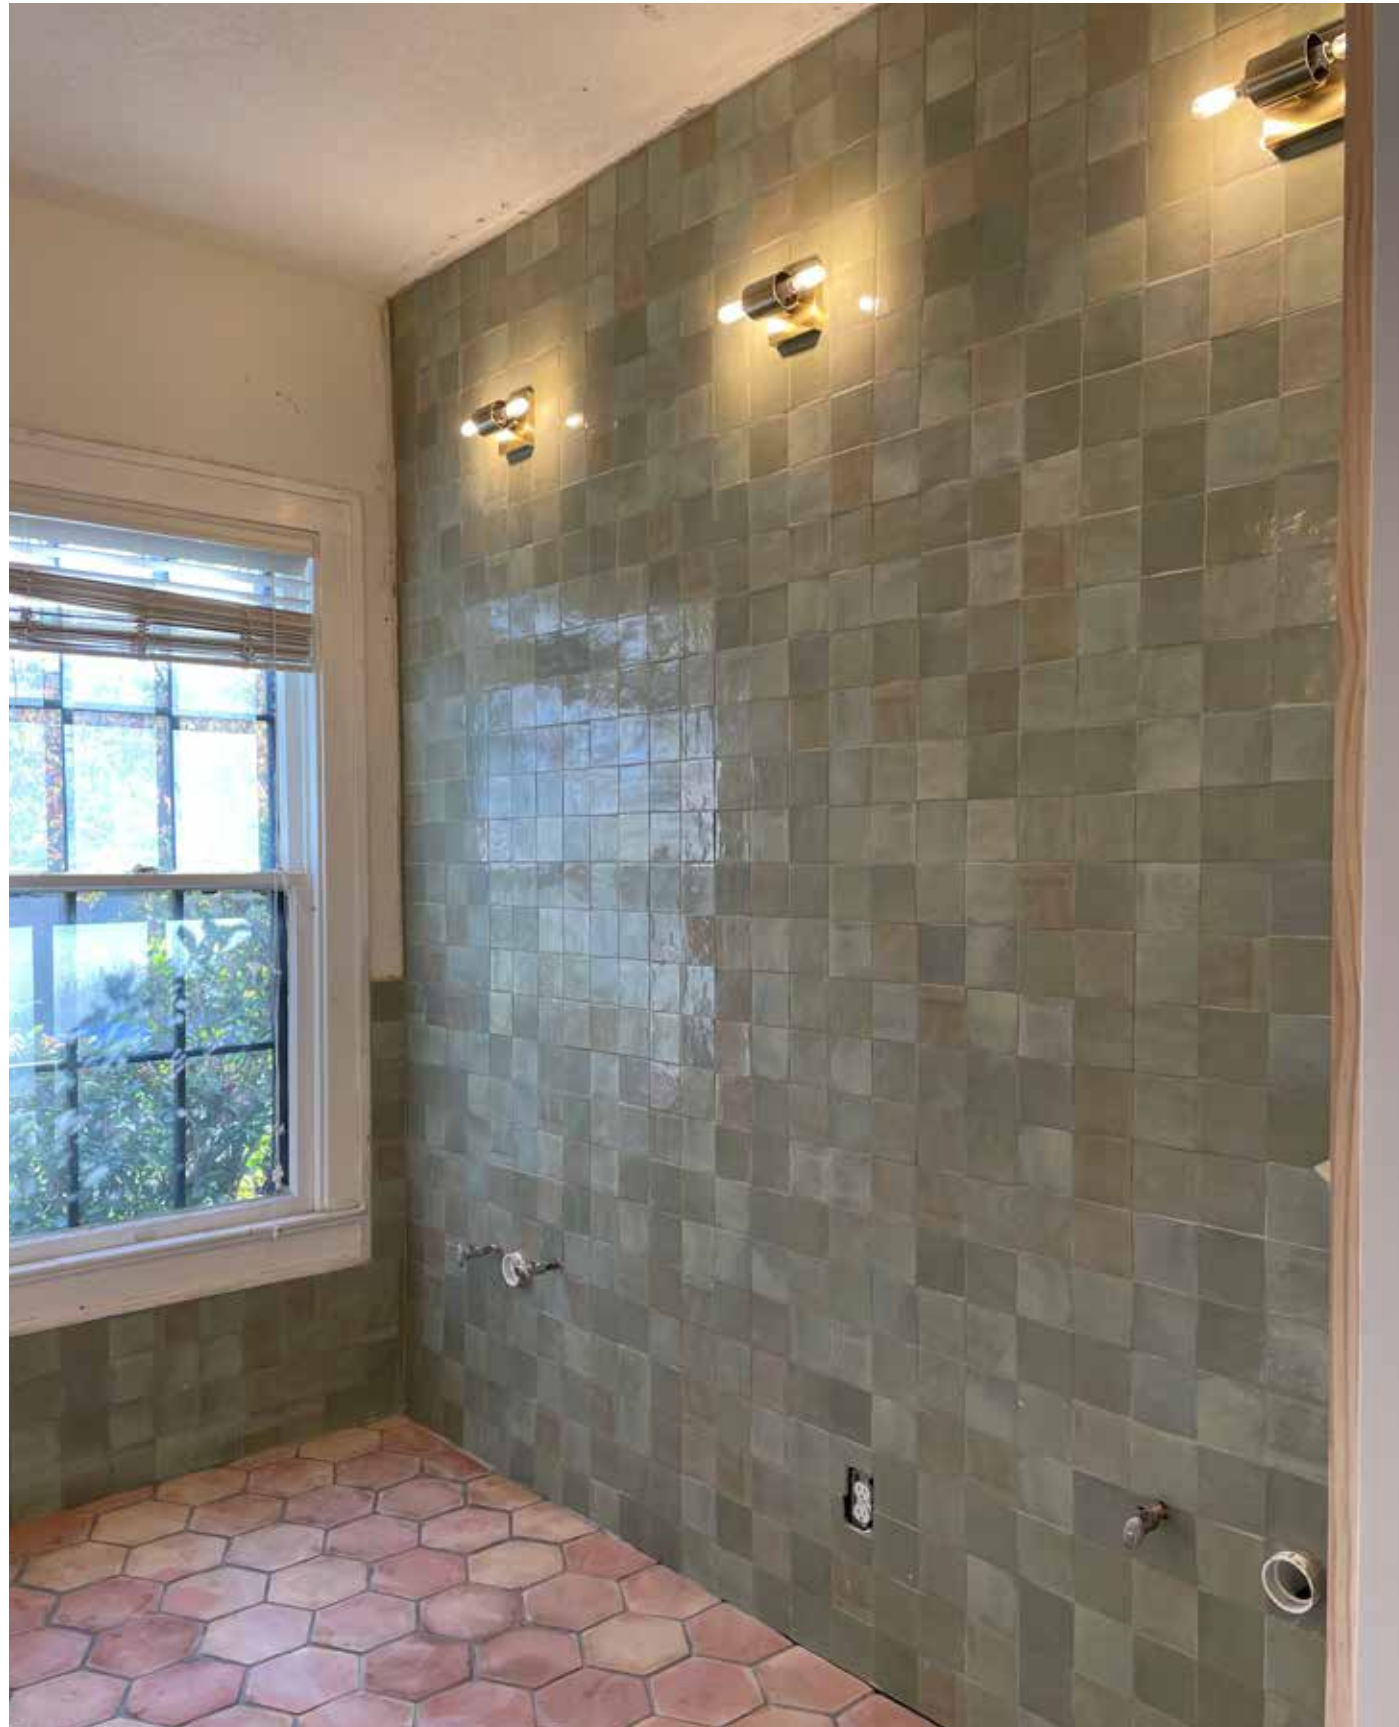
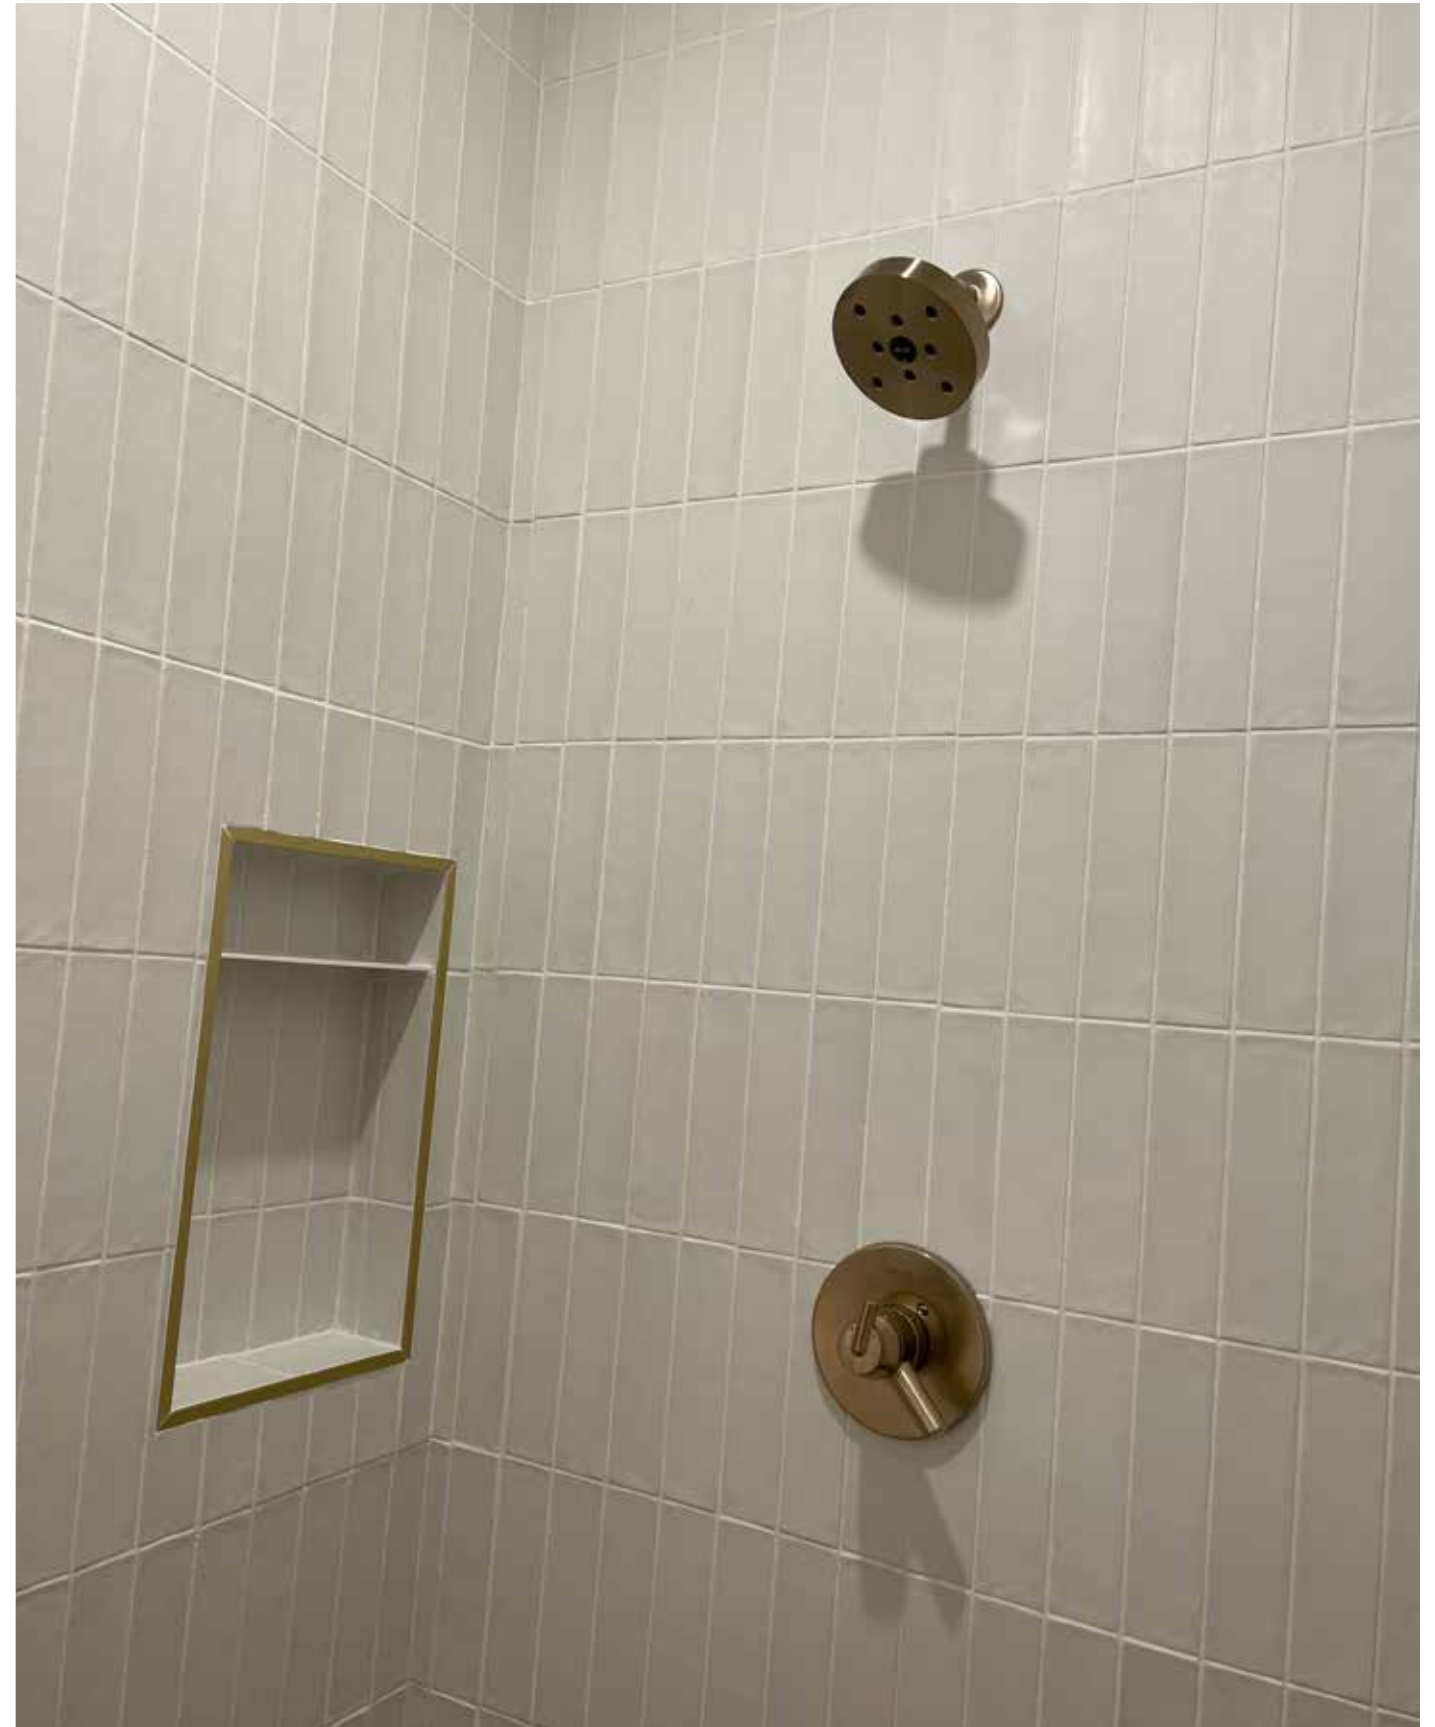
NEW MAIN BATHROOM (ESTIMATED COMPLETION AT THE END OF JANUARY)

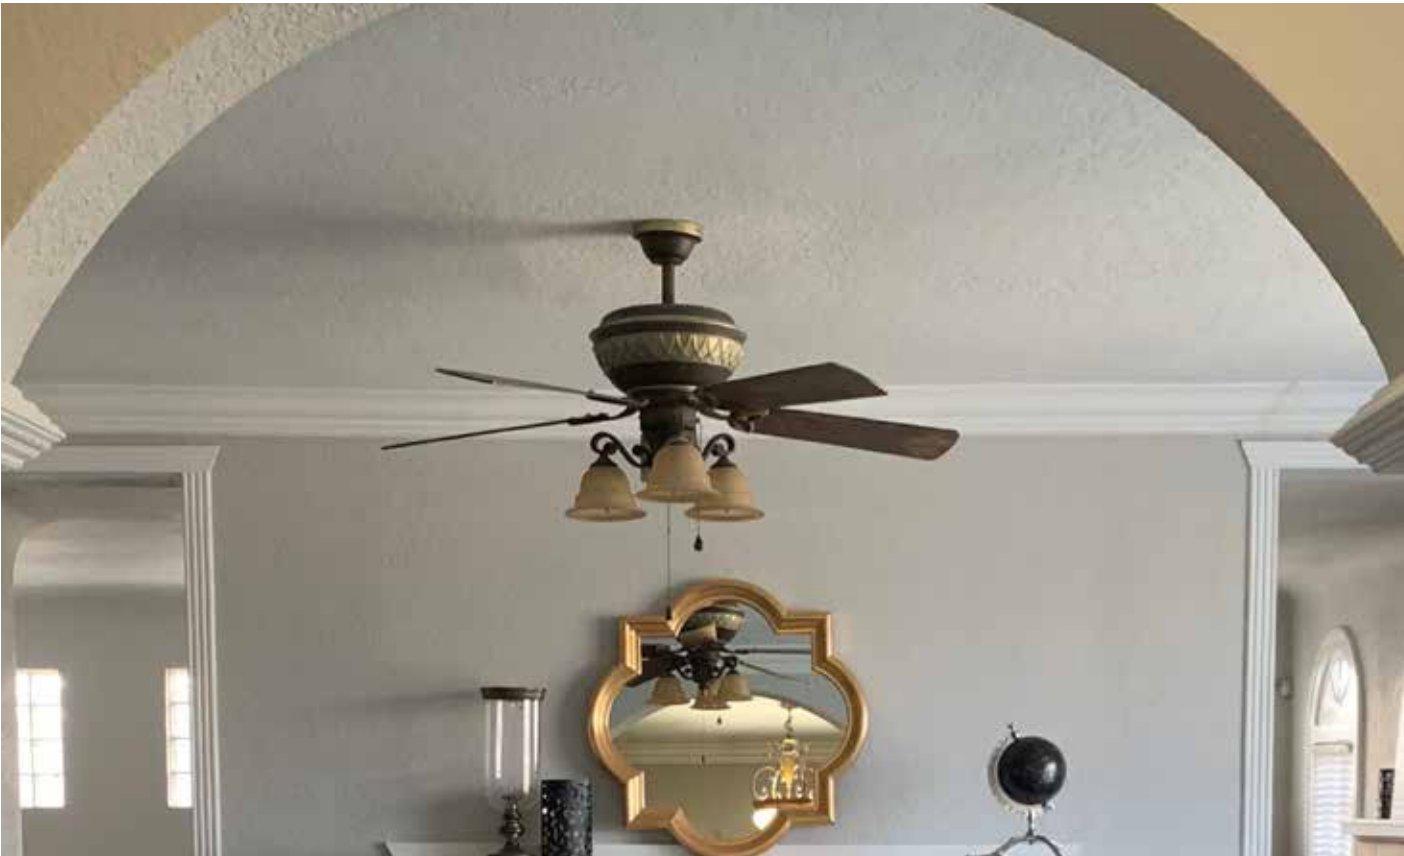
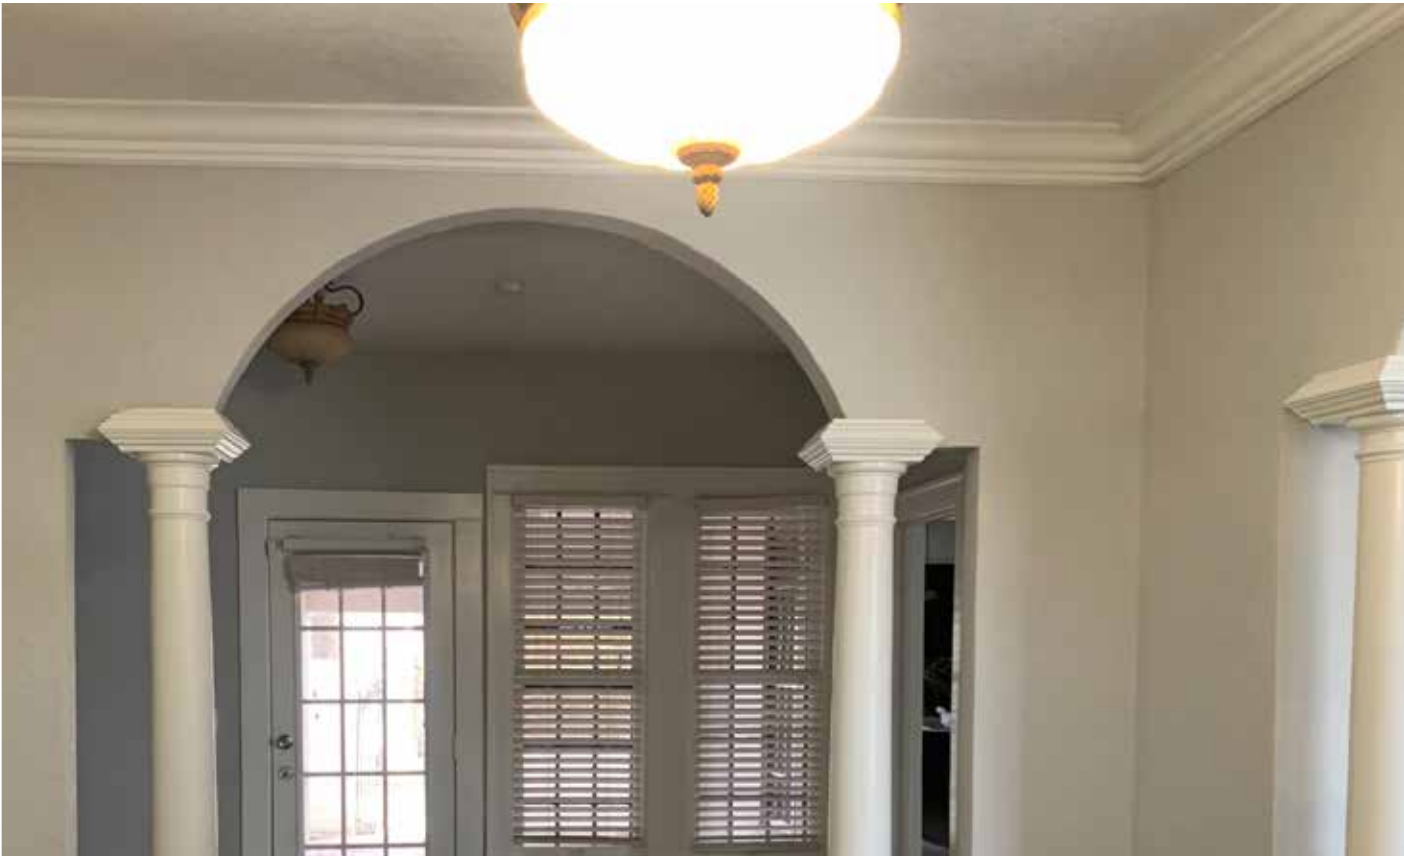
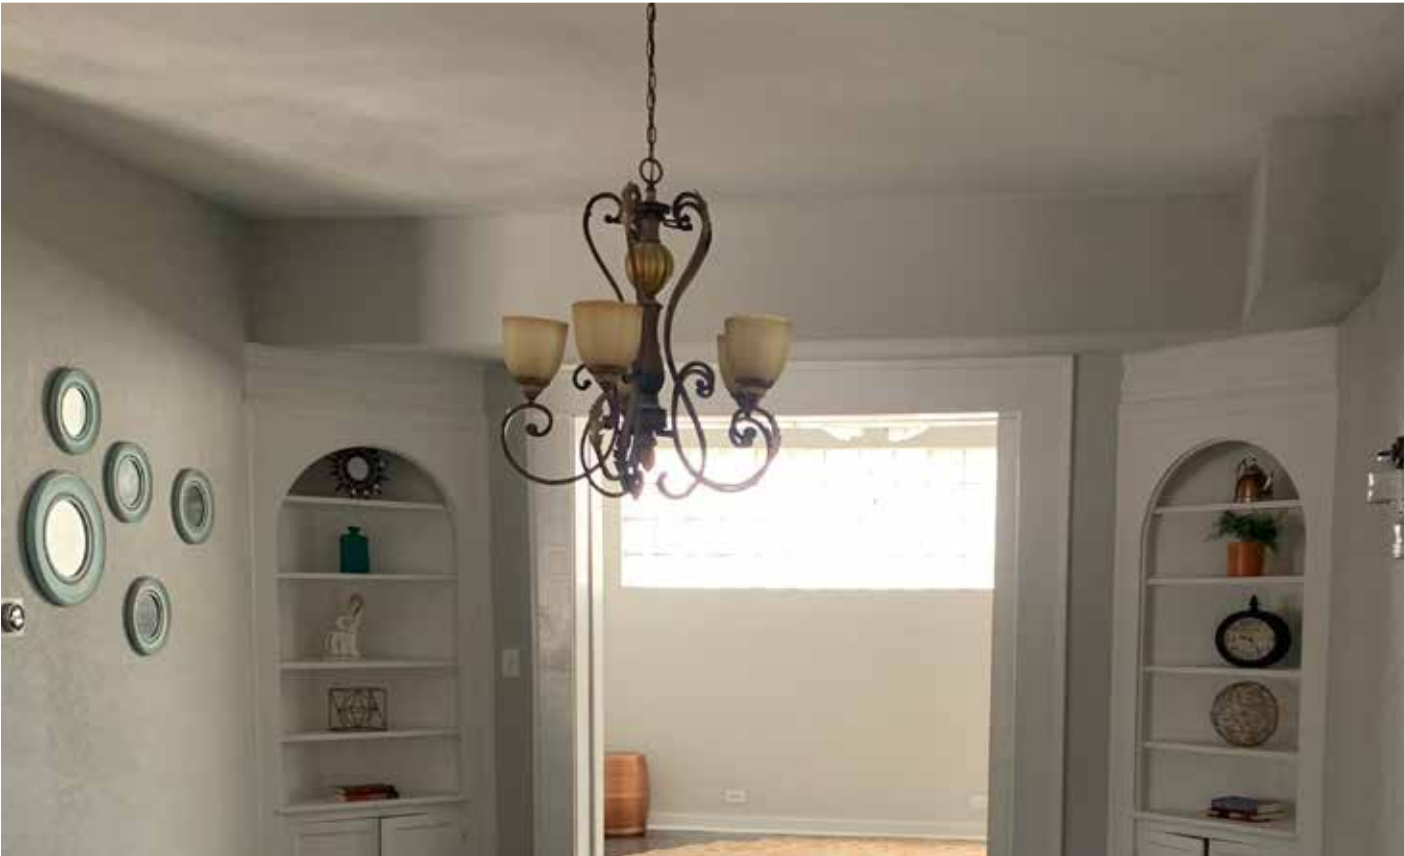
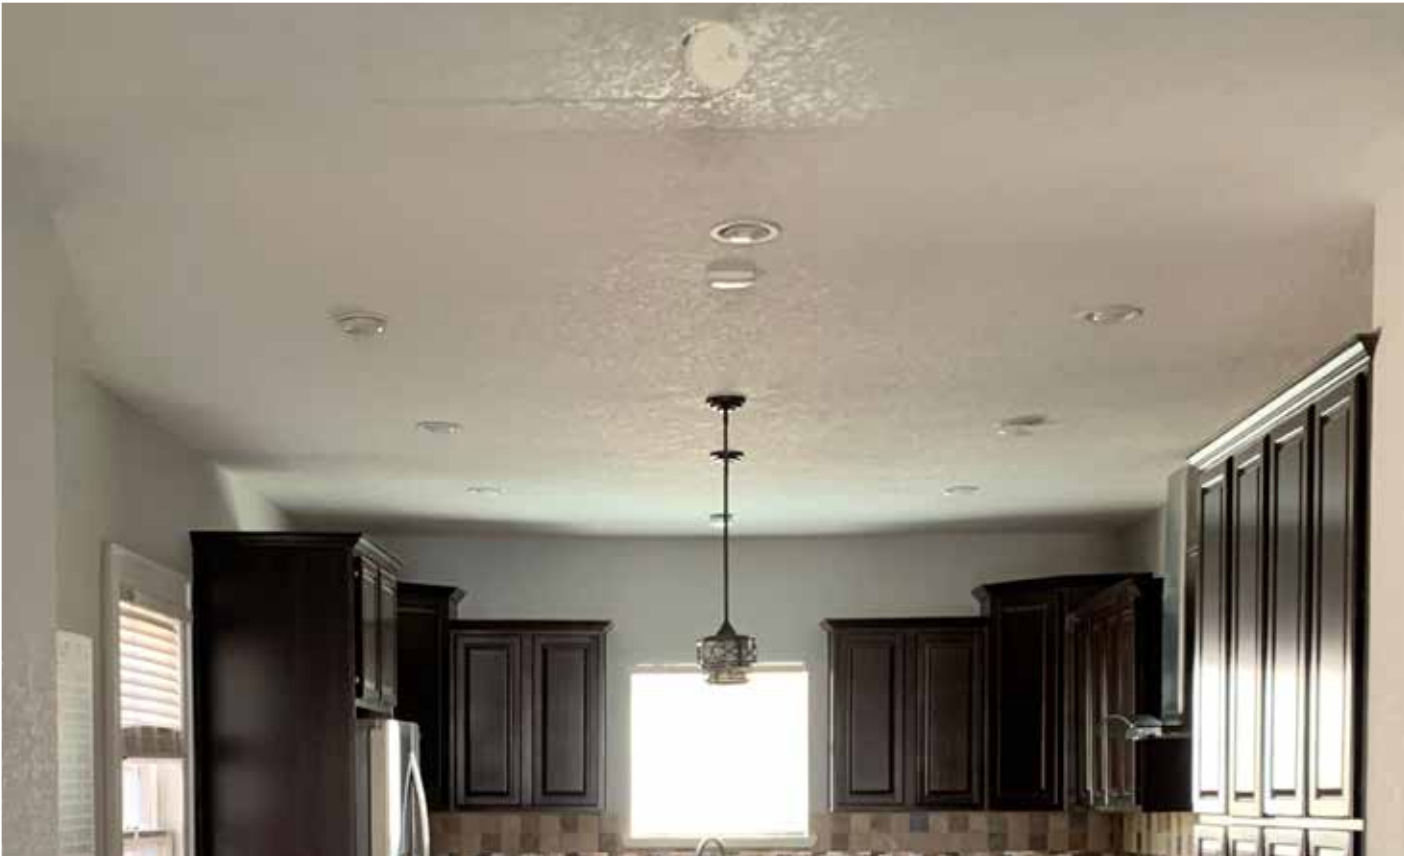
EXISTING LIGHTING
