HISTORIC AND DESIGN REVIEW COMMISSION

HDRC CASE NO: 2022-065
ADDRESS: 202 MARY LOUISE
LEGAL DESCRIPTION: NCB 6699 BLK 8 LOT 21
ZONING: R-6, H
CITY COUNCIL DIST.: 7
DISTRICT: Monticello Park Historic District
APPLICANT: Benjamin & Jennifer Rosas
OWNER: Benjamin & Jennifer Rosas
TYPE OF WORK: Historic Tax Verification
APPLICATION RECEIVED: January 21, 2022
60-DAY REVIEW: Not applicable due to City Council Emergency Orders
CASE MANAGER: Rachel Rettaliata

The applicant is requesting Historic Tax Verification for the property at 202 Mary Louise.

HISTORIC REHABILITATION APPLICATION PART 2 | JANUARY 2022

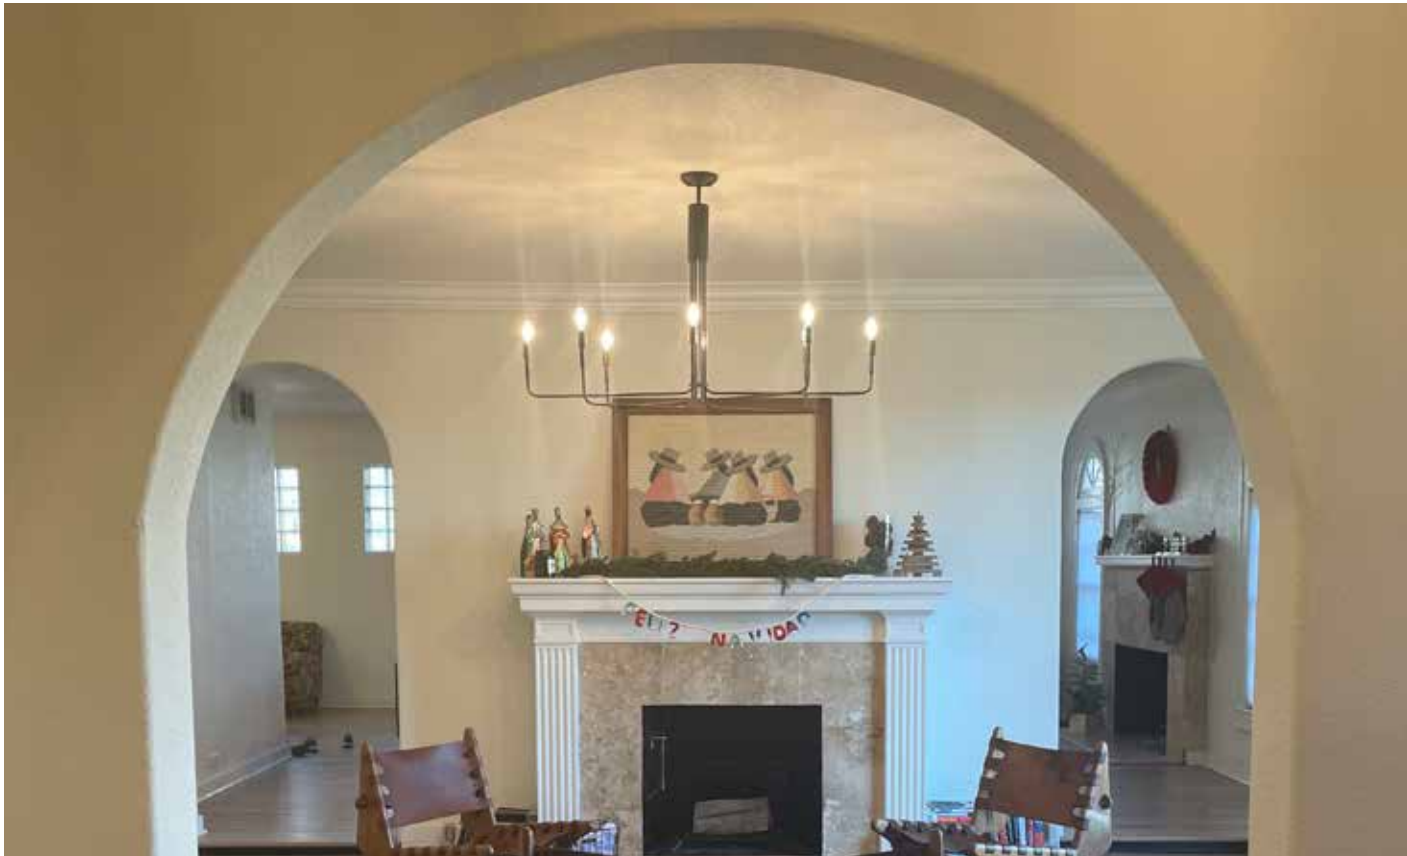
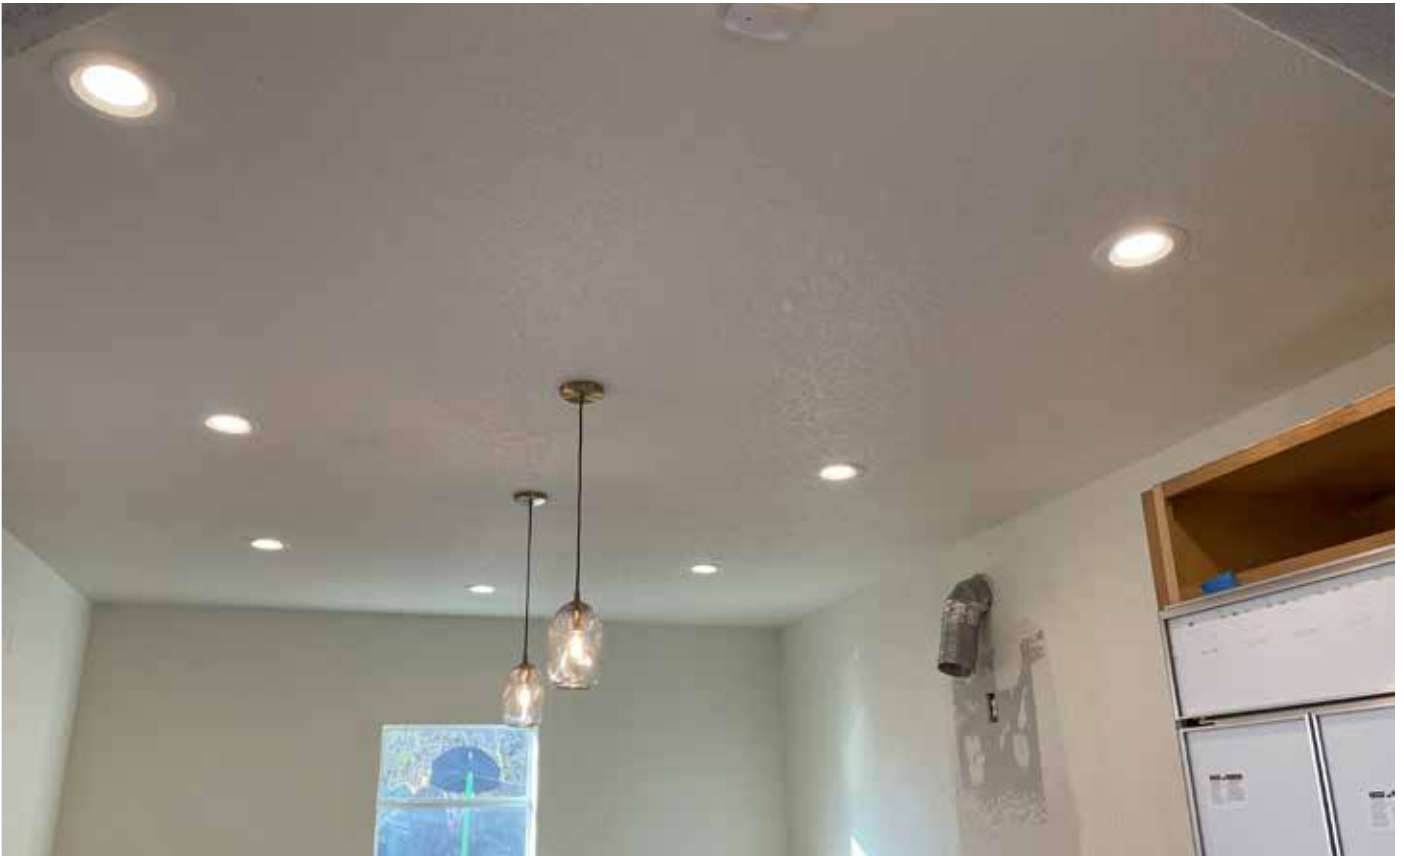
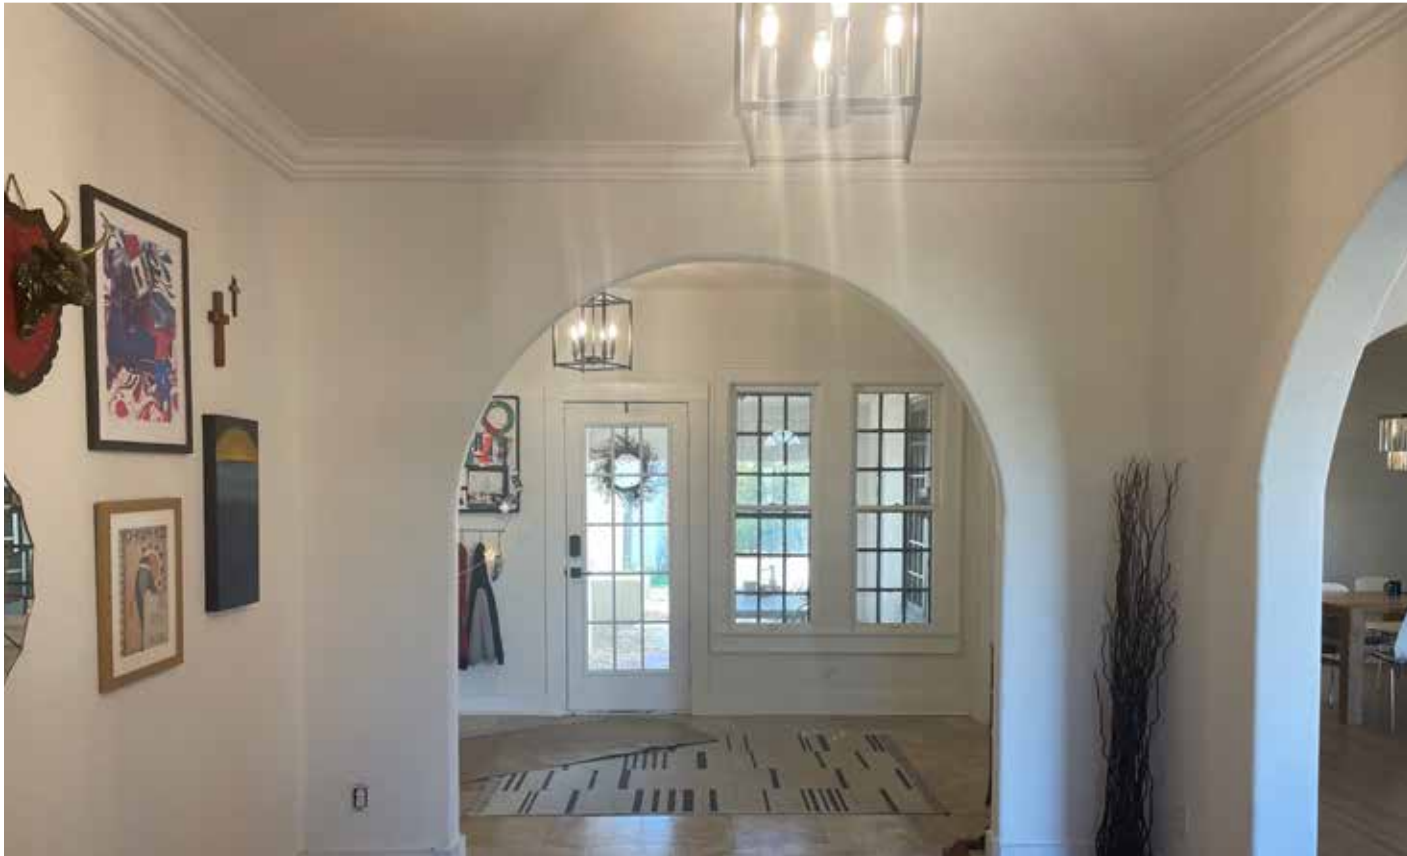
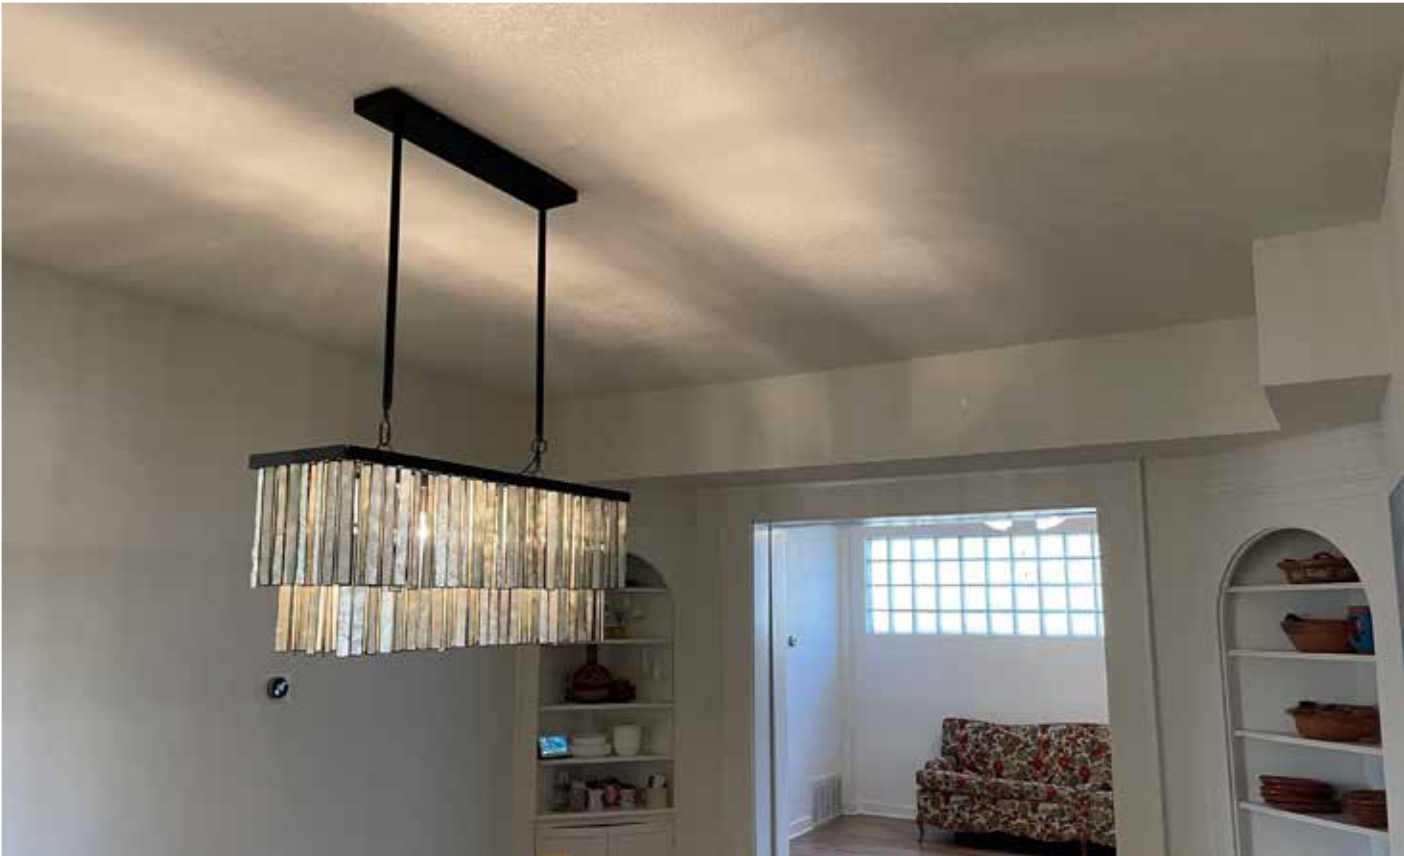
NEW LED LIGHTING THROUGHT

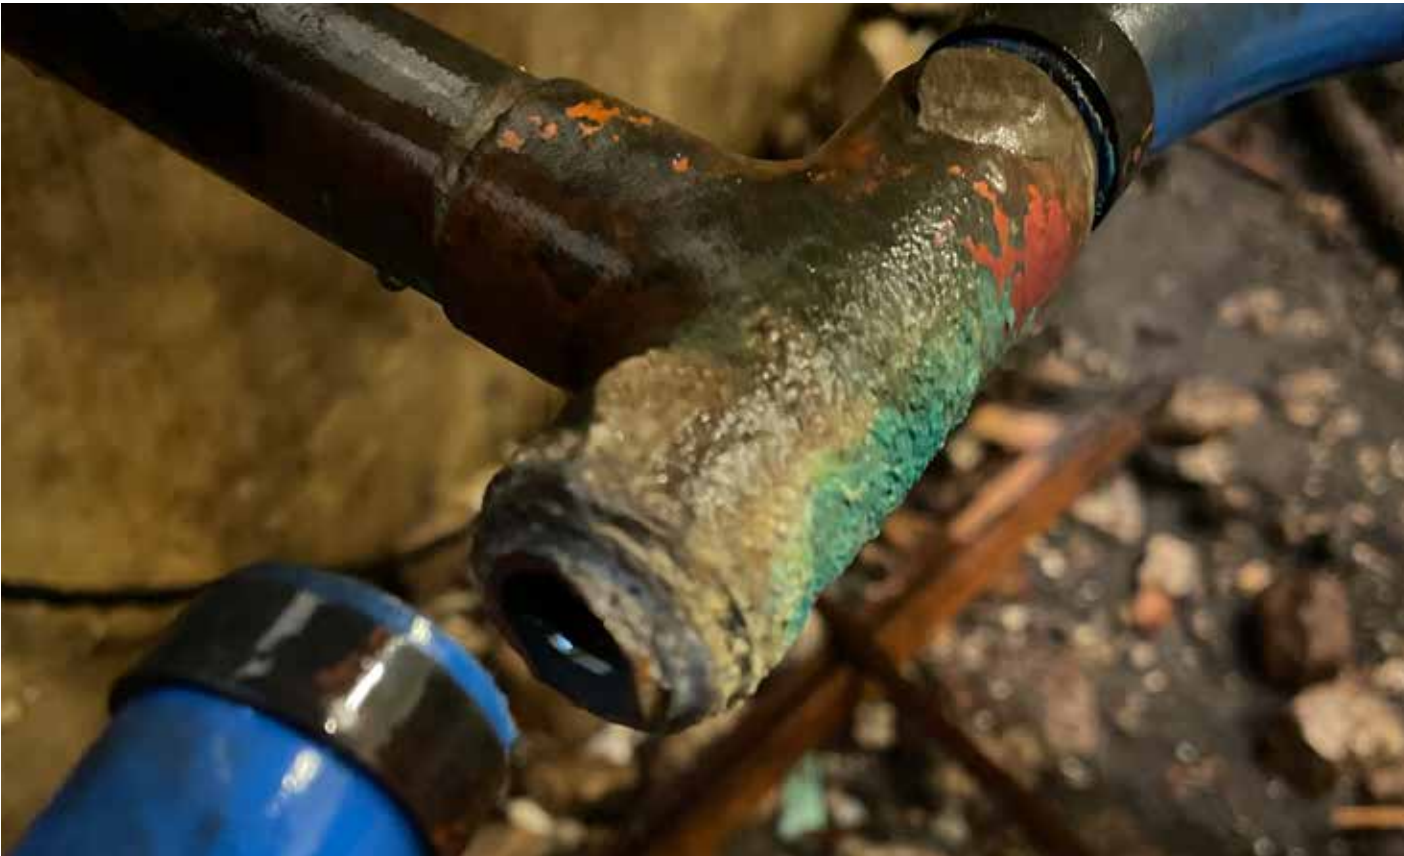
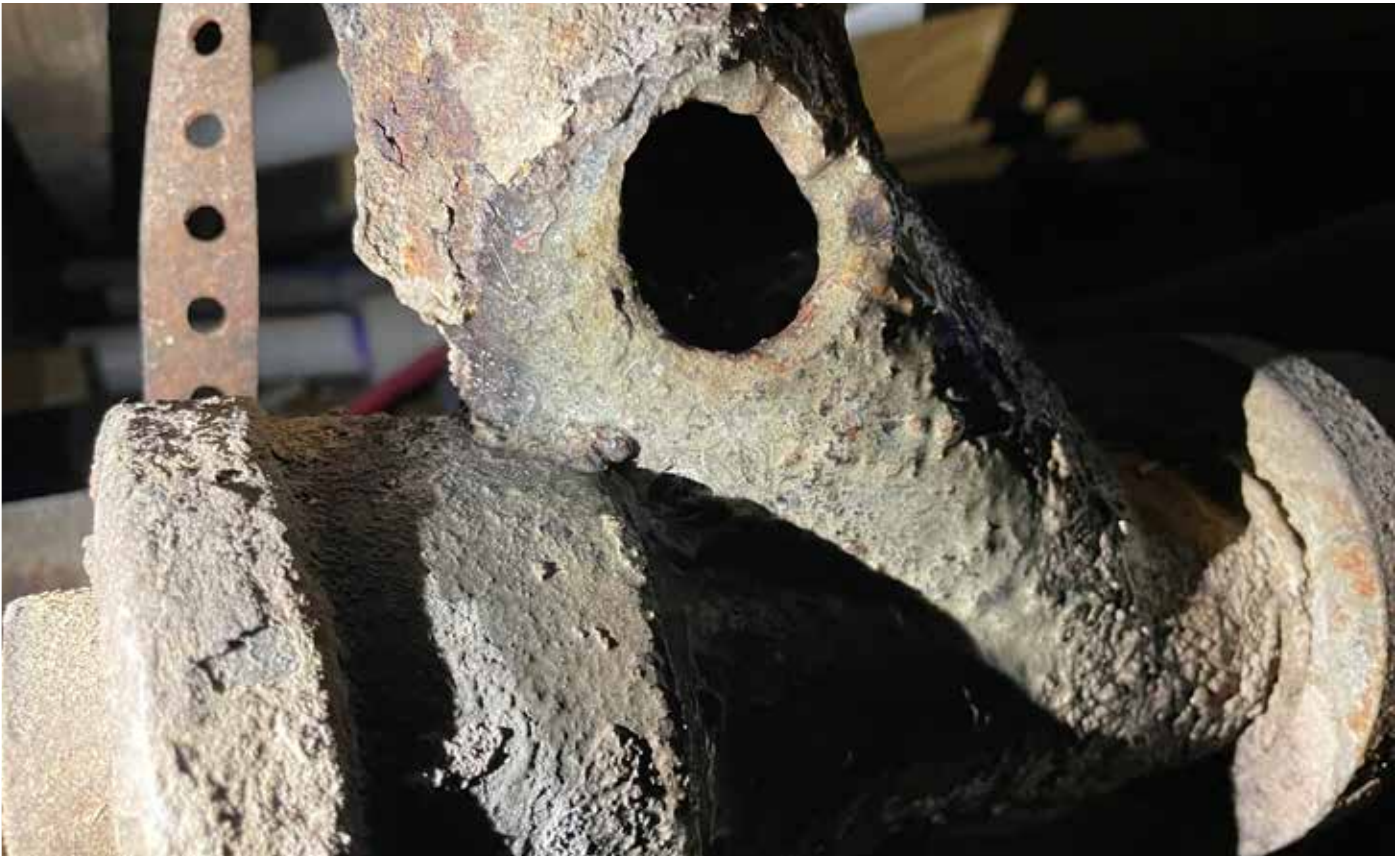
EXISTING BROKEN HVAC AND DAMAGED PLUMBING

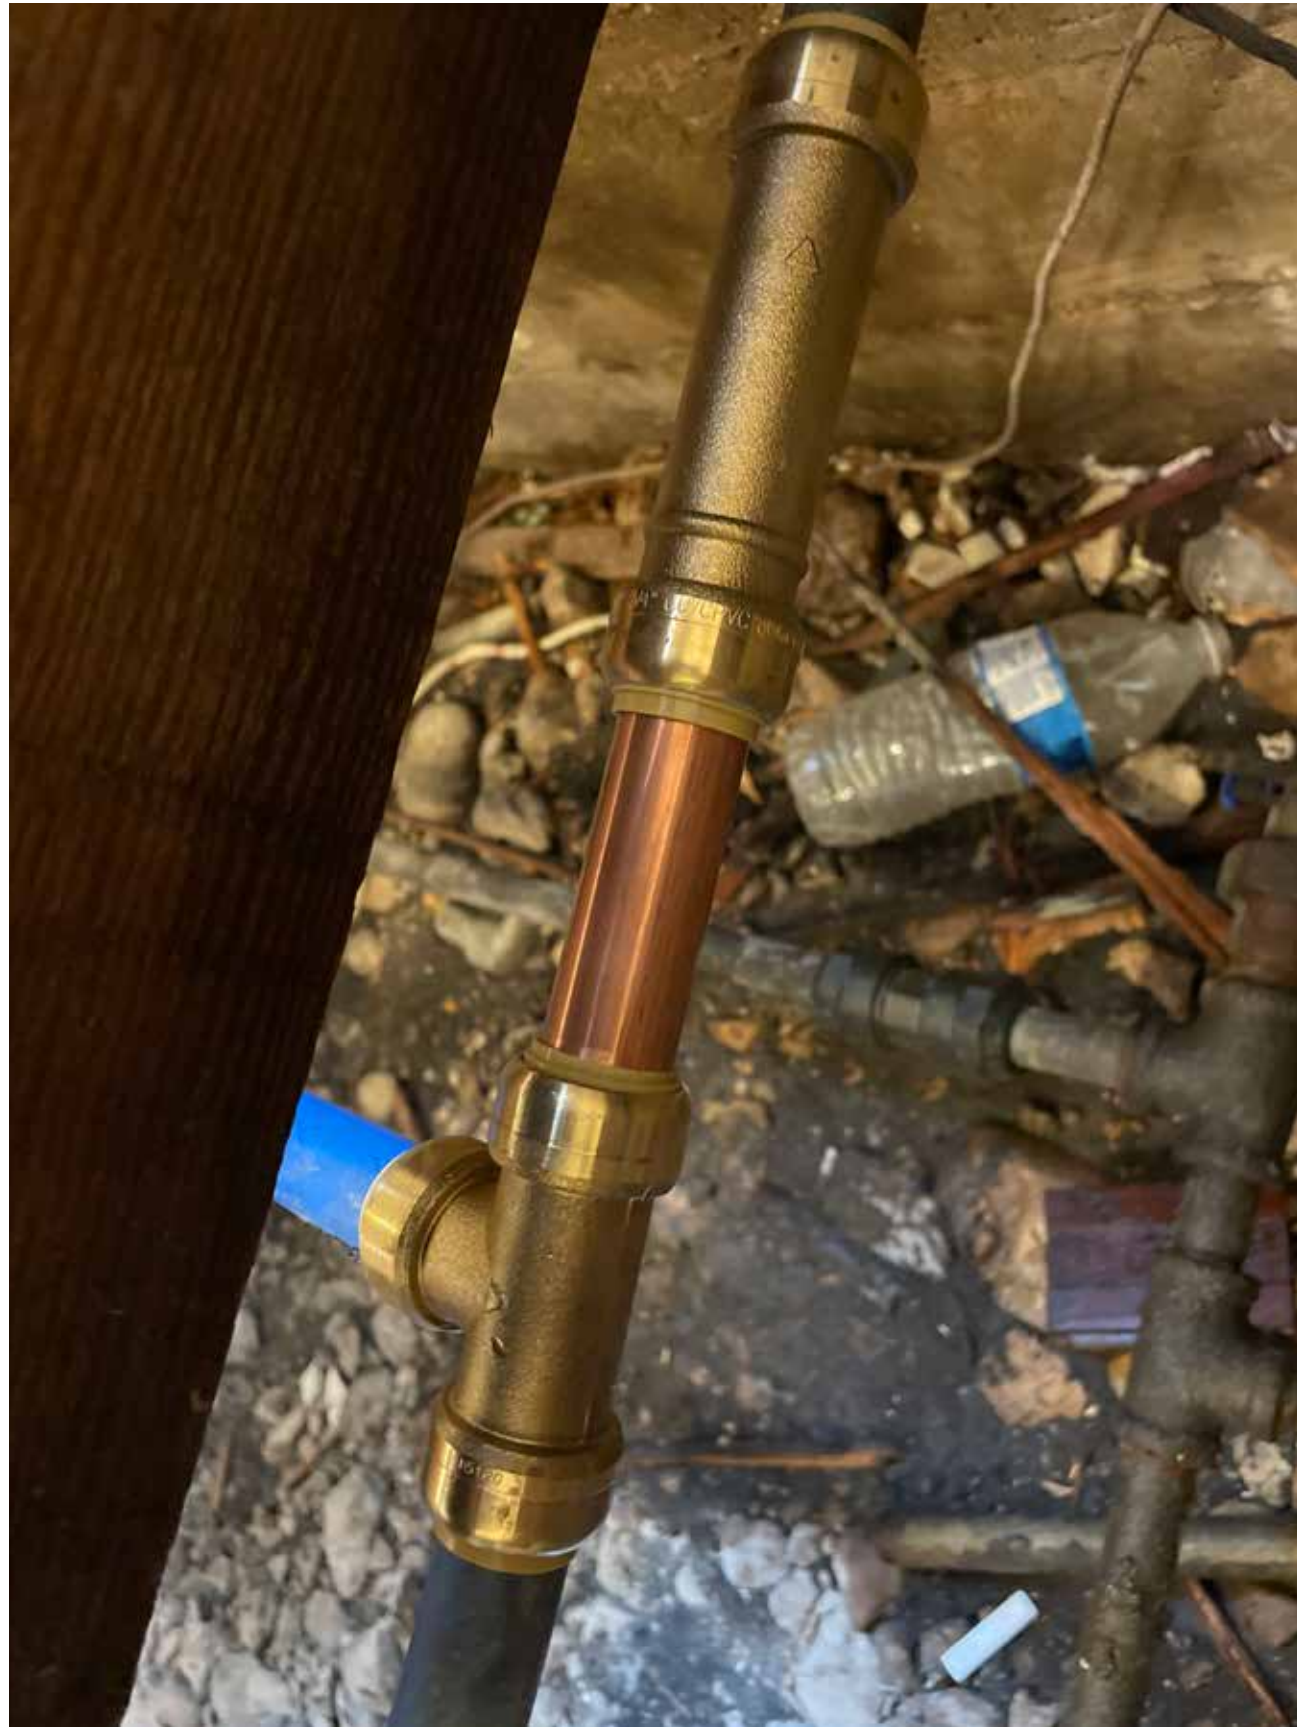
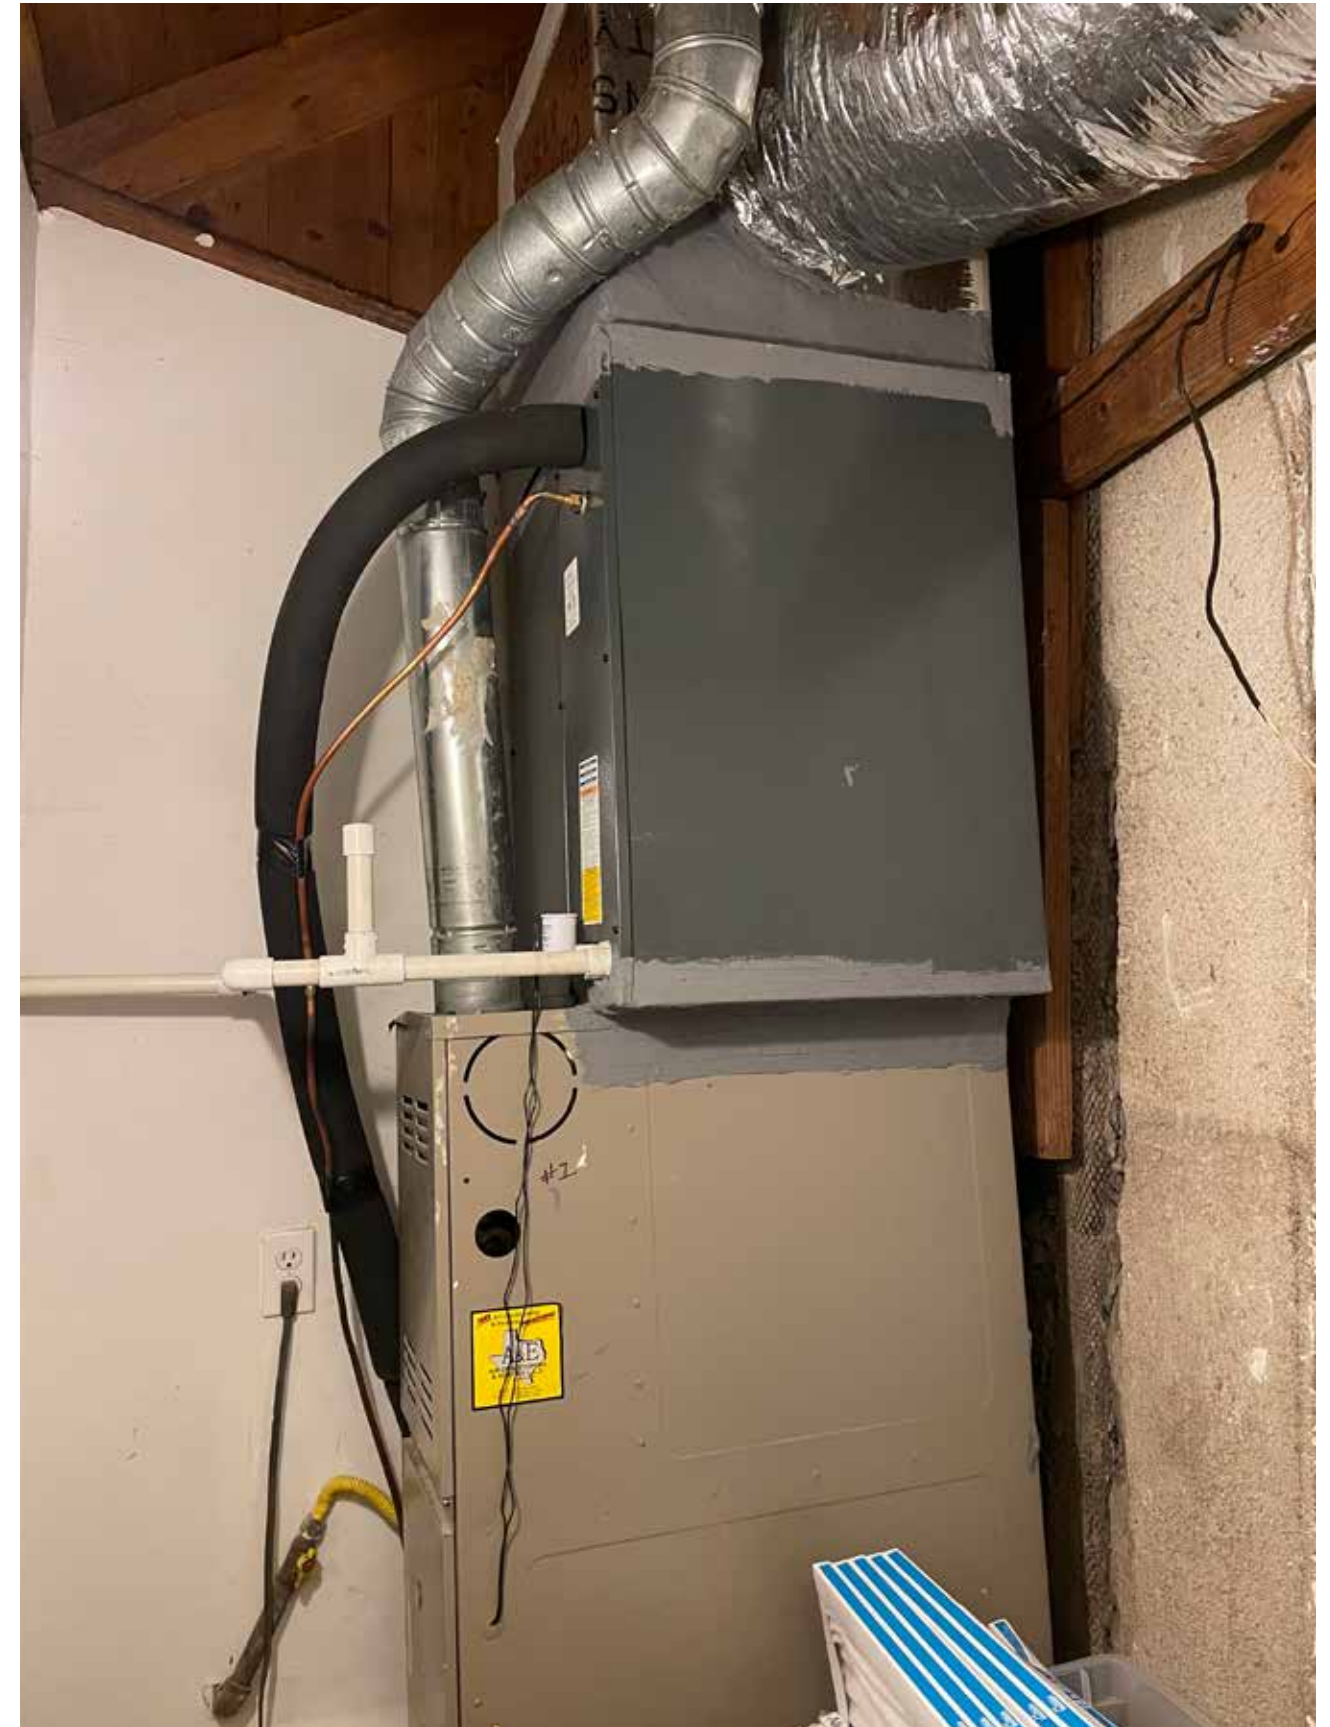
NEW HVAC AND REPAIRED PLUMBING
