**HISTORIC AND DESIGN REVIEW
COMPLIANCE AND TECHNICAL ADVISORY BOARD
March 22, 2024**

HDRC CASE NO: 2024-103
ADDRESS: 515 WICKES
LEGAL DESCRIPTION: NCB 2916 BLK 5 LOT 16
ZONING: RM-4, H
CITY COUNCIL DIST.: 1
DISTRICT: King William Historic District
APPLICANT: Rebecca Clausewitz
OWNER: CLAUSEWITZ REBECCA
TYPE OF WORK: Retaining wall installation, landscape modifications, and steps replacement
APPLICATION RECEIVED: March 1, 2024
60-DAY REVIEW: April 30, 2024

The applicant is requesting a Certificate of Appropriateness for approval to:

1. Construct a limestone retaining wall.
2. Regrade the front yard; create level surface at top of new wall.
3. Replace the concrete porch steps with stone.
4. Replace the concrete walkway steps with stone.
5. Construct limestone planters along the southern and eastern façade's foundation skirting.

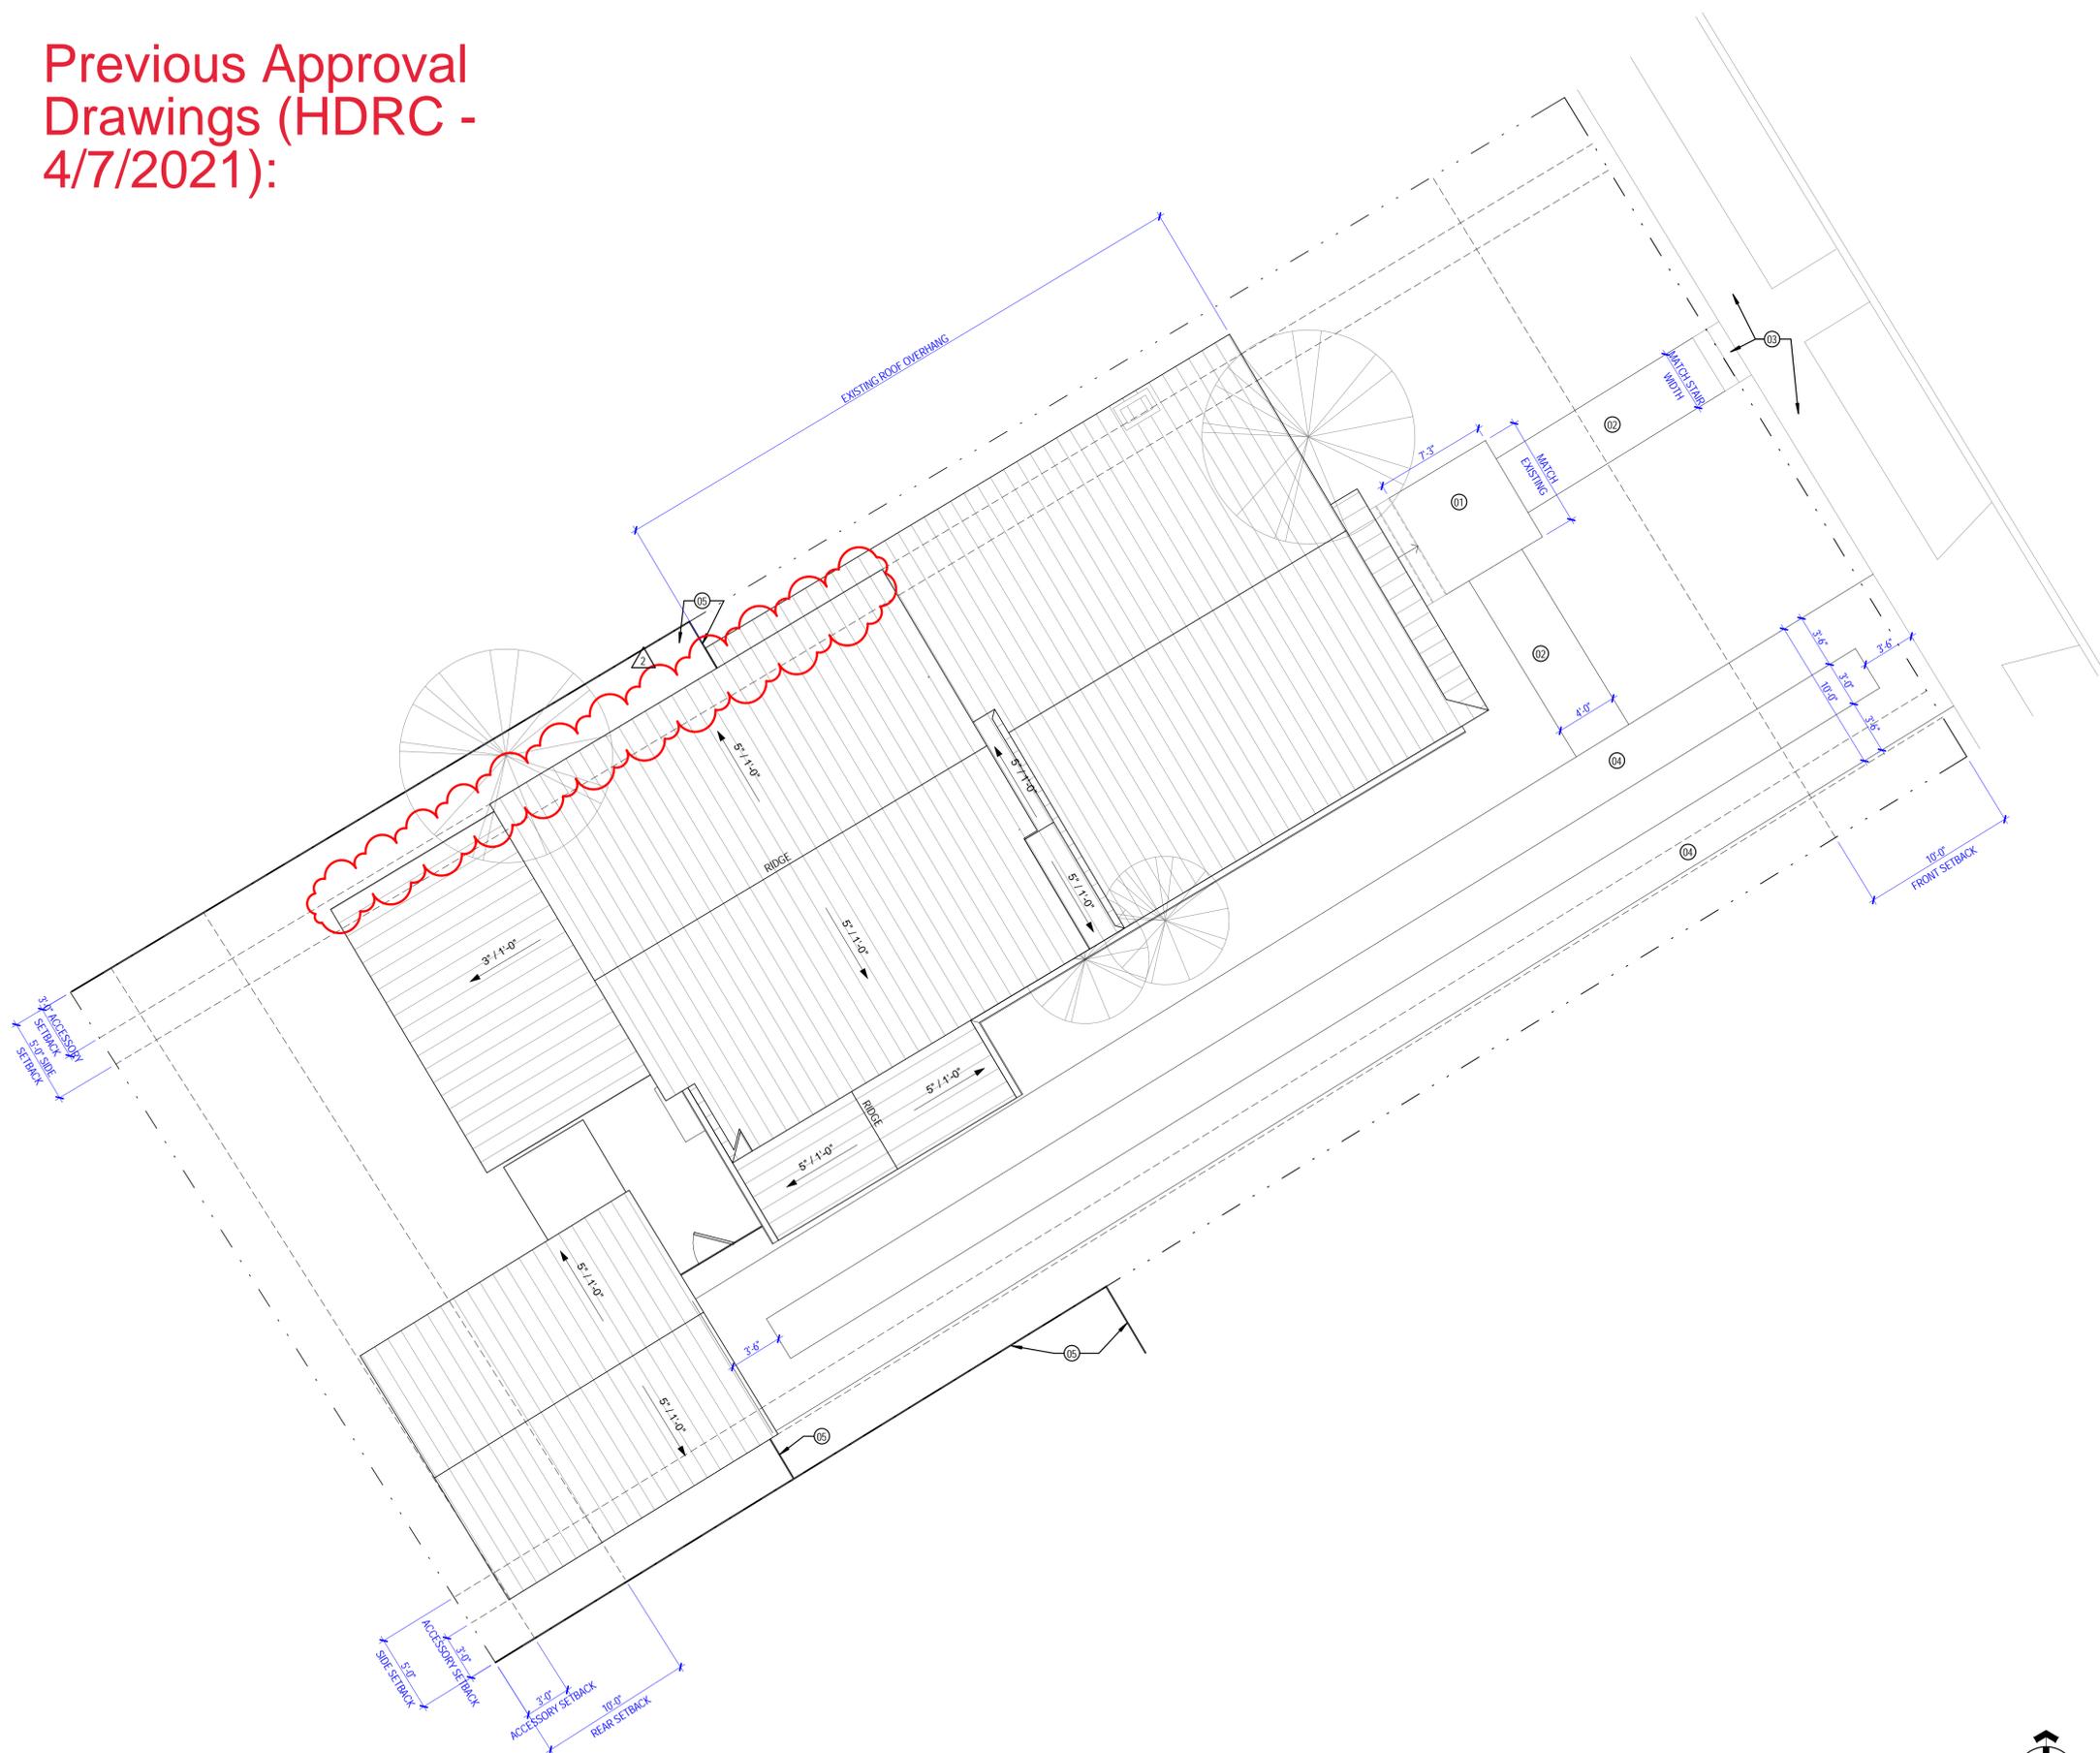
1 SITE PLAN
3/16" = 1'-0"

- 01 CONCRETE LANDING
- 02 PAVER SIDEWALK
- 03 PRESSURE WASH EXISTING CONCRETE STEPS AND SIDEWALK
- 04 CONCRETE DRIVEWAY
- 05 6H CEDAR PICKET FENCE WITH METAL POSTS

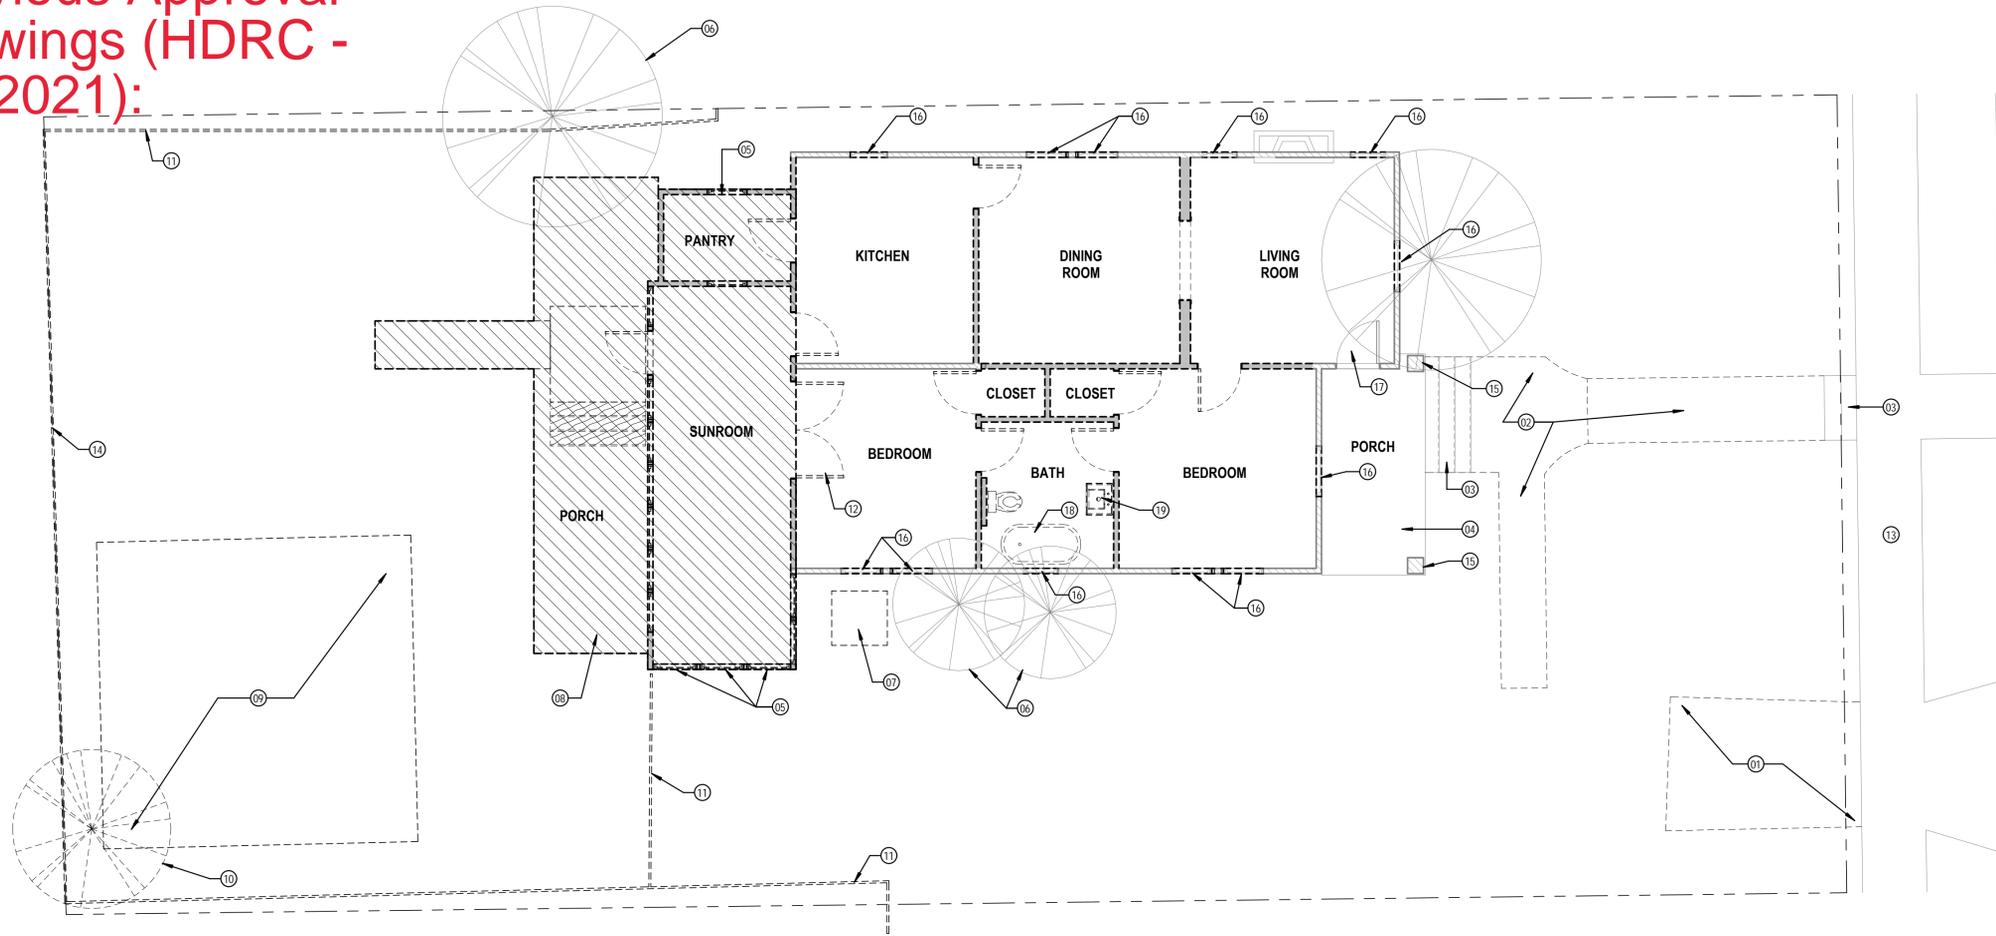
1 LEVEL 01 - DEMOLITION PLAN
3/16" = 1'-0"

- 01 DEMO EXISTING CONCRETE DRIVE
- 02 DEMO EXISTING CONCRETE SIDEWALK
- 03 EXISTING CONCRETE STEPS TO REMAIN
- 04 DEMO EXISTING WOOD PORCH FLOOR BOARDS. REPAIR EXISTING PORCH FRAMING AS REQUIRED IN PREP FOR NEW FLOOR BOARDS

- 05 DEMO EXISTING NON-HISTORIC WINDOW AND FRAME
- 06 EXISTING TREES TO REMAIN AND BE PROTECTED DURING CONSTRUCTION
- 07 DEMO EXISTING A/C PAD AND UNIT
- 08 DEMO HATCHED AREA OF EXISTING HOUSE AND PREP TO RECEIVE NEW ADDITION

- 09 DEMO EXISTING GARAGE SLAB AND PREP GROUND FOR NEW GARAGE FOUNDATION PER STRUCTURAL
- 10 DEMO EXISTING TREE AND GRIND STUMP AS REQUIRED
- 11 DEMO EXISTING FENCE AND PREP TO INSTALL NEW WOOD FENCE AT PROPERTY LINE

- 12 CAREFULLY REMOVE AND SALVAGE EXISTING DOORS TO BE REUSED
- 13 EXISTING CONCRETE SIDEWALK AND DRIVE APPROACH TO REMAIN
- 14 DEMO EXISTING METAL FENCE AND RANDOM FENCE BOARDS

- 15 EXISTING COLUMN TO REMAIN AND BE REPAIRED IN PREPARATION TO BE REFINISHED
- 16 EXISTING WINDOW TO REMAIN AND BE REPAIRED AS REQUIRED IN PREPARATION TO BE REFINISHED

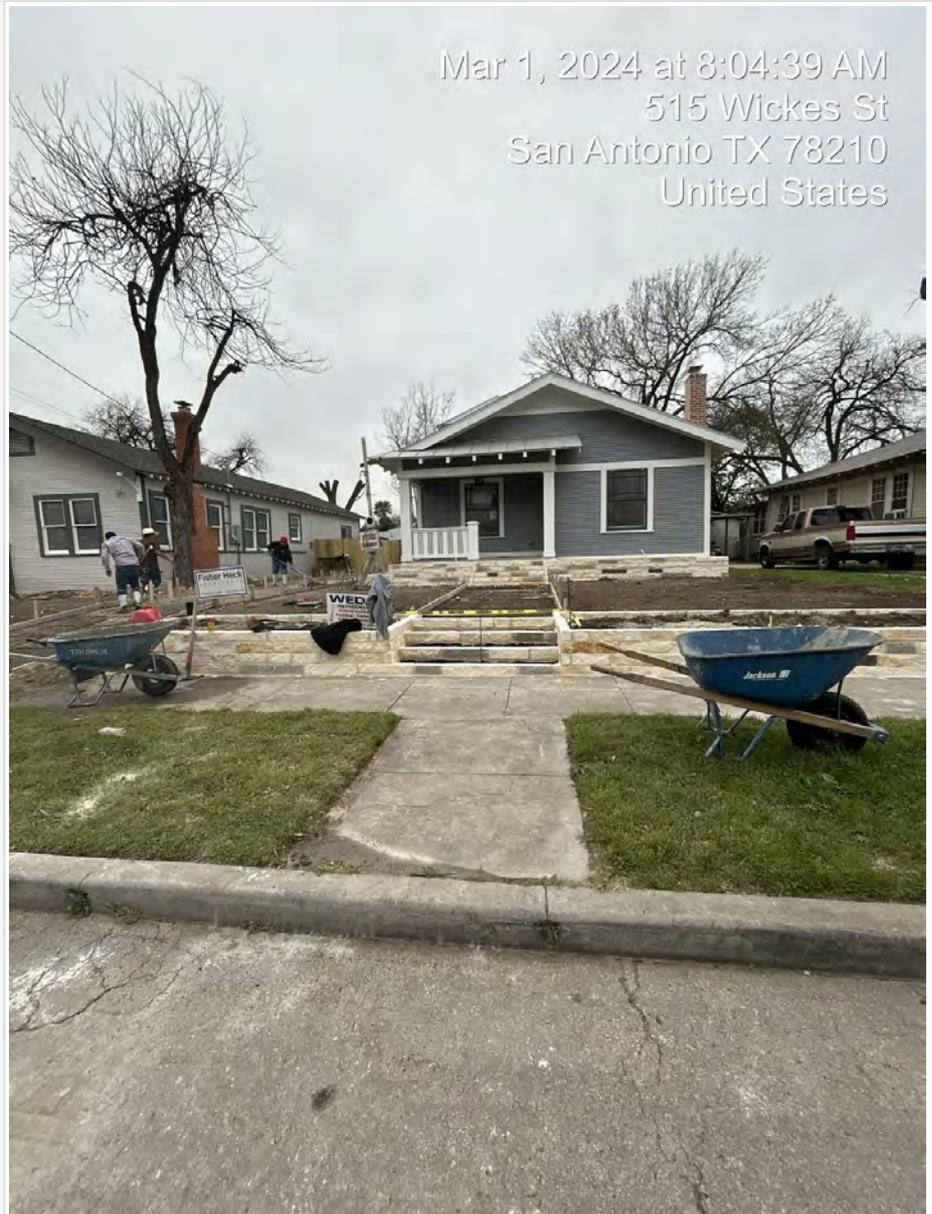
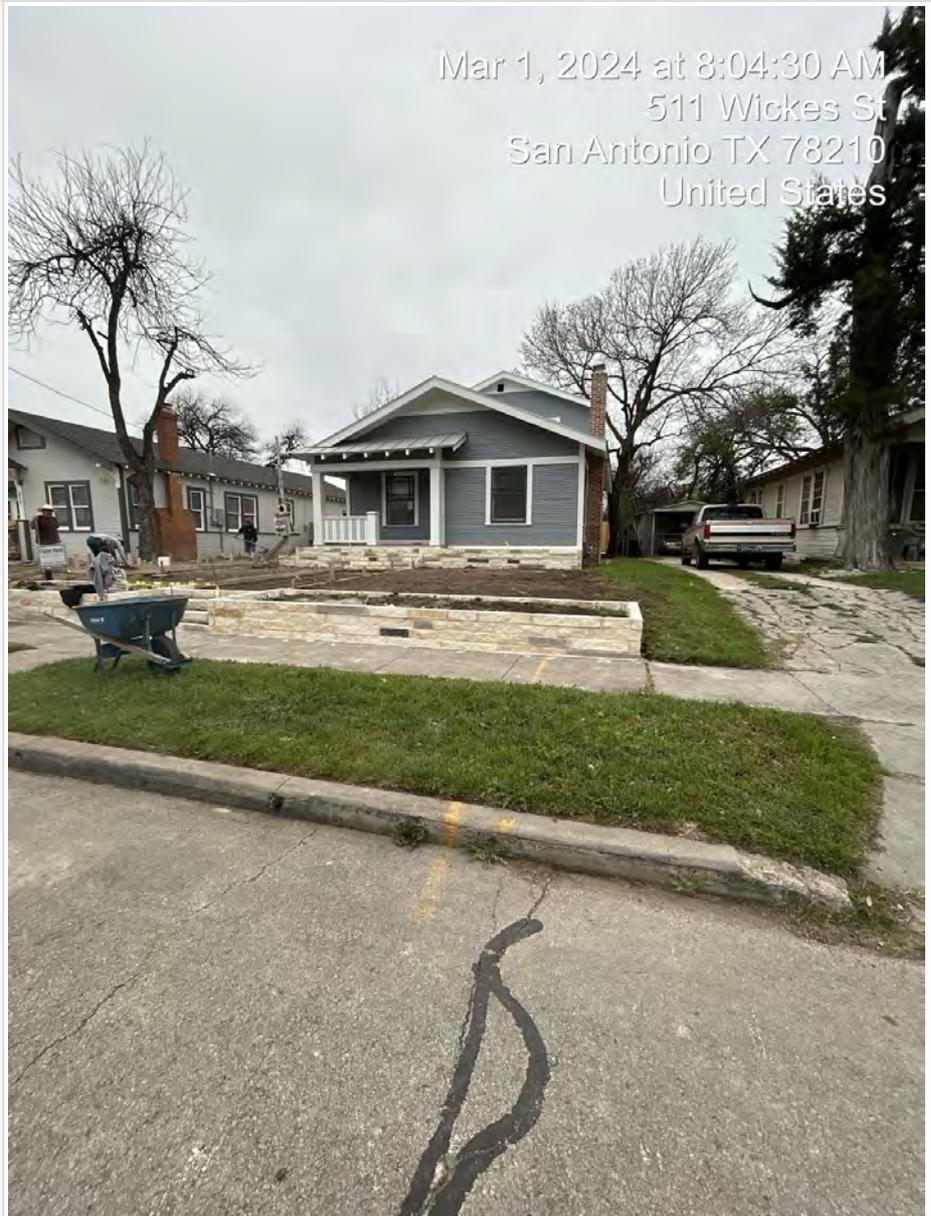
Photographs

- b. VIOLATION – On March 1, 2024, staff observed work occurring on the property without a Certificate of Appropriateness. Staff discussed the project with the driveway contractor onsite and he stated that the property owner, had all COAs and permits for the scopes of work observed. Staff contacted the property owner via phone call and let her know of the violations observed and issued a Stop Work Order the same day. Violations include planter box construction; porch steps and walkway steps replacement; and retaining wall construction.

Date	03/01/2024
Time	08:00 AM (-6 GMT)
Context	drive-by
Present Staff	Claudia Espinosa
Present Individuals	Contractor(s)
Contractor/Realtor Companies	Mike
Types of Work Observed	Exterior Maintenance and Alterations
Amount of Work Completed	Completed
Description of work	Addition of limestone retaining walls, introduction of sidewalk, limestone skirting and stairs
Description of interaction	Spoke to the contractor, Mike, for the driveway. He stated that the property owner, Rebecca Clausewitz, had all the COAs and permits for the scopes of work listed. He stated he was not the contractor for those completed scopes of work and didn't have any information for those contractors but provided the property owners phone number. Staff contacted the property owner via phone and let her know that the scopes of work listed require a COA. Additionally let the property owner know of the violation. The property owner has been notified of the deadline of Friday, March 1, 2024, to be considered for the upcoming CTAB agenda.

Staff does not recommend approval of items 1 through 5, based on findings a through i. Staff recommends the applicant work with staff to return the modifications to their previous configurations.
