HISTORIC AND DESIGN REVIEW COMMISSION COMPLIANCE AND TECHNICAL ADVISORY BOARD

HDRC CASE NO: 2024-096
ADDRESS: 115 W HUISACHE AVE
LEGAL DESCRIPTION: NCB 1769 BLK 5 LOT 15
ZONING: R-4, H
CITY COUNCIL DIST.: 1
DISTRICT: Monte Vista Historic District
APPLICANT: Katharine Martin/MARTIN KATHARINE M & DEALY ROBERT E
OWNER: Katharine Martin/MARTIN KATHARINE M & DEALY ROBERT E
TYPE OF WORK: Roof replacement
APPLICATION RECEIVED: February 29, 2024
60-DAY REVIEW: April 29, 2024
CASE MANAGER: Rachel Rettaliata

The applicant is requesting a Certificate of Appropriateness for approval to replace the existing asphalt shingle roof with a standing seam metal roof

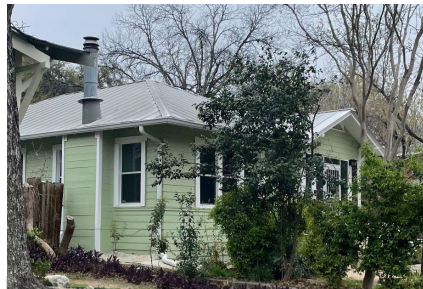
111 W Huisache

Our neighbors have metal roofs.
