HISTORIC AND DESIGN REVIEW COMMISSION

HDRC CASE NO: 2024-004
ADDRESS: 138 KING WILLIAM
LEGAL DESCRIPTION: NCB 737 BLK 2 LOT 9
ZONING: RM-4, HS
CITY COUNCIL DIST.: 1
DISTRICT: King William Historic District
LANDMARK: Individual Landmark
APPLICANT: Nick Whitelonis
OWNER: Nick Whitelonis
TYPE OF WORK: Historic Tax Certification & Verification
APPLICATION RECEIVED: January 03, 2024
60-DAY REVIEW: February 2, 2024
CASE MANAGER: Rachel Rettaliata

The applicant is requesting Historic Tax Certification and Verification for the property at 138 King William.

1. Scope and Overview

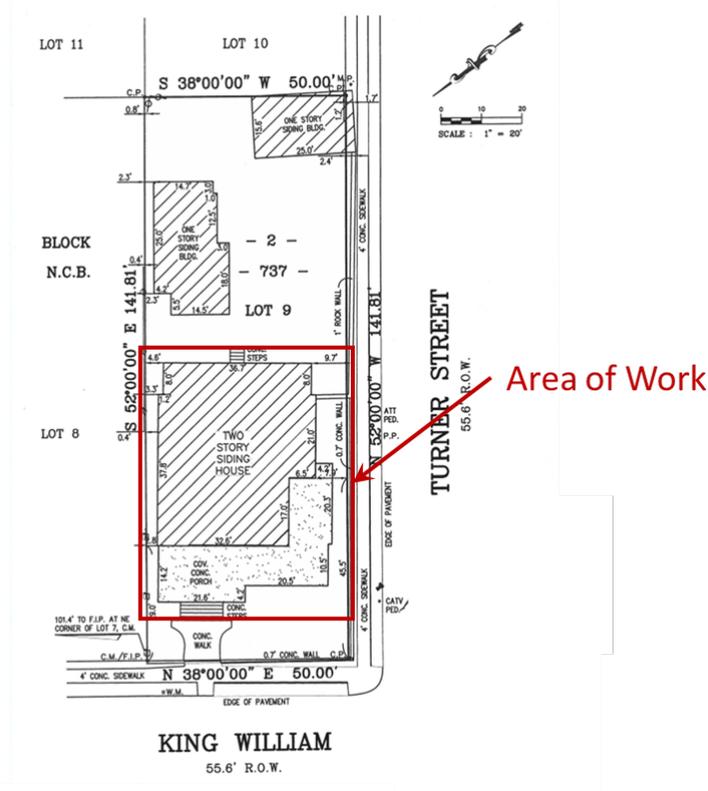
Figure 1 138 King William St. Site Overview

The rehabilitation work includes foundation and roof repair for the primary structure on the property, see Figure 1 for site overview. The exterior of the structure prior to repairs is shown in Figures 2-5.

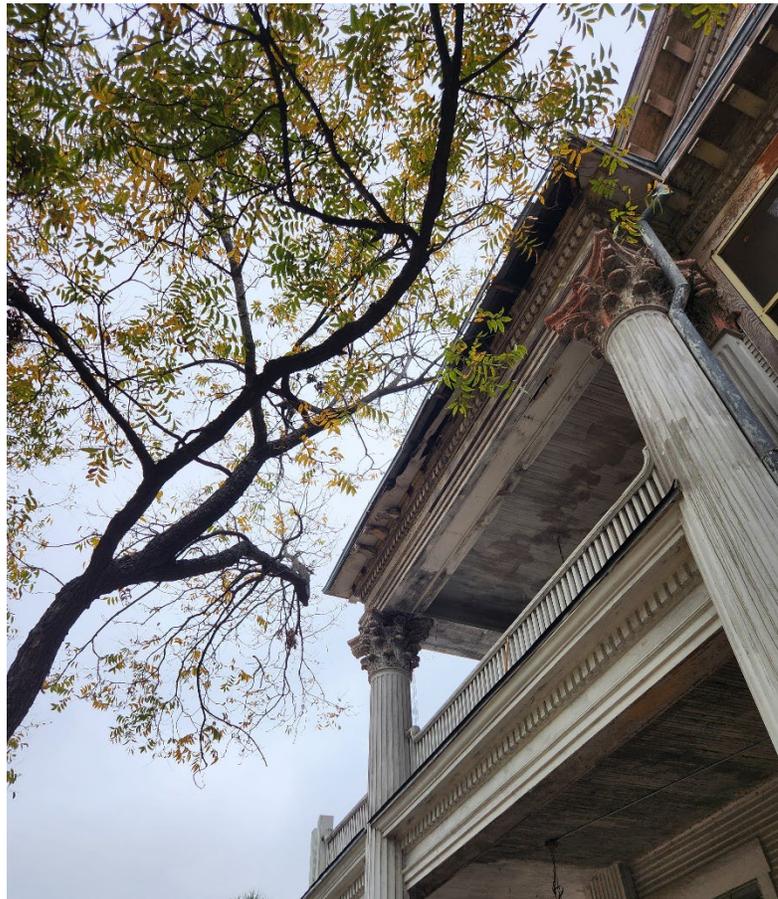
The current roof on the primary structure is an asphalt three-tab shingle. It is unknown how old the roof is, but the shingles are severely degraded and there are areas of water ingress in the attic. The proposed roof work is to replace the shingle roof with an approved Galvalume metal roof. In addition, the fascia and soffit in areas is damaged and in need of repair, e.g. see Figure 6. The roof work is to also include repair of the fascia and soffit as needed.

Figure 6 Example of Soffit Damage.

1. Demo and dispose of fascia and soffit
2. Remove corbels from soffit and set aside
3. Install new 1x6 fascia and 1x12 soffits - Inspect all areas
3. Clean in broom like condition
