#### HISTORIC AND DESIGN REVIEW COMMISSION April 06, 2022

HDRC CASE NO: 2022-183 **ADDRESS:** 138 KING WILLIAM **LEGAL DESCRIPTION:** NCB 737 BLK 2 LOT 9 **ZONING:** RM-4, H **CITY COUNCIL DIST.:** 1 **DISTRICT:** King William Historic District **APPLICANT:** NICHOLAS WHITELONIS/WHITELONIS NICHOLAS & AMANDA NICHOLAS WHITELONIS/WHITELONIS NICHOLAS & AMANDA **OWNER: TYPE OF WORK: Exterior** alterations **APPLICATION RECEIVED:** March 15, 2022 Not applicable due to City Council Emergency Orders **60-DAY REVIEW: CASE MANAGER:** Hannah Leighner **REQUEST:**

The applicant is requesting a Certificate of Appropriateness for approval to remove the rear chimney.

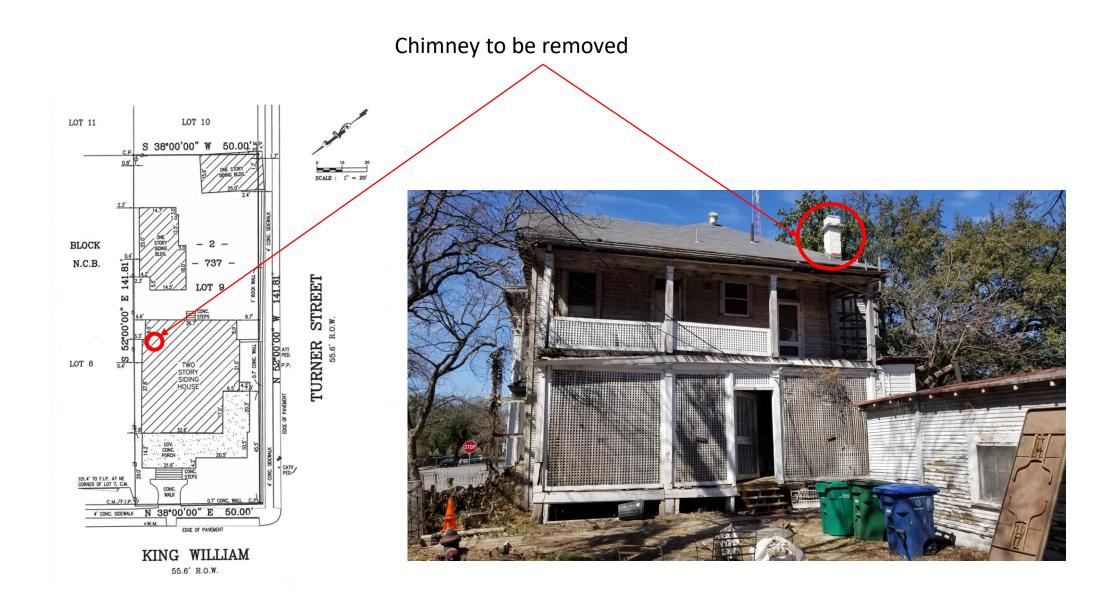
# Proposed Work

- Remove chimney
- Repair hole left in roof with matching shingles

- a. The primary structure located at 138 King William is a two-story, residential structure with a wrap around porch and double height porch columns. The property is contributing to the King William Historic District.
- b. CHIMNEY REMOVAL The applicant has proposed to remove the existing chimney from the rear corner of the primary structure as part of foundation repairs. The Historic Design Guidelines 3.B.iii state that existing historic roof forms should be maintained. Staff finds the removal of the chimney to be inconsistent with the Guidelines. Staff finds that the exterior appearance of the chimney should not be impacted by foundation repair.

Staff does not recommend approval based on finding b. The exterior appearance of the chimney should not be impacted by foundation repair.
