HISTORIC AND DESIGN REVIEW COMMISSION

HDRC CASE NO: 2022-215
ADDRESS: 1819 NEVADA
LEGAL DESCRIPTION: NCB 1506 BLK 6 LOT 17 (HOLY REDEEMER CATHOLIC CHURCH)
ZONING: RM-4, H
CITY COUNCIL DIST.: 2
APPLICANT: Will Soward/SLK Construction
OWNER: HOLY REDEEMER CHURCH
TYPE OF WORK: Roof replacement
APPLICATION RECEIVED: April 01, 2022
60-DAY REVIEW: Not applicable due to City Council Emergency Orders
CASE MANAGER: Claudia Espinosa

The applicant is requesting a Certificate of Appropriateness for approval to replace the existing, standing seam metal roofs on four, individual structures on site. Each structure on site is designated historic.

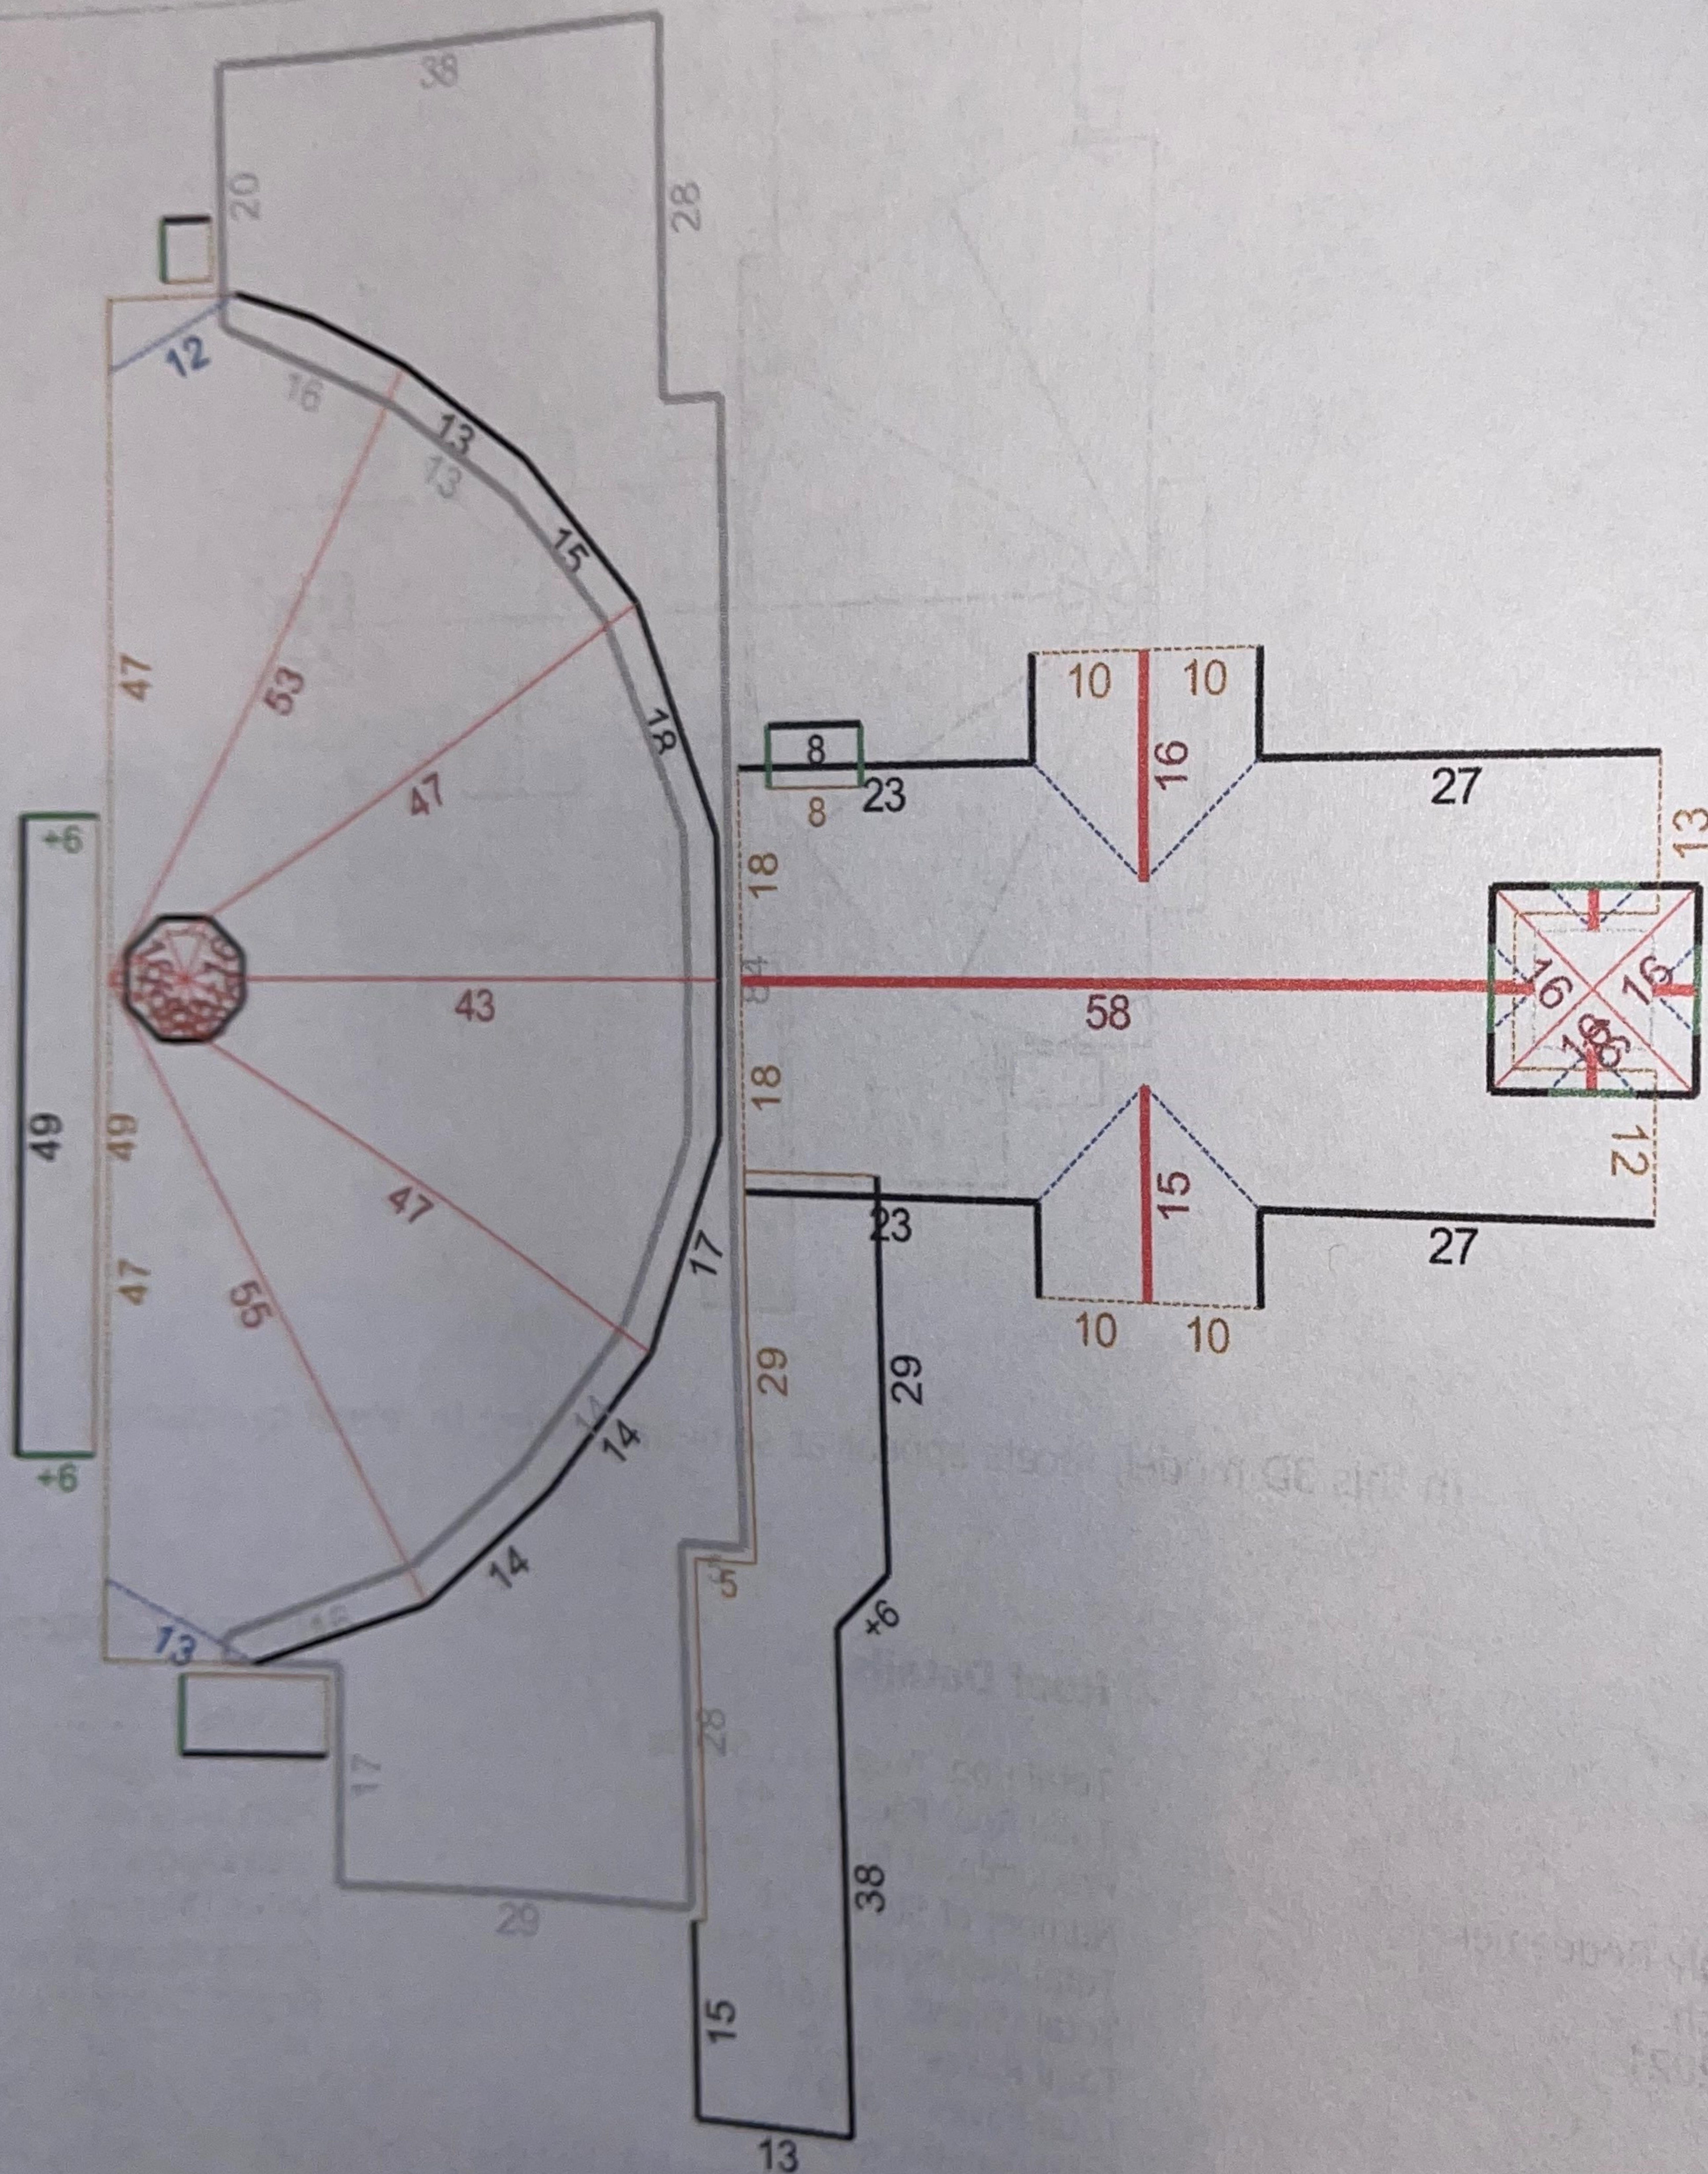
Total Line Lengths:

Ridges = 101 ft

Hips = 463 ft

Valleys = 116 ft

Rakes = 66 ft

Eaves = 509 ft

Flashing = 182 ft

Step flashing = 260 ft

Parapets = 402 ft

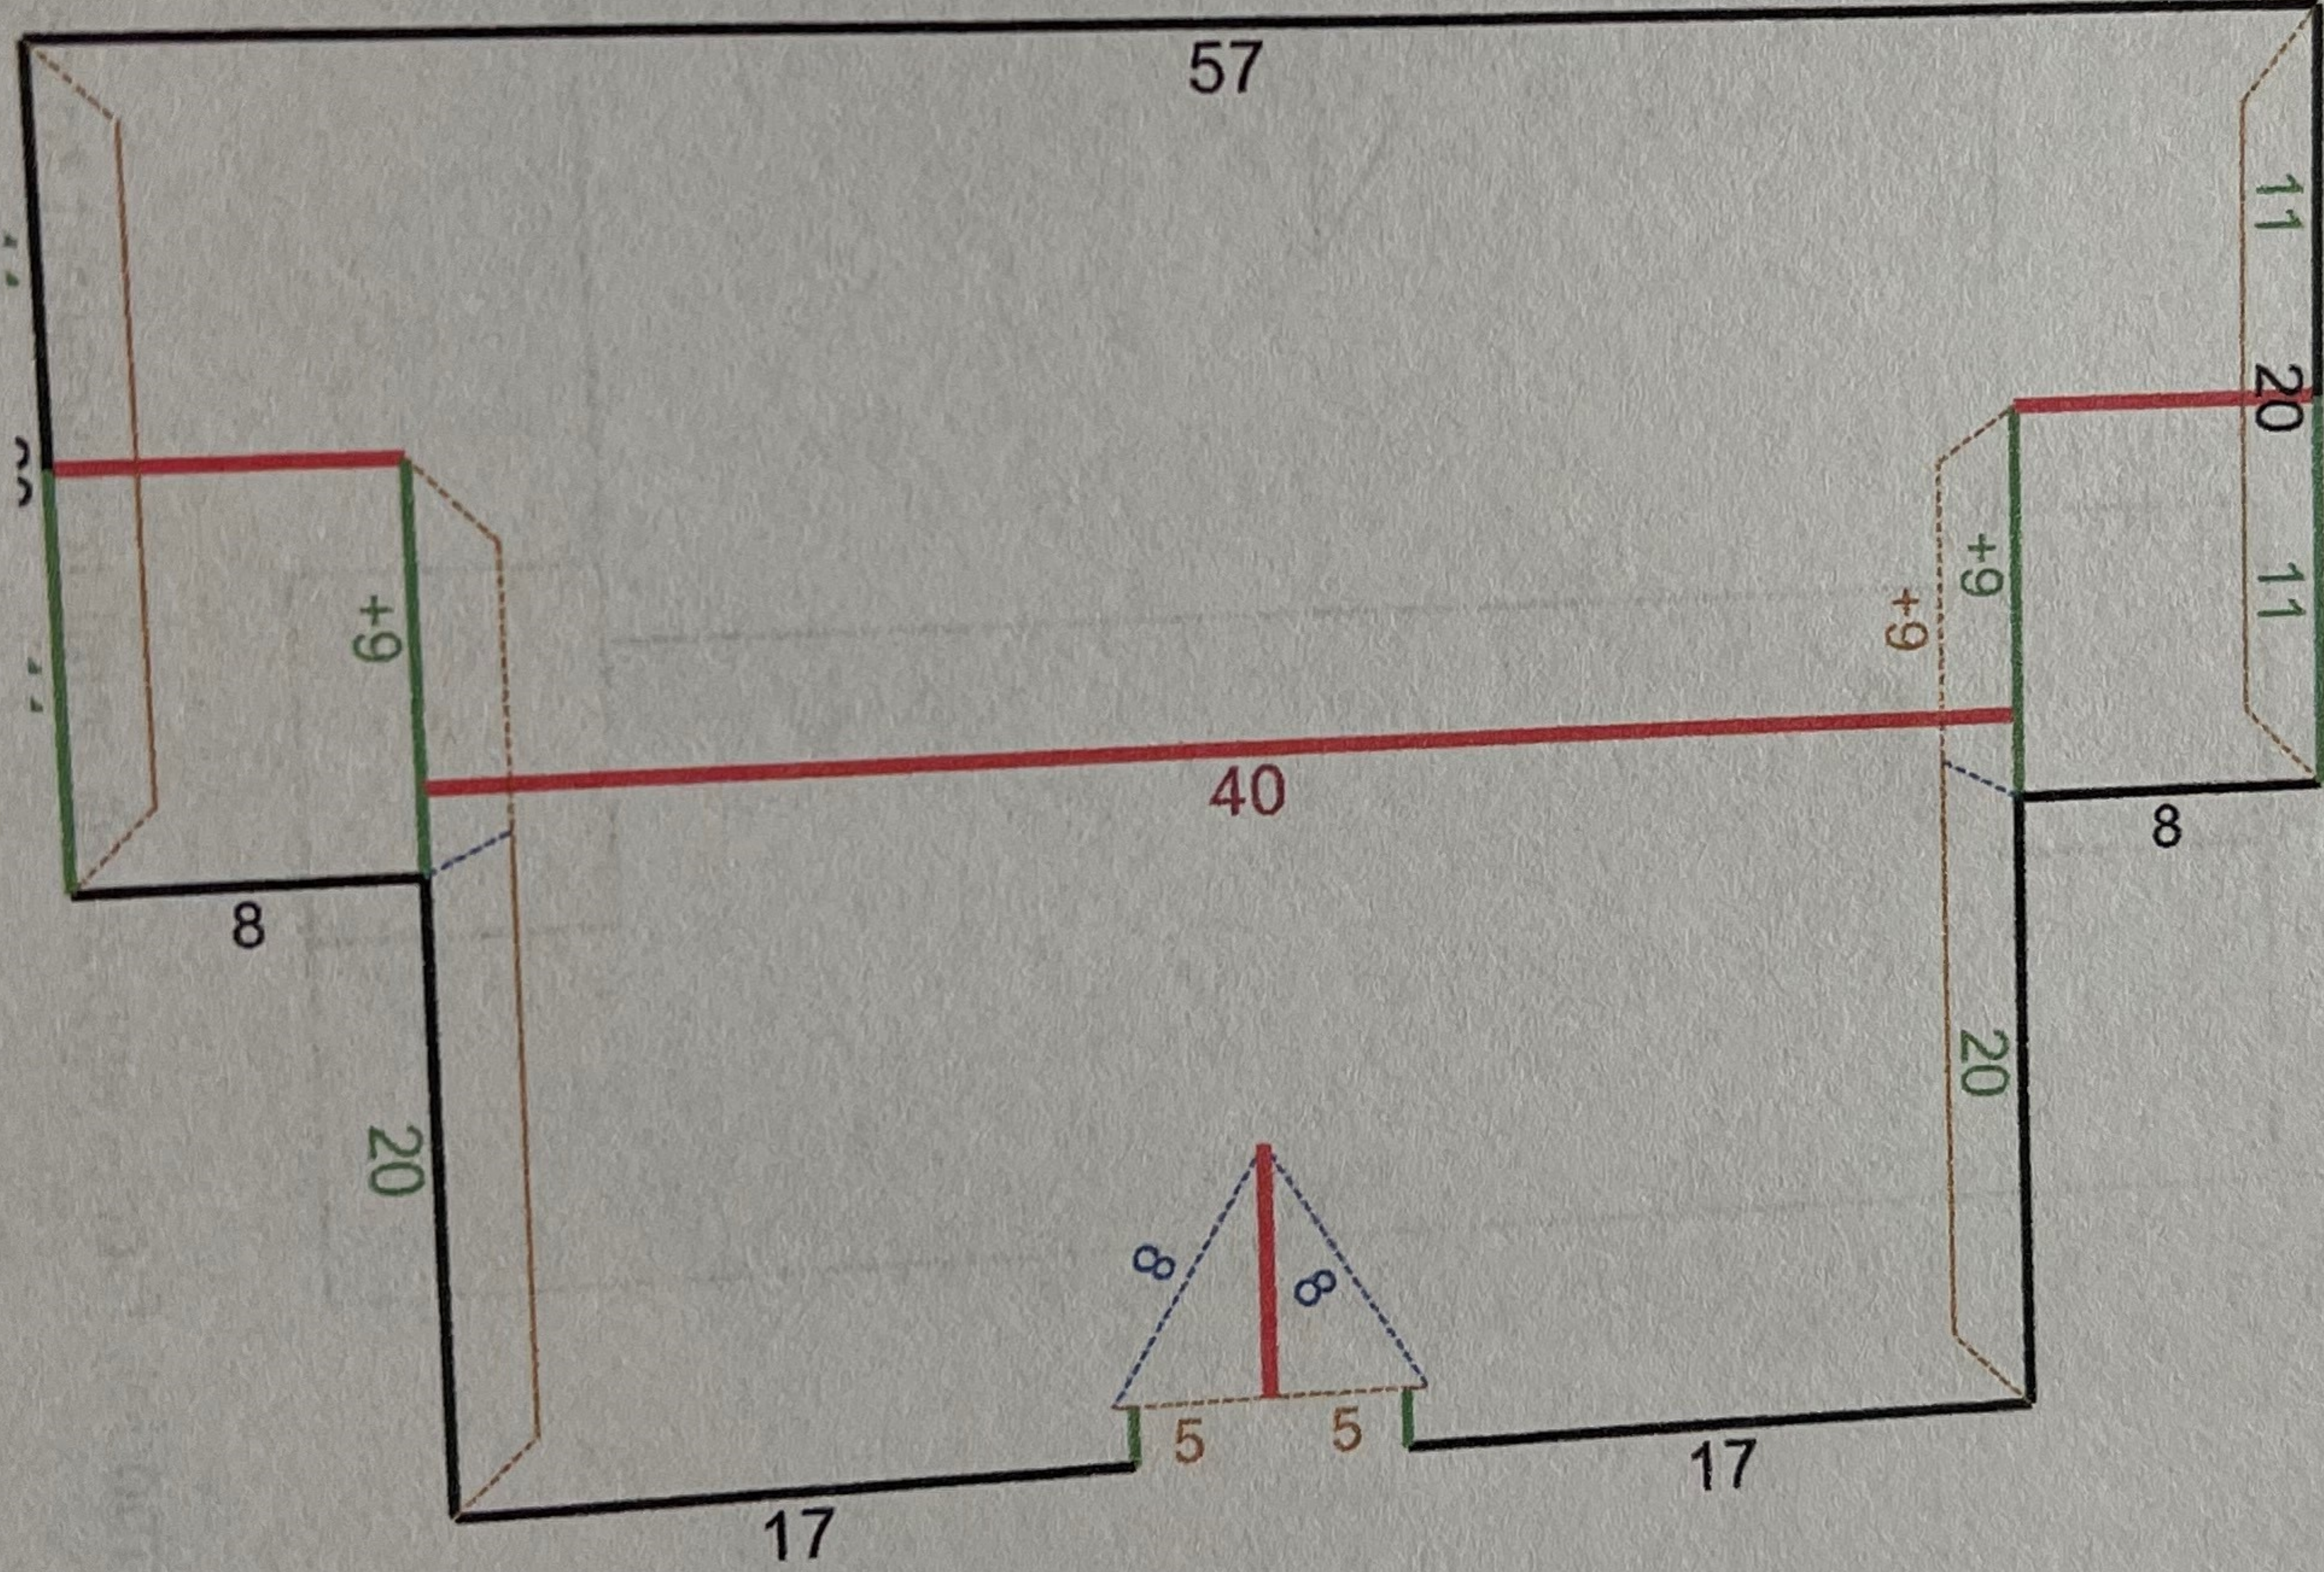
Length Diagram

Total Line Lengths:

Ridges = 64 ft
Hips = 0 ft

Valleys = 22 ft
Rakes = 107 ft
Eaves = 179 ft

Flashing = 63 ft
Step flashing = 50 ft
Parapets = 0 ft

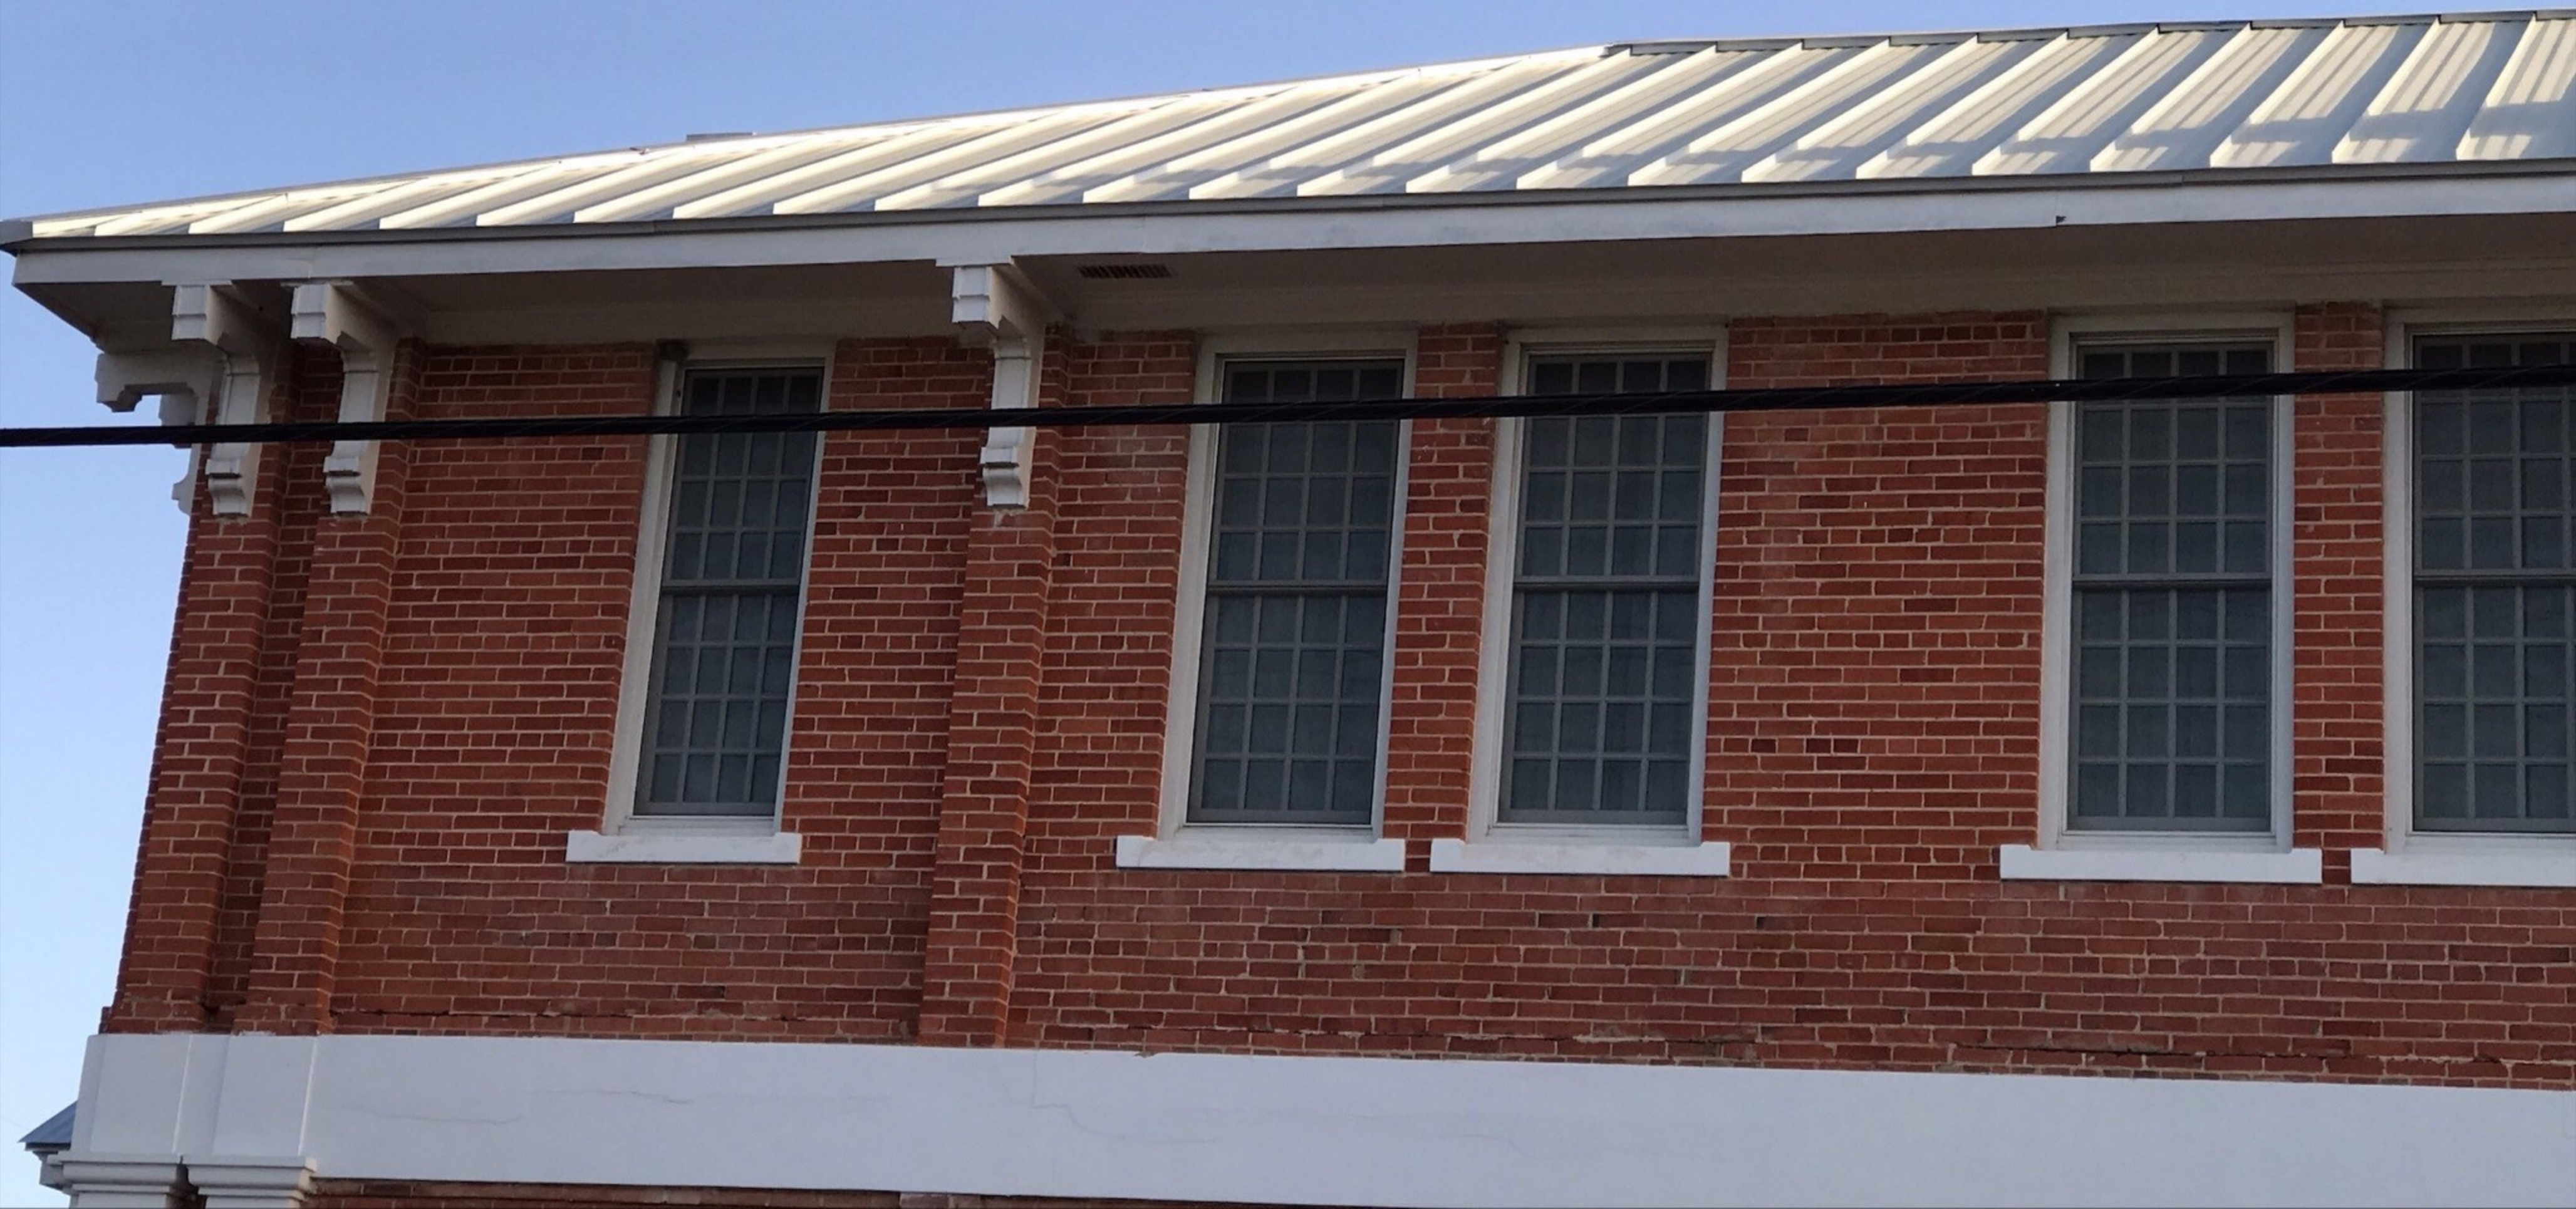
- b. VIOLATION – Office of Historic Preservation staff performed a site visit on Thursday, April 7, 2022, and observed a standing seam metal roof with a ridge cap was installed and completed without a Certificate of Appropriateness. New roofs were installed on other structures on site without a COA as well. No permit was issued by Development Services Department for roof replacement.

April 7, 2022 at 8:13 AM
230 Vargas Alley
San Antonio TX 78203
United States

- i. That the applicant installs a standing seam metal roof featuring panels that are 18 to 21 inches wide, seams that are 1 to 2 inches high, a crimped ridge seam, and a standard galvalume finish. Panels should be smooth without striation or corrugation. Ridges are to feature a double-munch or crimped ridge configuration; no vented ridge caps or end caps are allowed. An on-site inspection must be scheduled with OHP staff prior to the start of work to verify that the roofing material matches the approved specifications. All original roof details are to be preserved.
- ii. Building 1, should retain the image of the metal shingles. The metal shingles should be replaced with in-kind materials
- iii. Building 2 and 3 should abide by the ridge cap details as noted per the Exterior Maintenance and Alterations Guidelines 3. B.vi
- iv. Building 4 can be approved as submitted by the applicant.

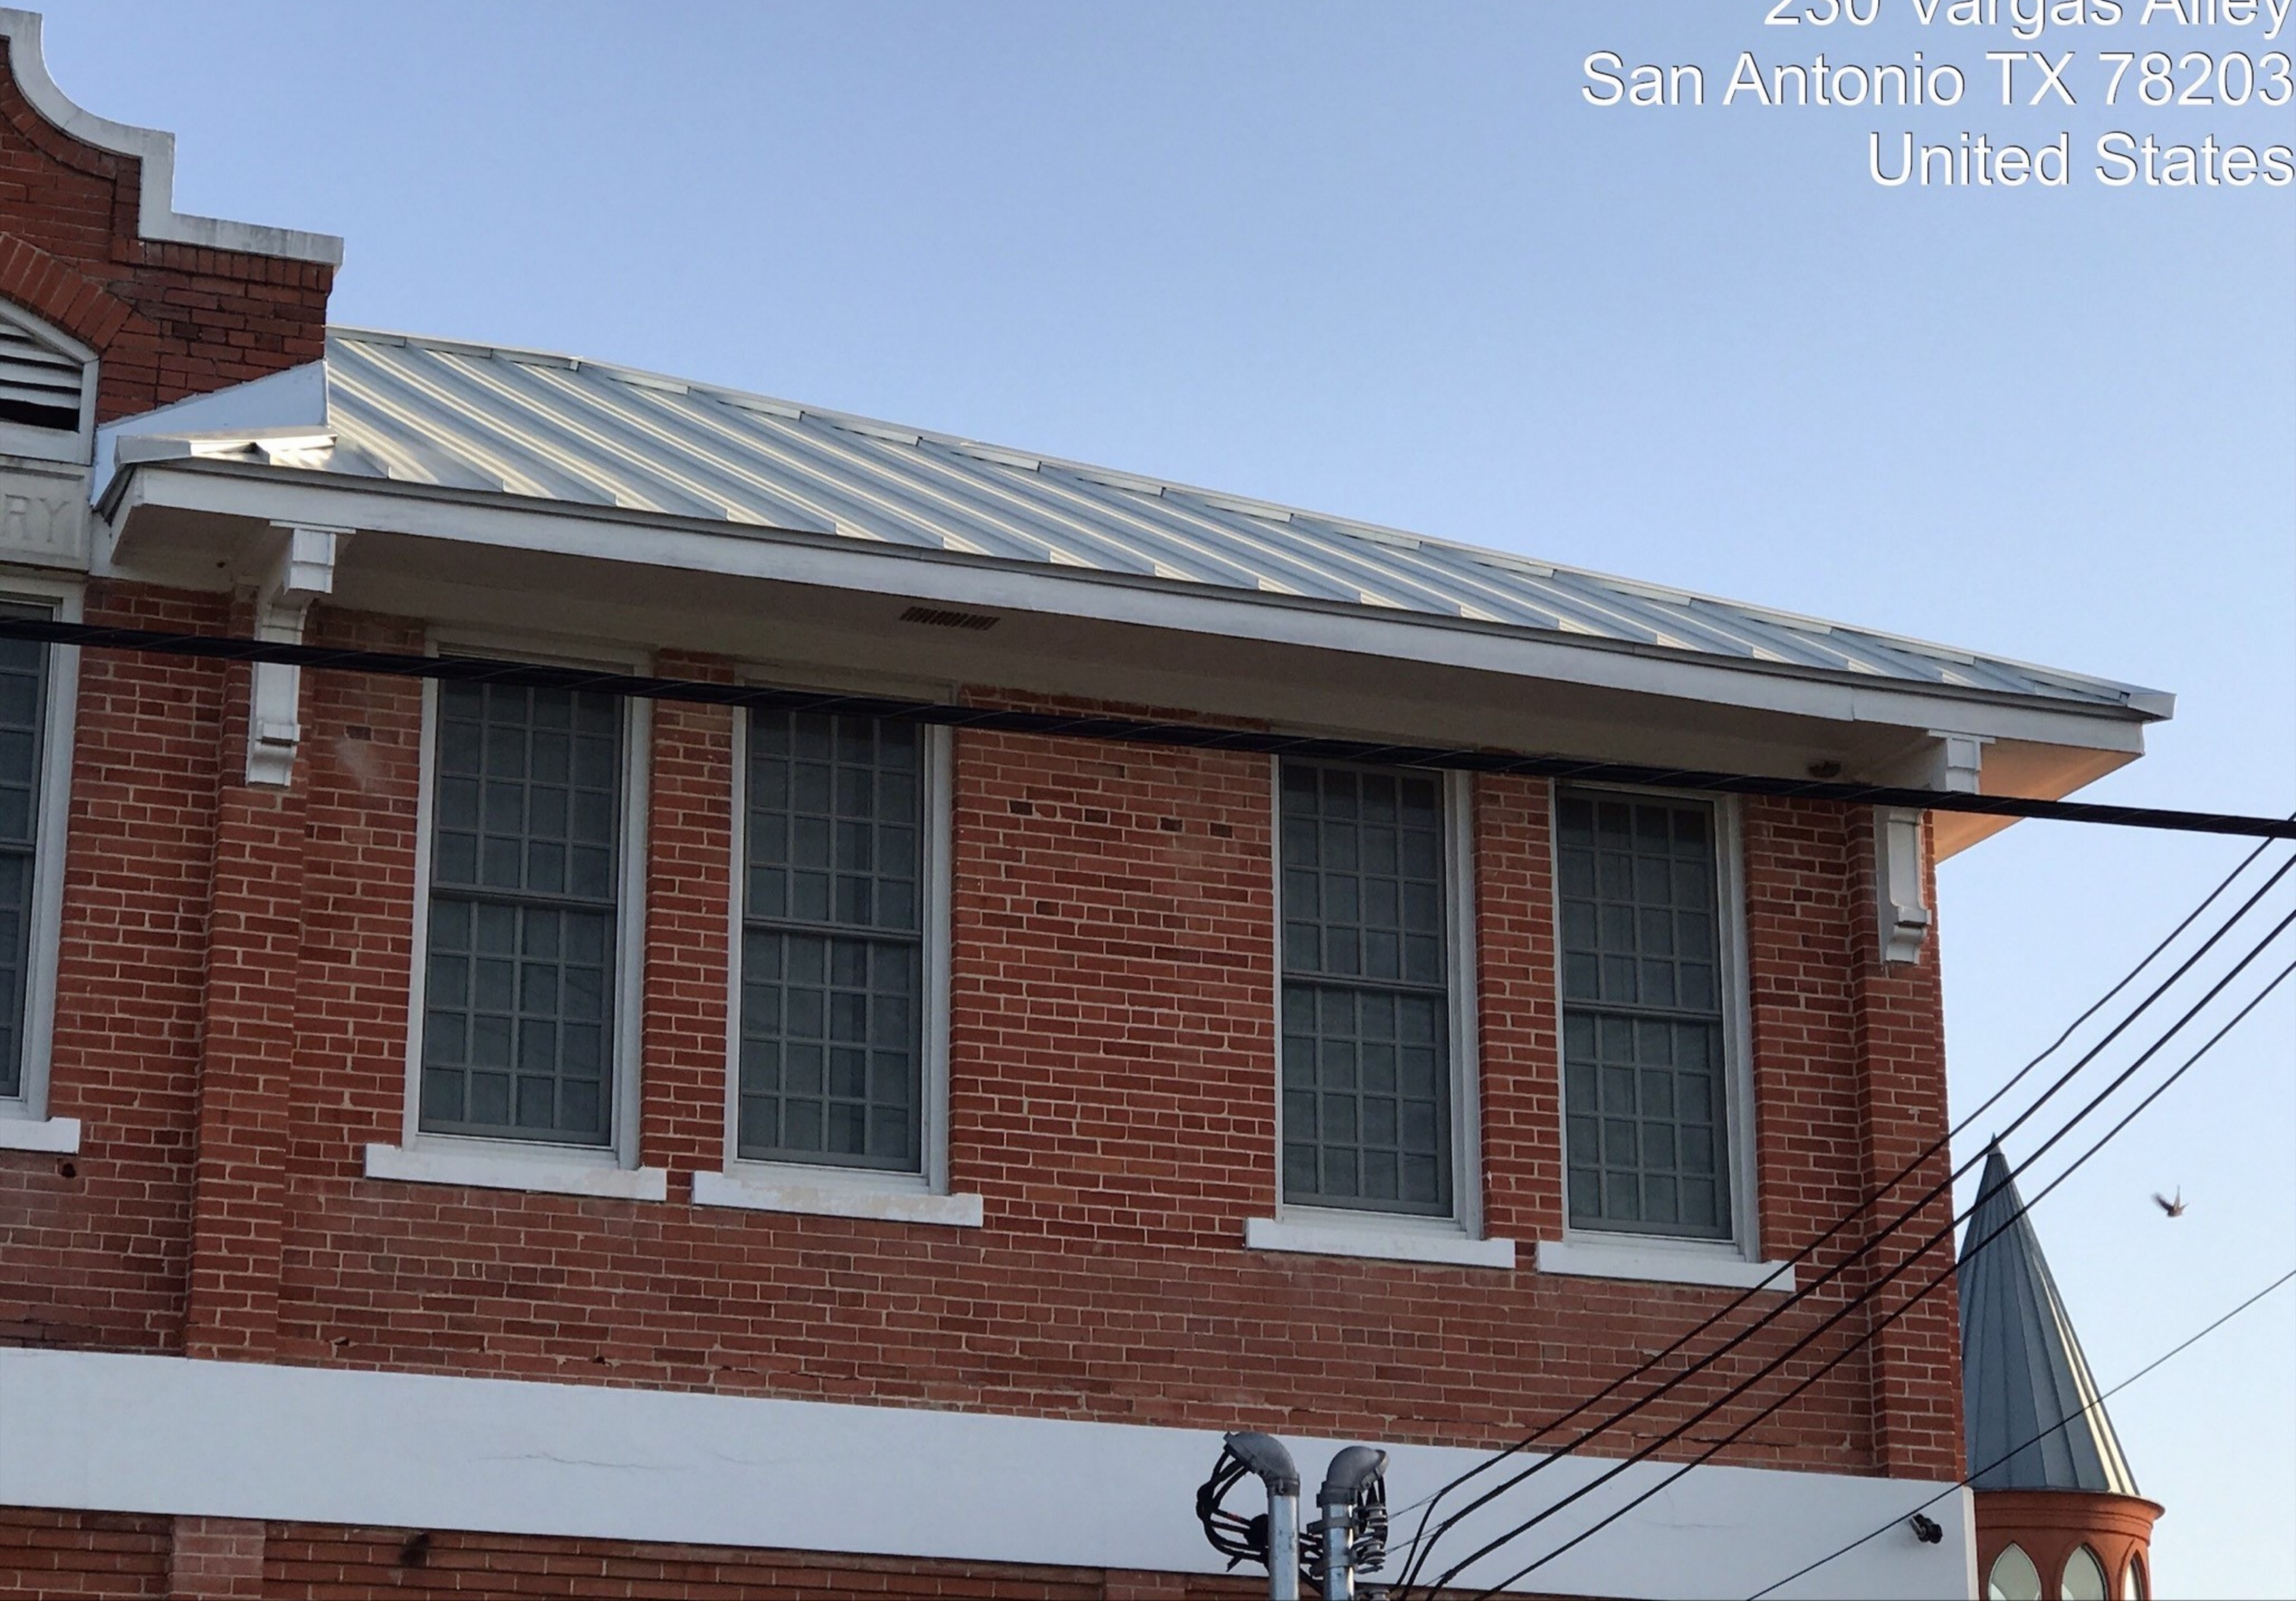
April 7, 2022 at 8:13 AM
230 Vargas Alley
San Antonio TX 78203
United States
