HISTORIC AND DESIGN REVIEW COMMISSION

HDRC CASE NO: 2022-268
ADDRESS: 327 FLORIDA ST
LEGAL DESCRIPTION: NCB 3007 BLK 5 LOT 16
ZONING: R-6, H
CITY COUNCIL DIST.: 1
DISTRICT: Lavaca Historic District
APPLICANT: ROC Acquisitions LLC
OWNER: ROC Acquisitions LLC
TYPE OF WORK: Historic Tax Verification
APPLICATION RECEIVED: May 04, 2022
60-DAY REVIEW: Not applicable due to City Council Emergency Orders
CASE MANAGER: Rachel Rettaliata

The applicant is requesting Historic Tax Verification for the property at 327 Florida.

EXTERIOR RESTORATION

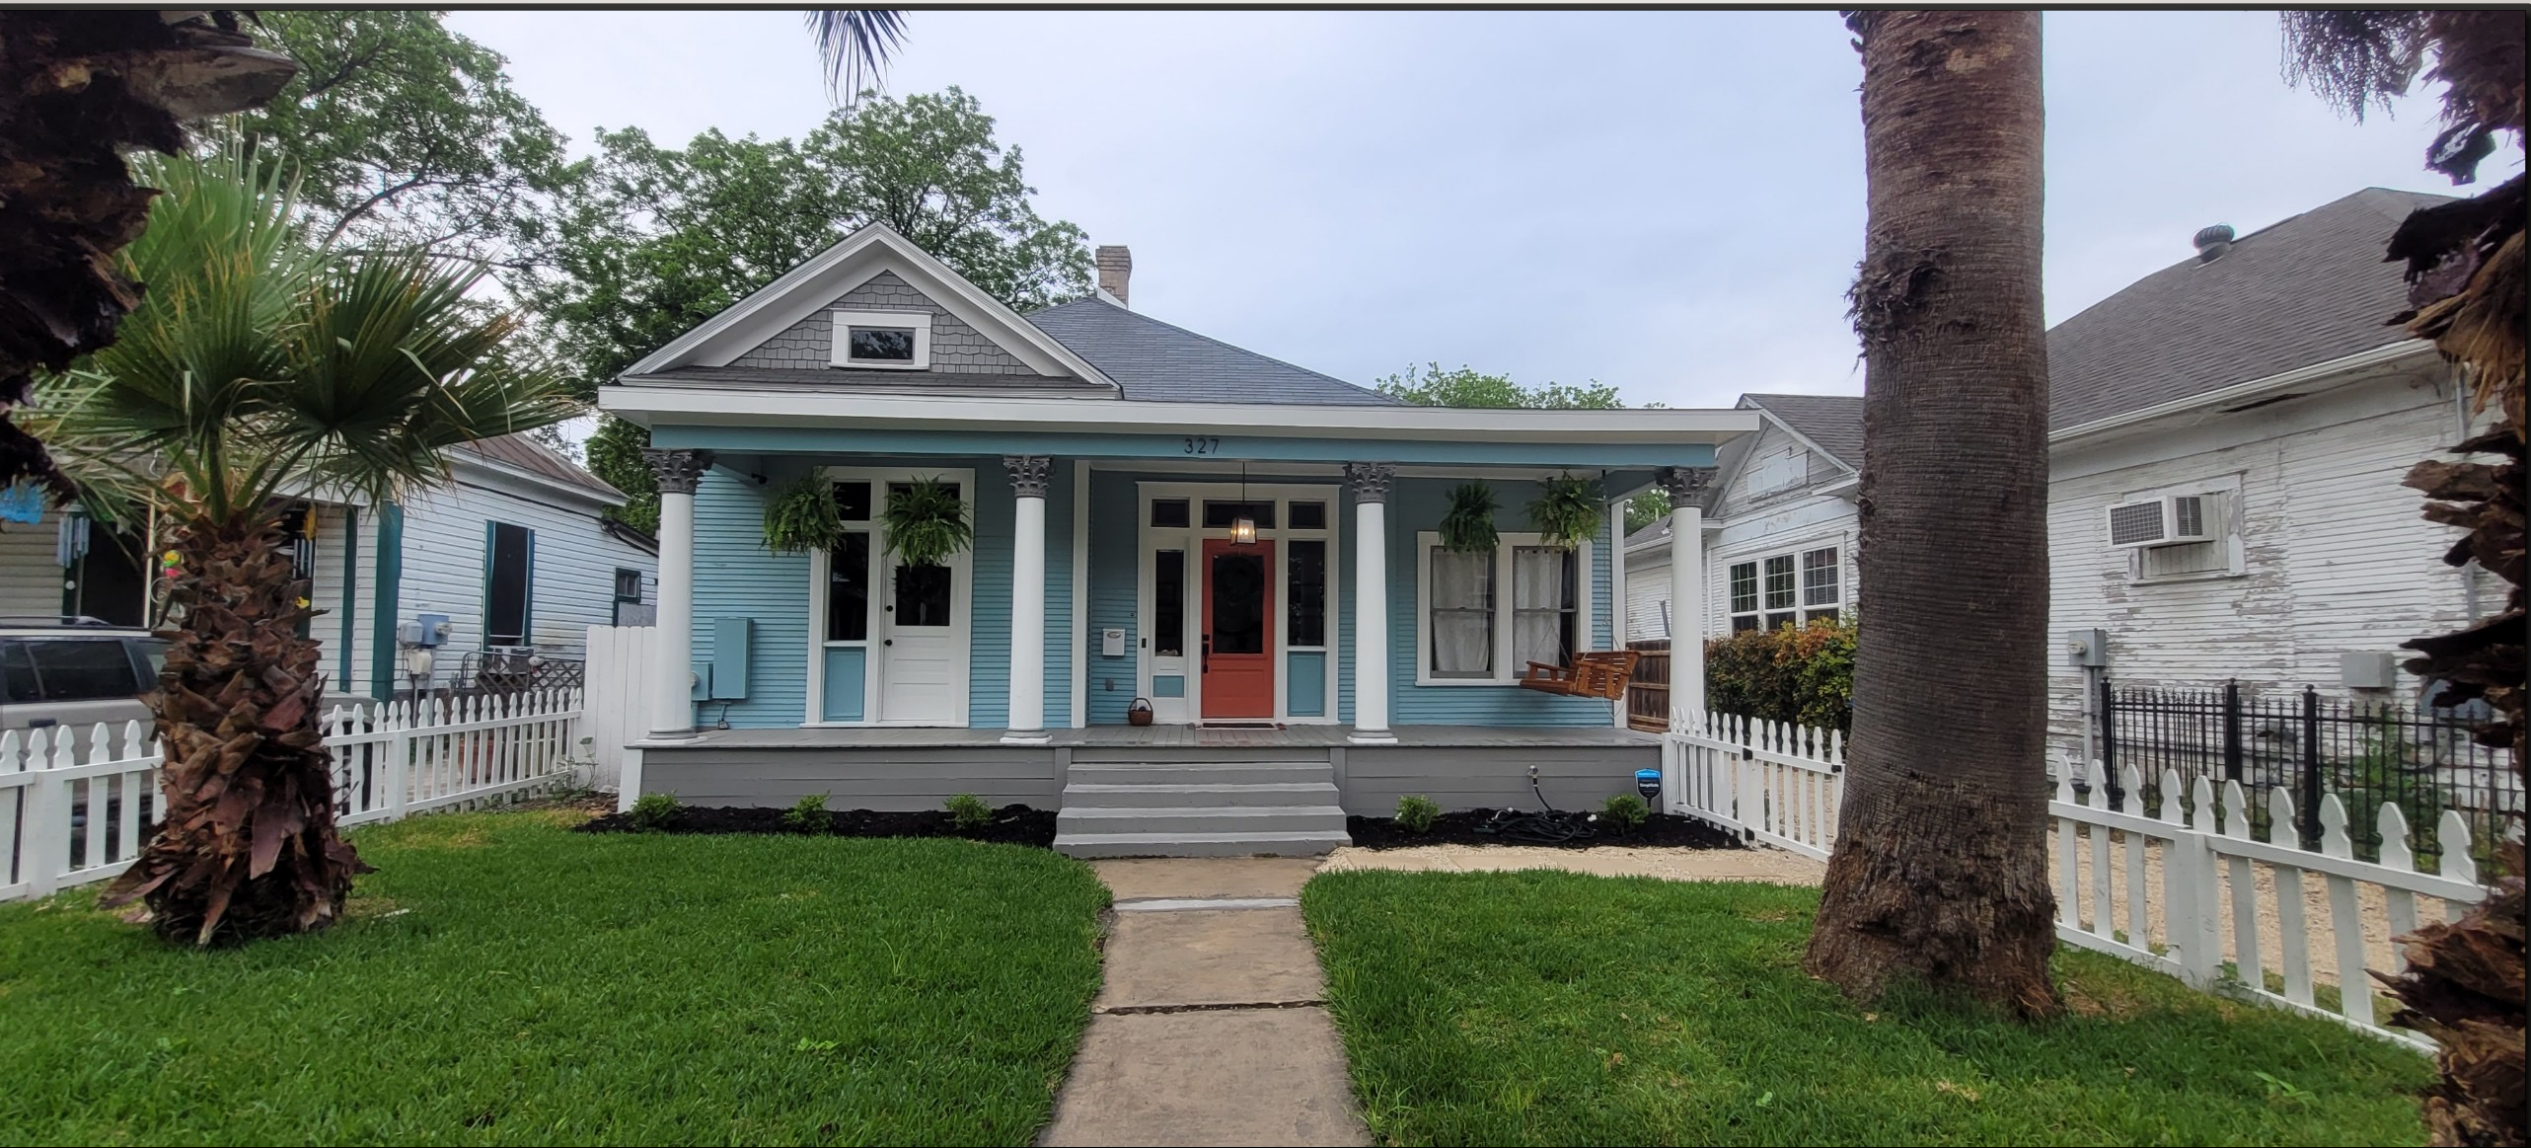
- Completely redid the foundation – all the cedar piers and wood beams underneath were rotten and need to be replaced with new wood concrete piers. Siding will continue down to the ground as pictured.
- Exterior roof is beyond repair. Added all new wood and then new shingles
- Repair and repaint the exterior wood siding, front door and windows. We will keep the original wood pattern on the house. Rotten wood around windows will be replaced. Repainted with Sherwin Williams Exterior Satin finish paint.

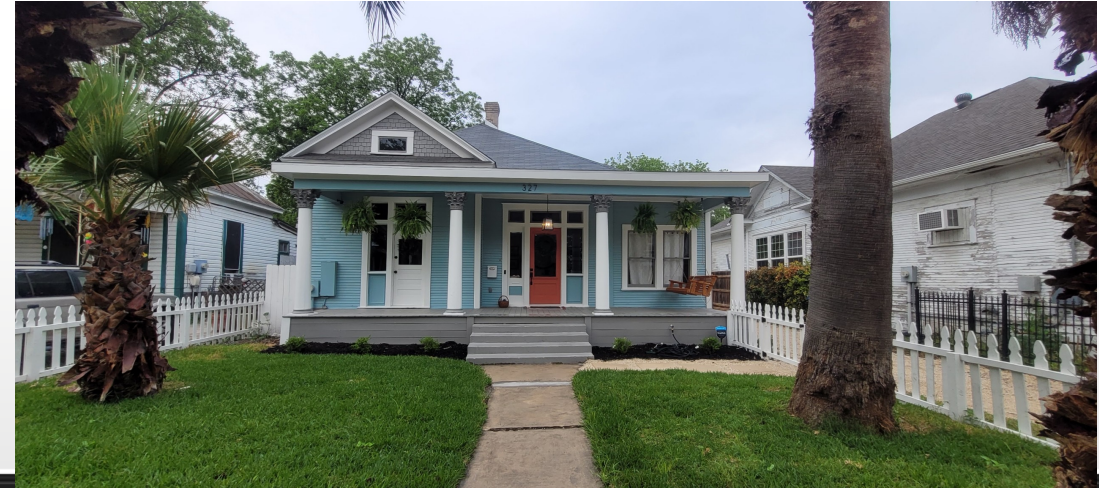
EXTERIOR RESTORATION CONTINUED

- We added a driveway on the right side of the property with a new sidewalk to the front door.
- New fence around the property made of wood – weather resistant stain on the fence.
- New Front door Porch light

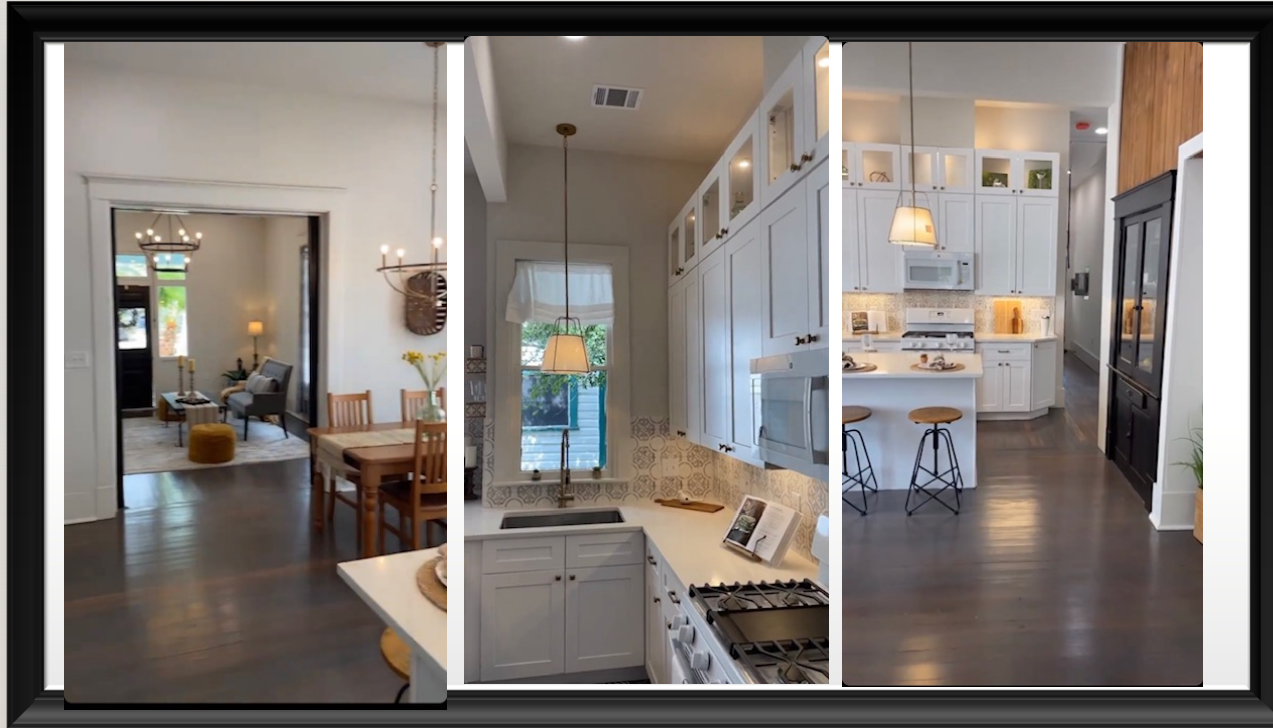
INTERIOR RESTORATION CONTINUED

- Brand new HVAC to be added
- Brand new electric from the city pole to the panel inside
- Brand new plumbing from the city connection to the fixtures inside to include new water lines, new sewer lines, new gas lines

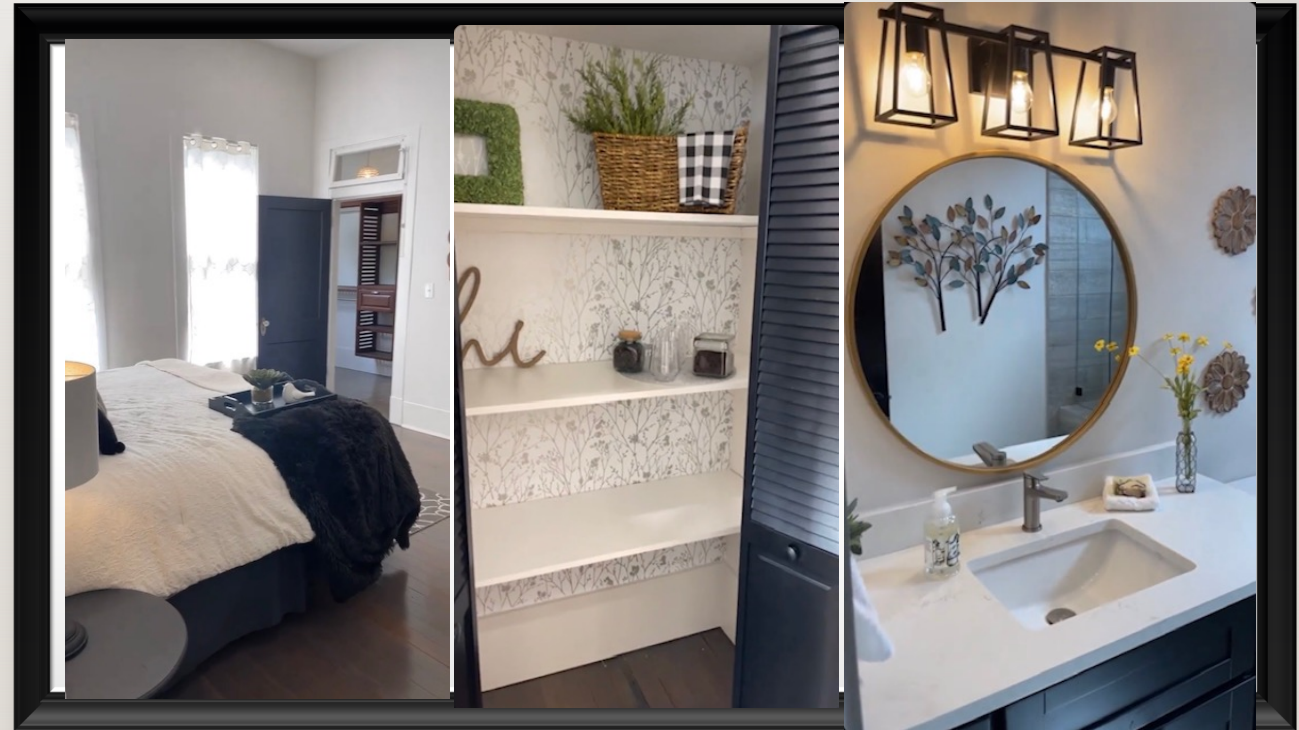
RESTORATION OF INTERIOR CONTINUED

- Removed any mold, damaged wood etc.
- Add new laundry area
- Bathroom- add new fixtures, tile, faucets etc.
- Remove all trash, furniture, cars, and dispose of all unwanted items that were left – 5 dumpsters to remove all the trash left

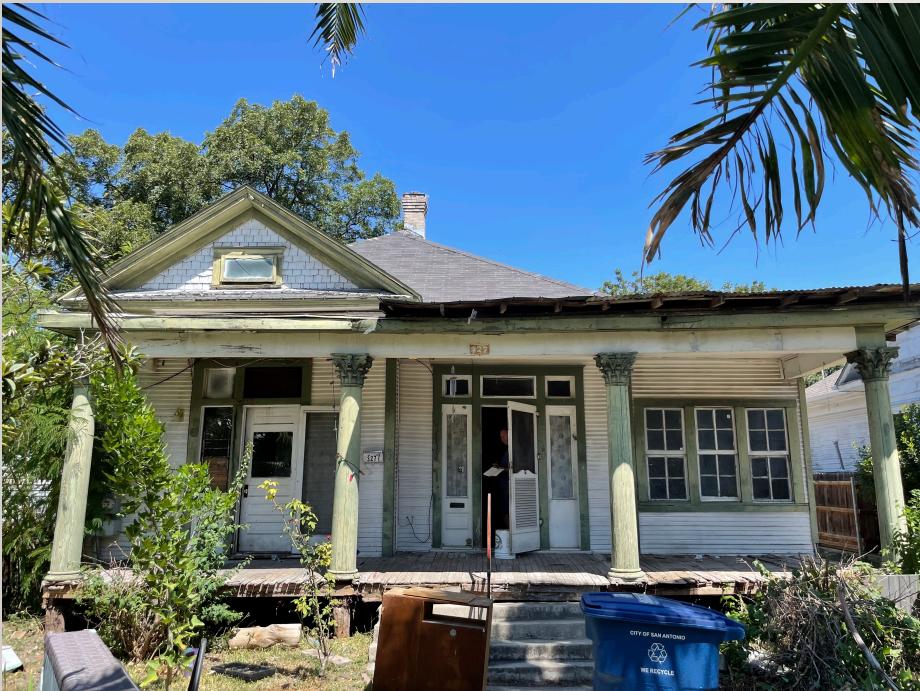
EXTERIOR RESTORATION PLANS

- Completely redo the foundation – all the cedar piers and wood beams underneath were rotten and need to be replaced with new wood concrete piers. Siding will continue down to the ground.
- Exterior roof is beyond repair. Add a new standing-seam metal roof (if approved) or use composition shingles which are what is on the house now
- Repair and repaint the exterior wood siding, front door and windows. We will keep the original wood pattern on the house. Rotten wood around windows will be replaced. Repainted with Sherwin Williams Exterior Satin finish paint.

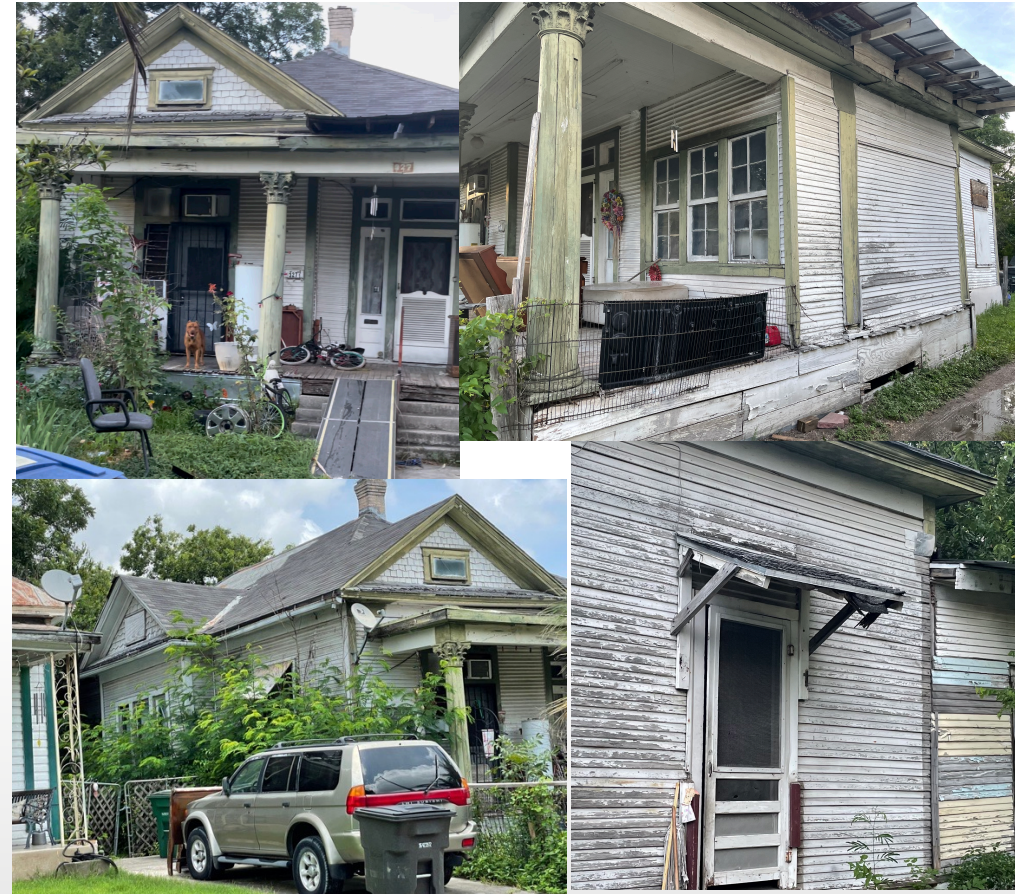
EXTERIOR RESTORATION CONTINUED

New fence around the property either a wood picket or a wrought iron like the neighbors on either side (see photos)

- Repair Front doors and add Porch lights on either side of the front door

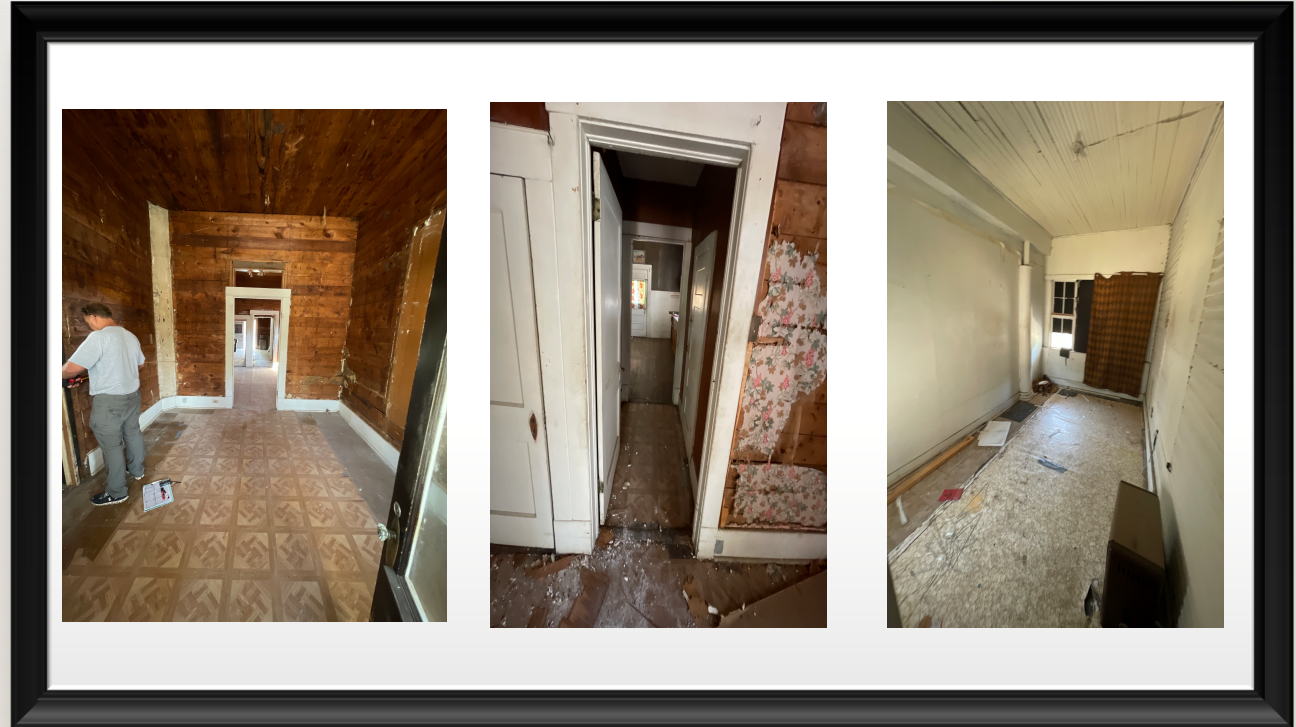
RESTORATION OF INTERIOR CONTINUED

- Remove any mold, damaged wood etc.
- Add new laundry area
- Bathroom- add new fixtures, tile, faucets etc.
- Remove all trash, furniture, cars, and dispose of all unwanted items that were left – will take 3 dumpsters and 5 days of labor for demo crew
