## HISTORIC AND DESIGN REVIEW COMMISSION

**HDRC CASE NO:** 2022-423  
**ADDRESS:** 115 CEDAR ST  
**LEGAL DESCRIPTION:** NCB 935 BLK B LOT S 40FT OF 3  
**ZONING:** MF-33, H  
**CITY COUNCIL DIST.:** 1  
**DISTRICT:** King William Historic District  
**APPLICANT:** lloyd briseno/OLIVIA SHAY INVESTMENTS LLC  
**OWNER:** lloyd briseno/OLIVIA SHAY INVESTMENTS LLC  
**TYPE OF WORK:** Fencing  
**APPLICATION RECEIVED:** July 19, 2022  
**60-DAY REVIEW:** Not applicable due to City Council Emergency Orders  
**CASE MANAGER:** Hannah Leighner

The applicant is requesting a Certificate of Appropriateness for approval to install an iron fence and vehicle gate at the existing driveway to meet the front façade of the house.

# 115 Cedar iron fence request

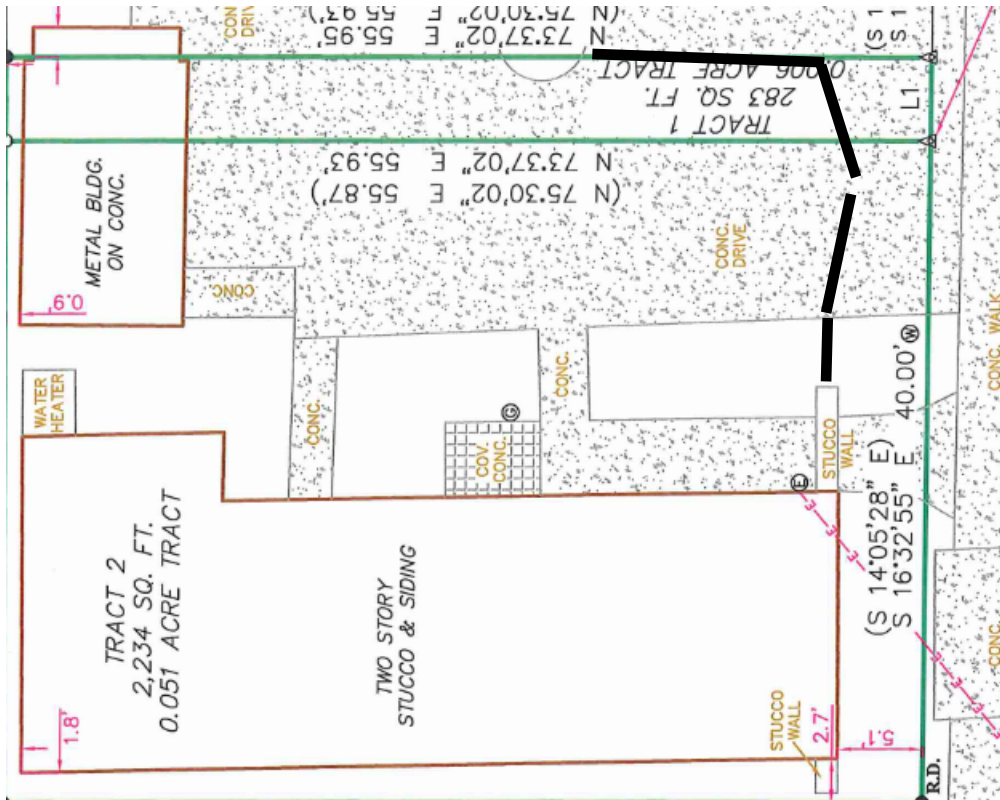
Gate is the Dark black lines

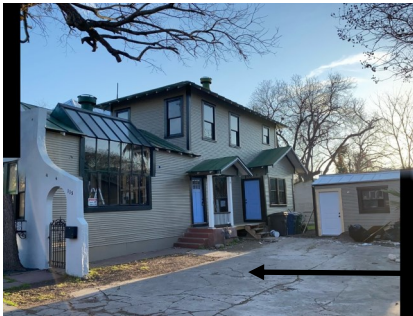
Gate is going here even with stucco wall within property line

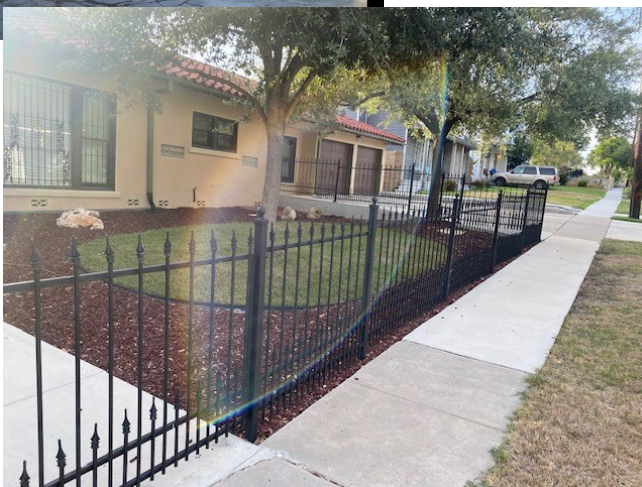
Example of fence

This one is in dignowity Hill

601 N. olive st

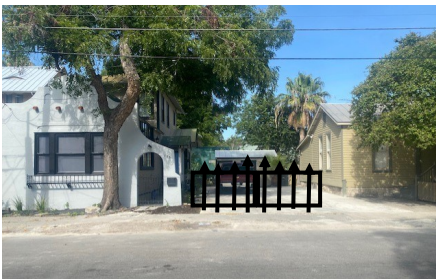
Fence is lining up with existing walkway gate to open out to not overlap with sidewalk.

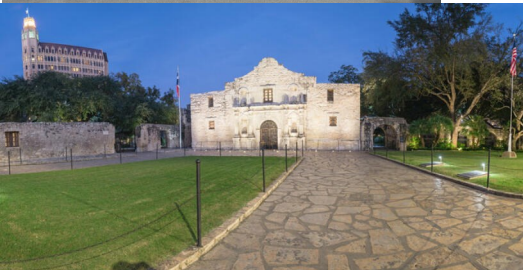
Similar property where fence is lined up with the façade

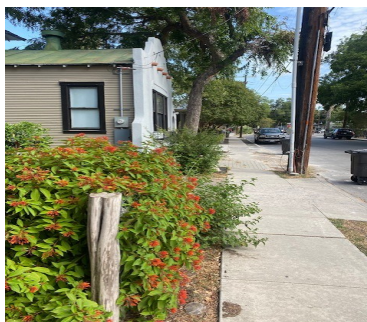
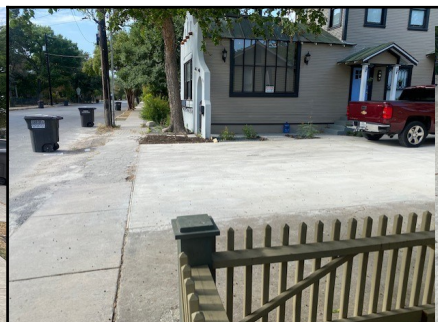
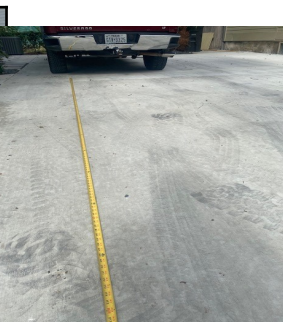
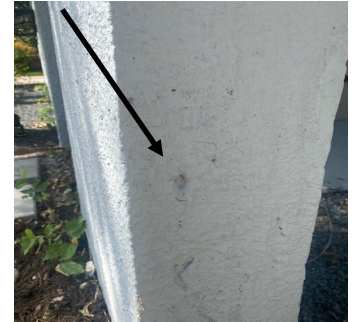
Scarring on stucco is most likely from a gate once attached
