HISTORIC AND DESIGN REVIEW COMMISSION

HDRC CASE NO: 2022-460
ADDRESS: 155 CROFTON
LEGAL DESCRIPTION: NCB 941 BLK 4 LOT S 9.68 OF E 192.28 OF 19, E IRR 189.8 OF 20, E IRR 17 FT OF 21 & P-100
ZONING: RM-4, H
CITY COUNCIL DIST.: 1
DISTRICT: King William Historic District
APPLICANT: Michael Rodriguez/Davco Custom Builders
OWNER: Josephine Davidson/DAVIDSON JOSEPHINE NEGLEY GILL
TYPE OF WORK: Standing seam metal roof installation
APPLICATION RECEIVED: August 22, 2022
60-DAY REVIEW: Not applicable due to City Council Emergency Orders
CASE MANAGER: Hannah Leighner

The applicant is requesting a Certificate of Appropriateness for approval to replace the existing, red standing seam metal roof with a new standing seam metal roof in aged copper color.

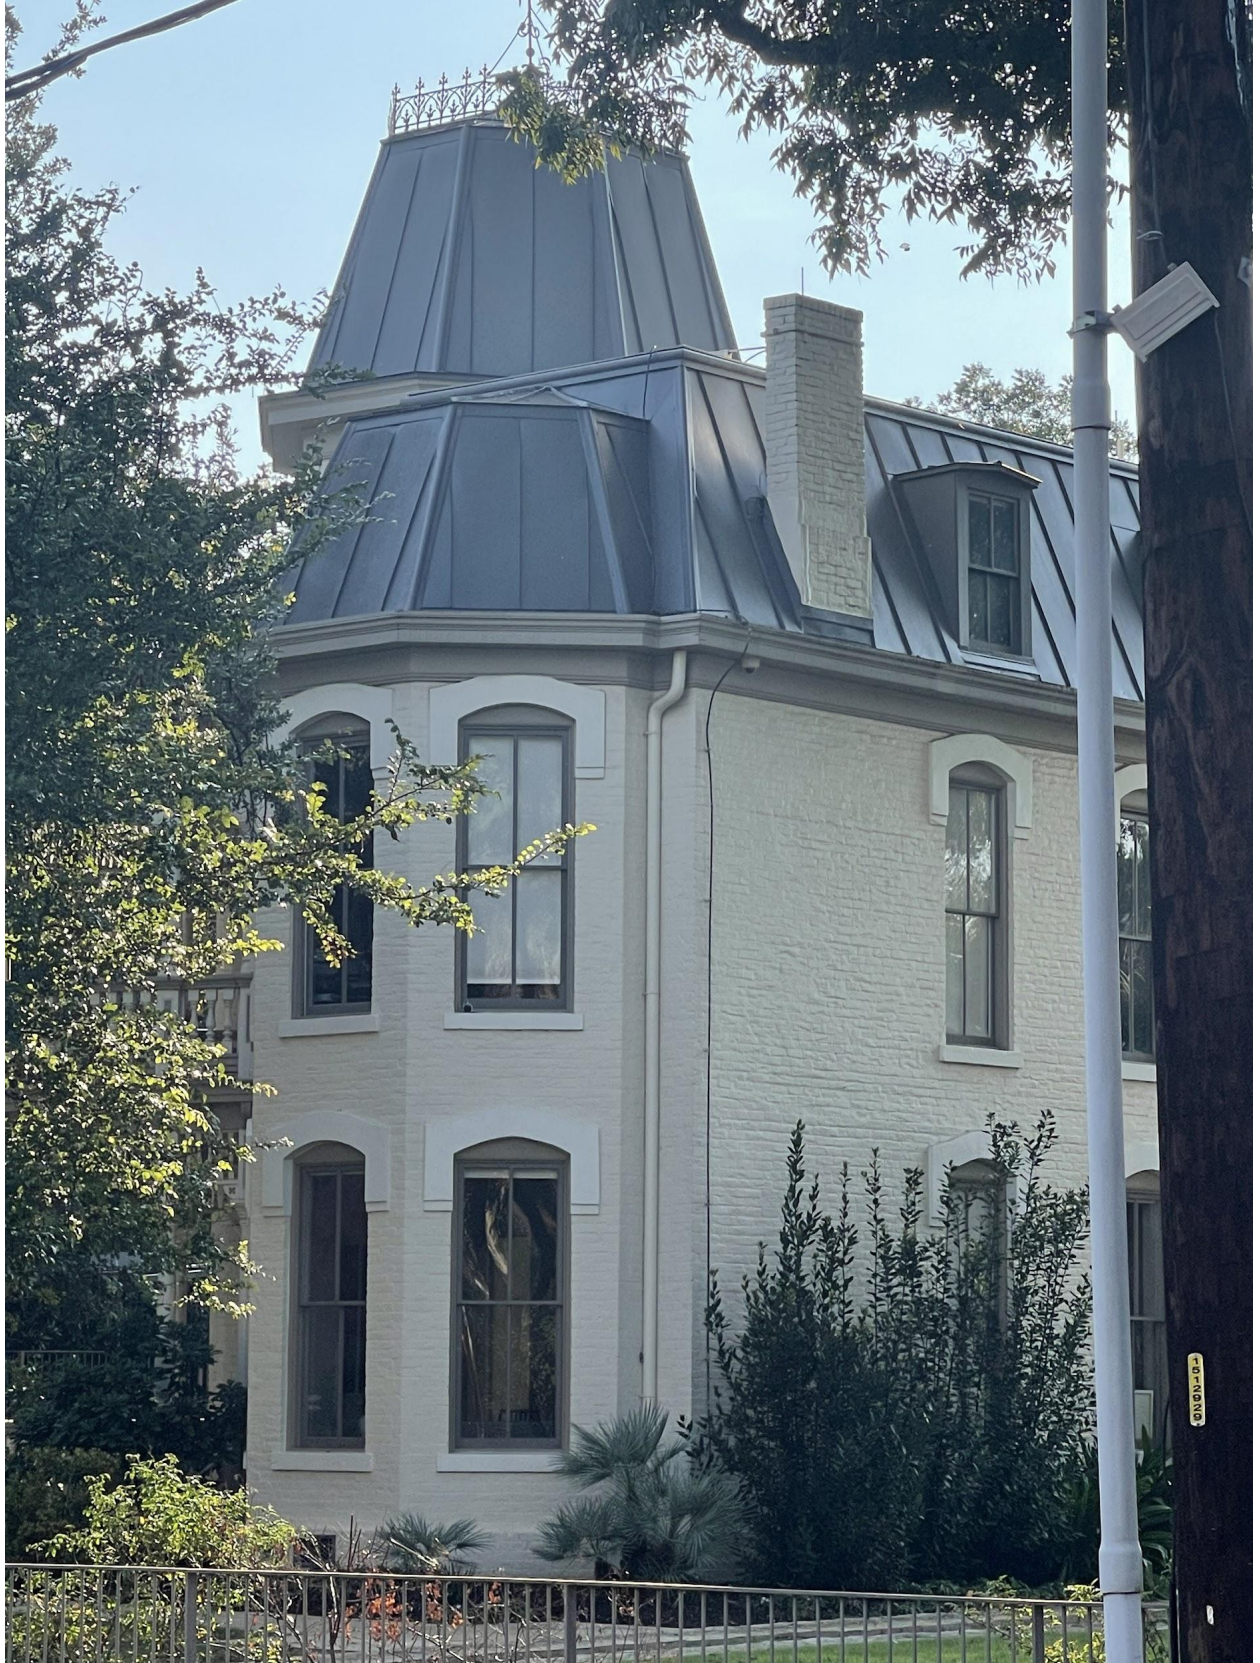
Examples of brown metal roofs in King William exist at 422 King William and at 504 King William.

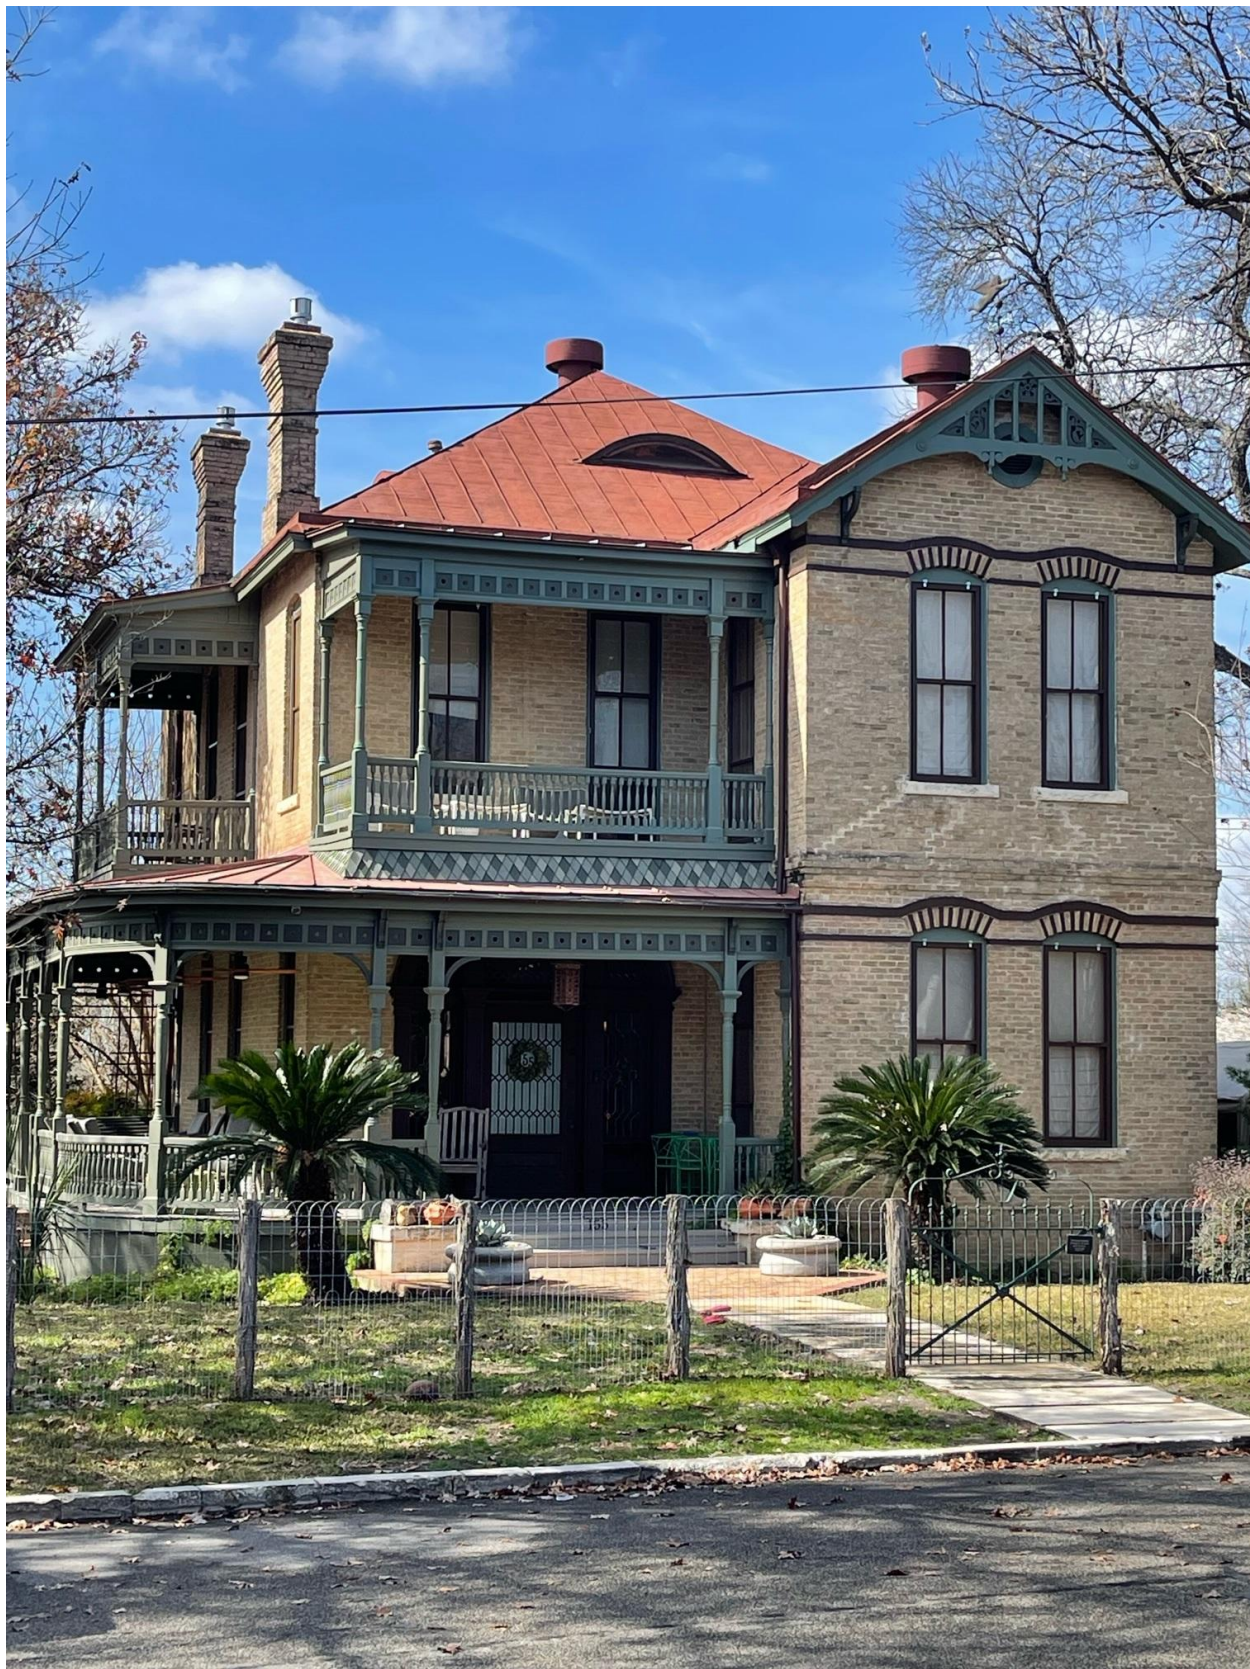
155 Crofton

The original roof at 155 Crofton, built in 1890, was a brown wood shake and is still in place as the metal roof, installed in the 1920s, was built directly onto that original.

We believe we are restoring the original color and that it will match existing copper gutters and down spouts.

- a. ROOF REPLACEMENT – The applicant proposed to replace the existing, red standing seam metal roof on the primary structure with a new standing seam metal roof, painted an aged copper color. Guideline 3.B.vi for Exterior Maintenance and Alterations states that metal roofs may be used on structures that historically had a metal roof, however, the guidelines also state that new metal roofs must match the existing historic metal roof color or use the standard galvalume; modern manufacturer's colors are not permitted. Staff finds the request for an aged copper-color standing seam metal roof to be inconsistent with the Guidelines. Staff finds that a red or galvalume colored standing seam metal roof would be appropriate.
