# HISTORIC AND DESIGN REVIEW COMMISSION

**HDRC CASE NO:** 2022-470  
**ADDRESS:** 521 E DEWEY PLACE  
**LEGAL DESCRIPTION:** NCB 2964 BLK 3 LOT E 24 FT OF 5 & W 36 FT OF 6  
**ZONING:** MF-33, H  
**CITY COUNCIL DIST.:** 1  
**DISTRICT:** Tobin Hill Historic District  
**APPLICANT:** America Santiago/Santiago Construction  
**OWNER:** CARDENAS ALEJANDRO JR  
**TYPE OF WORK:** Window replacement  
**APPLICATION RECEIVED:** September 01, 2022  
**60-DAY REVIEW:** Not applicable due to City Council Emergency Orders  
**CASE MANAGER:** Claudia Espinosa  
**REQUEST:**

The applicant is requesting a Certificate of Appropriateness for approval to replace forty-four existing windows with aluminum windows. The existing windows consist of original wood windows as well as non-original aluminum and vinyl windows.

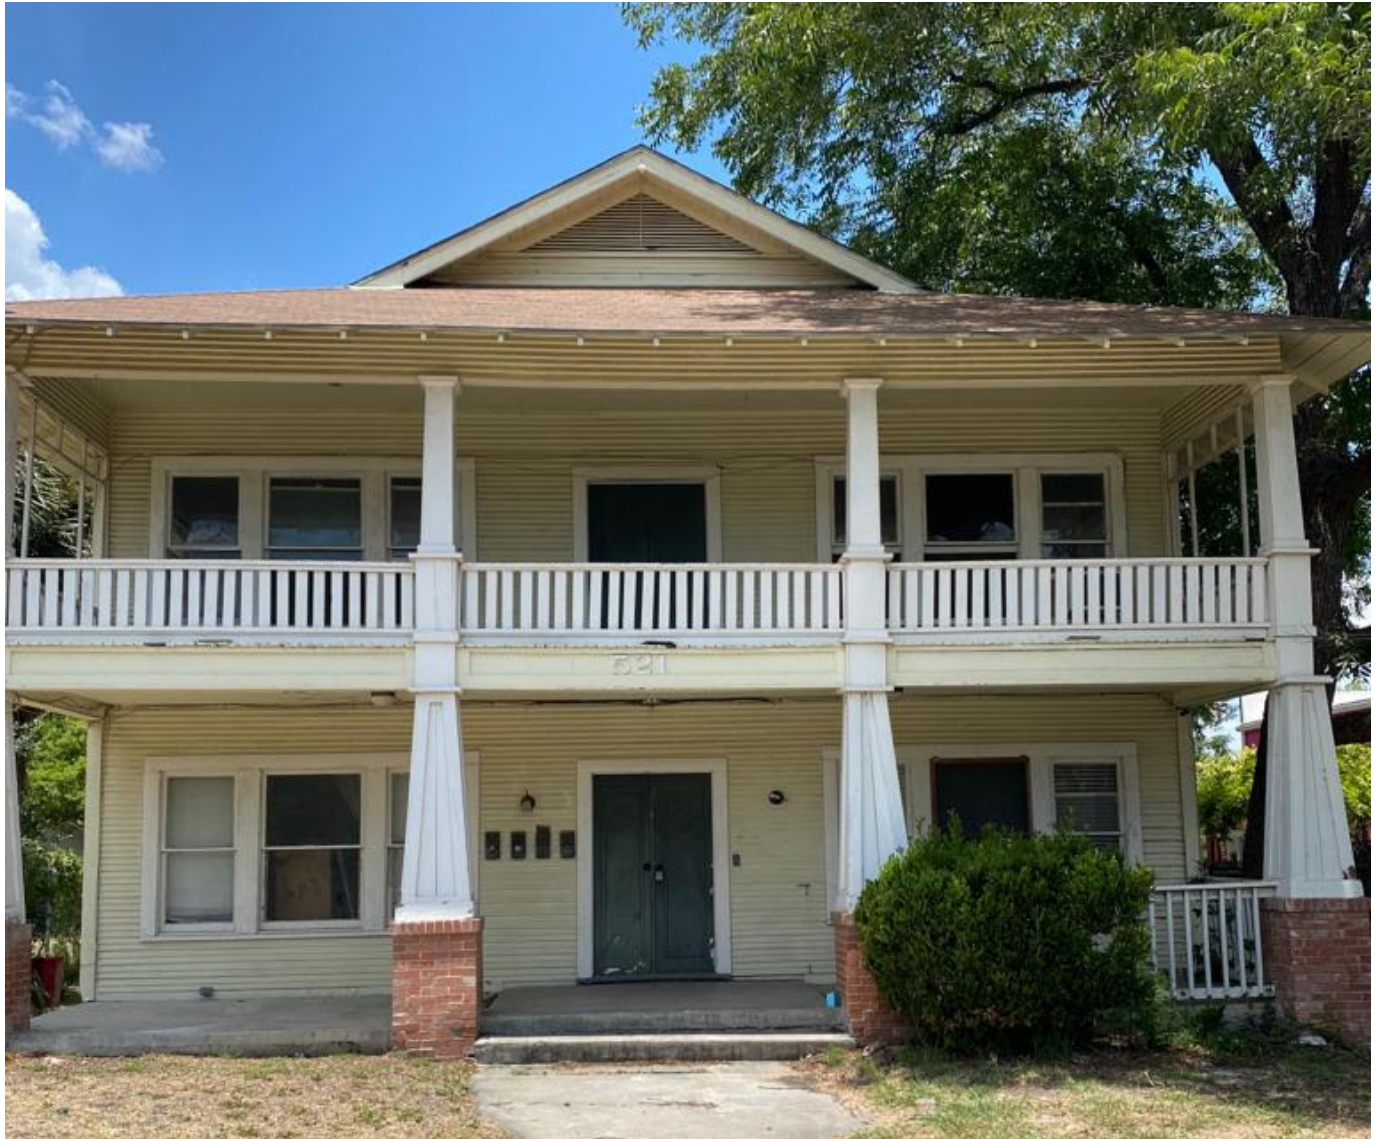
Windows 32, 33, 34, 35, 36, and 37

- c. WINDOW REPLACEMENT: EXISTING CONDITION – Per the submitted application documents, OHP staff does not find the original wood windows to be in a state that is beyond repair. Staff has observed evidence of paint flaking, and deteriorated glazing. However, almost all of the original wood is intact in all cases with very limited evidence of irreversible rot or damage. The joints of the top sashes appear to be in good condition with no evidence of slipping or separation. Staff finds that all windows are in repairable condition, with most requiring minimal repair and intervention like re-glazing and painting, along with refitting into the trim and frames. Staff finds that the existing wood windows should be repaired, in-kind. Aluminum and vinyl windows may be replaced with a window that is consistent with staff's standards for replacement windows. The replacement of aluminum windows that are consistent with staff's standards for replacement windows would be eligible for administrative approval.

Staff recommends the applicant repair the existing, wood windows with in-kind materials. Staff does not recommend the replacement of any wood windows.

Aluminum and vinyl windows may be replaced with a window that is consistent with staff's standards for replacement windows. The replacement of aluminum windows that are consistent with staff's standards for replacement windows would be eligible for administrative approval. Staff's standards for replacement windows are noted in the applicable citations.
