HISTORIC AND DESIGN REVIEW COMMISSION

HDRC CASE NO: 2022-514
ADDRESS: 281 LOVERA BLVD
LEGAL DESCRIPTION: NCB 9004 BLK 2 LOT 95 THRU 97
ZONING: R-4, H
CITY COUNCIL DIST.: 1
DISTRICT: Olmos Park Terrace Historic District
APPLICANT: Glenn Smiley/SMILEY GLENN E
OWNER: Glenn Smiley/SMILEY GLENN E
TYPE OF WORK: Installation of striated standing-seam metal roof
APPLICATION RECEIVED: October 03, 2022
60-DAY REVIEW: Not applicable due to City Council Emergency Orders
CASE MANAGER: Jessica Anderson

Investigation Report

STANDING-SEAM METAL ROOF INSPECTION FORM

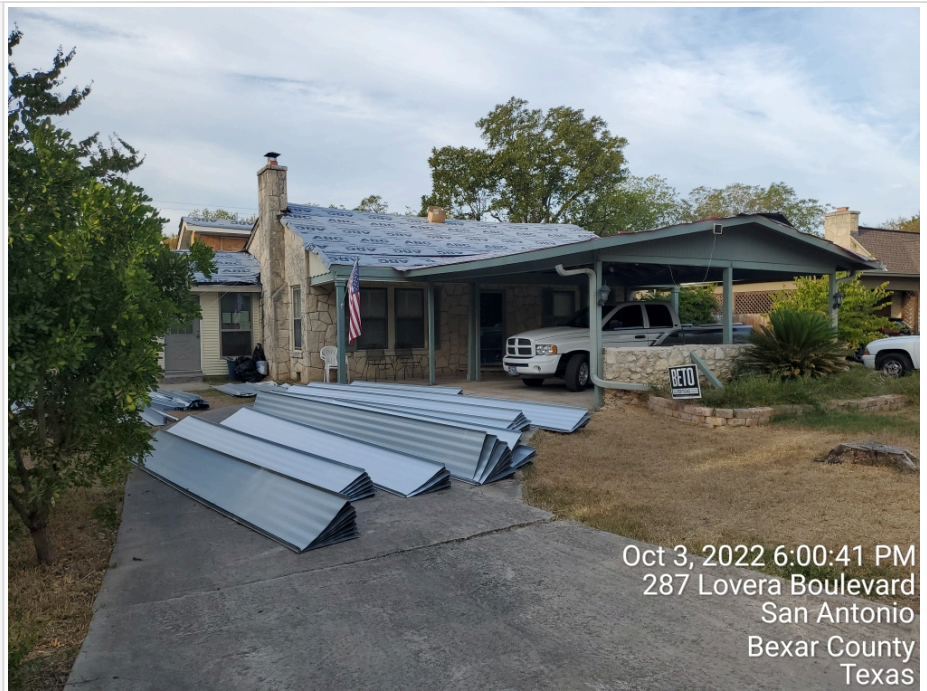
Photographs

Date	10/03/2022
Time	06:03 PM (-5 GMT)
Context	drive-by
Present Staff	Jessica Anderson
Present Individuals	Homeowner
Types of Work Observed	Exterior Maintenance and Alterations
Amount of Work Completed	75%
Description of work	Installation of nonconforming standing seam metal roof (corrugated)
Description of interaction	Spoke with homeowner about approval language on his COA (posted in his window) re flat panels only. Told him to submit a COA asap for corrugated panels and shared next available hearing is Nov 2. Advised he call the contractor/roofer to assess hi options. Homeowner shares installation was scheduled for tomorrow. We also discussed possible outcomes if he chooses to install corrugated metal roof despite stop work order. NOTE: App would not allow me to choose third photo. Photo of SWO will be added to the property file.

1. That the panels are smooth without striation or corrugation.

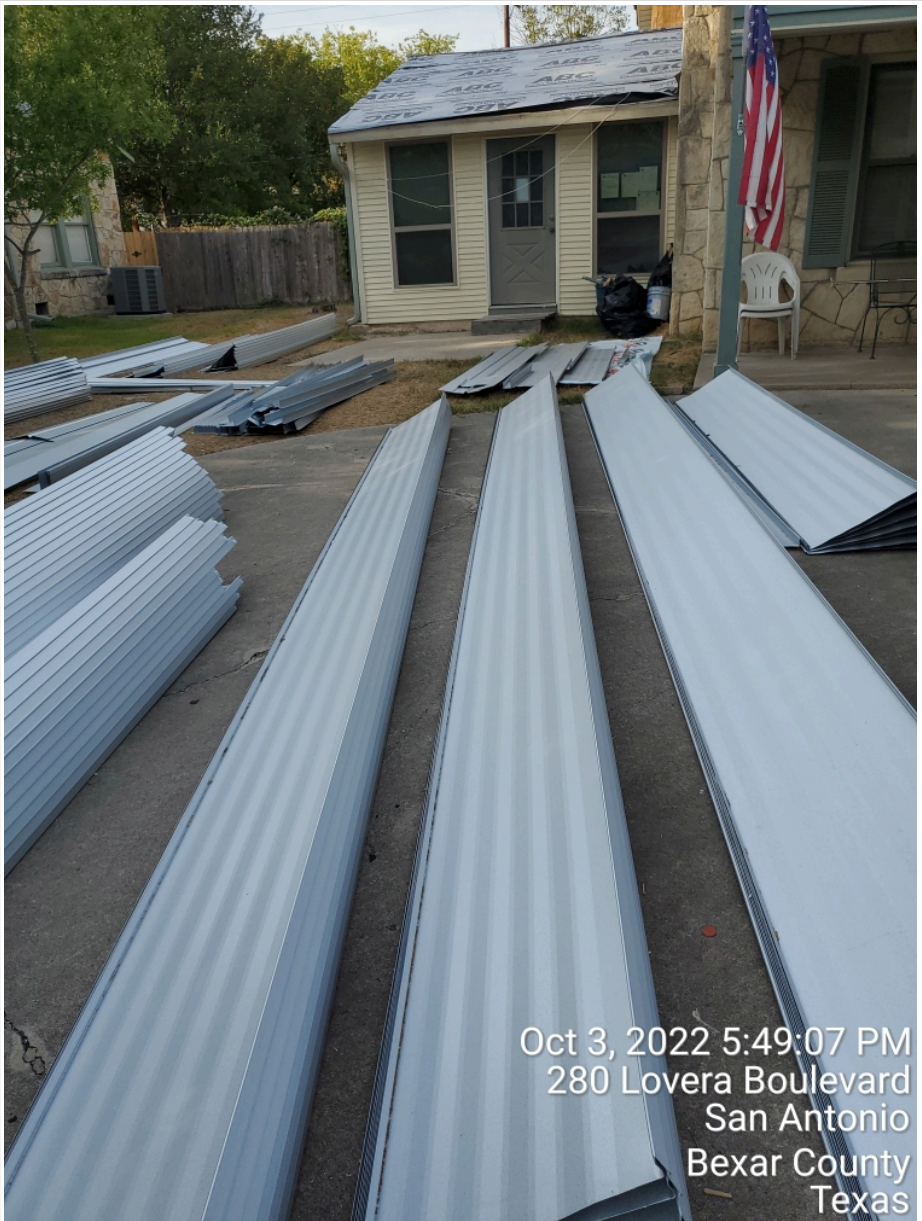
Oct 3, 2022 5:49:07 PM
280 Lovera Boulevard
San Antonio
Bexar County
Texas

- c. VIOLATION: On October 3, 2022, OHP staff observed striated metal roofing panels on site at 281 Lovera. Staff spoke with the homeowner, who posted the COA with full approval language in a window on site. The full investigation report is included in this case file.

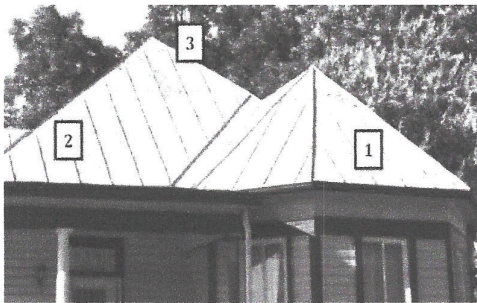
Historic standing-seam metal roof

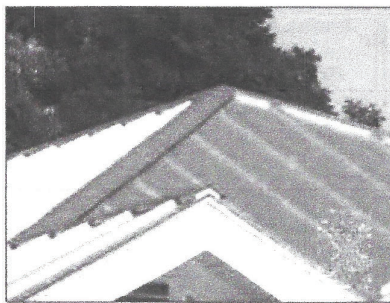
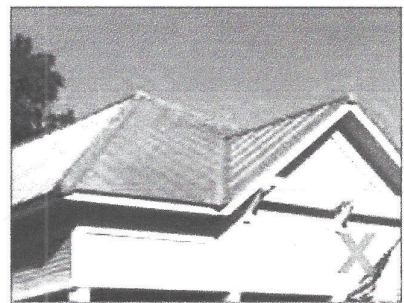
Do not use ridge caps with vents (left) or end caps (right).
