HISTORIC AND DESIGN REVIEW COMMISSION

HDRC CASE NO: 2022-561
ADDRESS: 224 E CAROLINA ST
LEGAL DESCRIPTION: NCB 2956 BLK LOT B
ZONING: RM-4, H
CITY COUNCIL DIST.: 1
DISTRICT: Lavaca Historic District
APPLICANT: Melissa Stendahl/STENDAHL MELISSA & BENJAMIN
OWNER: Melissa Stendahl/STENDAHL MELISSA & BENJAMIN
TYPE OF WORK: Fenestration modifications and Historic Tax Certification
APPLICATION RECEIVED: November 11, 2022
60-DAY REVIEW: Not applicable due to City Council Emergency Orders
CASE MANAGER: Rachel Rettaliata

1. Complete fenestration modifications.
2. Receive Historic Tax Certification.

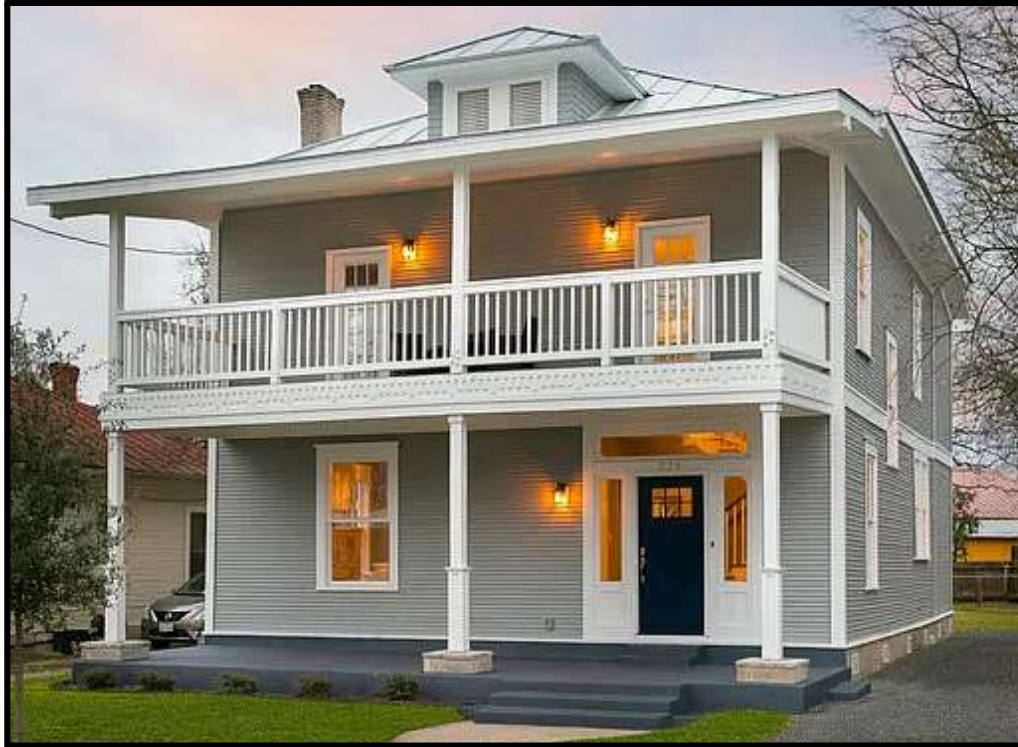
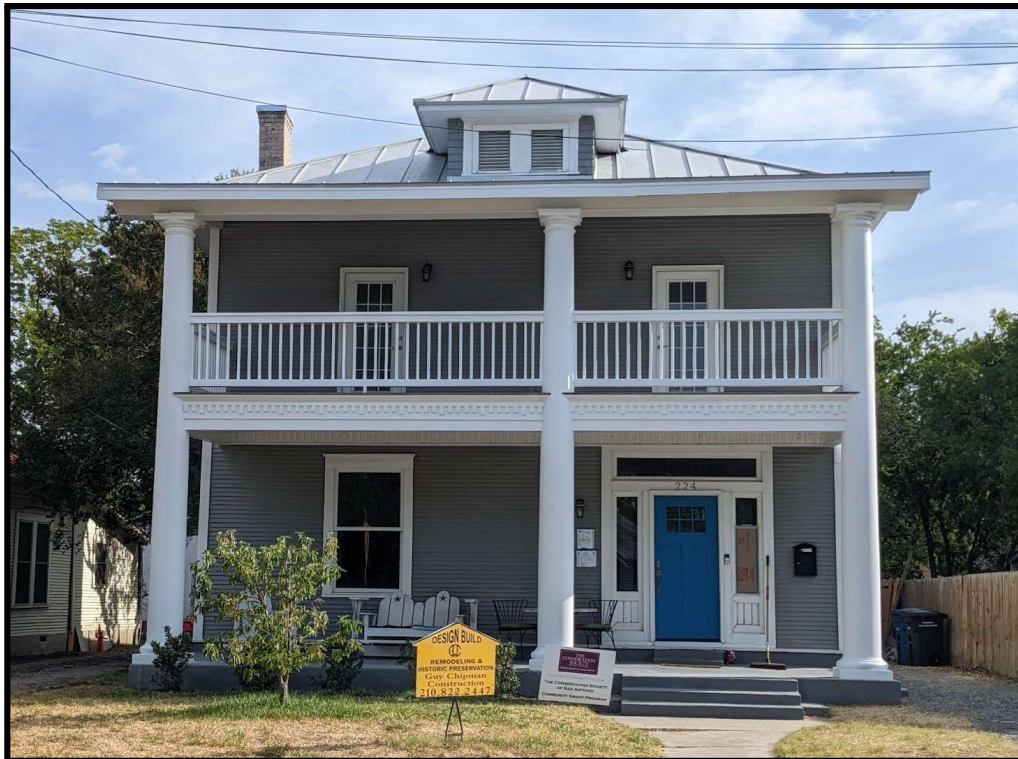
Column Restoration - completed Oct 2022

Correction of violation from HDRC COA approval in 2016 for full height classical columns

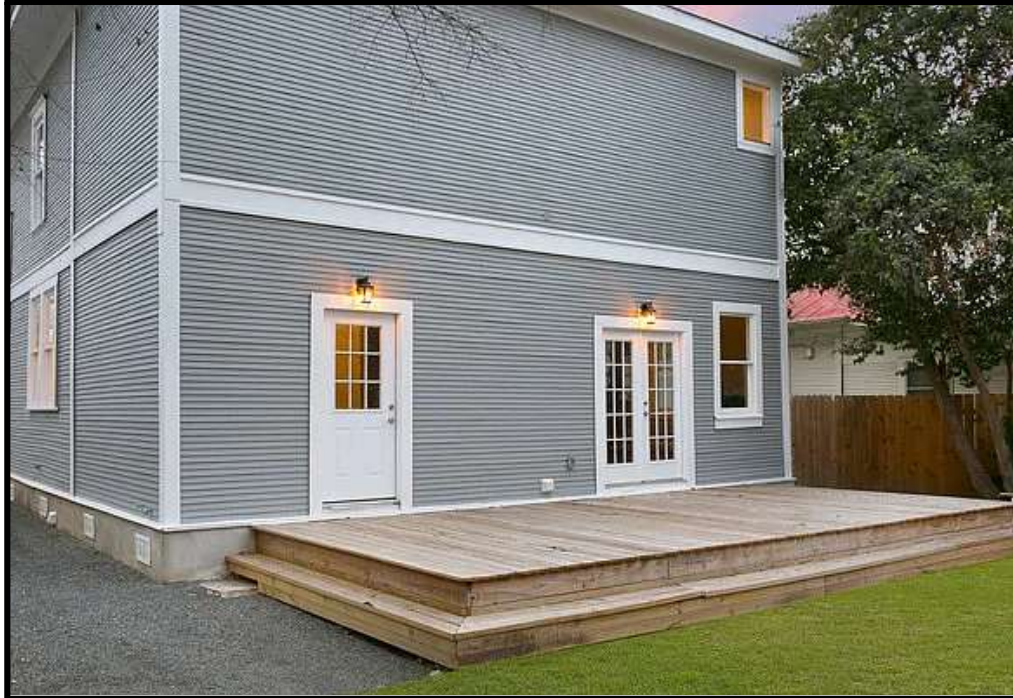
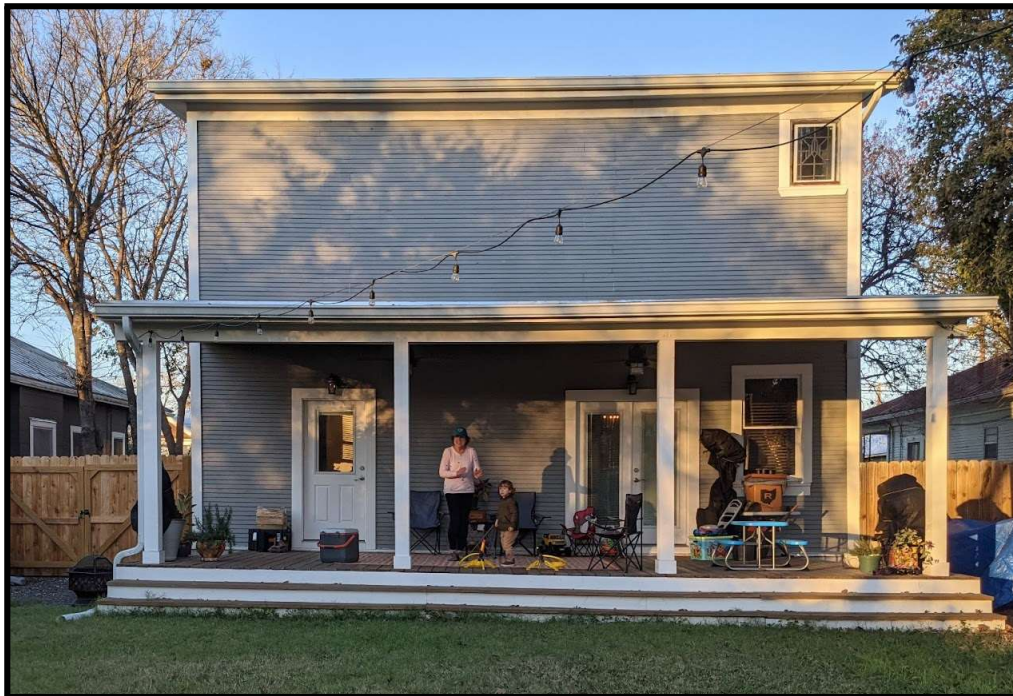
Rear Weather Cover (rear deck, first floor features) – completed 2020

South-facing rear of house was accumulating weather damage from sun and rain water along the door and window frames and base of the siding. A rear deck cover was chosen to cover all first floor features needing coverage, to preserve the health of the south-facing exterior.

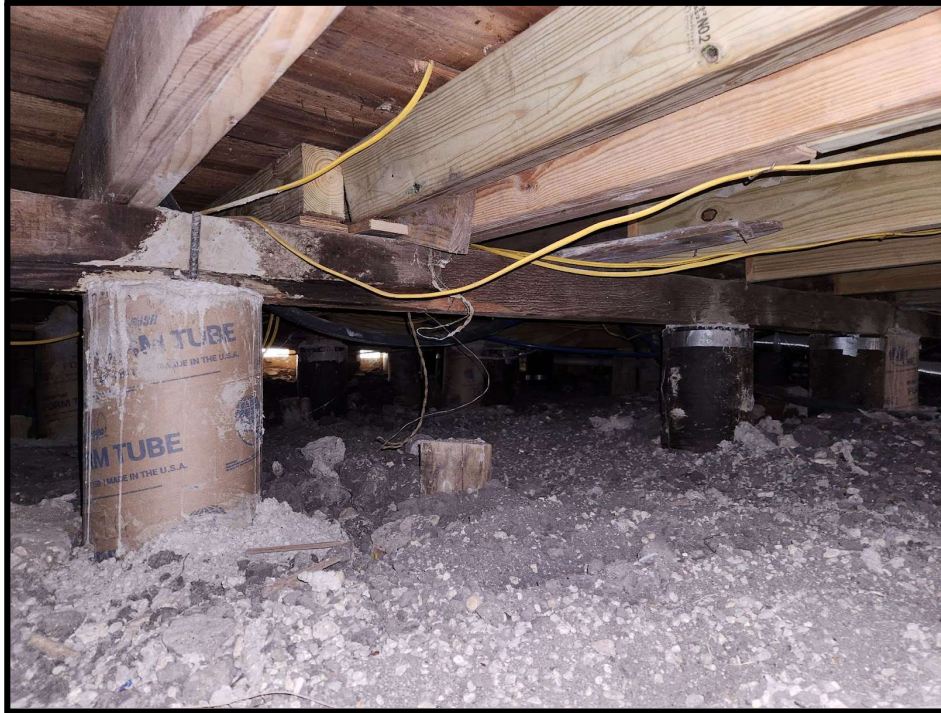
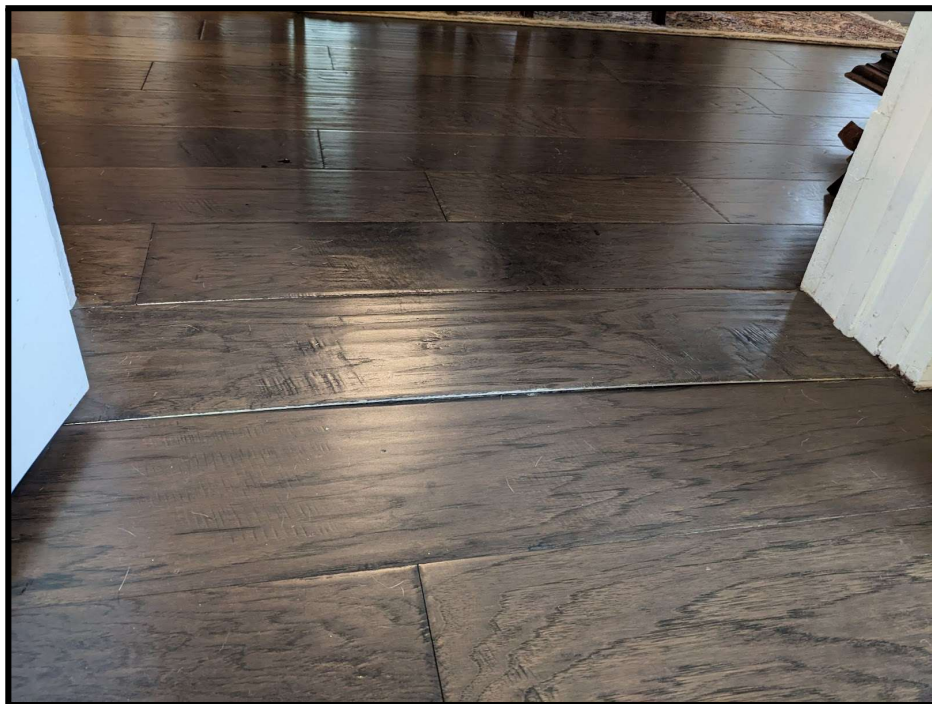
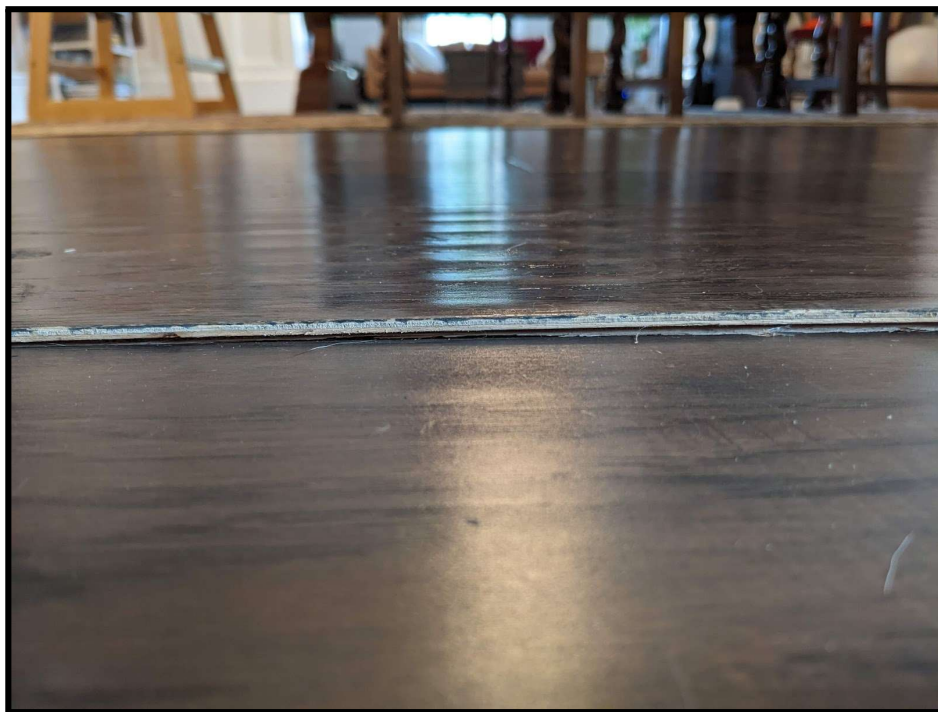
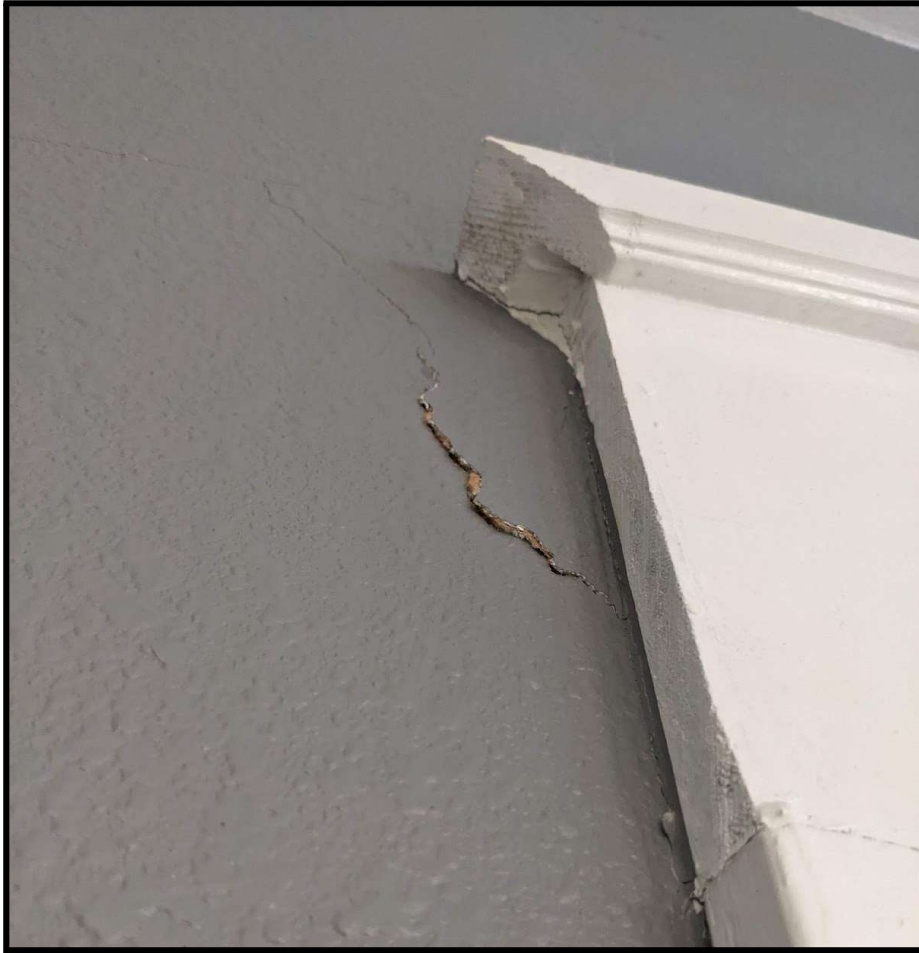
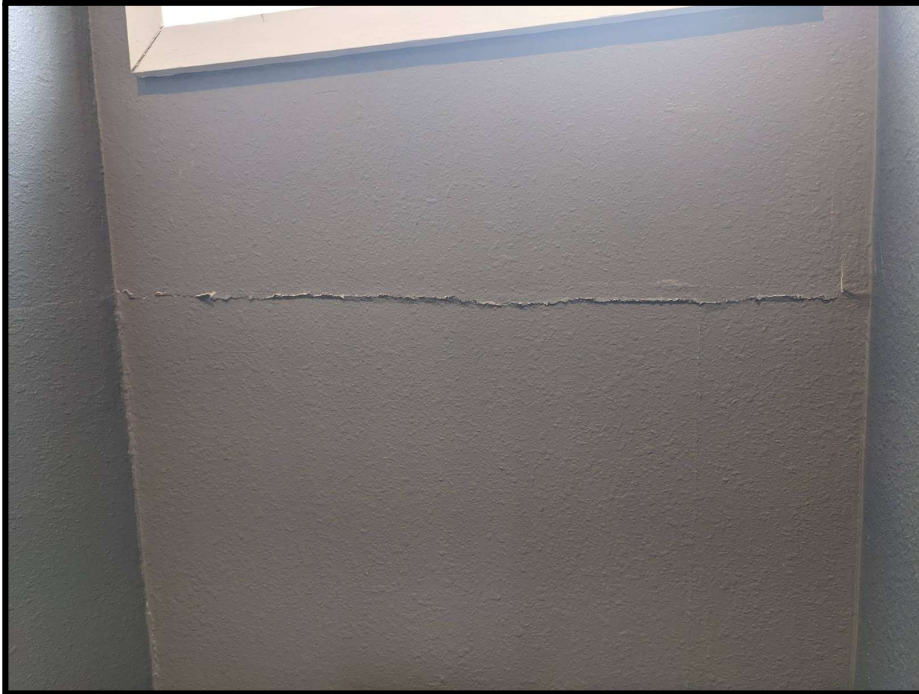
Foundation Repair - completed July 2021

Notable changes in floor level and peeling drywall were occurring, mainly in the center and rear of the interior of the home. Consultation determined that piers were sinking due to lack of footings, and that addition of new piers with proper footings was required to minimize disruptive shifting and structural changes. In the photos here, the black piers are the ones existing at time of sale; the covered piers are new per our repairs.

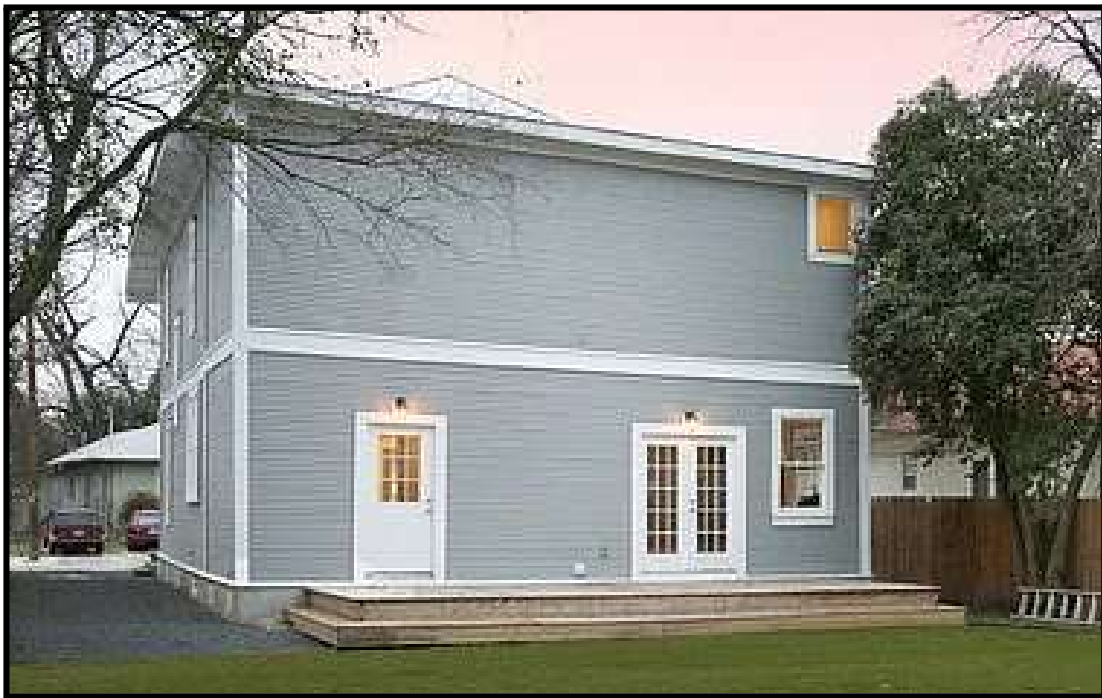
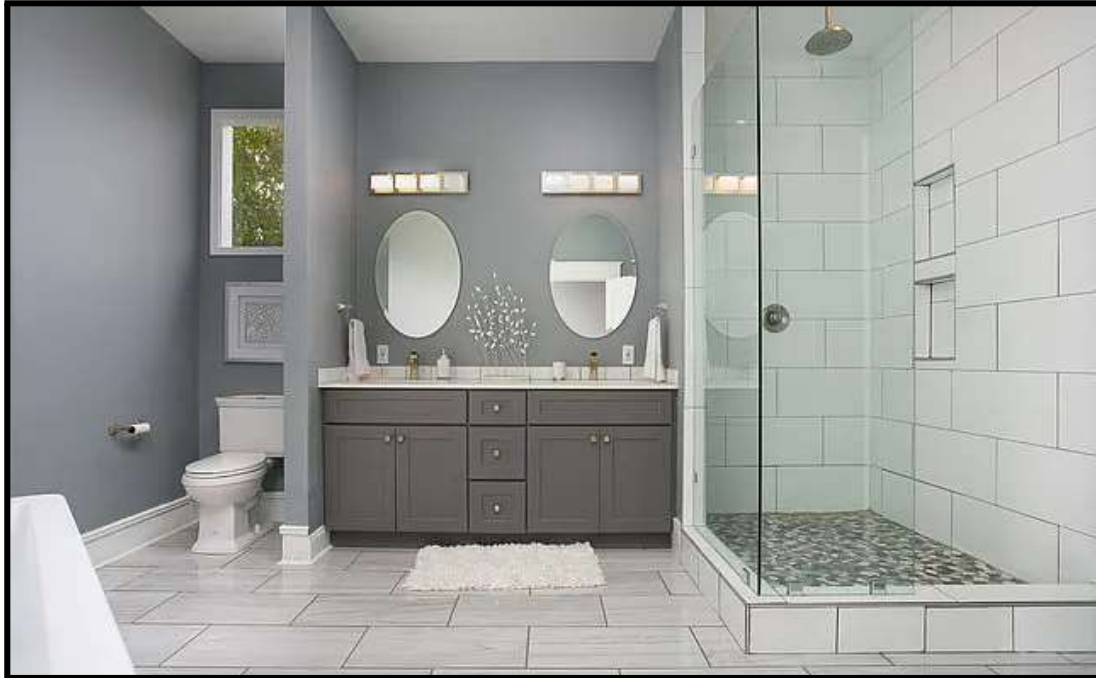
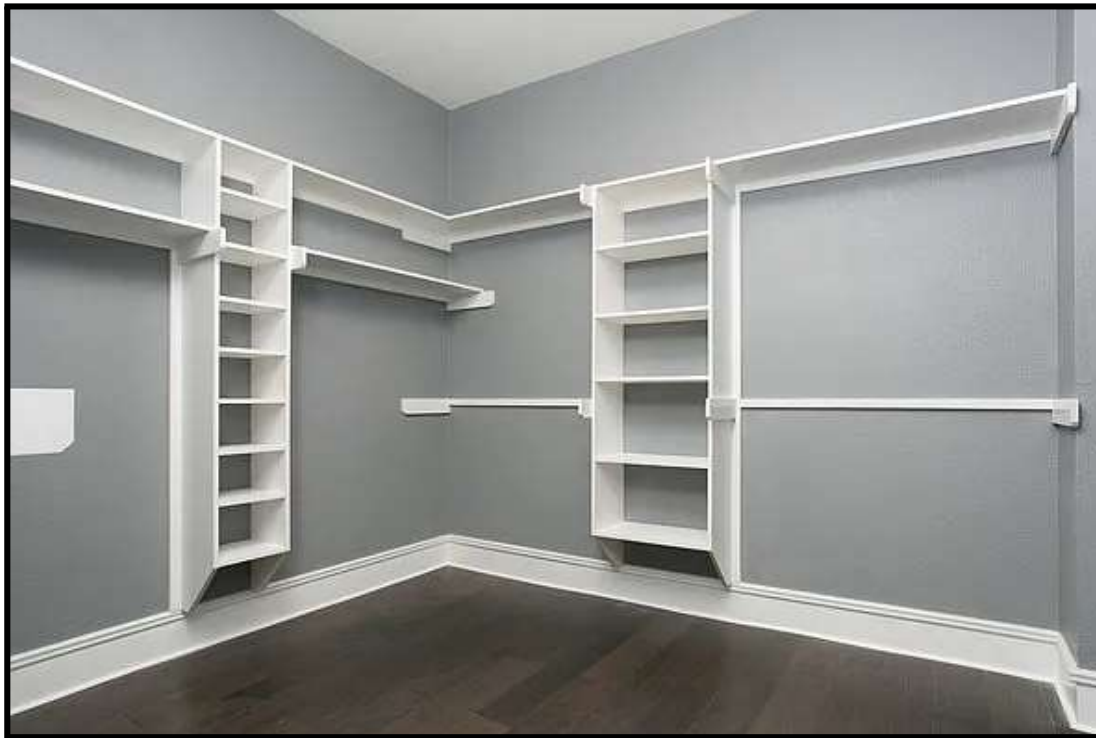
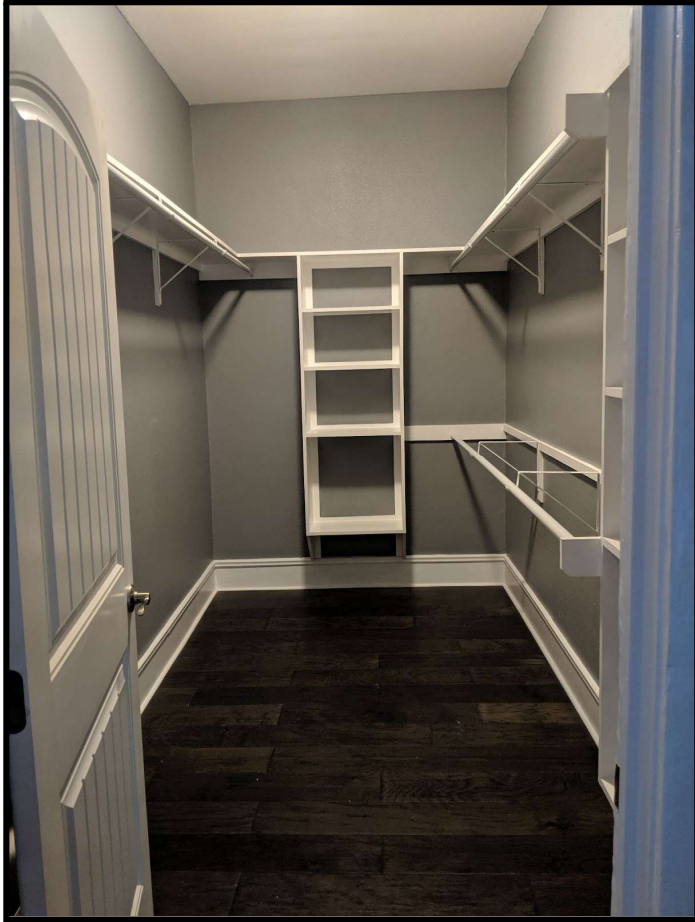
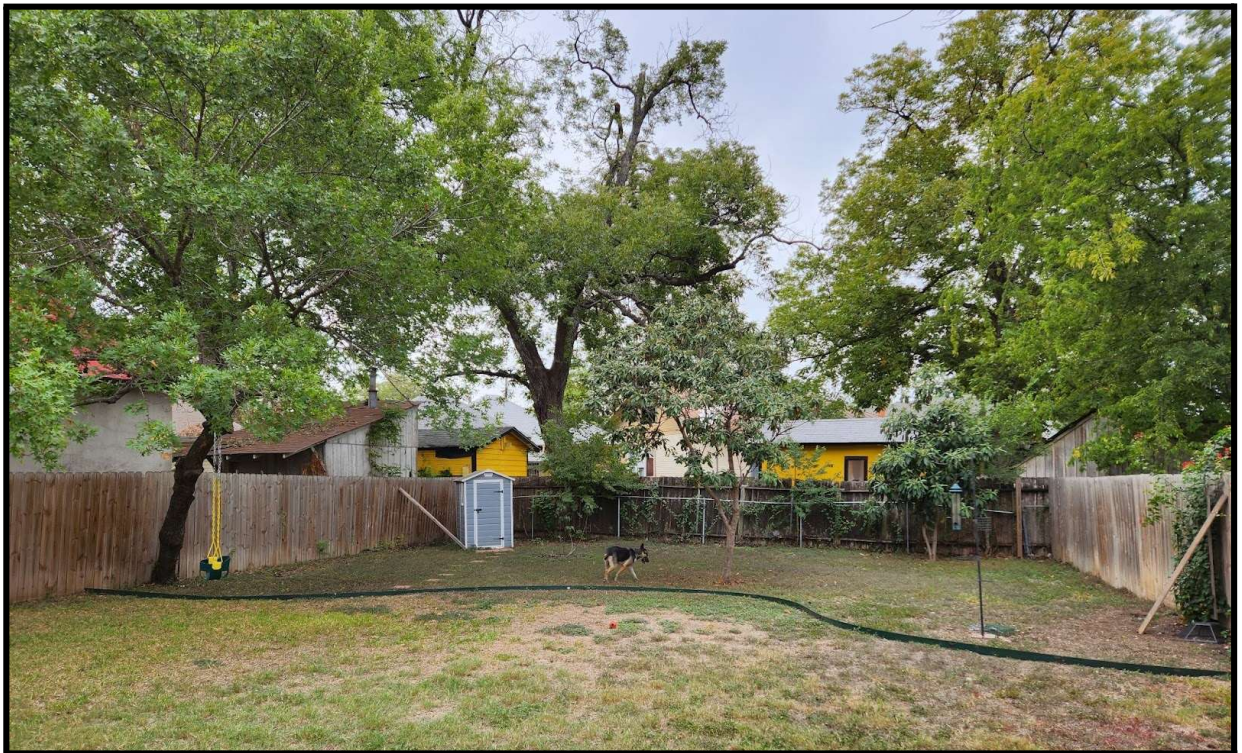
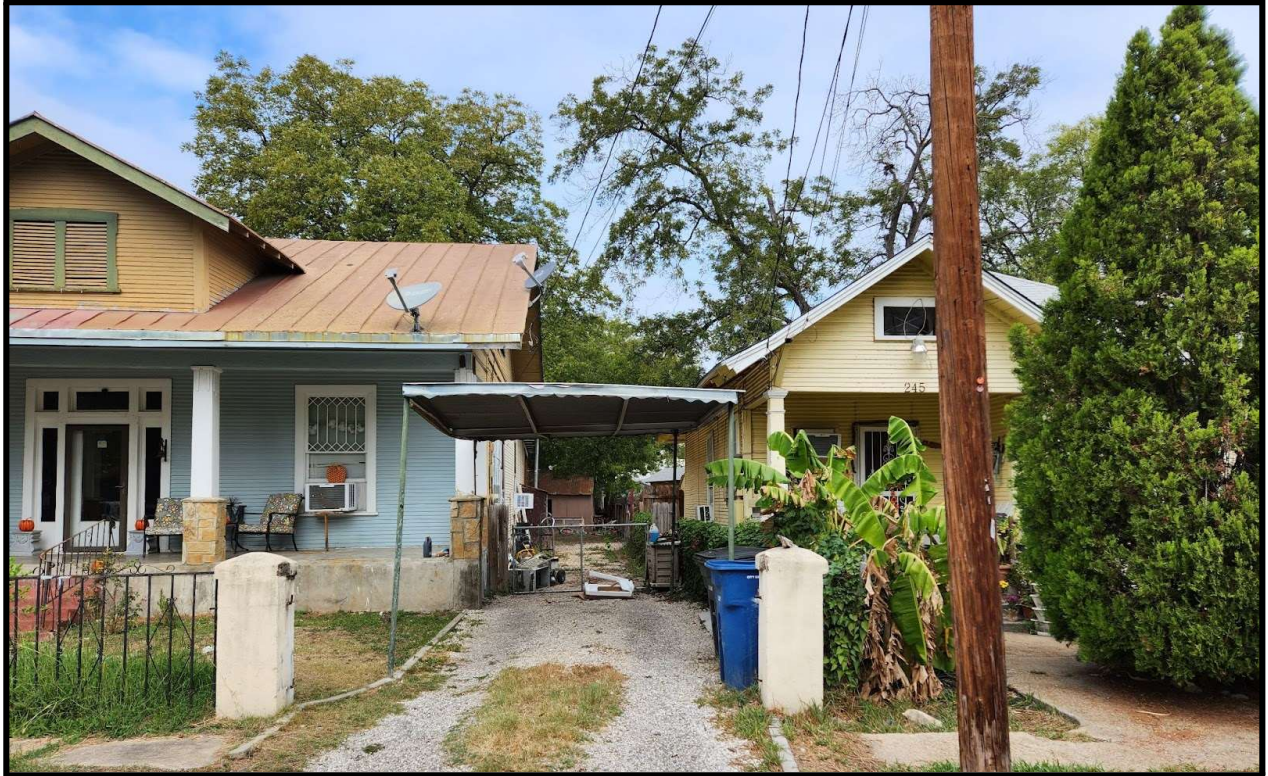
Rear Configuration - support for exemption from further changes

The interior (second floor) does not support the addition of windows. The master bathroom, master closet, and another bedroom closet fully occupy this wall. Additionally, the rear of the house is not visible from the street behind it. Photo evidence, in order, includes:

- Rear of house
- Master bath
- Master closet
- Bedroom closet
- View of backyard from rear of house
- View from directly behind our house on the street behind us
- Second view from the rear street
- Third view from the rear street
- Google map showing location of home in relation to neighboring streets and the impossibility of a sight line to the rear of the house from a neighboring street

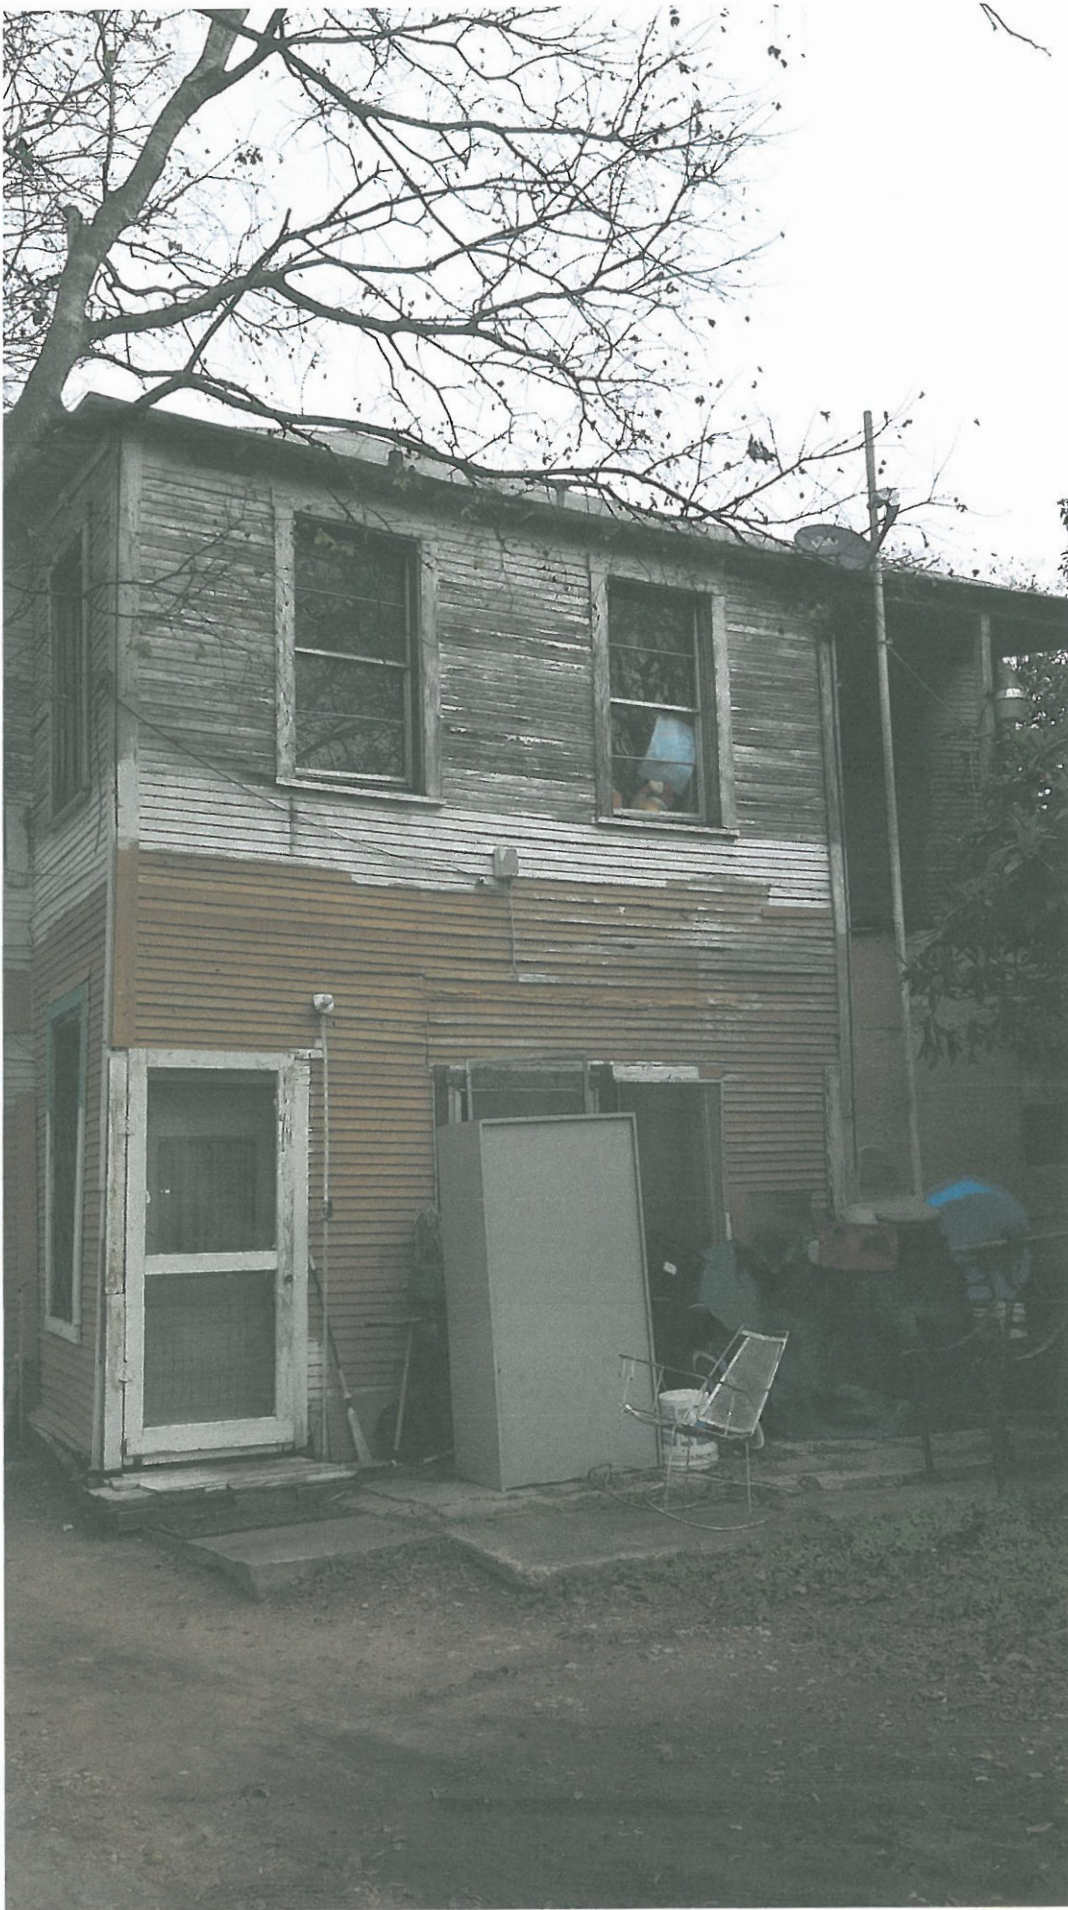
REMOVED REAR PORTION, FIRST APPEARS ON 1911 SANBORN MAP
