## HISTORIC AND DESIGN REVIEW COMMISSION

**HDRC CASE NO:** 2023-008  
**ADDRESS:** 120 W LYNWOOD  
**LEGAL DESCRIPTION:** NCB 6383 BLK 3 LOT 81 THRU 85  
**ZONING:** R-5, H  
**CITY COUNCIL DIST.:** 1  
**DISTRICT:** Monte Vista Historic District  
**APPLICANT:** Robert Frankland/Frankland 4 Company LLC  
**OWNER:** Robert Barnwell/BARNWELL MEGAN LYNN & ROBERT MICHAEL BARNWELL  
**TYPE OF WORK:** Driveway modifications, retaining wall modifications, repair and maintenance of driveway approach and sidewalk, curbing modifications  
**APPLICATION RECEIVED:** December 09, 2022  
**60-DAY REVIEW:** Not applicable due to City Council Emergency Orders  
**CASE MANAGER:** Claudia Espinosa

## 120 West Lynwood – Historic Review Information for New Driveway

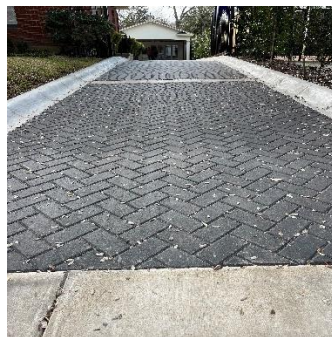
- 1) Charcoal Gray Concrete Pavers in a Herringbone/Chevron Pattern

This is the exact concrete paver and pattern the owner is requesting. This house is located on Hollywood Avenue in Monte Vista and was completed in December 2022.

- d. **DRIVEWAY REPLACEMENT** - The applicant has proposed to replace the existing 7-foot-wide fully concrete driveway with a 10-foot-wide driveway featuring grey concrete pavers installed in a herringbone pattern. According to Guideline 5.B.i for Site Elements, applicants should incorporate a similar driveway configuration—materials, width, and design—to that historically found on the site. Historic driveways are typically no wider than 10 feet. Previous paving surfaces may be considered where replacement is necessary to increase stormwater infiltration. Staff finds that the widening of the existing driveway to ten (10) feet is generally appropriate; however, the replacement of the existing fully concrete driveway with a concrete paver driveway is not consistent with the Guidelines.

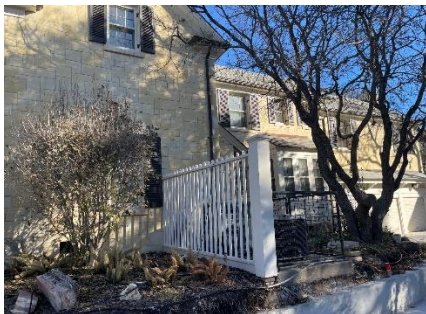
- 2) New Security Gate to Match the Existing Fence. Gate will be 6 feet tall.

The gate will be built to match this white fence that is existing. The owner would like to paint both the fence and the gate the same color as the shutters of the windows.

- g. **DRIVEWAY GATE INSTALLATION** – The applicant has proposed to install a metal swinging driveway gate measuring six feet in height to meet the existing rear fencing behind the front façade wall plane. The proposed gate will be painted to match the existing fencing. The Guidelines for Site Elements note

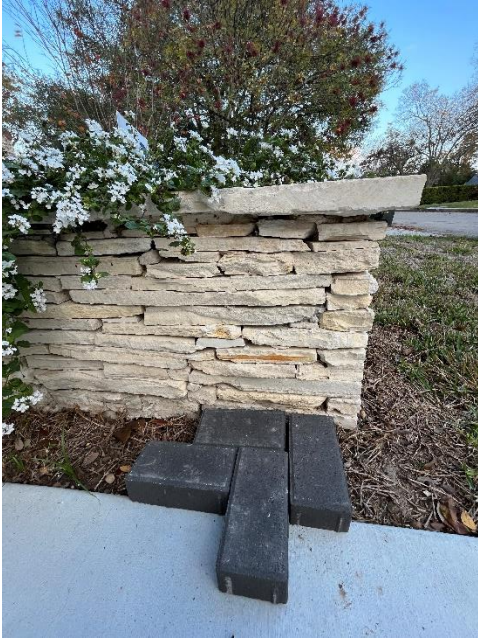
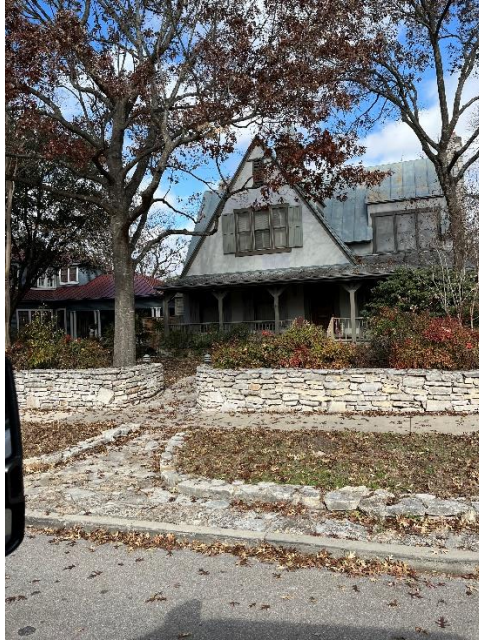
4)

- 3) Stacked Stone Retaining Wall. The material uses will be Mexican Cream Patio Stone, the color will match the patina of the existing house.

This is an example of the stacked stone look the owner wants and the exact same material we would use to build it. The other picture is of a house on West Hollywood Avenue in Monte Vista that has a very similar stacked stone wall.

- e. **RETAINING WALL REPLACEMENT** – The applicant has proposed to replace the existing limestone-clad retaining wall with a stacked limestone retaining wall. The Guidelines for Site Elements note that new fences and walls should appear similar to those used historically within the district in terms of their scale, transparency, and character. Guideline 2.A.ii for Site Elements states that only sections of historic fences and walls that are deteriorated beyond repair should be replaced. Match replacement materials (including mortar) to the color, texture, size, profile, and finish of the original. Staff finds this request is inconsistent with the guidelines and that the replacement retaining walls should match the existing.

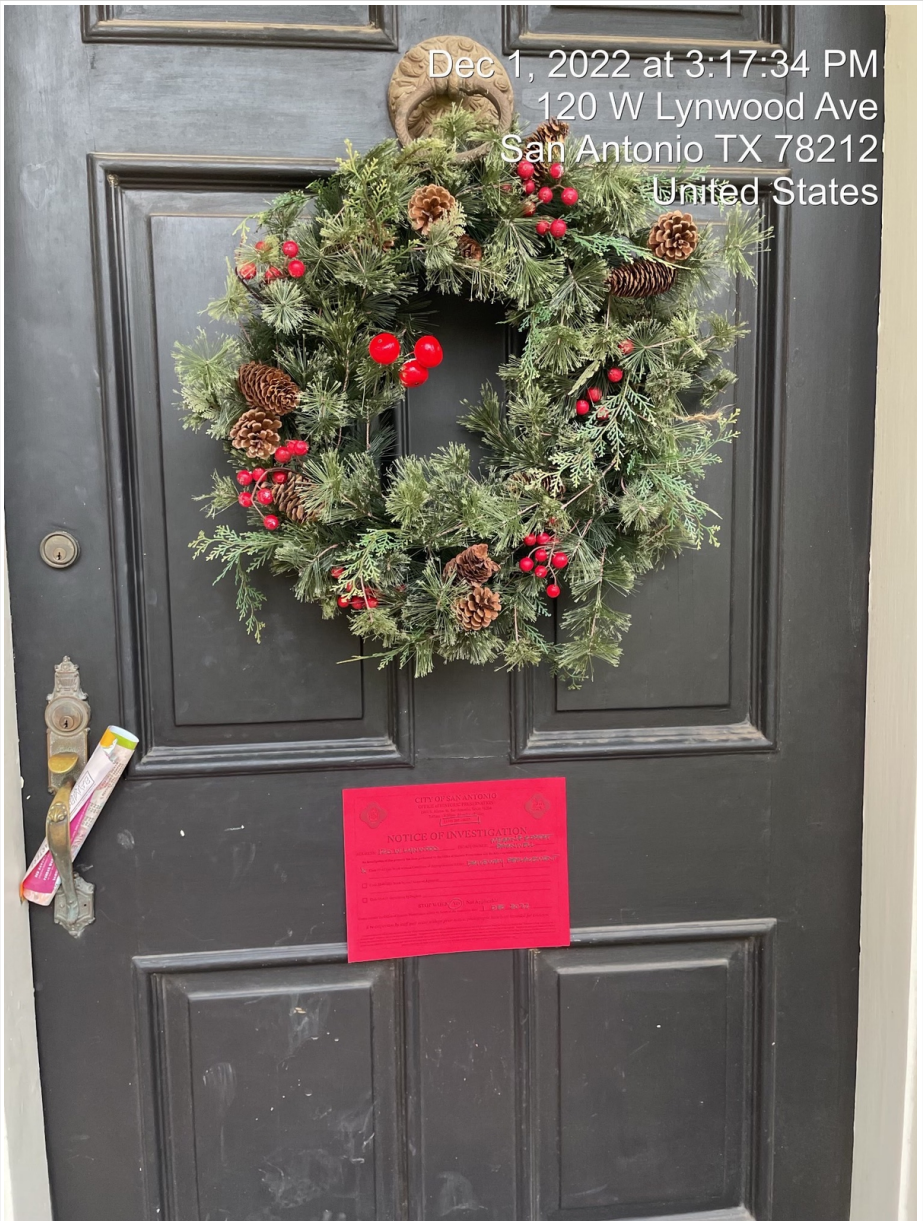
Investigation Report

Date	12/01/2022
Time	04:33 PM (-6 GMT)
Context	citizen report
Present Staff	Claudia Espinosa
Present Individuals	Contractor(s)
Types of Work Observed	Site Elements
Amount of Work Completed	Completed
Description of work	Installation of a new driveway and retaining wall. One retaining wall has been removed. The original retaining walls were clad in stone.
Description of interaction	OHP communicated with contractors on site that all work was to stop. A Stop Work Order was issued on site.

Violation Type	No Certificate of Appropriateness (Code 35-451a)
OHP Action	Spoke with contractor(s), Posted "Notice of Investigation", Posted additional "Stop Work Notice"
Will post-work application fee apply?	To be determined
