# **Lorence Creek HOA Retrofit Project**

**Funded as Lorence Creek Stormwater Retrofit and Research Project  
Under the Proposition 1 Edwards Aquifer Protection Projects**

**Conservation Advisory Board (CAB)**  
**January 25, 2023**

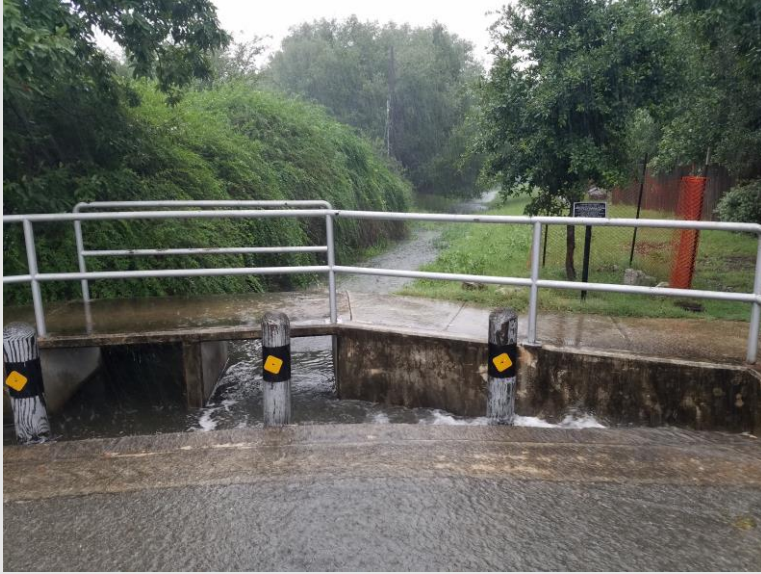
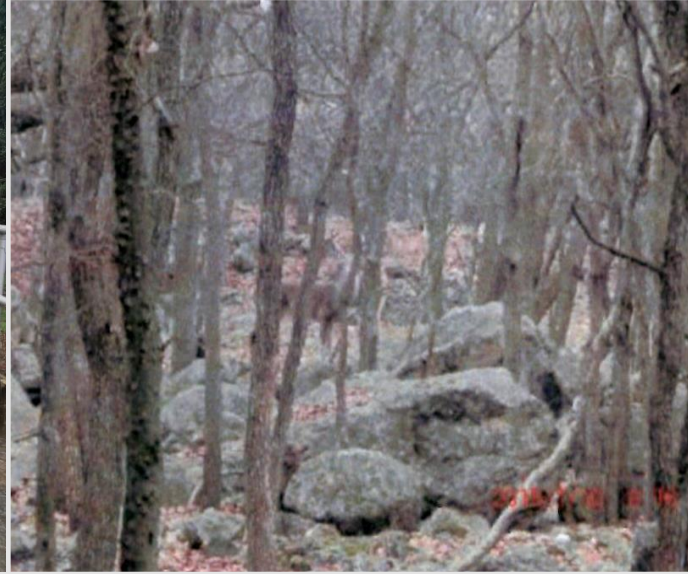
Site before project initiation

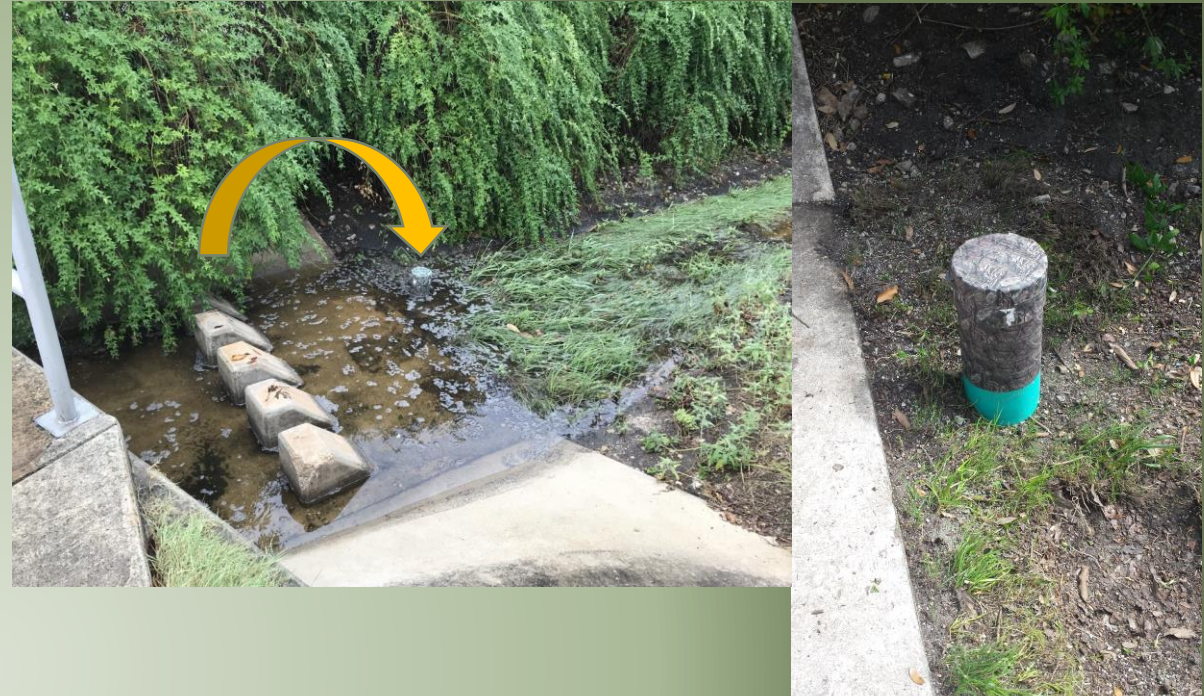
**Single-phase sample bottle**

- Sampler was situated at the outfall that collects stormwater from the 26.1 ac drainage area.
- Sampling unit contained a single-phase sampling bottle.
- 5 stormwater samples were collected from “qualifying” rain events along with 5 soil samples.

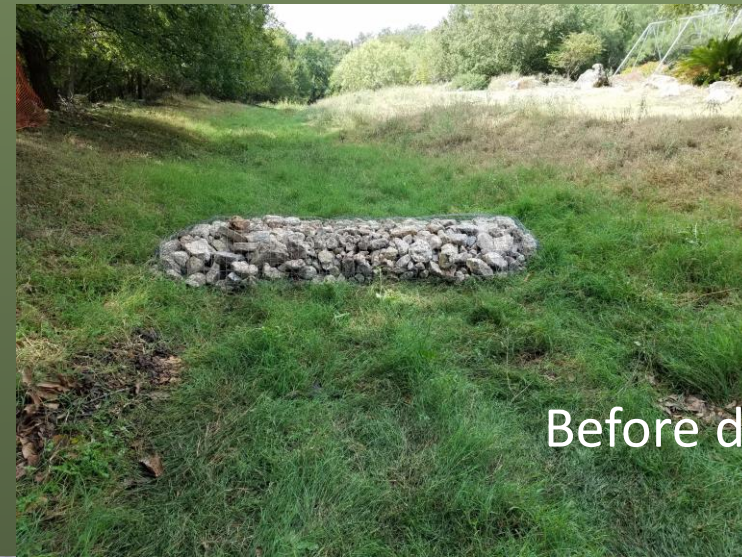
Before de-silting

- Installation of the SWAPP feature, a rock gabion across the channel
- Desilting and revegetation of the channel to the rock gabion.
- Percolation rate analysis within future bioretention area.
- Tree protection installed with mulch.

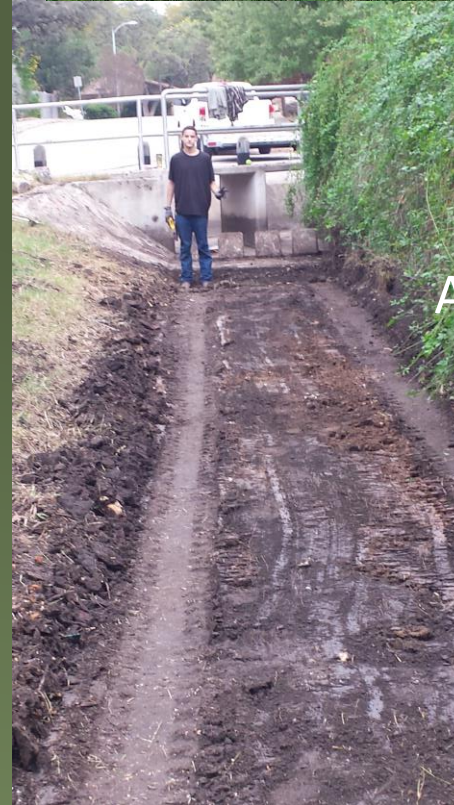
After de-silting

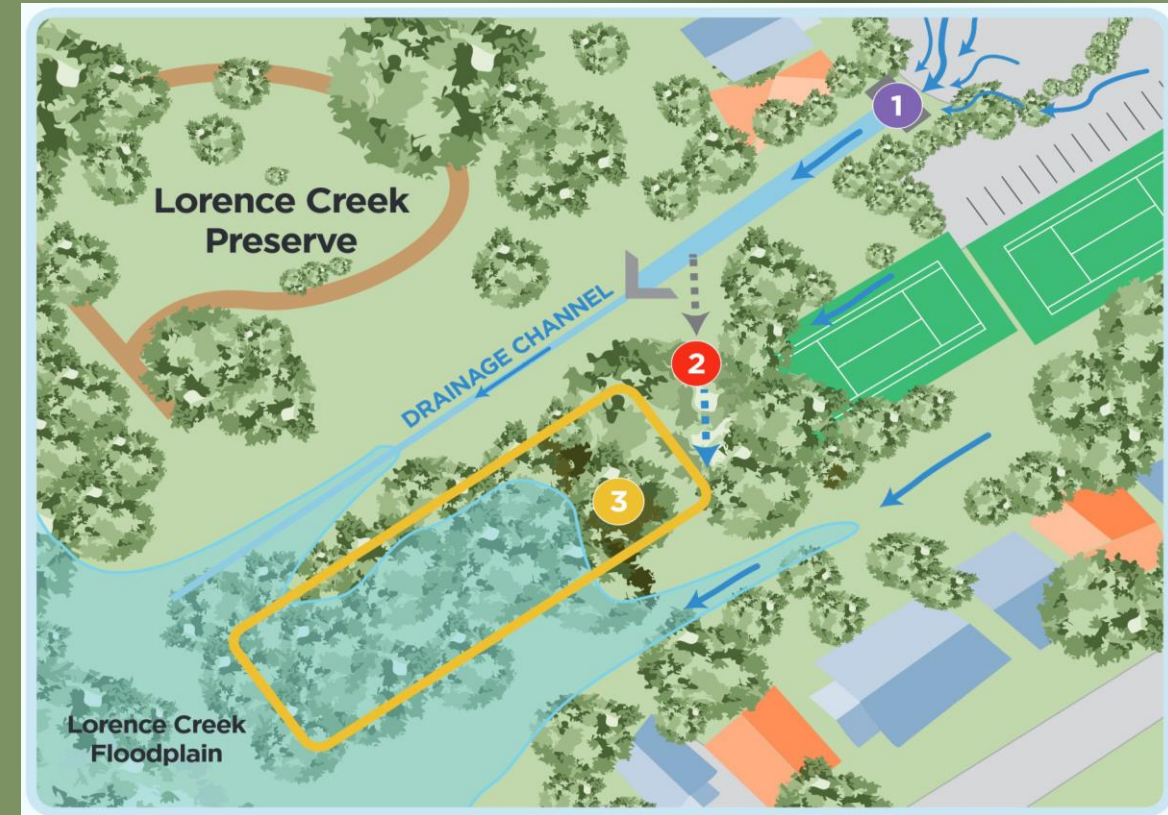
- Project site was approximately 1.5 ac.
- To maximize potential, a LID treatment train with 3 main components was designed :
  1. Forebay to detain sediment and debris,
  2. Bioinfiltration basin to provide post-treatment sampling,
  3. Enhanced natural bioretention basin area which provides the greatest amount of stormwater treatment.

= diversion directs stormwater into the system.

= cross vane in the channel raises the water level slightly ensuring stormwater enters the diversion.

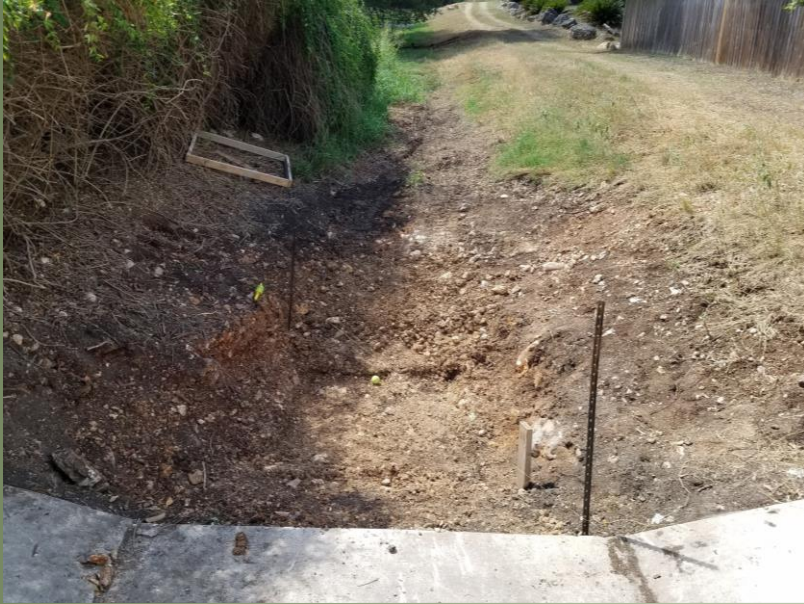
## Sediment Forebay

The amount of sediment washed from the neighborhood was surprising and prompted an additional study on its rate of accumulation within the Sediment Forebay.

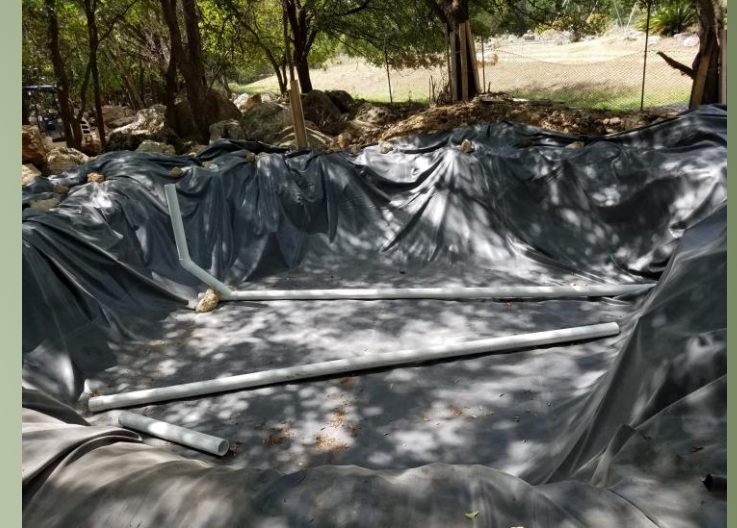
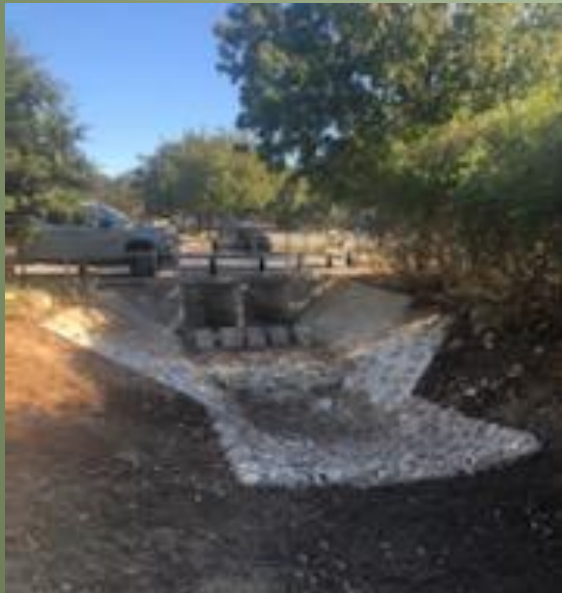
## Bioinfiltration basin

This treatment train directs flow into the enhanced natural bioretention area – the area calculated to treat 0.5”.

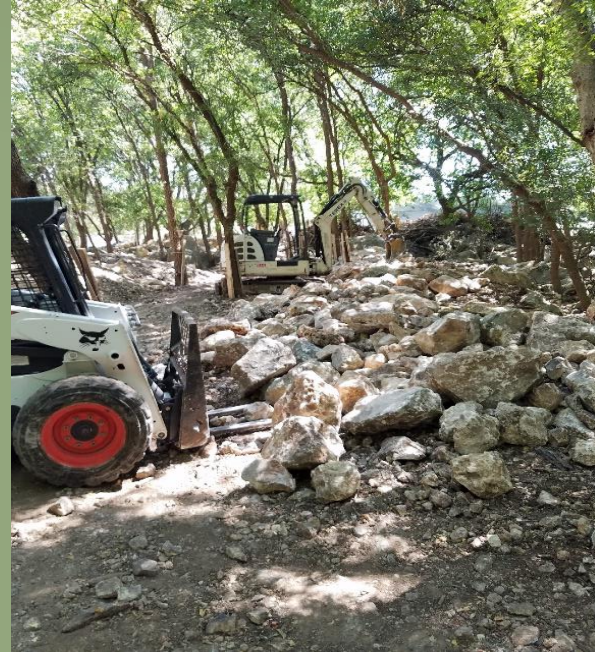
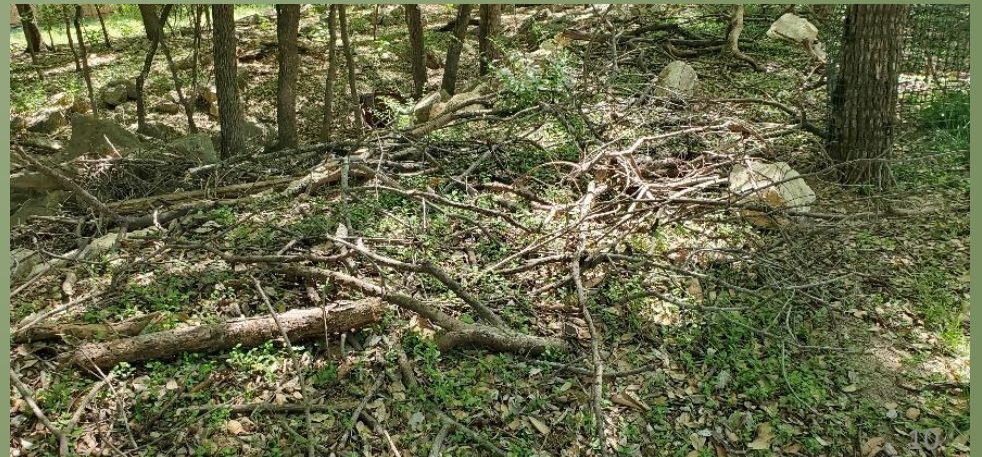
# Enhanced Natural Bioretention Area

- An existing rock berm on one side and a partial on the other side were used.
- This partial berm was extended with rock on site, and the entire berm was covered with an impermeable barrier.
- Creative strategies were required to protect re-vegetation efforts from local deer.

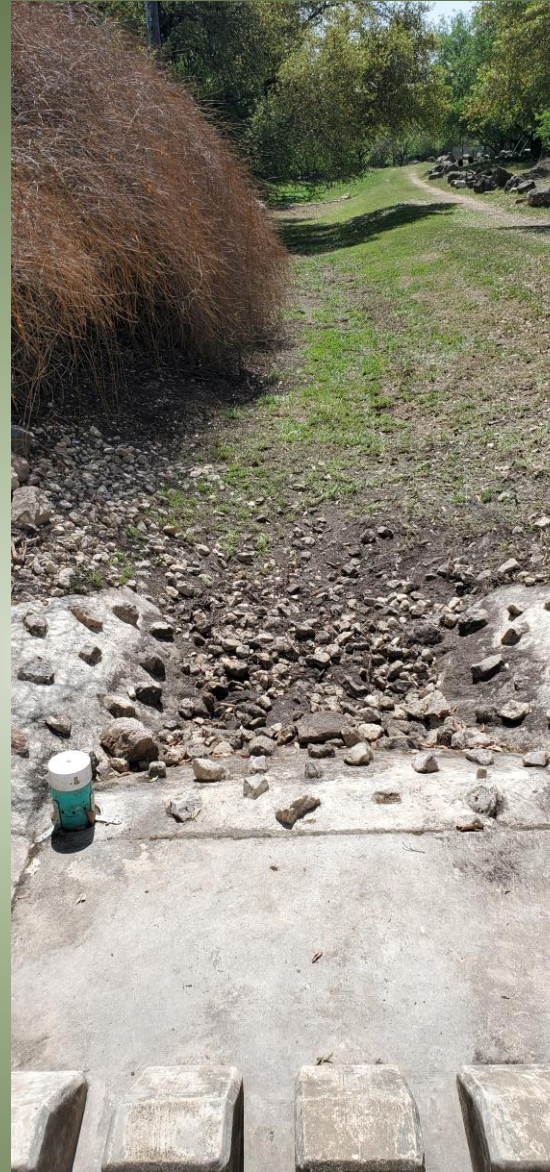
Post-Treatment Sampler Unit

- To assess the performance of the stormwater water quality feature, 5 paired (pretreatment and post treatment) samples were collected.
- Location of the sampling equipment:
  - Street interceptor outfall for pre-treatment.
  - Bioinfiltration outfall for post treatment .

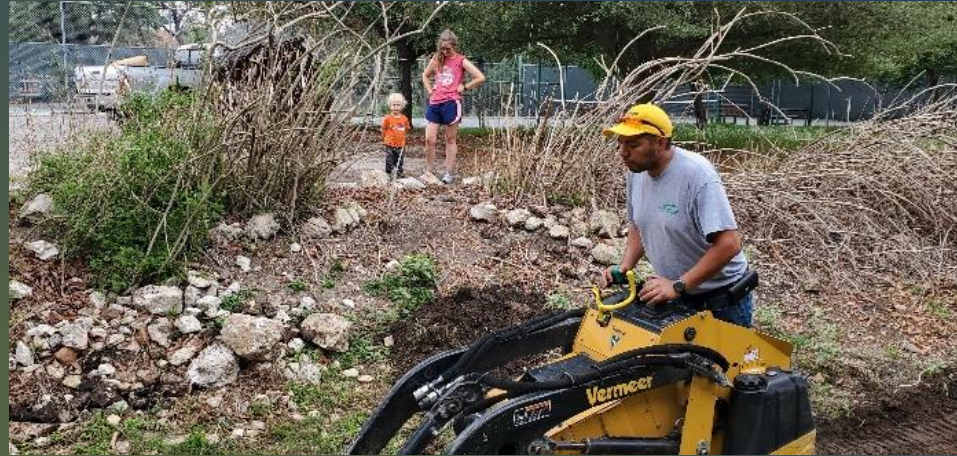
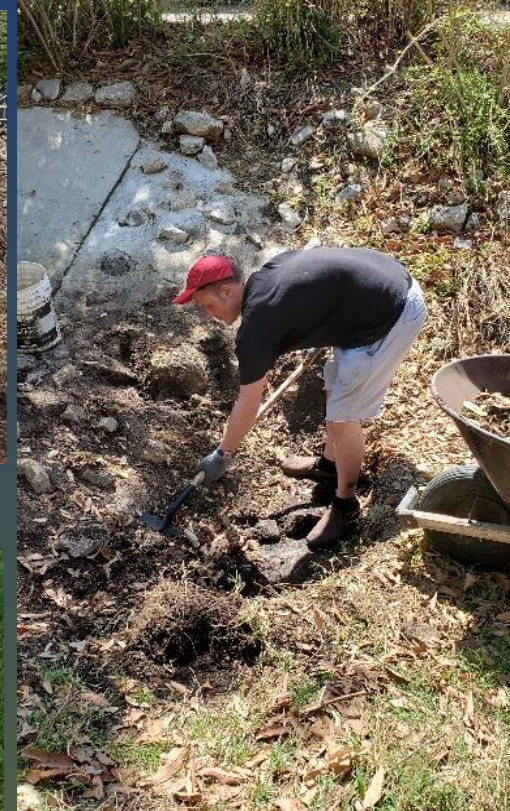
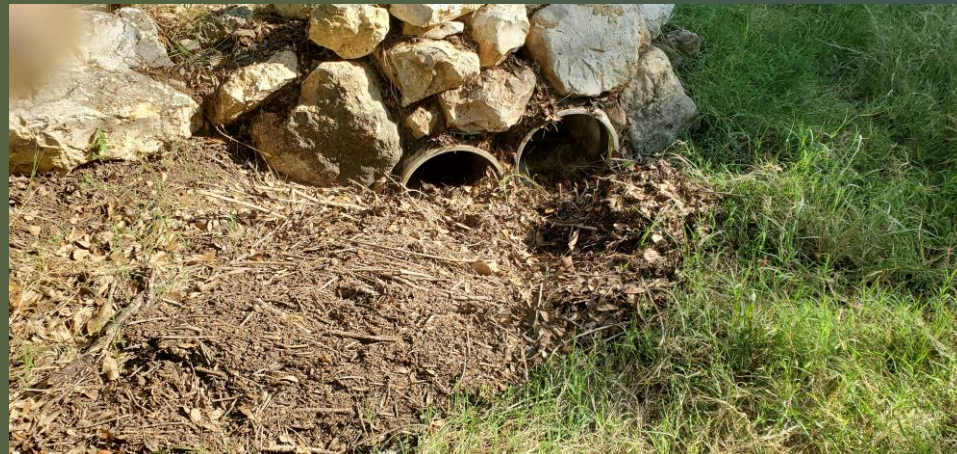
Maintenance has primarily been:

- Removing sediment from the sediment forebay.
- Removing debris from in front of the diversion culverts,
- Keeping plants protected from deer and alive during drought conditions.
