HISTORIC AND DESIGN REVIEW COMMISSION

HDRC CASE NO: 2023-025
ADDRESS: 208 MISSION ST
LEGAL DESCRIPTION: NCB 933 BLK 5 LOT S 54.54 FT OF 14 & 15
ZONING: RM-4, H
CITY COUNCIL DIST.: 1
DISTRICT: King William Historic District
APPLICANT: Richard R Pierson/SKY General Contracting LLC
OWNER: Russell Grabois/LUTZ ANGELA MICHELLE
TYPE OF WORK: Front yard fencing, driveway gate, landscaping
APPLICATION RECEIVED: January 13, 2023
60-DAY REVIEW: Not applicable due to City Council Emergency Orders
CASE MANAGER: Bryan Morales

The applicant requests a Certificate of Appropriateness for approval to construct a four (4) foot wood picket fence around the front yard between the house and the sidewalk, a swinging gate for the driveway and sidewalk, and to replace the front lawn with decomposed granite.

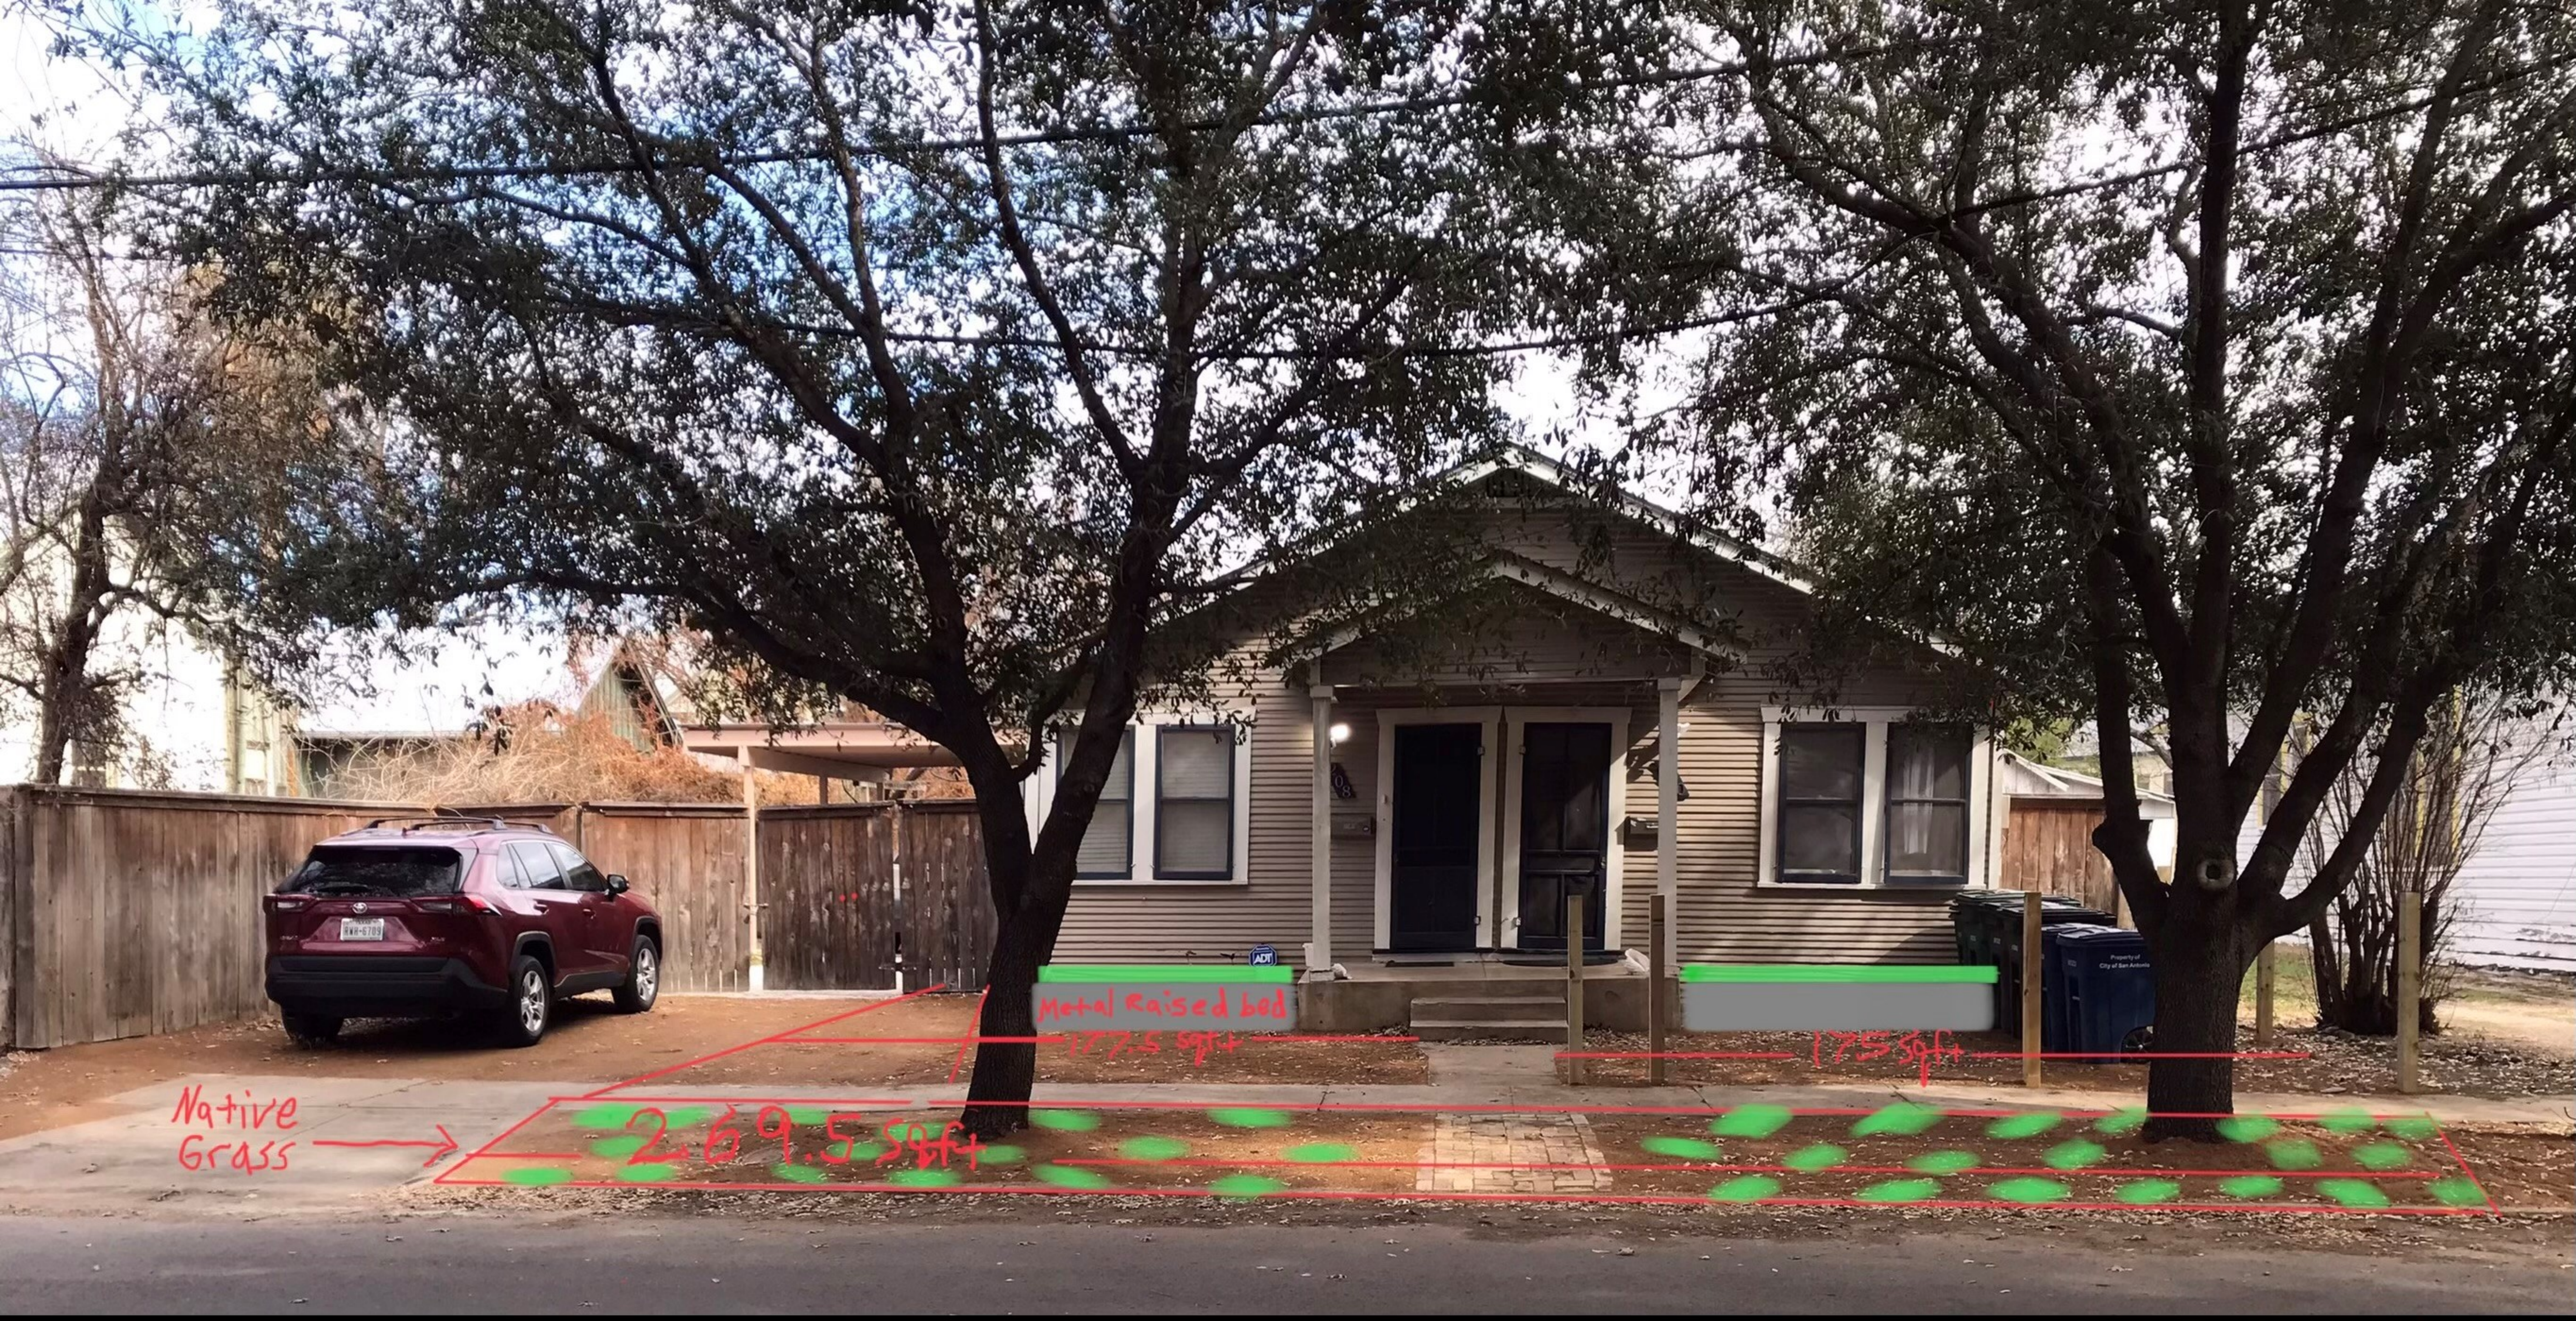
Native
Grass

269.5 sqft

Metal Raised bed
177.5 sqft

175 sqft

- g. LANDSCAPING: The applicant proposes to replace the front yard with decomposed granite. Given the small size of the front yard, this condition would be appropriate. Guideline for Site Elements 3.B.iii states do not use rock mulch or gravel as a wholesale replacement for lawn area. If used, plantings should be incorporated into the design. While the applicant prefers no plantings, he has submitted an option which shows xeric grasses planted in the parkway space between the street and the sidewalk.

- i. That the fence not exceed four feet in height when measured at any point;
- ii. That the fence be constructed of wood based on finding e;
- iii. That the proposed driveway gate be set back behind the front façade of the house based on finding c; The existing driveway gate is at an appropriate location and can remain without any additional approvals. The proposed 4 foot fence should return to the front façade along the driveway and terminate at the front façade.
- iv. That the applicant incorporates plantings into the front yard design to provide at least 50% coverage.

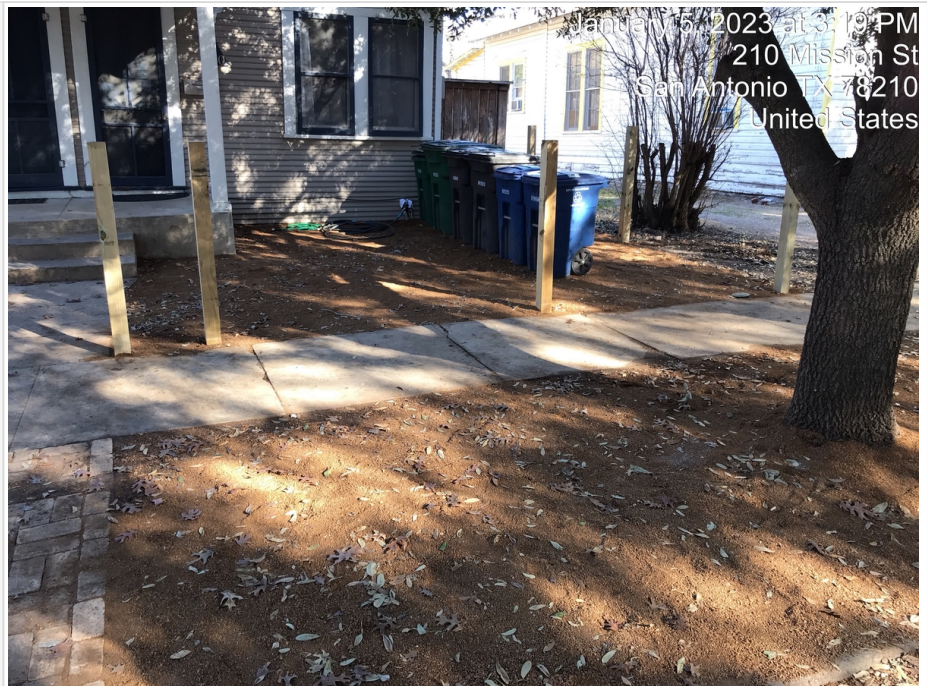
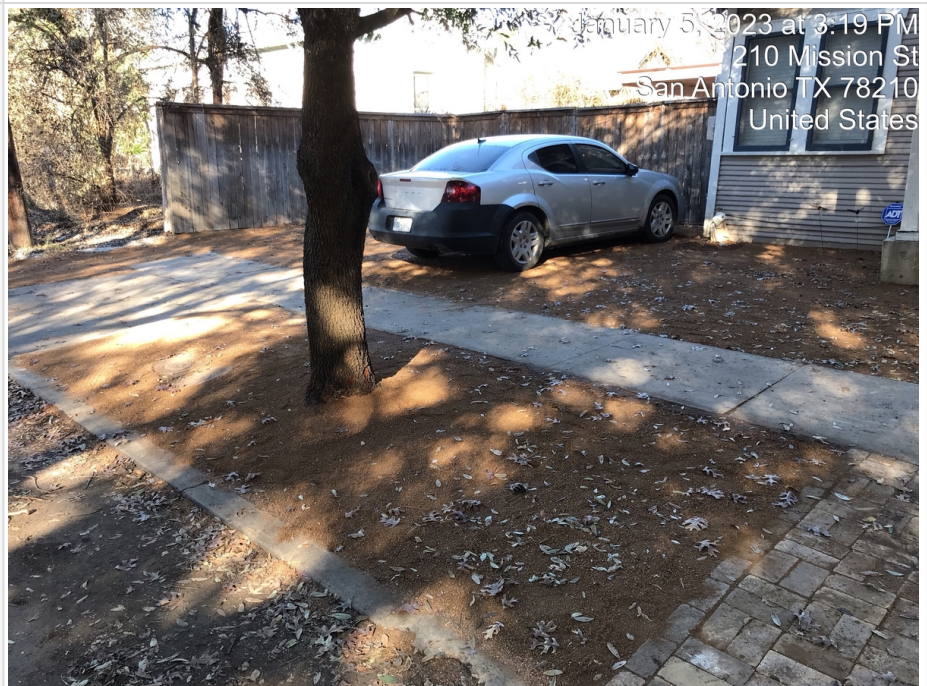
Investigation Report

Date	01/05/2023
Time	03:23 PM (-6 GMT)
Context	citizen report
Present Staff	Edward Hall, Other
Present Individuals	Family/Tenant
Types of Work Observed	Site Elements
Amount of Work Completed	50%
Description of work	Xeriscaping with decomposed granite and fencing.
Description of interaction	OHP staff spoke with a tenant and left a stop work order on site for the property owner.

☒ Code 35-451(a): Work without Certificate of Appropriateness (COA) FRONT YARD LANDSCAPING
MODIFICATIONS, REMOV

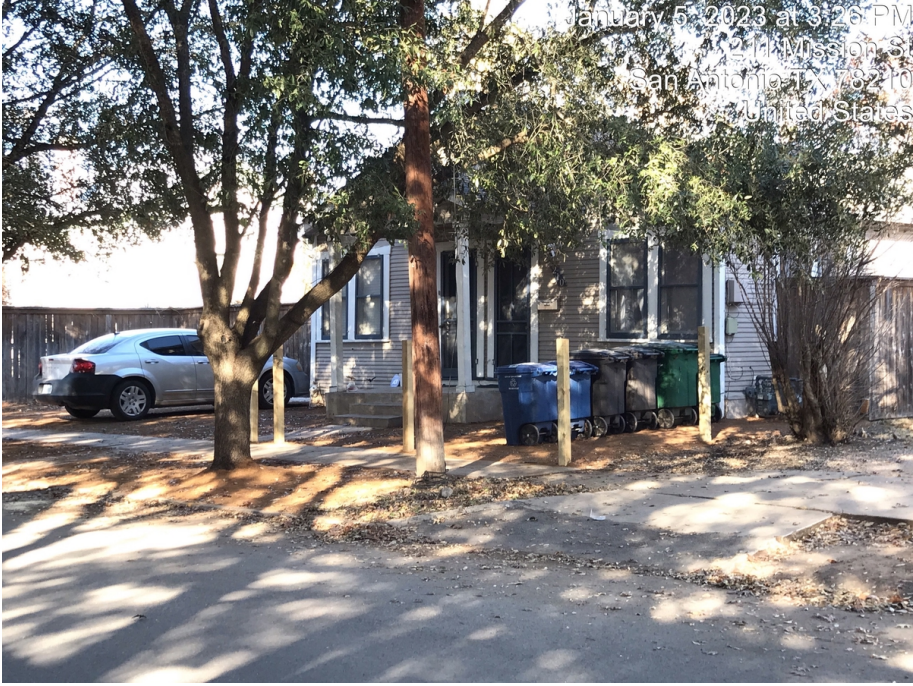
Investigation Report

01/05/2023 03:27 PM
	No
Additional photos were taken on another device.
