### HISTORIC AND DESIGN REVIEW COMMISSION

**HDRC CASE NO:** 2023-145

**ADDRESS:** 620 LABOR ST

# LABOR ST STUDIO

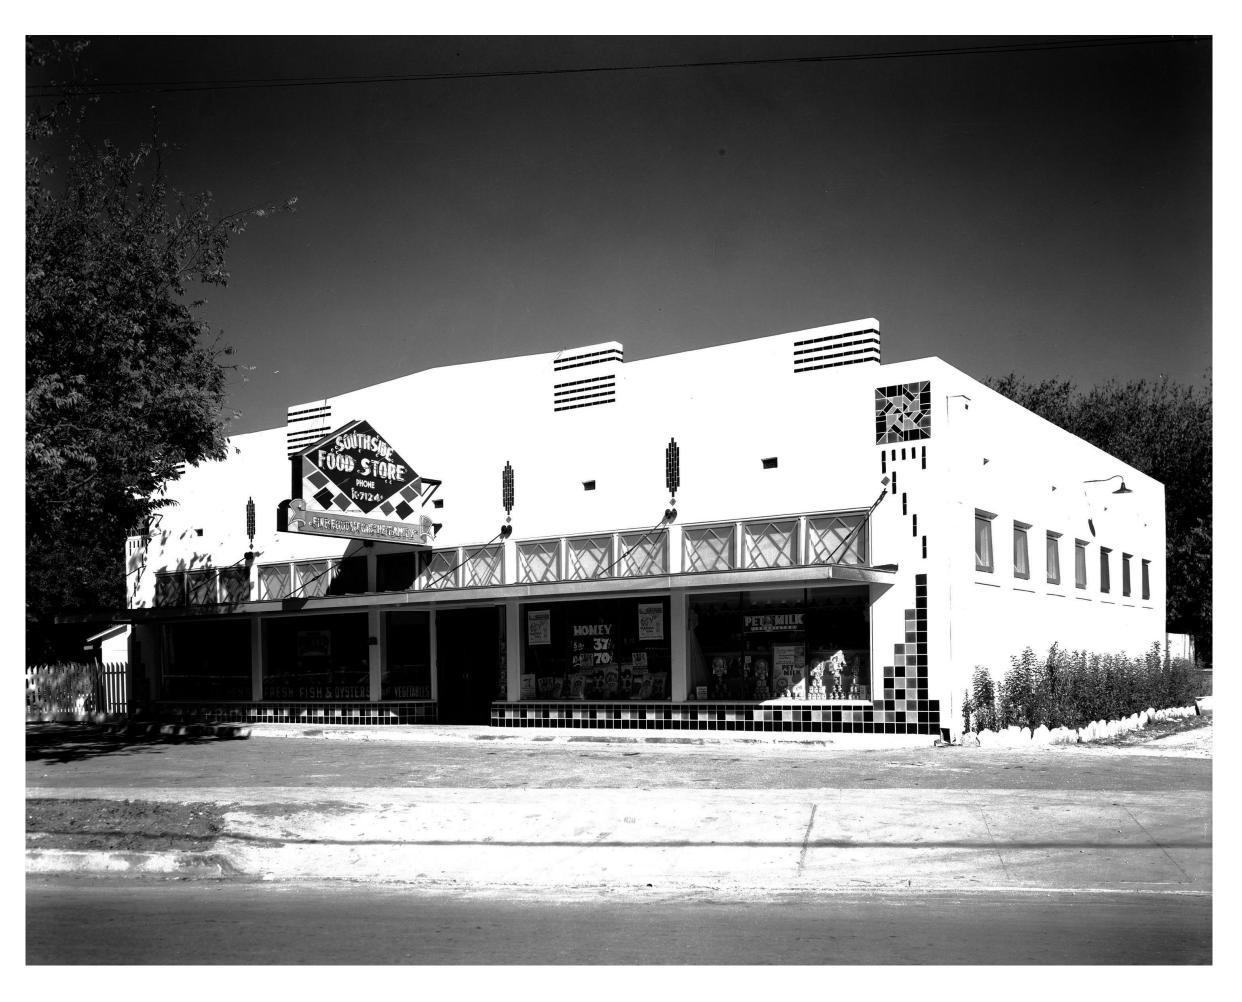
HISTORIC PHOTO OF 620 LABOR ST PRIOR TO ANY ADDITIONS OR ALTERATIONS.

- a. The historic structure at 620 Labor Street was constructed circa 1935 and originally featured a storefront system with transom windows, a front canopy that extended the length of the front façade and a stepped front parapet wall. Since its construction, the structure has featured numerous additions, including one to its north façade, as seen on the 1951 Sanborn Map. The 1970 Sanborn Map notes an additional south addition as well as various façade modifications that were completed in the Art Deco style. More recently, other exterior modifications have been completed, including fenestration modifications and the construction of a rooftop addition.

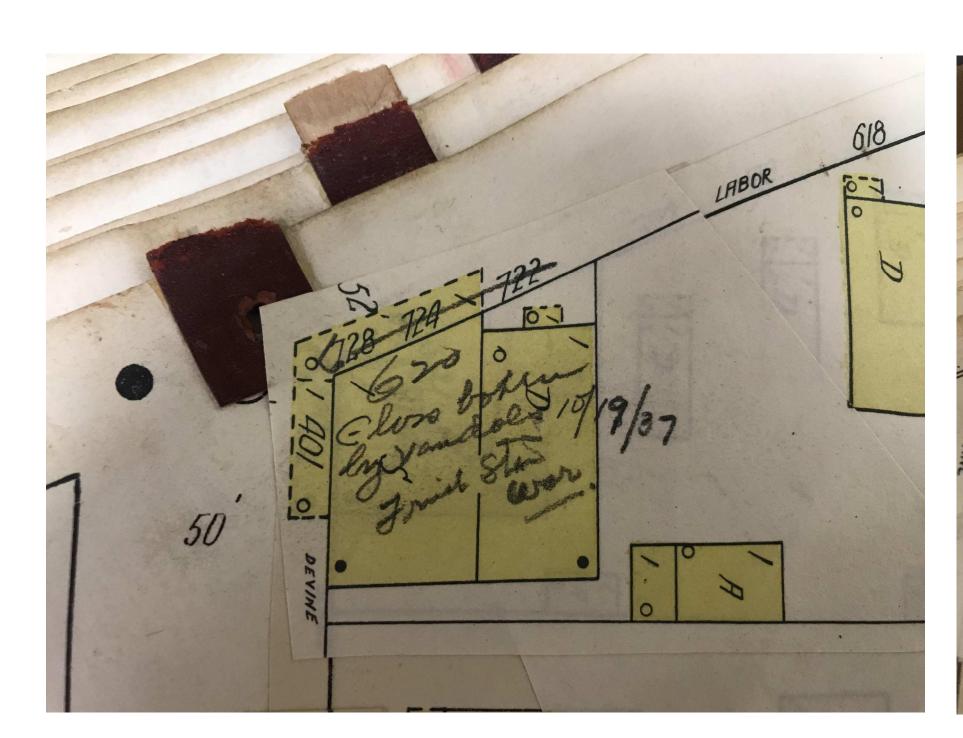
1935 SANDBORN MAP WITH HANDWRITTEN NOTE FROM 1937 - MAP SHOWS A PREVIOUS DWELLING OR STRUCTURE ON THE PROEPRTY.

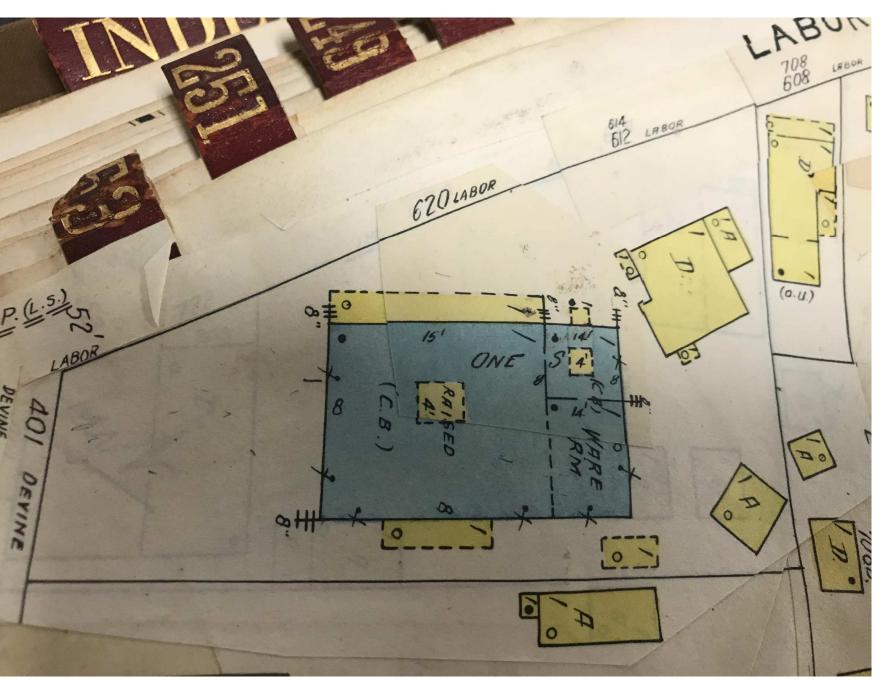
1951 SANDBORN MAP - SHOWS ORIGIONAL STRUCTURE AS WELL AS THE NORTH ADDITION BELIEVED TO BE CONSTRUCTED BETWEEN 1935 - 1951

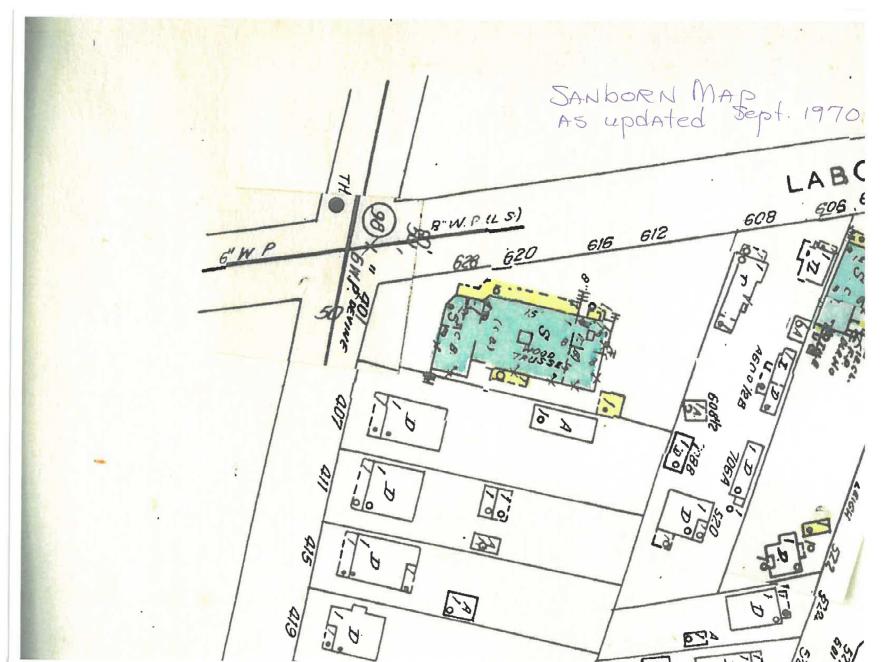
1970 SANDBORN MAP - SHOW BOTH NORTH AND SOUTH ADDITIONS AS WELL AS CURVED WALL MODIFICATIONS TO ORIGIONAL STRUCTURE. MAP DOES NOT YET SHOW THE SECOND STORY ADDITION
