# HISTORIC AND DESIGN REVIEW COMMISSION

**HDRC CASE NO:** 2023-159  
**ADDRESS:** 1402 FULTON AVE  
**LEGAL DESCRIPTION:** NCB 2752 BLK 58 LOT 12  
**ZONING:** R-4, H  
**CITY COUNCIL DIST.:** 1  
**DISTRICT:** Fulton Historic District  
**APPLICANT:** Maria Luisa Cesar & Esnire Abigail Gomez  
**OWNER:** Maria Luisa Cesar & Esnire Abigail Gomez  
**TYPE OF WORK:** Courtyard wall modification & Historic Tax Certification  
**APPLICATION RECEIVED:** May 09, 2023  
**60-DAY REVIEW:** Not applicable due to City Council Emergency Orders  
**CASE MANAGER:** Rachel Rettaliata

The applicant is requesting Historic Tax Verification for the property at 1402 Fulton.

**Application Materials:** Office of Historic Preservation – Complete Plans for Restoration and Rehabilitation for 1402 Fulton Avenue, San Antonio, Texas, 78210

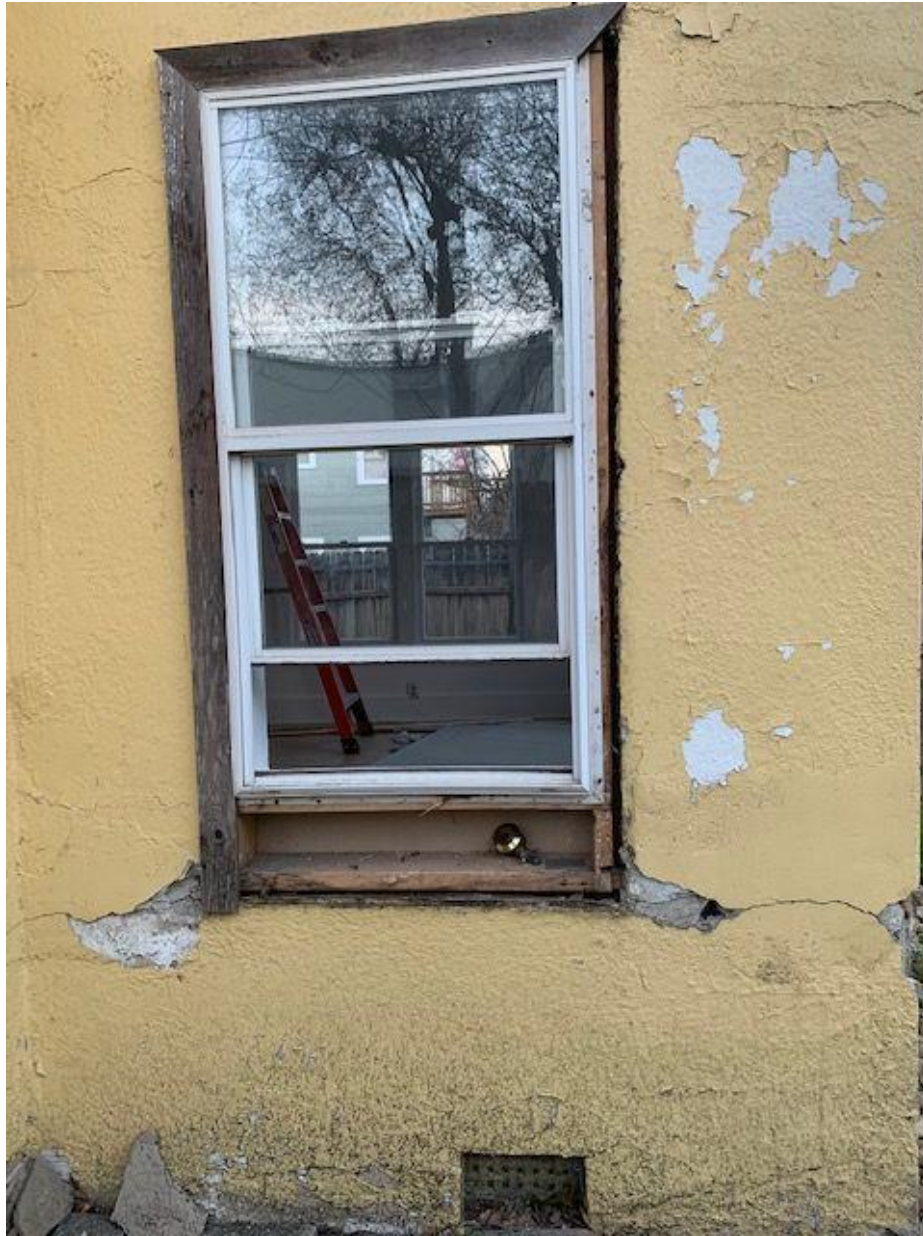
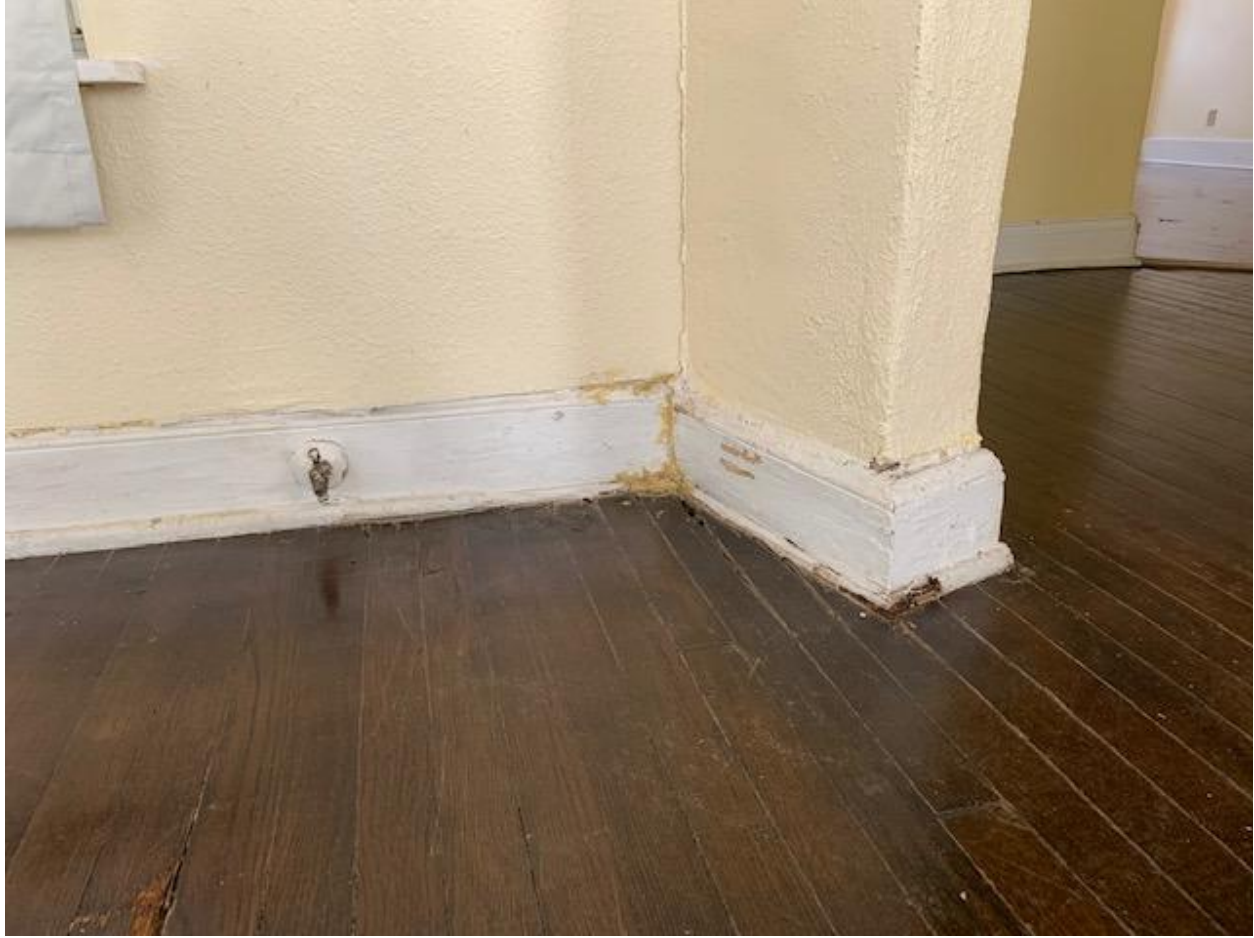
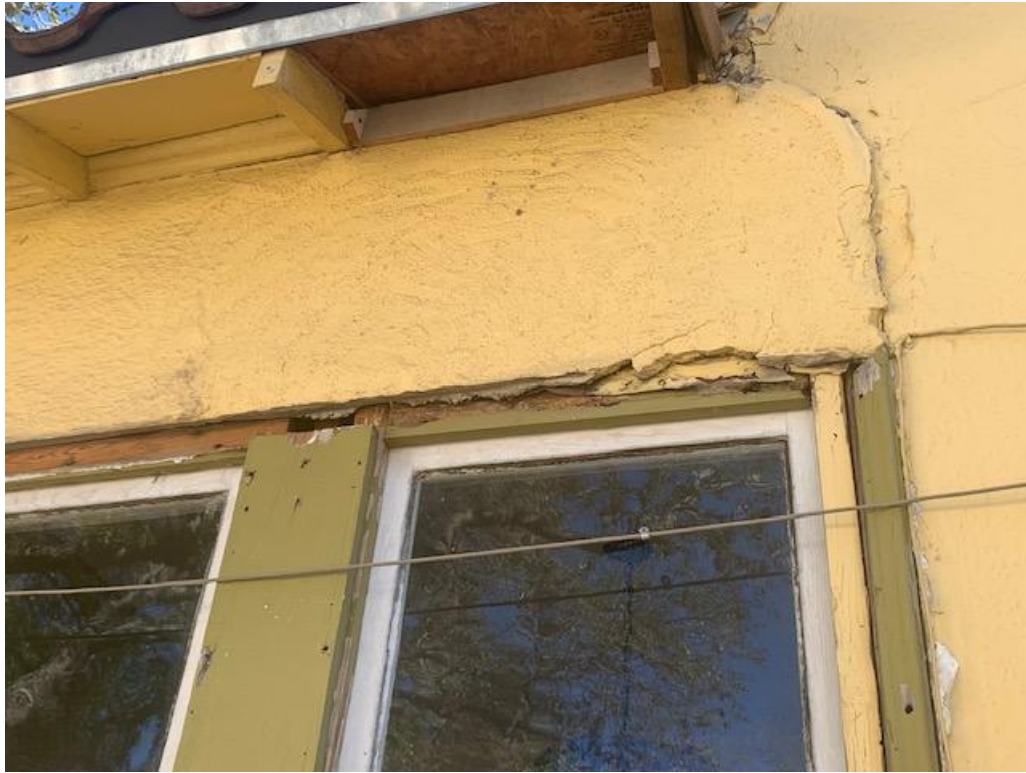
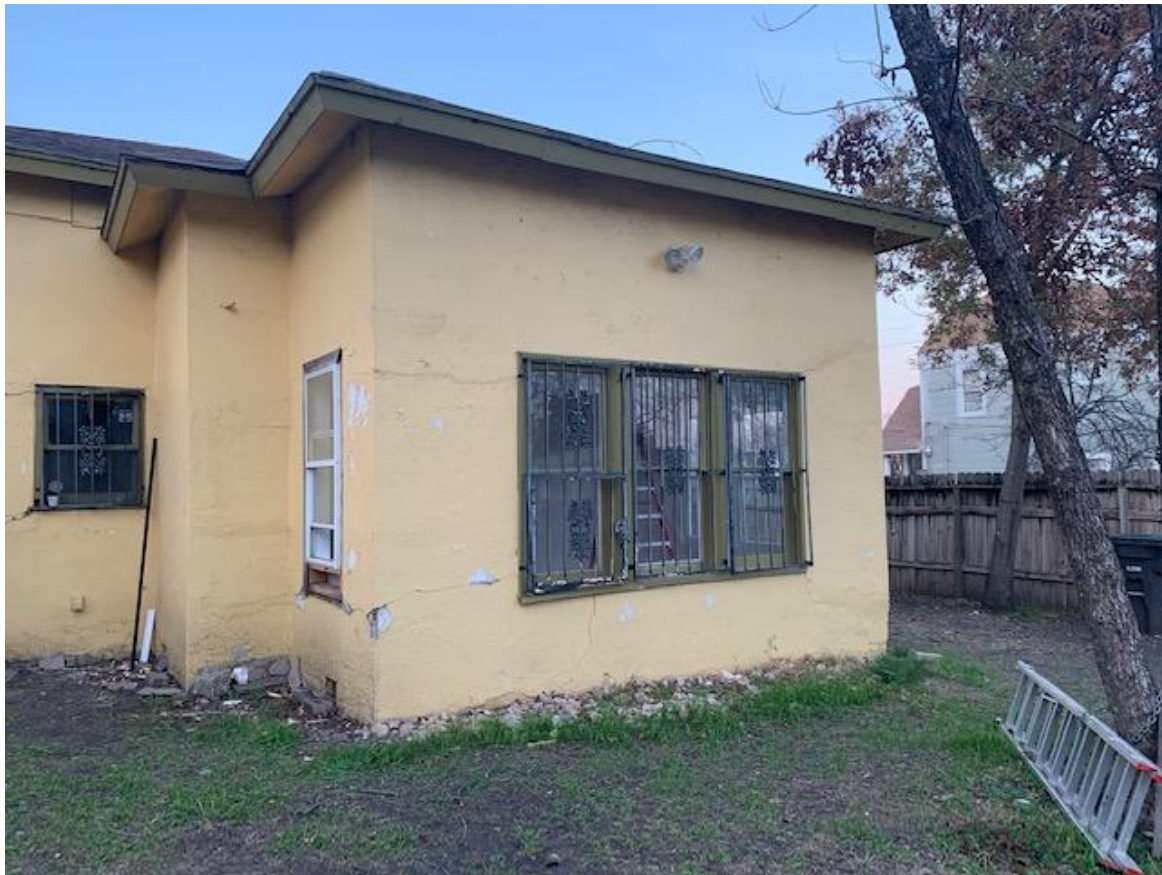
**Before and After Photos:**

Issue: Exterior and interior cracks, wood rot on exterior windows and exterior paint chipping

**Work Plan and Solution:** The home had significant fractures on exterior walls that gave us structural concerns as the stucco had detached itself from the wood beams that made up the house frame. We also realized that significant wood rot across the window trim was keeping the house from being insulated from the elements and properly weatherized. Working with our contractor and his team, we sketched out a plan to repair and restore the exterior stucco, remove areas of wood rot along the window trim and replace with new wood and add sealant to ensure we were “drying” the home and protecting it from the elements. We also decided to repair all interior cracks that existed when we purchased the home and those that formed as the house settled after the foundation work. Our contractor and his team repaired shoddy interior

trim work, and added wood trim to the house where previous patchwork had failed to produce standard, up-to-code work. These repairs added structural security and insulation to the home while also restoring it. Our contracting team also took this opportunity to replace the door leading to the exterior of the house. They also repaired rotting wood trim on the interior of the house and repaired windows in each room, ensuring that at least one window in each room was functional for egress, per code and safety standards. To complete the work, we worked with our contractor to ensure that the paint we selected was approved by the Office of Historic Preservation, a task he completed on our behalf. Lastly, our contractor and his team repaired areas of the interior trim and baseboard that were damaged.

**More information:** We plan to re-stucco the entire house by 2026, which will provide us an opportunity to insulate the entire home and replace the windows that will further support weatherization efforts and seal the home from the elements. Longterm, this will add to the value of the property and the historic district. **Cost (labor and materials):** [REDACTED]

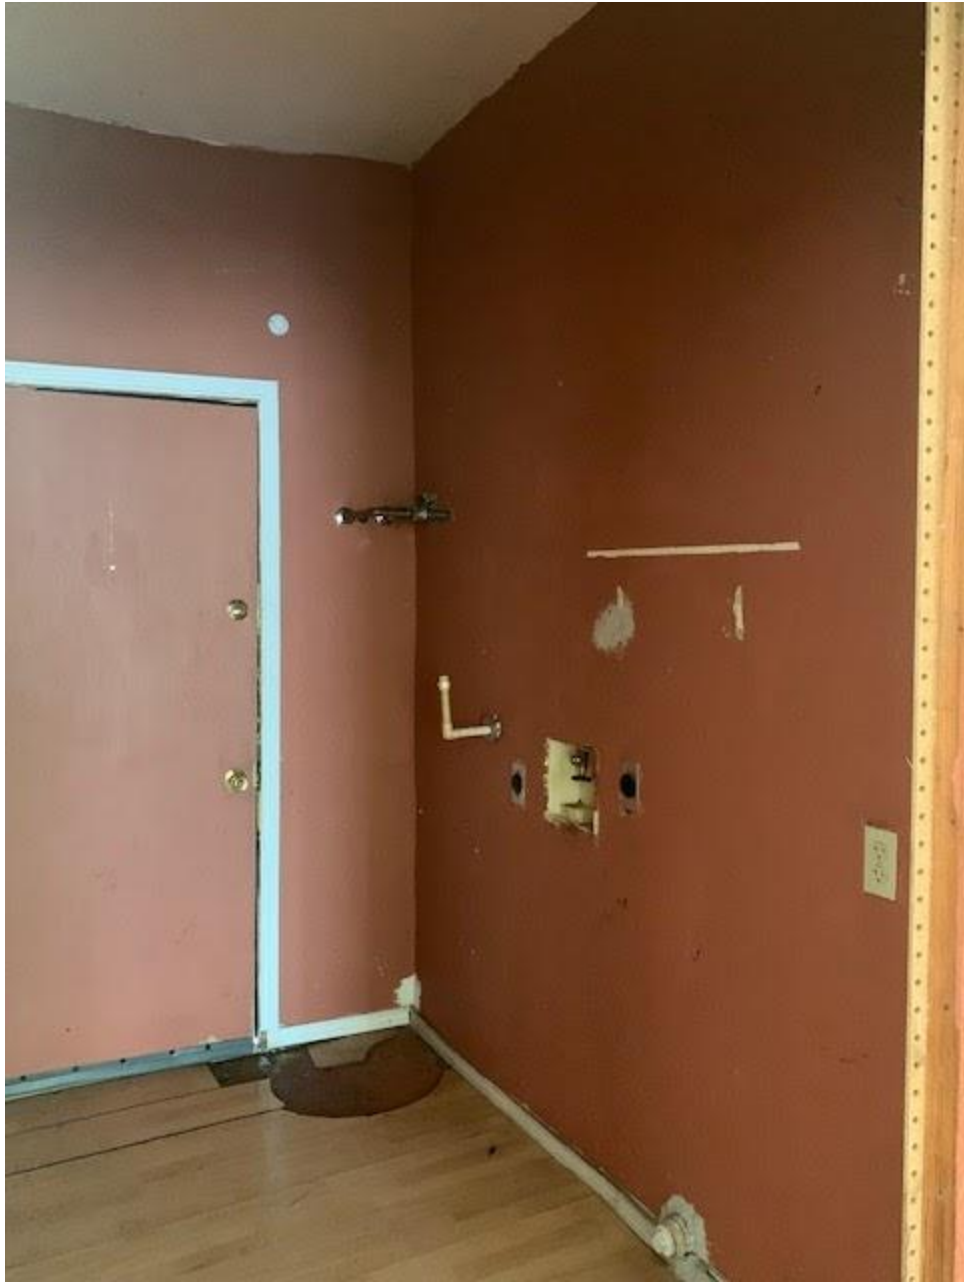
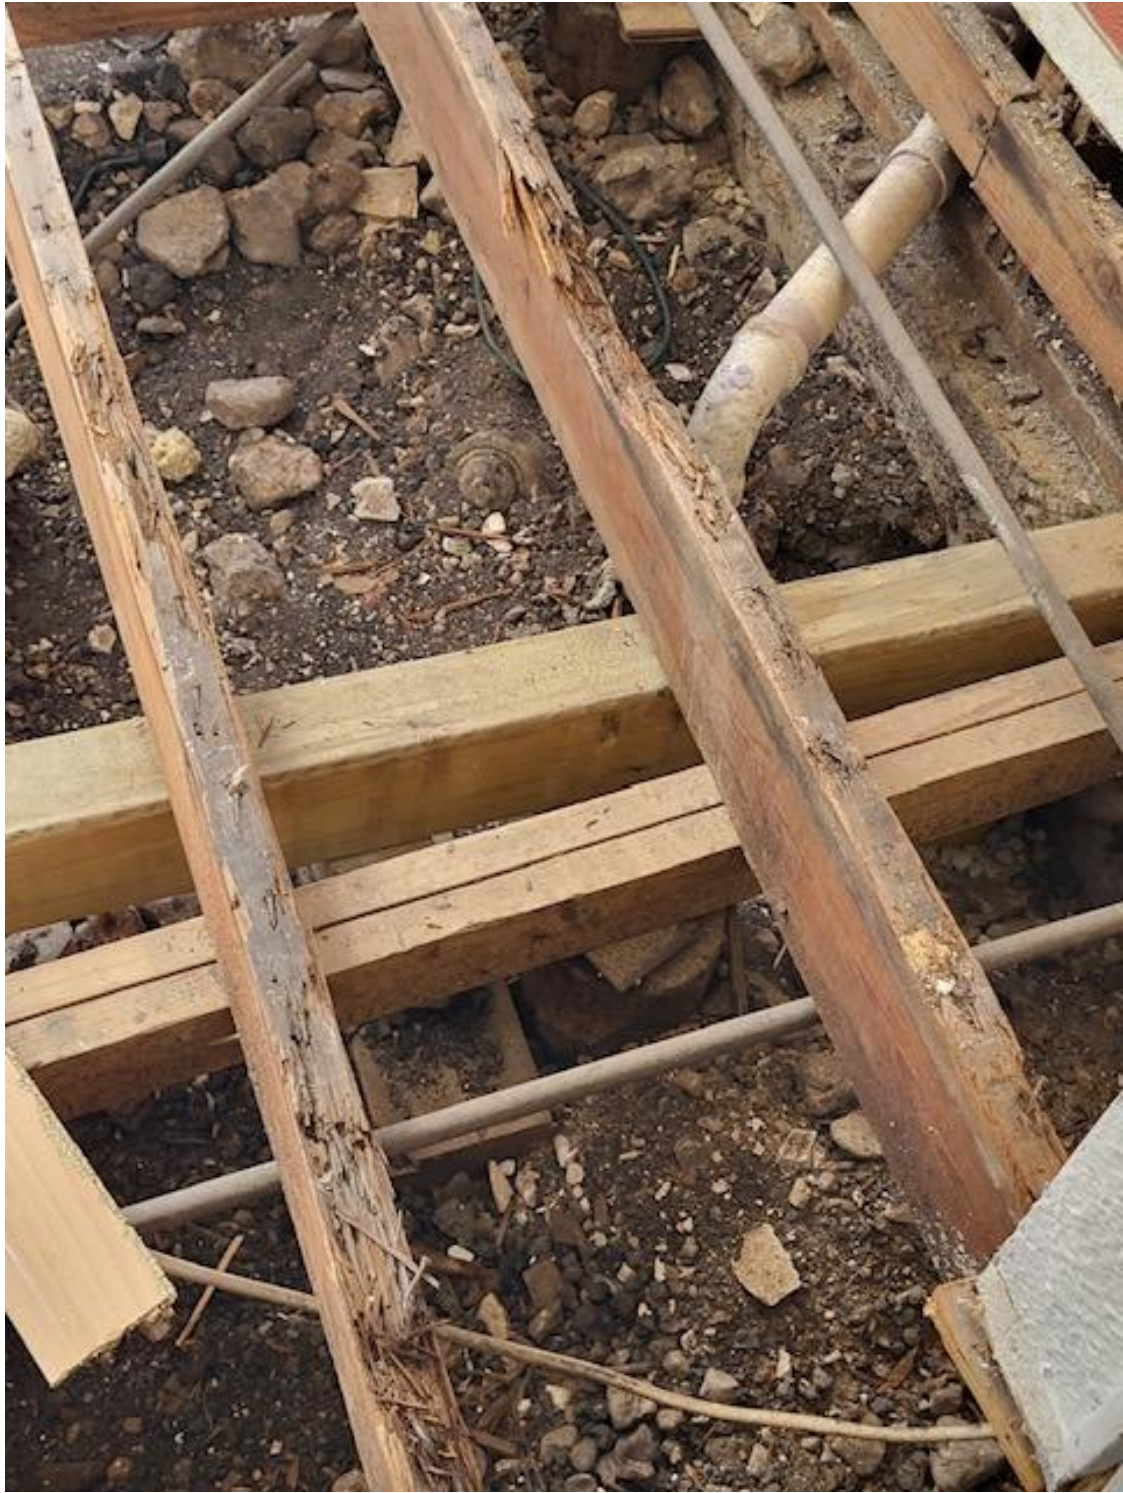
**Before and After Photos:**

Issue: Damaged laminate flooring in hallway, bedroom and laundry room

**Work Plan and Solution:** When we purchased the home, there was cheap laminate faux wood flooring leading from the hallway to the two bedrooms, with moderate damage in some places and significant damage in other places. What's more, when we removed the flooring in the laundry room, where stepping over the floor would give in certain places, we found significant wood rot.

Working with our contractor, we decided to remove the laminate flooring, replace rotten floor joists where necessary and repair those pieces that could be salvaged, and then replace the laminate flooring with tile that matched the style of the house.

**More Information:** After doing research, we found that saltillo tile was popular among the style of home and settled on replacing the laminate floor in the bedroom and hallway. We also replaced the flooring of the bathroom, which was done poorly and lacked grout in certain areas. To replace the laminate in the laundry room, we chose a different style but adhered to tile flooring. **Cost (Labor and materials):** [REDACTED]

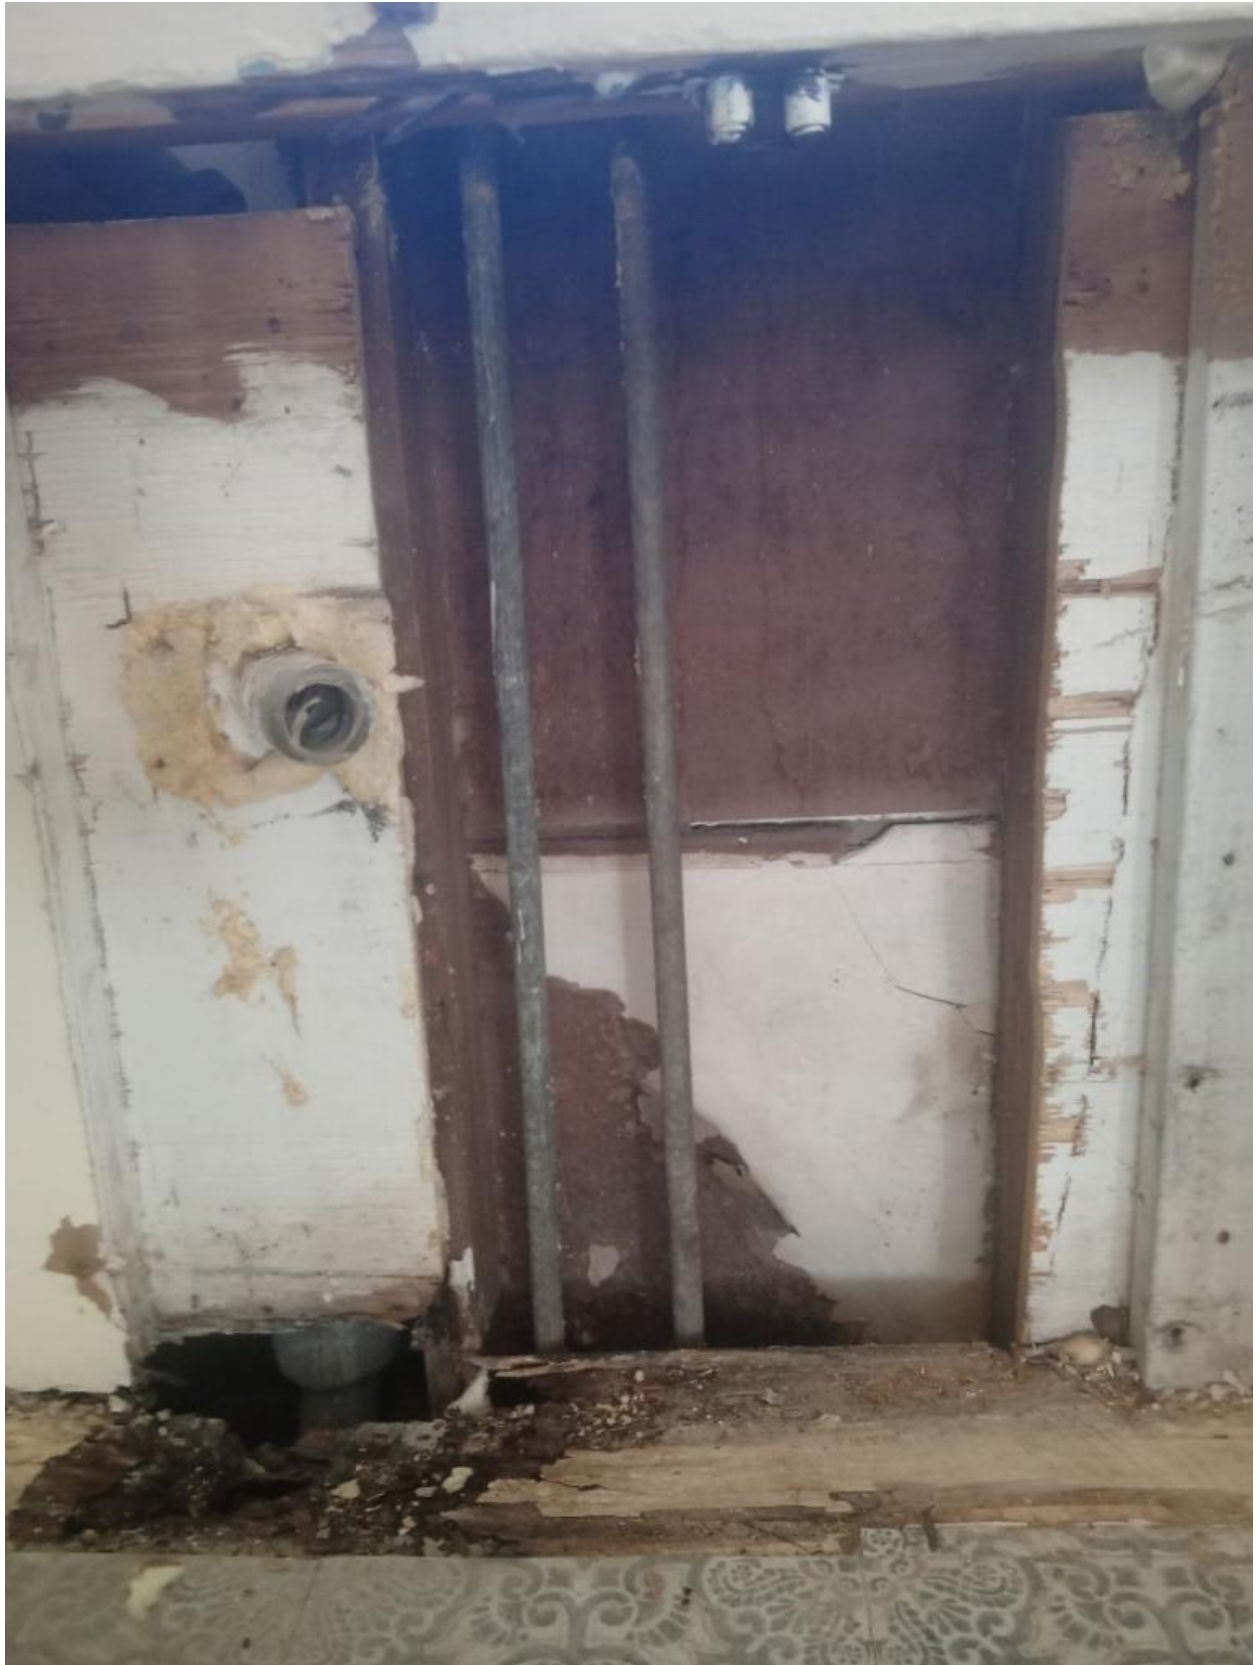
**Before and After Photos:**

Issue: Galvanized pipes susceptible to leaks

**Work Plan and Solution:** In the initial inspection report we were made aware of leaks in the kitchen. Our faucet and underneath the sink. We were later informed that there was rotten wood present underneath the sink. We consulted with our contractor and their plumber. We decided it was best to replace all the rotten wood. He also recommended that we change out all galvanized pipes in the kitchen and laundry room with PEX. During the freeze that took place during December 2022, we had an outside pipe burst that has also been replaced with PEX pipe.

**More Information:** Future plans include replacing all galvanized pipes with PEX pipe, which would total [REDACTED] In the short term, we replaced all kitchen and laundry galvanized pipes.
