HISTORIC AND DESIGN REVIEW COMMISSION

HDRC CASE NO: 2021-486
ADDRESS: 327 W COMMERCE ST
LEGAL DESCRIPTION: NCB 105 BLK LOT ARB A-9, A-10 & A-13
ZONING: D, H
CITY COUNCIL DIST.: 1
APPLICANT: Andi Rodriguez/Centro San Antonio
OWNER: Patrick Shearer/331 WEST COMMERCE L P
TYPE OF WORK: Mural installation
APPLICATION RECEIVED: September 09, 2021
60-DAY REVIEW: Not applicable due to City Council Emergency Orders
CASE MANAGER: Rachel Rettaliata

The applicant requests a Certificate of Appropriateness for approval to install a mural on the east elevation of 327 W Commerce.

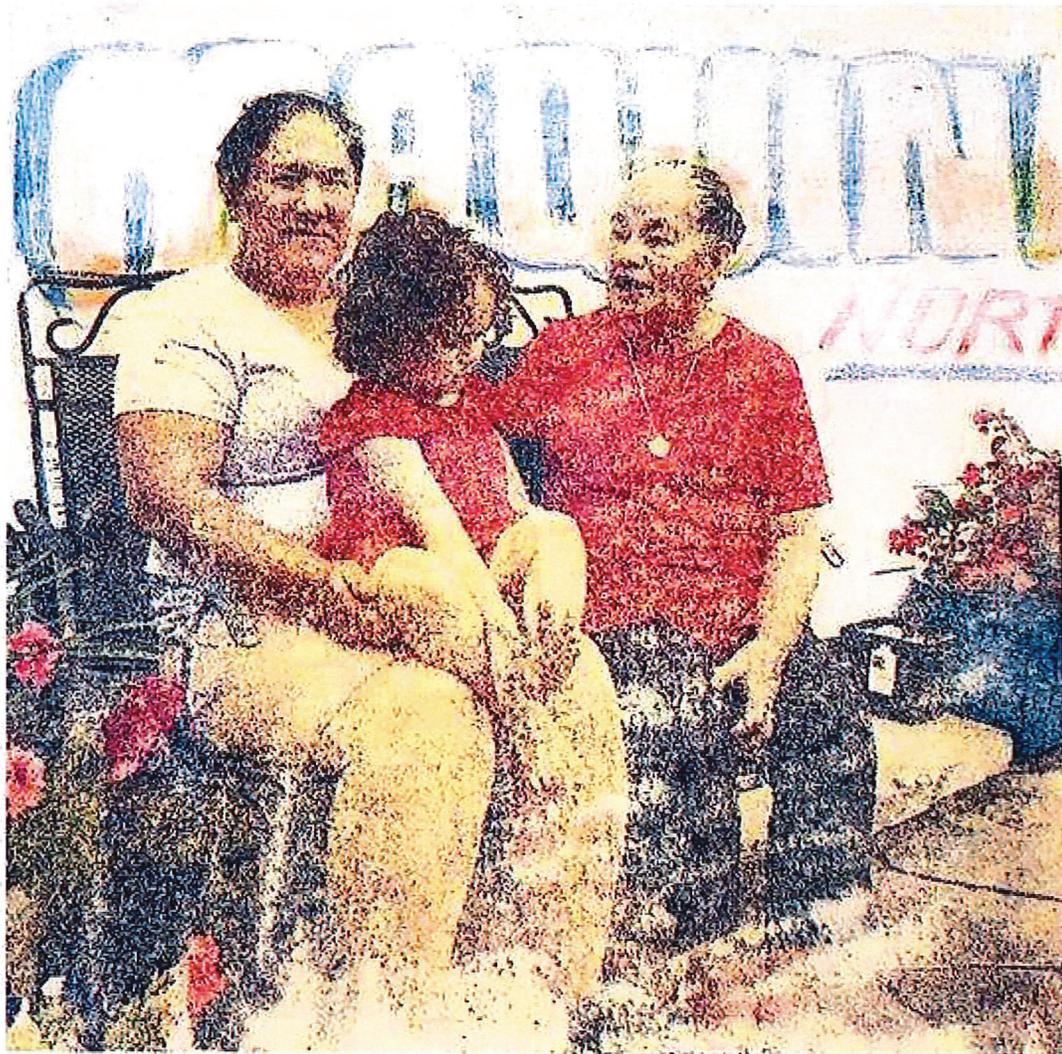
Transfer Photograph, Acrylic Paint, Graphite, Colored Pencil

10 x 10

La Maquina Norteña is from a series titled En El Norte (In the north) that depicts my family's roles in the United States and pairs them with a series of works titled En El Ranch (In the Ranch) to show what

ives were like prior to coming to the United States. This piece depicts 3 generations of Serna Women, My mother, My Grandmother and My Niece. La Maquina Norteña translates to "The Northern Machine". Since moving to

- b. PUBLIC ART – The applicant has proposed to install a mural on the east elevation of the structure. The mural proposed is "En El Norte" by Alan Serna, depicting three generations of women in the artist's family. "Art Everywhere" deliberately selects works of art that tells personal stories from the community, especially in Zona Cultural. The mural may be as large as 15' x 20' feet. Composition of the piece is proposed as artwork on a removable substrate which will not harm the environment nor the building; this mural is temporary and can be removed at the owner's request. Staff finds the proposal appropriate.
