HISTORIC AND DESIGN REVIEW COMMISSION

HDRC CASE NO: 2025-122
ADDRESS: 1914 W KINGS HWY
LEGAL DESCRIPTION: NCB 1941 BLK 29 LOT 23
ZONING: R-6, H
CITY COUNCIL DIST.: 7
DISTRICT: Monticello Park Historic District
APPLICANT: Zachary Fischer
OWNER: Zachary Fischer/FISCHER ZACHARY
TYPE OF WORK: Wholesale window replacement and Historic Tax Certification
APPLICATION RECEIVED: April 20, 2025
60-DAY REVIEW: June 19, 2025
CASE MANAGER: Bryan Morales
REQUEST:

1914 West Kings Highway
Certificate of Appropriateness Application
Submitted: 4/20/2025

1914 W Kings Hwy
Exterior Conditions Survey

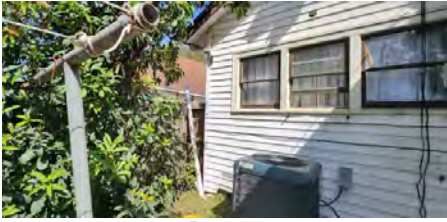
Rear

Downspout Terminations

At foundation

A properly functioning gutter system will minimize ponding, soil loss and erosion, and can help control seasonal movement of the foundation. The gutter system should discharge the water a minimum of 5 feet from the foundation or into a below-grade drainage system.

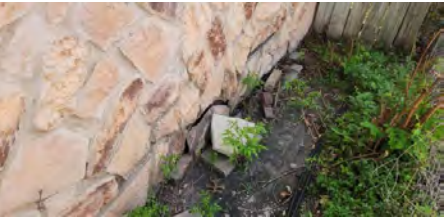
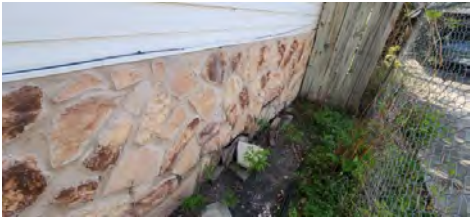
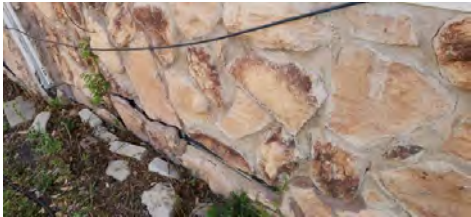
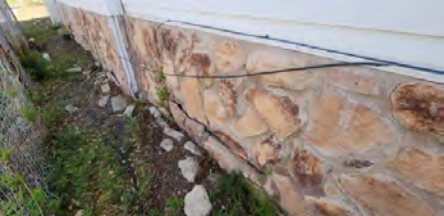
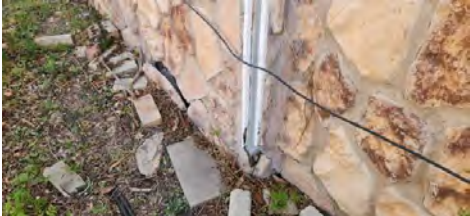
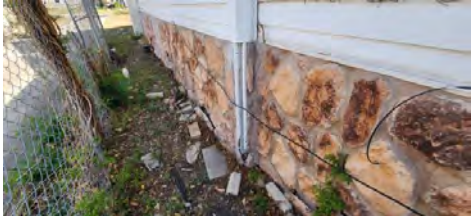
Veneer Cracks

Brick/stone veneer cracks can be filled with mortar. Note, expansion joints in veneer should be filled with an elastic silicone caulk, not mortar.

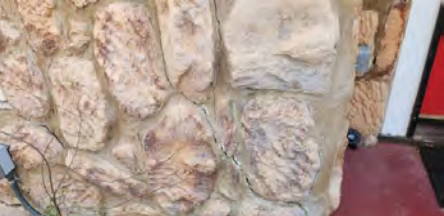
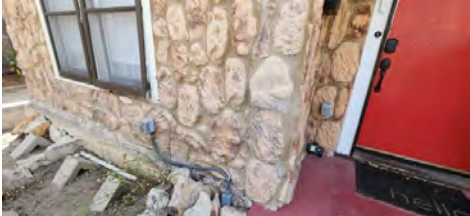
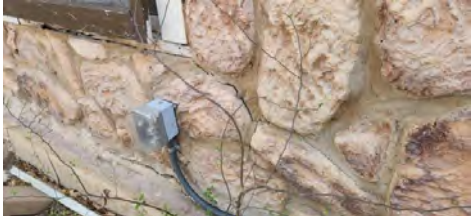
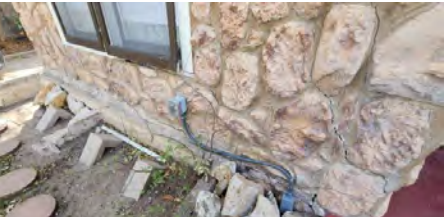
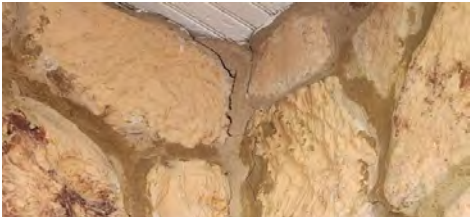
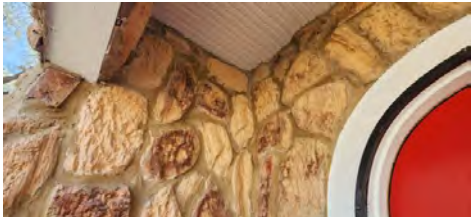
Mortar Separation

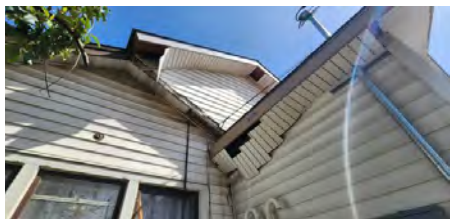
Rear

Trim Separation

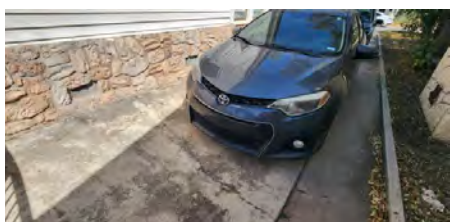
Left

Flatwork Separation/Settlement

Flatwork can be re-leveled with mud-jacking or poly-jacking if desired.

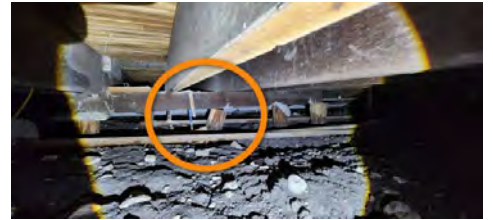
7.1.1 Areas of Concern

LEANING/DISPLACED PIERS

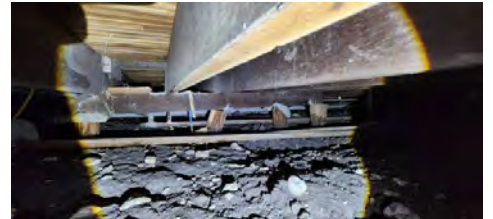
7.1.2 Areas of Concern

WOOD PIERS IN DIRECT CONTACT WITH THE GROUND

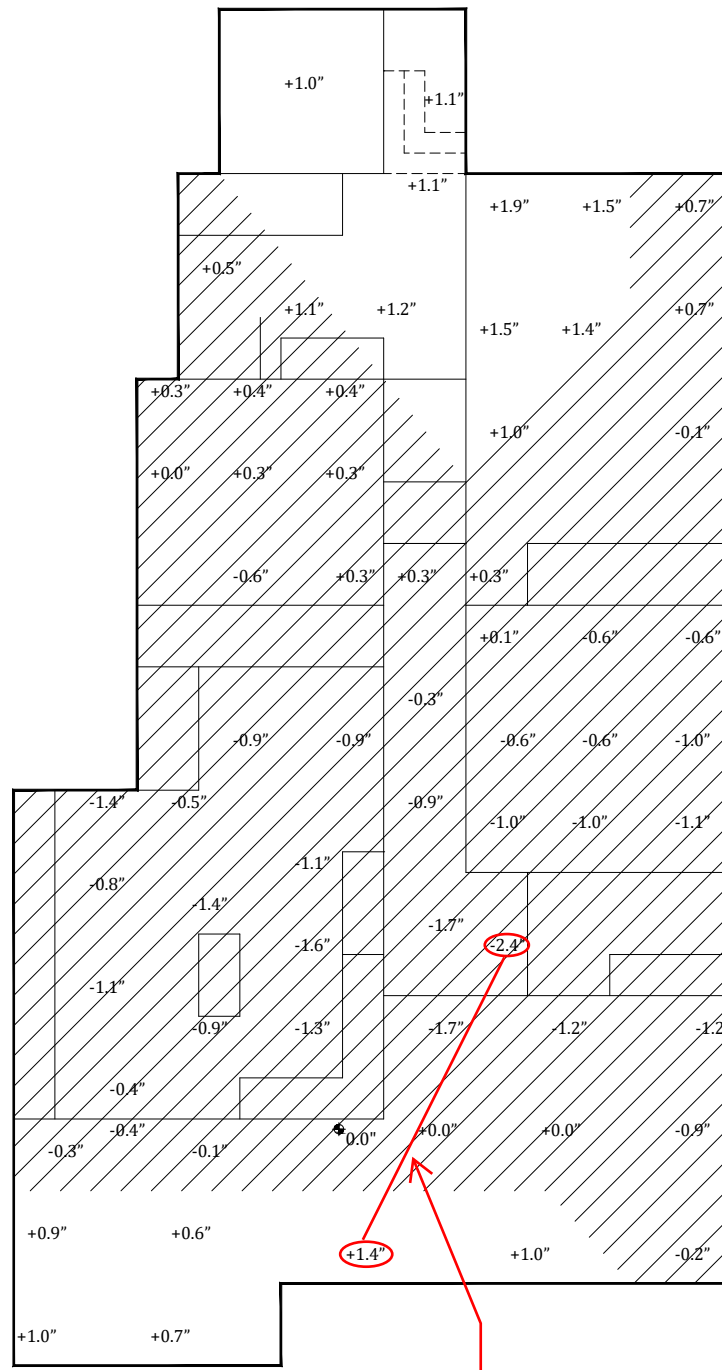
FIGURE 1

3.8" change in
elevation over 25'

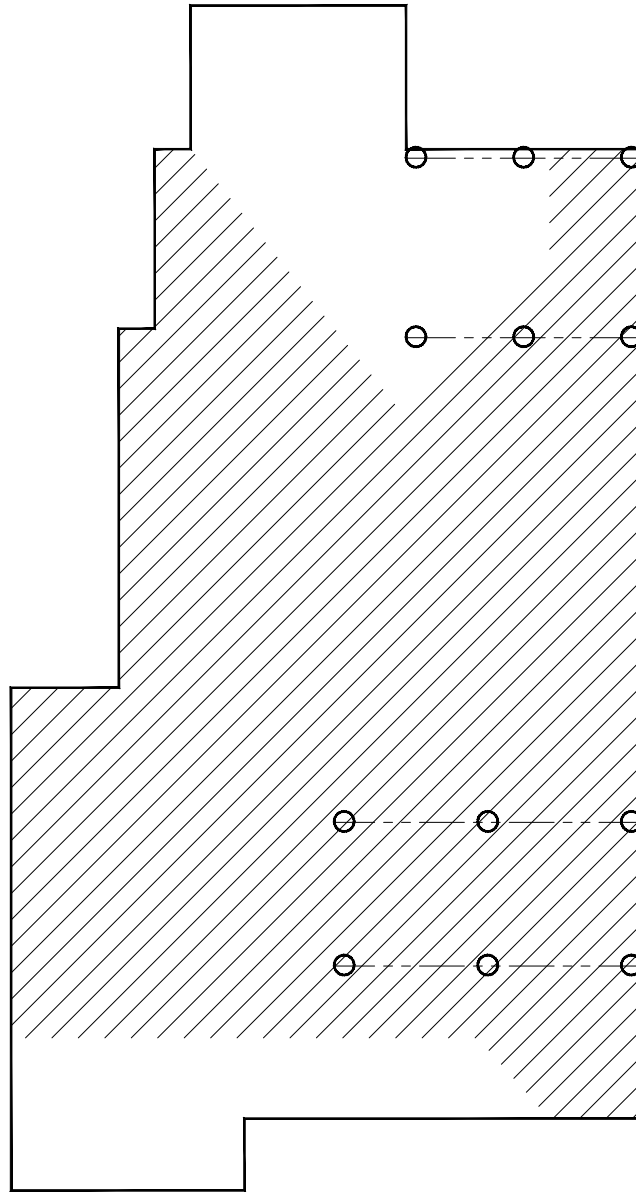
FIGURE 2

We were not able to access and visually assess the entirety of the crawlspace. See Figure 2 for the extents of the crawlspace we were able to access.

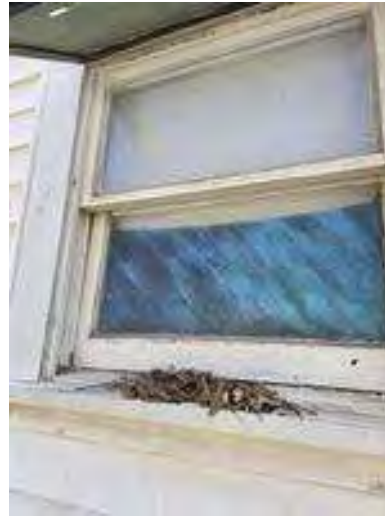
Location: Bathroom 1

- Needs new lower sash & glass
- Needs structural repair to frame
- Potential water intrusion issue
- Sill flashing needs replacement
- Screen inoperable

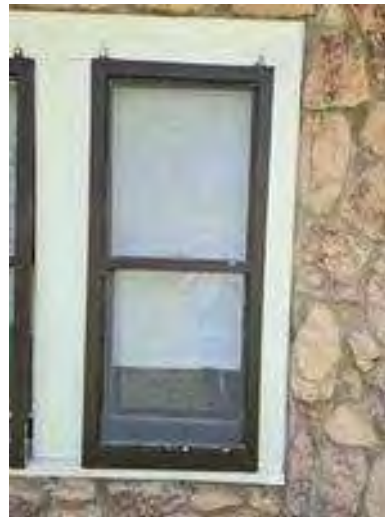
Location: **Living Room Window #1**

- Screen inoperable, damage to casing
- Window opening is skewed

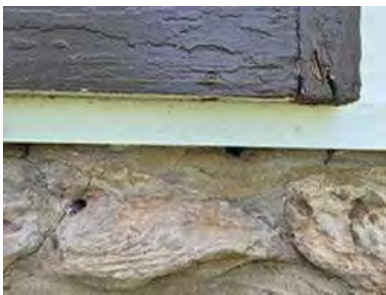
Location: **Living Room Window #2**

- Window Screen is cracked and has extensive cosmetic damage

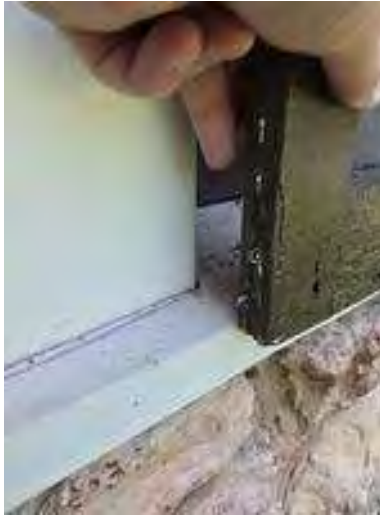
Location: **Living Room Window #2**

- Screen does not fit into window opening, rubs against sill flashing.
- Screen is blown around by wind
- Flashing has pulled back from window sill, creating a gap with moisture intrusion potential

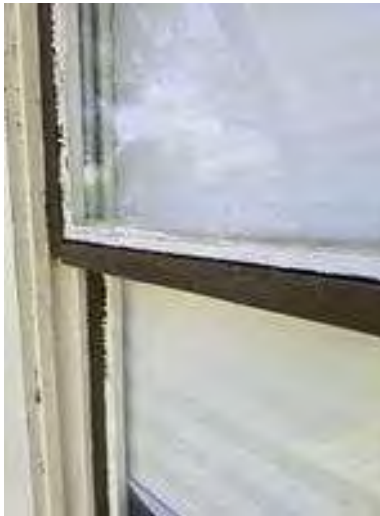
Location: **Dining Room Window #1**

- Top and bottom sashes do not align, large $\frac{1}{2}$ " gap allowing air transfer between inside & outside.
- Trim separating from window frame, moisture intrusion concern

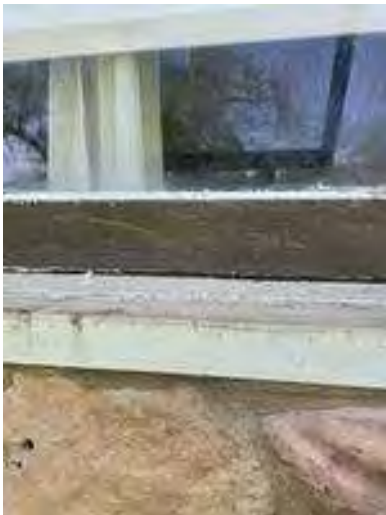
Location: **Living Room Window #2**

- Bottom sash does not meet up with sill
- Sill flashing has pulled away from frame, creates a moisture intrusion concern
- Punctures in sill flashing
- Some chipping of plaster @ joint w/ window frame

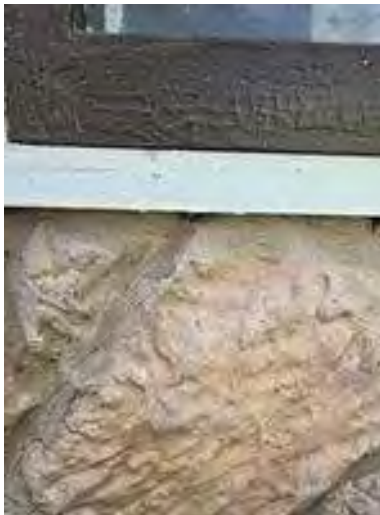
Location: **Living Room Window #2**

- Some chipping of plaster @ joint w/ window frame
- Damage to screen frame, poor appearance

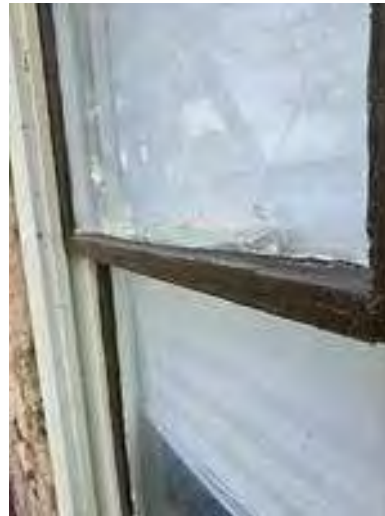
Location: **Living Room Window #3**

-Top sash is badly damaged and needs replacement
- Top and bottom sashes out of alignment, allows outside air into house.

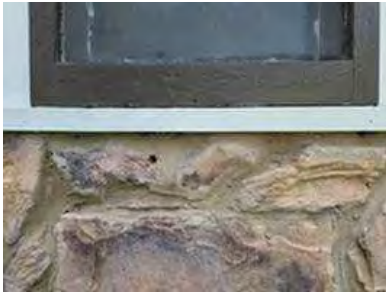
Location: **Living Room Window #3**

-Moisture intrusion concern at sill, flashing has pulled away from sill plate

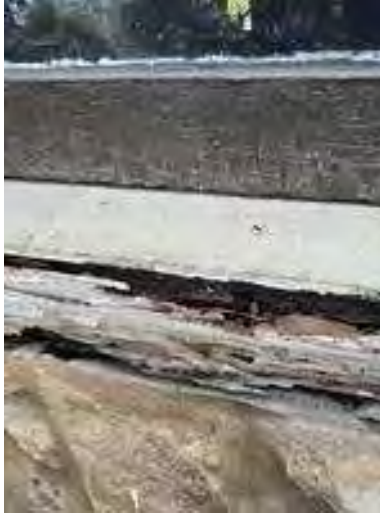
Location: **Dining Room Window #1**

- Close up of exposed rotting wood

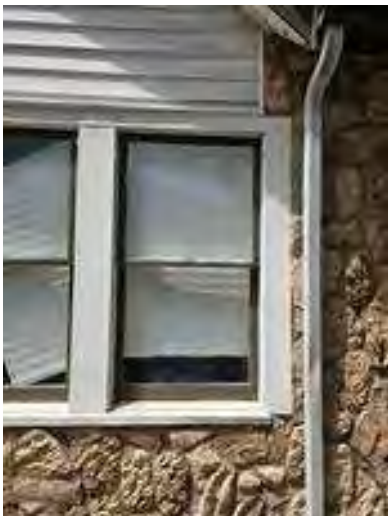
Location: **Dining Room Window #3**

- Top and bottom sash don't align, $\frac{1}{2}$ " gap allows for air exchange between interior and exterior.

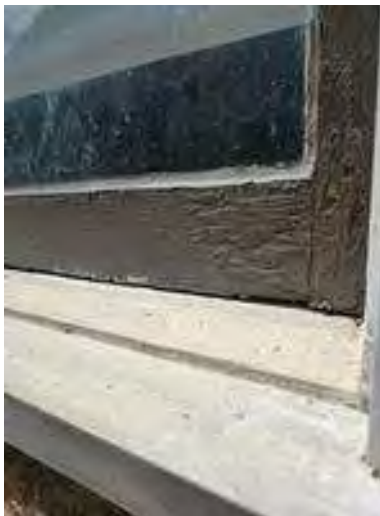
Location: **Dining Room Window #3**

- Gap between sill and bottom sash, $\frac{1}{4}$ " gap allows for air exchange between interior and exterior.

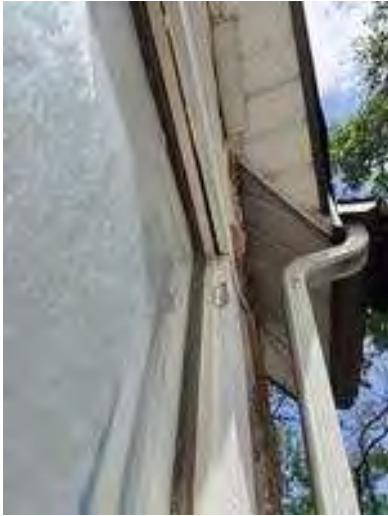
Location: **Dining Room Window #3**

-Trim has pulled away from frame, $\frac{3}{4}$ " gap allows
air exchange between interior and exterior
Moisture intrusion concerns

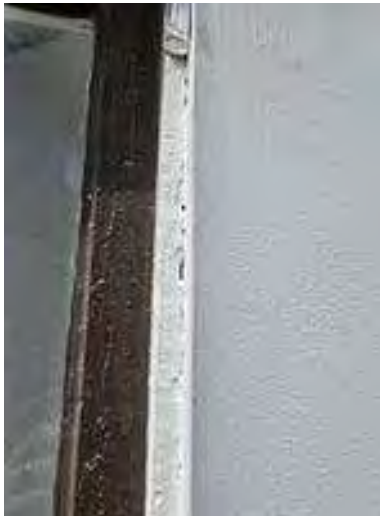
Location: **Dining Room Window #4**

-Pinholes creating a moisture intrusion concern

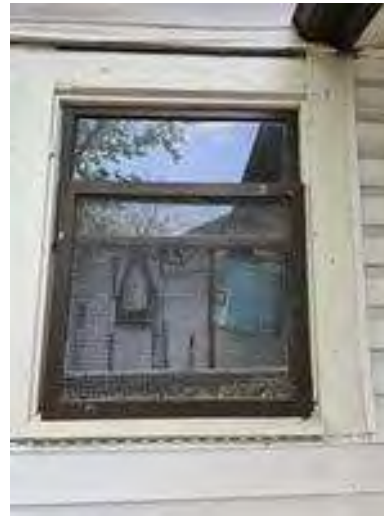
Location: **Kitchen Window #2**

- Screen does not match rest of house, screwed into frame, causing moisture intrusion concerns.
- Drip edge at top has large gap with frame, allowing air exchange between interior and exterior.

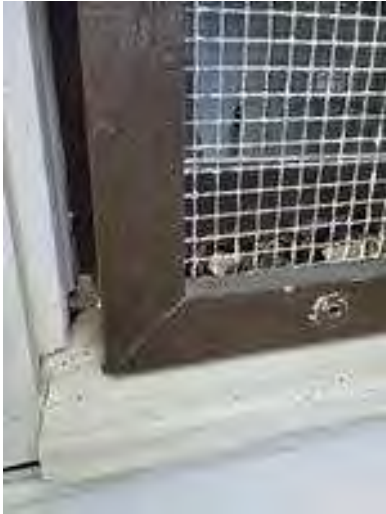
Location: **Kitchen Window #2**

-Screen frame is too tall and too narrow for window, allowing leaves and other debris to accumulate

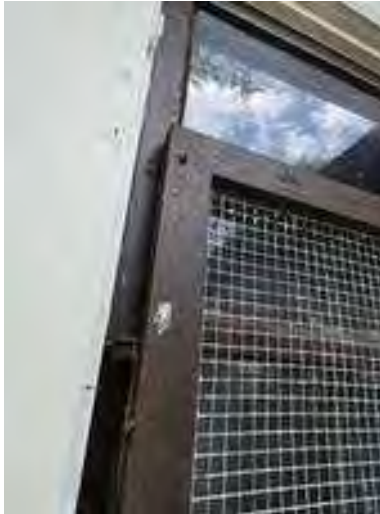
Location: **Kitchen Window #2**

-Screen frame screwed into window frame.
-Moisture intrusion concerns

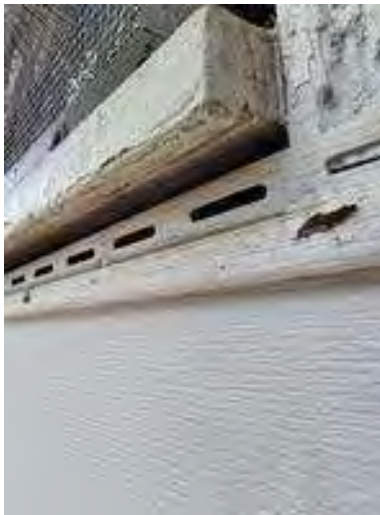
Location: **Kitchen Window #2**

-Unsealed gap between underside of sill and end of jamb. Water intrusion concern

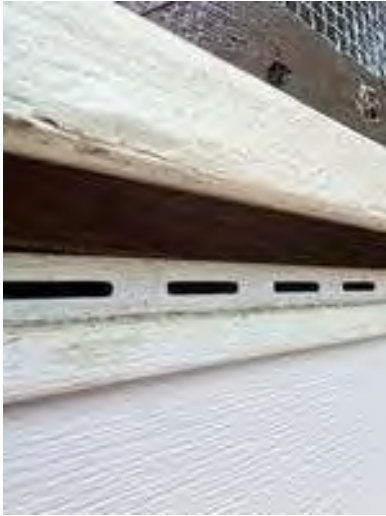
Location: **Kitchen Window #2**

-Unsealed gap between underside of sill and end of jamb. Water intrusion concern

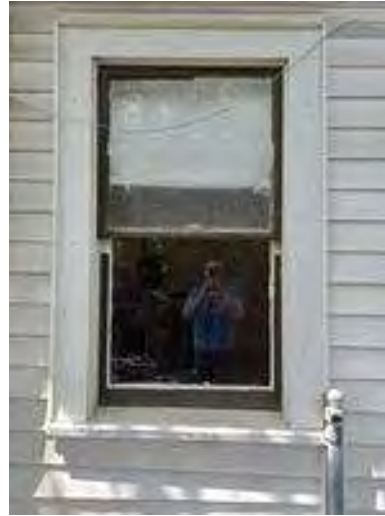
Location: **Guest Room Window #1**

-Gaps allow air exchange between interior & exterior
-Bottom sash is taller than top, window does not fully seal.

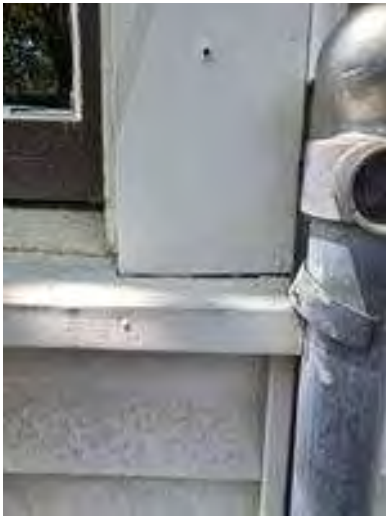
Location: **Guest Room Window #1**

-Unsealed gap between trim and sill plate
Moisture intrusion concern

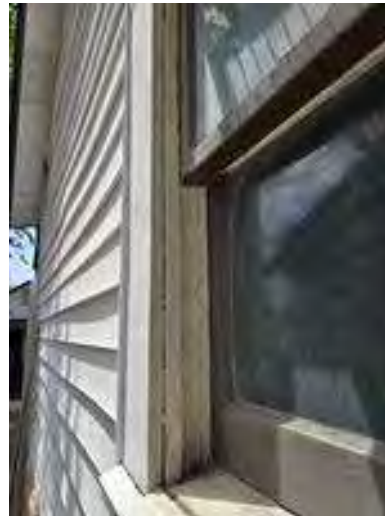
Location: **Guest Room Window #1**

-Trim has pulled away from frame, 1/4" creates moisture intrusion concern

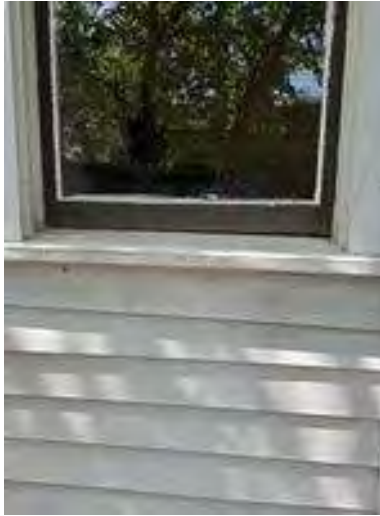
Location: **Guest Room Window #1**

Notes:

-Right corner of window has a 1/2" gap, but is flush on left side.
-Frame appears warped, needs to be leveled.

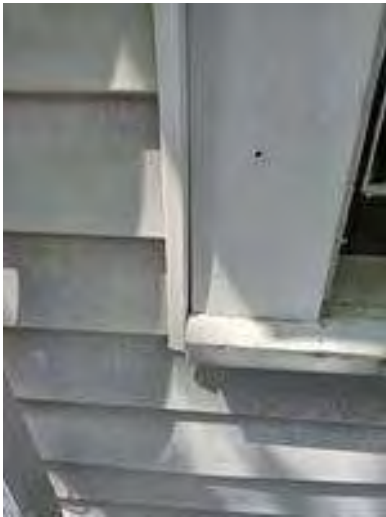
Location: **Guest Room Window #1**

Notes:

-Unsealed gap between window trim and siding moulding. Moisture intrusion concern

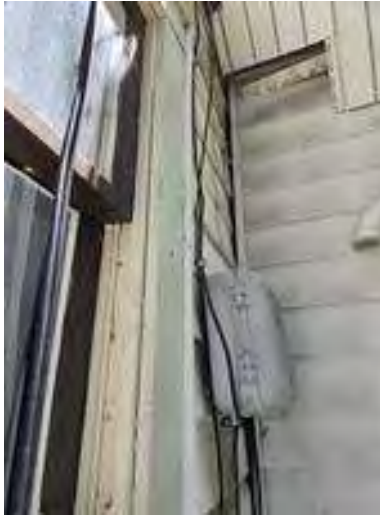
Location: **Master Bedroom Window #1**

Notes:

-Sash rails are damaged
-Siding pulling away from trim, moisture intrusion concerns.
-Nearby penetrations through wall may have compromised window frame

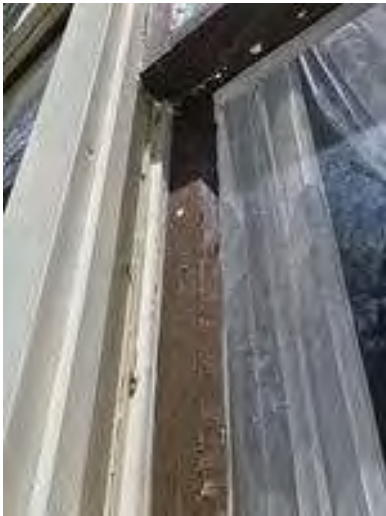
Location: **Master Bedroom Window #1**

Notes:

-Top and bottom sashes are not aligned, allowing air exchange between interior and exterior.

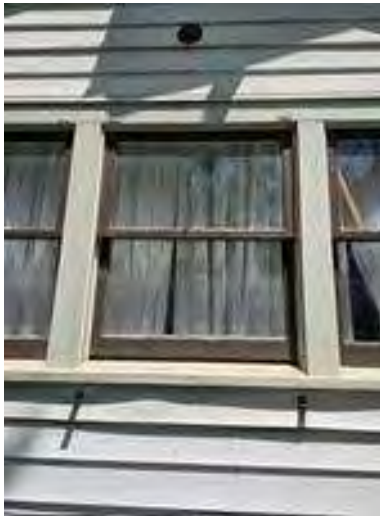
Location: **Master Bedroom Window #2**

Notes:

-No screen
-Weathered exposed wood

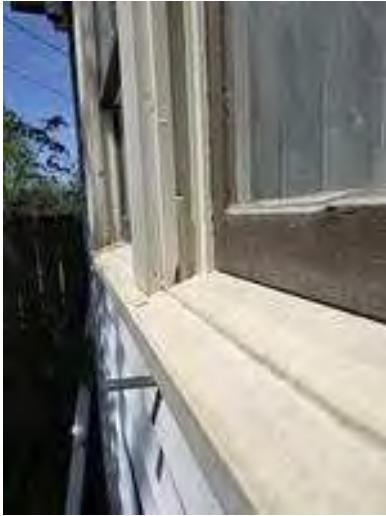
Location: **Master Bedroom Window #2**

Notes:

- Gap between trim and frame creates moisture intrusion concern.
- Sash has 1/4" gap with sill, creates air exchange between interior and exterior

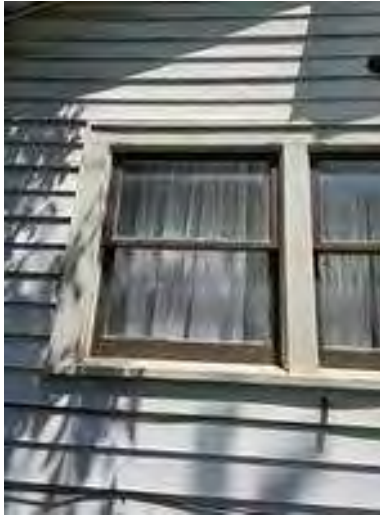
Location: **Master Bedroom Window #3**

Notes:

- No screen
- Weathered exposed wood

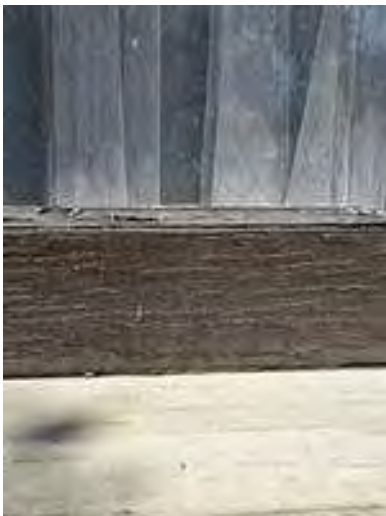
Location: **Master Bedroom Window #3**

Notes:

- 1/4" gap between sill and sash creates air exchange between interior and exterior.
- Sash is weathered and appears to be rotting underneath paint.

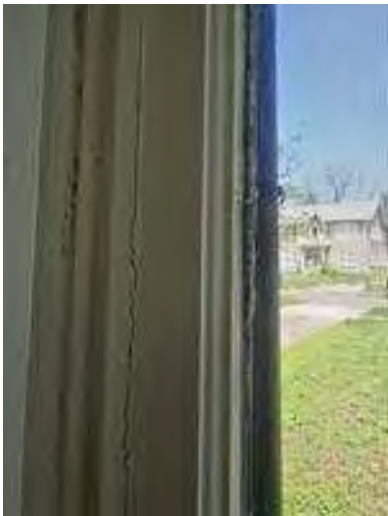
Location: **Living room, all non-operational windows**

Notes:

- Frame separation

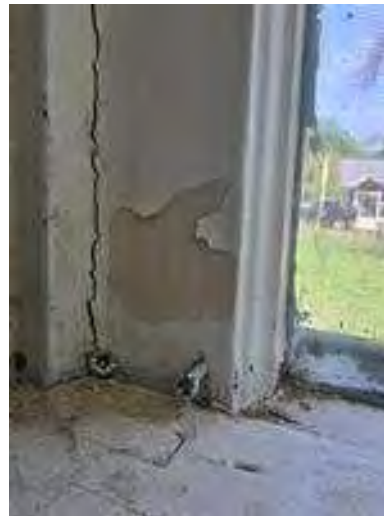
Location: **Living Room**

Notes:

- Frame damage by previous owner;
- frame separation
- Stool damage

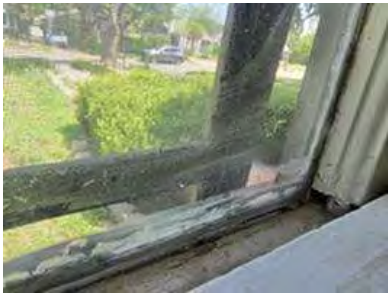
Location: **Living Room**

Notes:

- Fully separated glass from frame, rotted and water damaged frame
- severely out of alignment

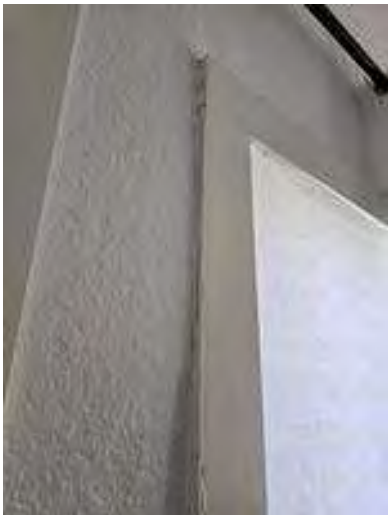
Location: **Living Room**

Notes:

- Separation of window frame and drywall
- Evidence of poor foundation
- Mismatched trim

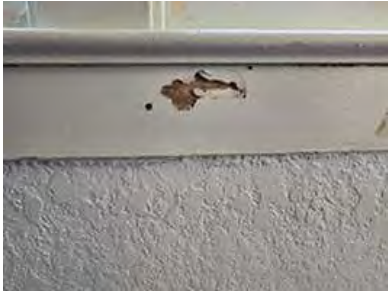
Location: **Living Room**

Notes:

- Wood rot
- Miss matched apron

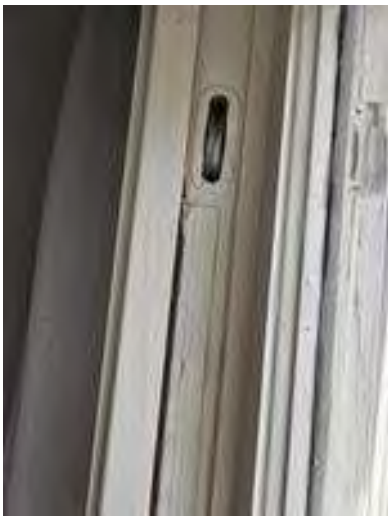
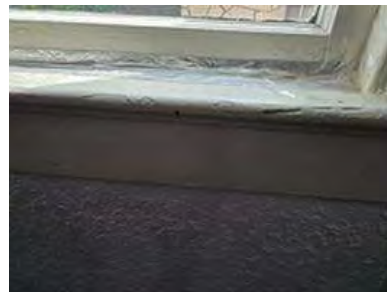
Location: **Dining room**

Notes:

- Stool and apron damage
- Miss matched apron

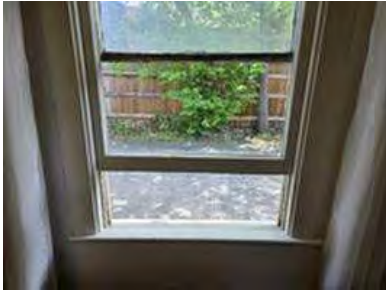
Location: **Bedroom 2**
Notes: Rotting frame, missing apron

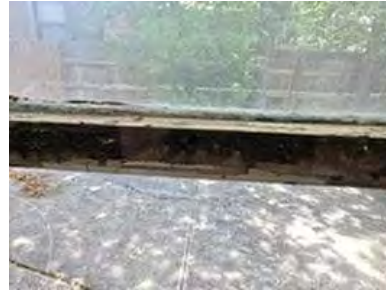
Location: **Bedroom 2**
Notes: water damage, wood rot

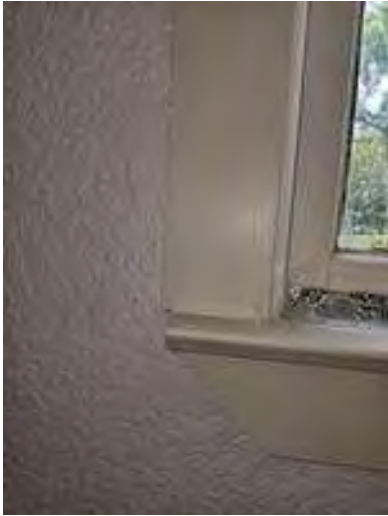
Location: **Bedroom 1**

Notes:

-Miss matched apron, sill, and frame

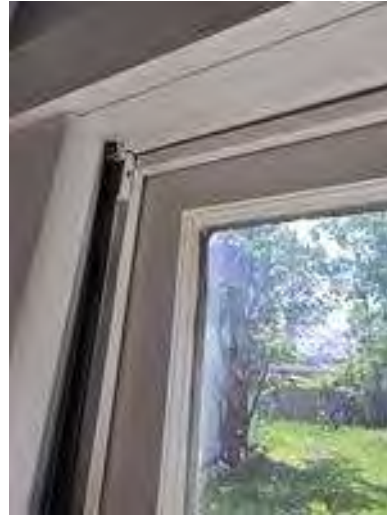
Location: **Bedroom 1**

Notes:

-Broken sash cover and cord

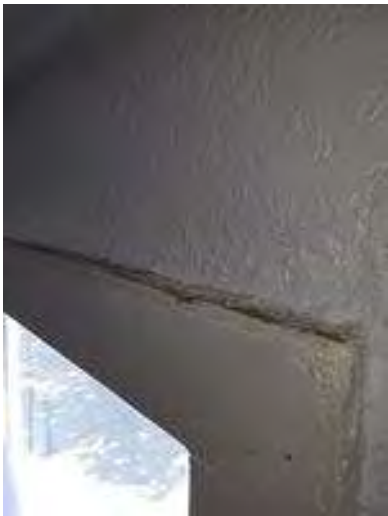
Location: **Living room, Dining room**

Notes:

- Damage to trim

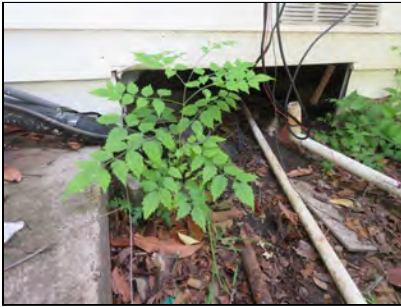
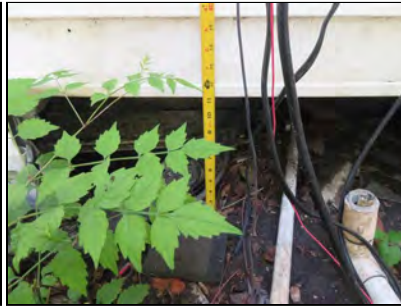
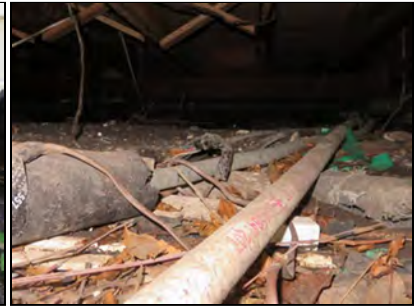
☒ In regards to inspector's safety, due to building materials in the way, height limitations of the opening (only twelve inches), and loose/hanging electrical wiring, the crawl space was not accessed.

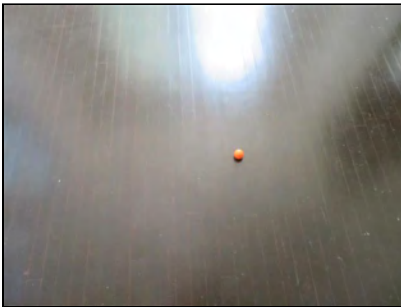
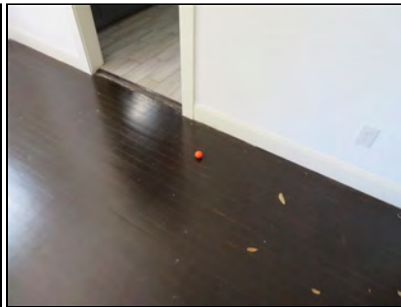
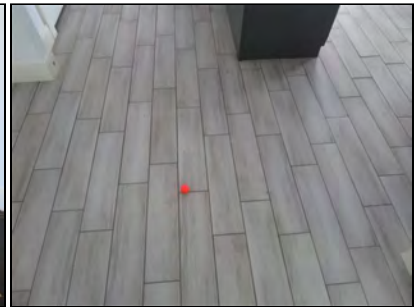
☒ Using a golf ball to demonstrate, observed uneven/sloping floors in multiple areas of the home. This condition is indicative of foundation movement.

☒ Due to the issues with the home's foundation, recommend consulting with a structural engineer prior to closing.

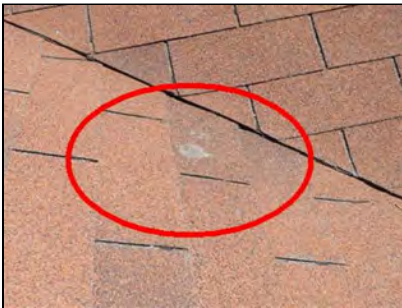
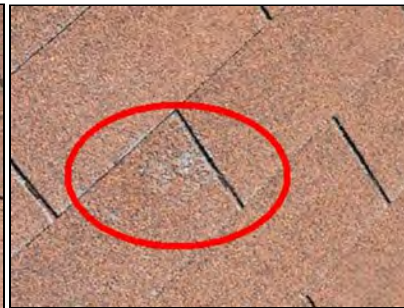
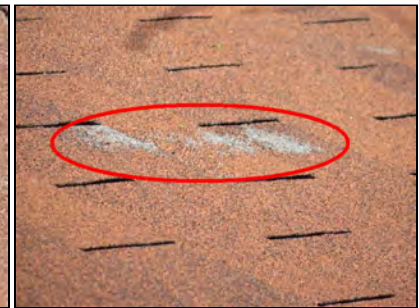
☒ Observed damaged shingles in multiple areas of the roof. The asphalt granules are missing, exposing the fiberglass underlayment of the shingles.

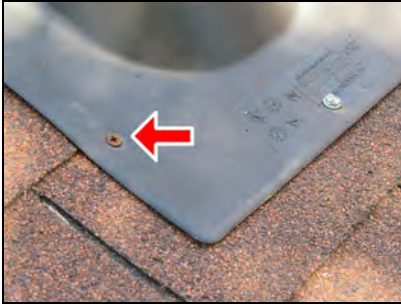
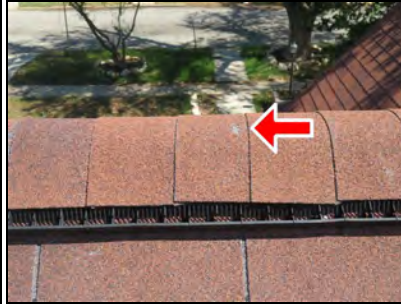
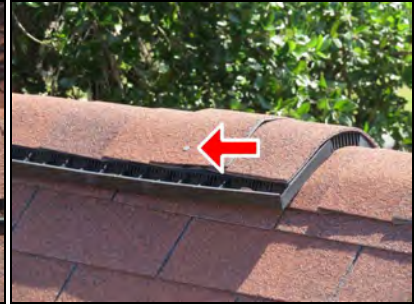
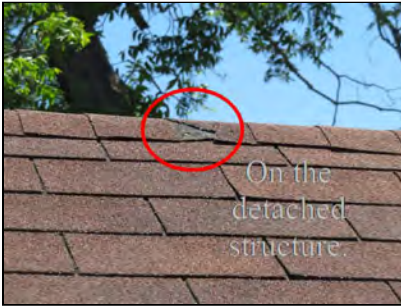
☒ Observed signs of possible previous repair to the home's roof. Note the differing colors of shingles in the photograph. Recommend consulting with seller regarding history, issues, etc. prior to closing.

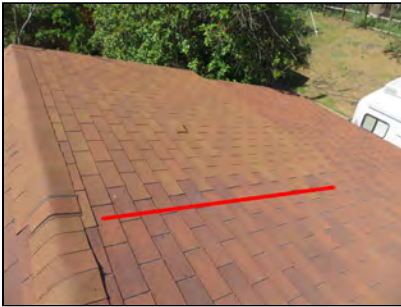
☒ Shingle up-lift and buckling were also observed.

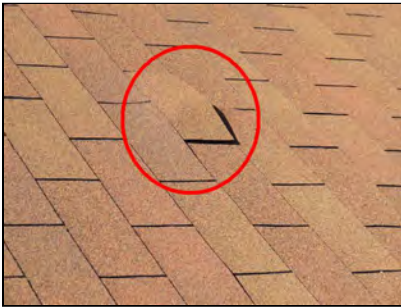
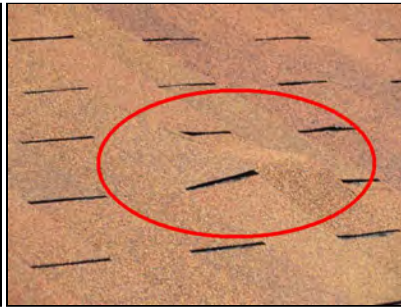
☒ Observed deflection in the home's roof. The origins or significance of the condition could not be determined at the time of the inspection.

☒ Recommend seeking multiple bids from reputable and qualified roofing contractors for repairs to the home's roof.

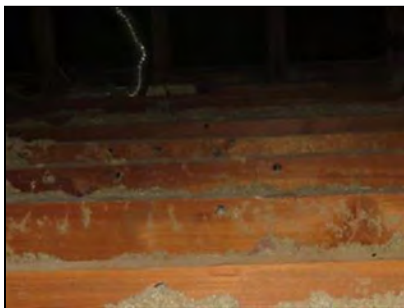
☒ The attic's insulation is not up to industry standards of ten to fourteen inches. Recommend adding insulation, as desired, to assist with energy efficiency.

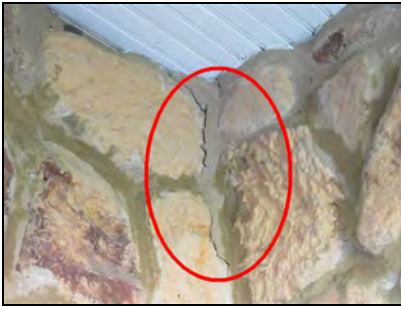
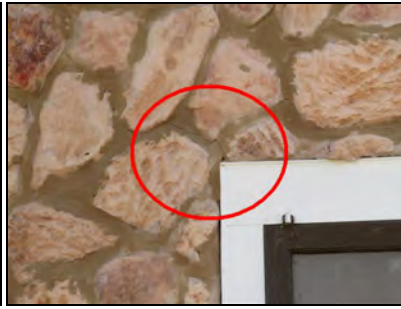
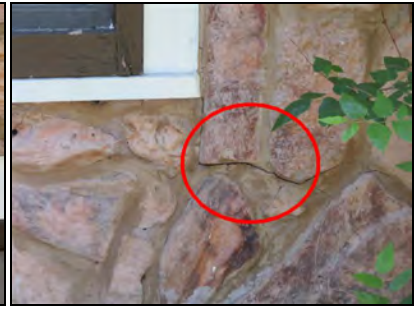
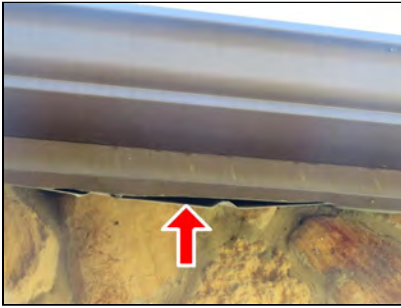
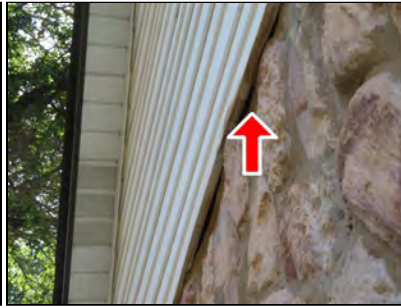
Comments:
☒ Observed cracks in the home's stone/brick veneer consistent with settling/expansion-contraction of building materials. Recommend filling with a weather-proof sealant/caulk to prevent water/insect intrusion into the wall space.

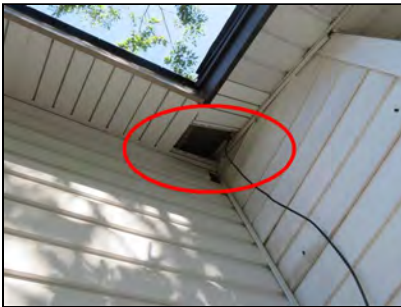
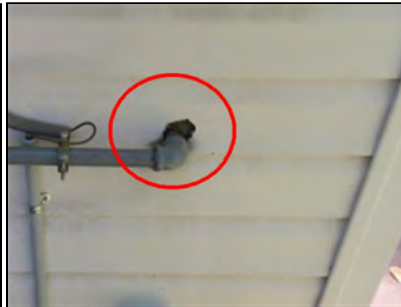
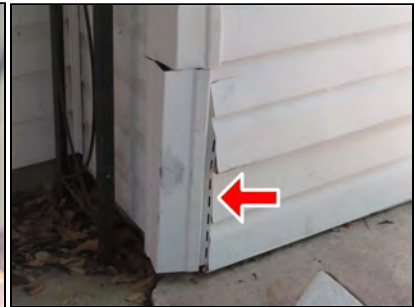
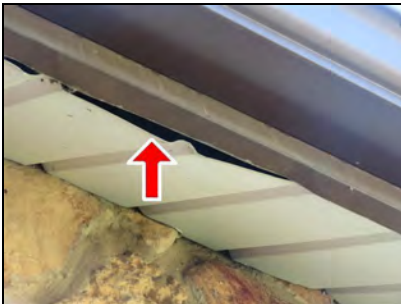
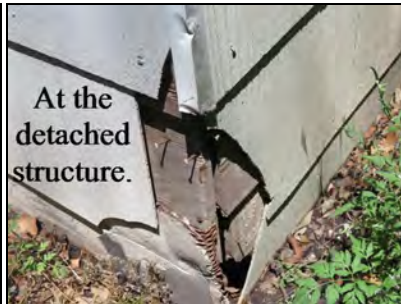
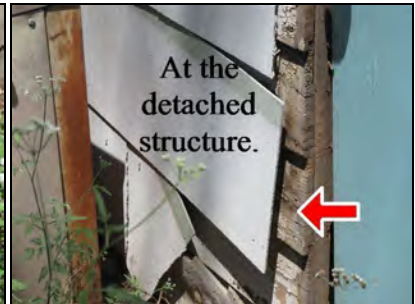
☒ Noted damaged/missing siding (gaps, penetrations, or fastenings) in multiple locations. Recommend repairs to prevent water/insect/rodent entering the wall space.

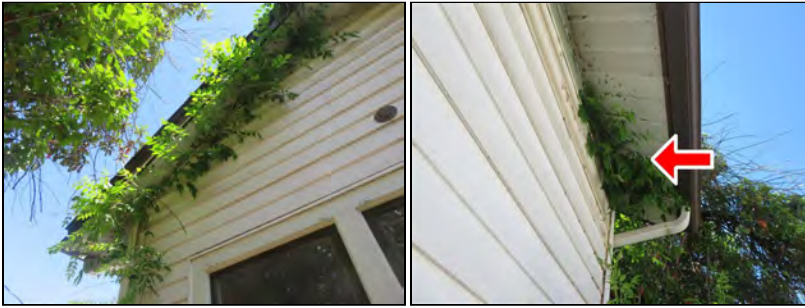
Recommend removing foliage at least three feet away from the home's siding to deter insect/moisture entering the home.

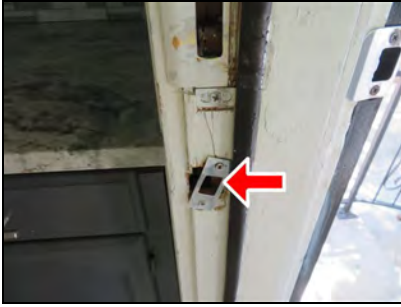
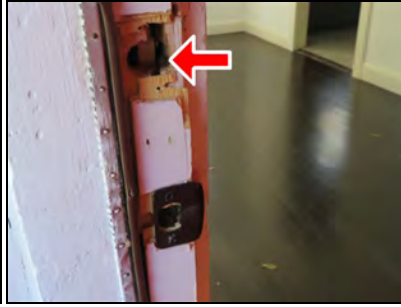
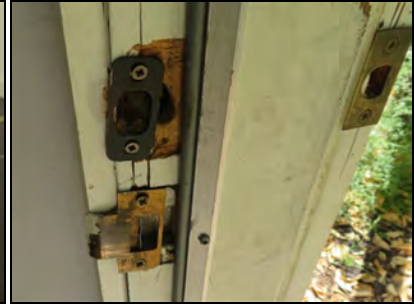
Many of the home's doors' jambs/hardware had been altered. Recommend repairs as desired.

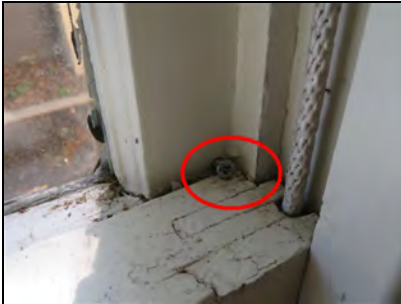
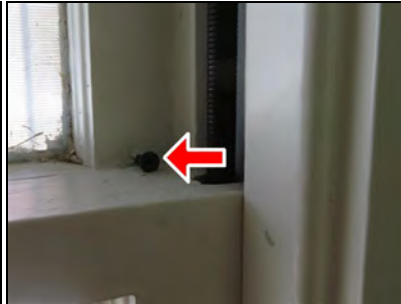
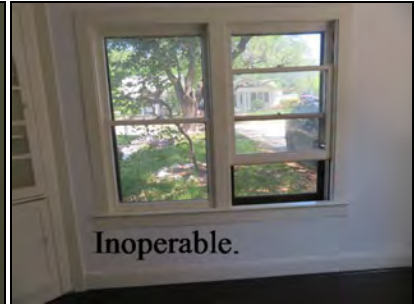
☒ Many of the home's windows were inoperable, either stuck/painted shut or closed with fasteners. Recommend a general contractor for repairs as windows are points of emergency egress and should be operable.
