HISTORIC AND DESIGN REVIEW COMMISSION

August 07, 2024

HDRC CASE NO: 2024-229
ADDRESS: 1514 W LYNWOOD
LEGAL DESCRIPTION: NCB 2759 BLK 65 LOT 11
ZONING: R-4, H
CITY COUNCIL DIST.: 1
DISTRICT: Keystone Park Historic District
APPLICANT: ELENA ANGELES SANCHEZ/MOVEHOUSE INVESTMENT CORP
OWNER: ELENA ANGELES SANCHEZ/MOVEHOUSE INVESTMENT CORP
TYPE OF WORK: Demolition of a historic landmark (accessory) and front porch column modifications
APPLICATION RECEIVED: May 30, 2024
60-DAY REVIEW: September 27, 2024
CASE MANAGER: Rachel Rettaliata

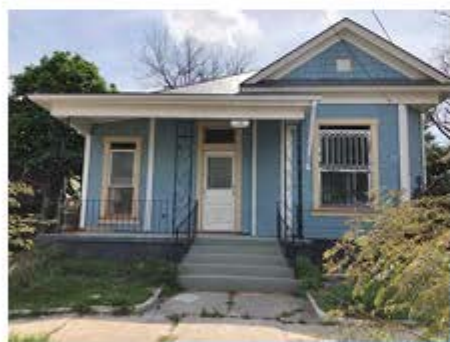
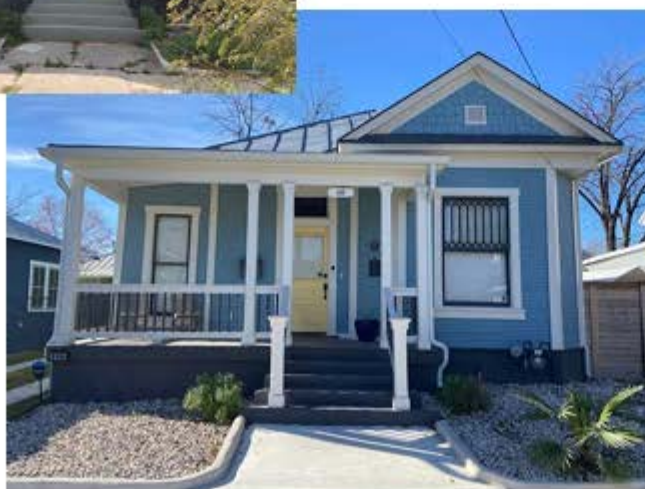
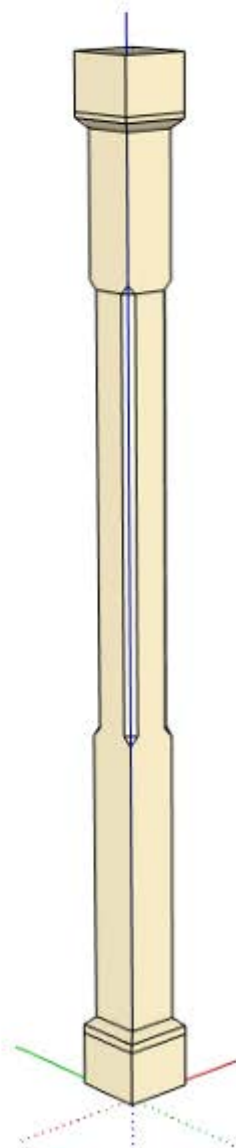
Pictured above: non-original metal posts replaced with wood columns meeting specifications

1. Feature capital and base trim
2. Be no more than six inches square (rounded columns may be more appropriate for colonial revival or classical homes)
3. If square, feature chamfered corners as shown
4. Replicate the appearance of any existing columns or pilasters (if present)
