# HISTORIC AND DESIGN REVIEW COMMISSION

June 21, 2024

**HDRC CASE NO:** 2024-188  
**ADDRESS:** 509 NOLAN ST  
**LEGAL DESCRIPTION:** NCB 546 BLK 19 LOT W 51.08 FT OF 12  
**ZONING:** R-6, H  
**CITY COUNCIL DIST.:** 2  
**DISTRICT:** Dignowity Hill Historic District  
**APPLICANT:** john moreno/jeveconst  
**OWNER:** Mary Martin/JEVE CONSTRUCTION LLC  
**TYPE OF WORK:** Front porch column replacement, fenestration modifications  
**APPLICATION RECEIVED:** May 13, 2024  
**60-DAY REVIEW:** July 12, 2024  
**CASE MANAGER:** Edward Hall

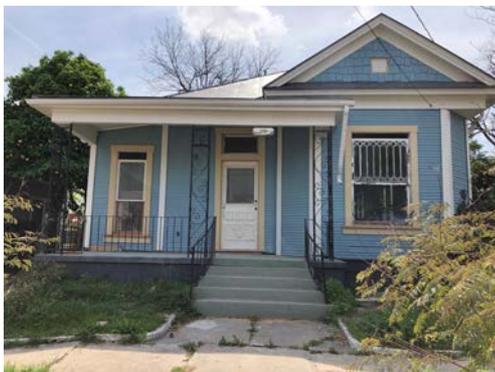
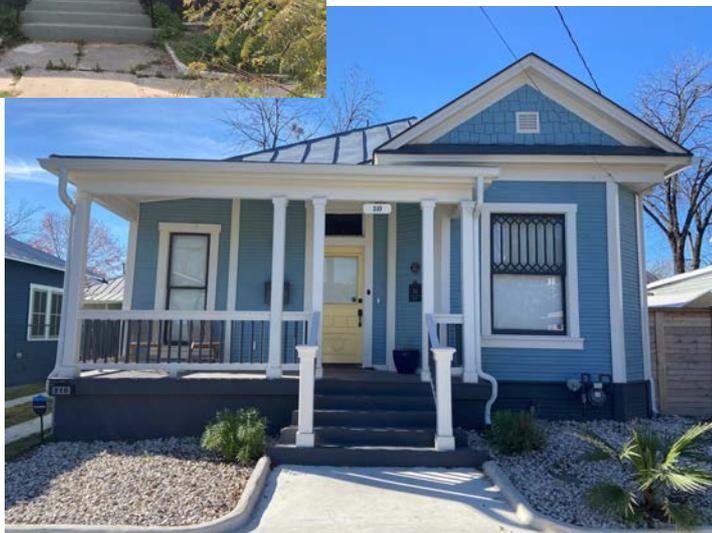
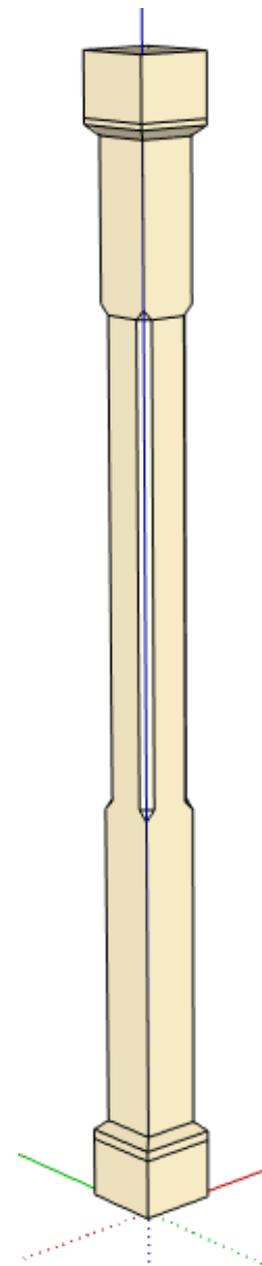
*Pictured above: non-original metal posts replaced with wood columns meeting specifications*

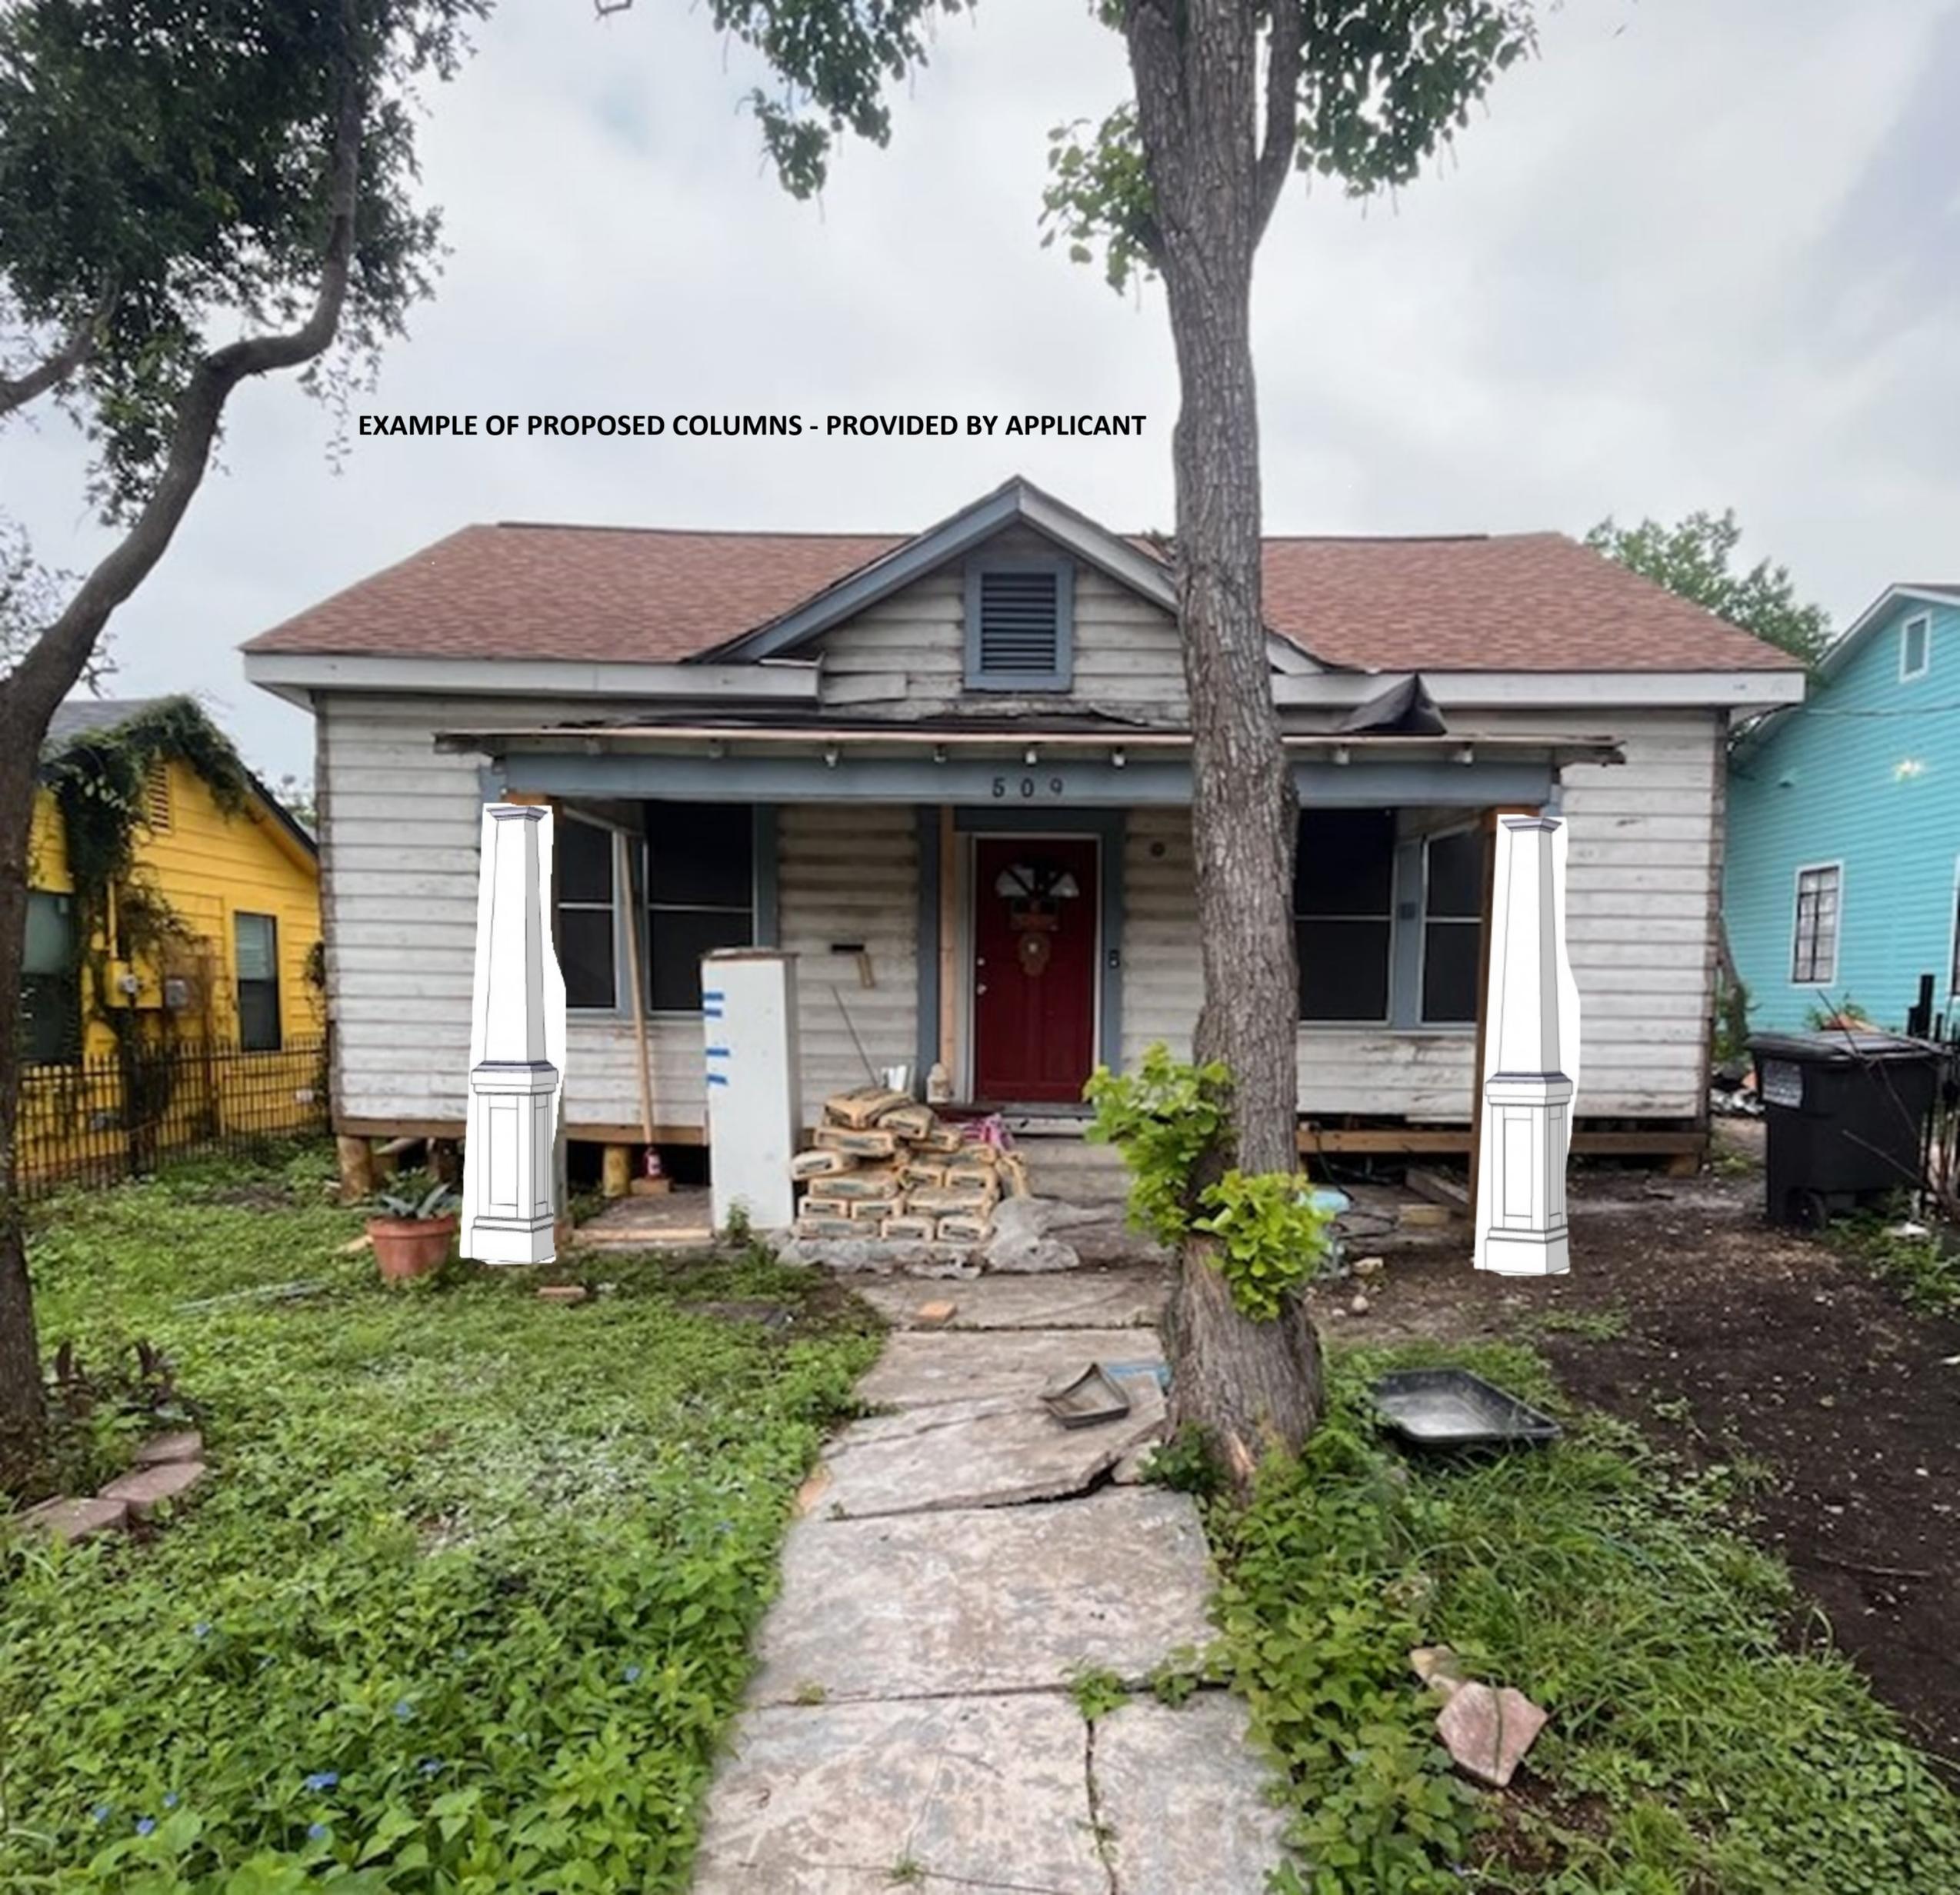
**EXAMPLE OF PROPOSED COLUMNS - PROVIDED BY APPLICANT**

1. Staff does not recommend approval of item #1, column replacement, as proposed, based on finding e. Staff recommend the applicant follow the column specifications outlined in the adopted Policy Guide for Porches and Reconstruction should be followed; columns should feature capital and base trim and should reference the existing columns regarding profile and appearance. While the current columns are not original (the entire porch is not original), staff finds them to be generally architecturally appropriate for the structure. Staff recommends the applicant install columns to match the existing.

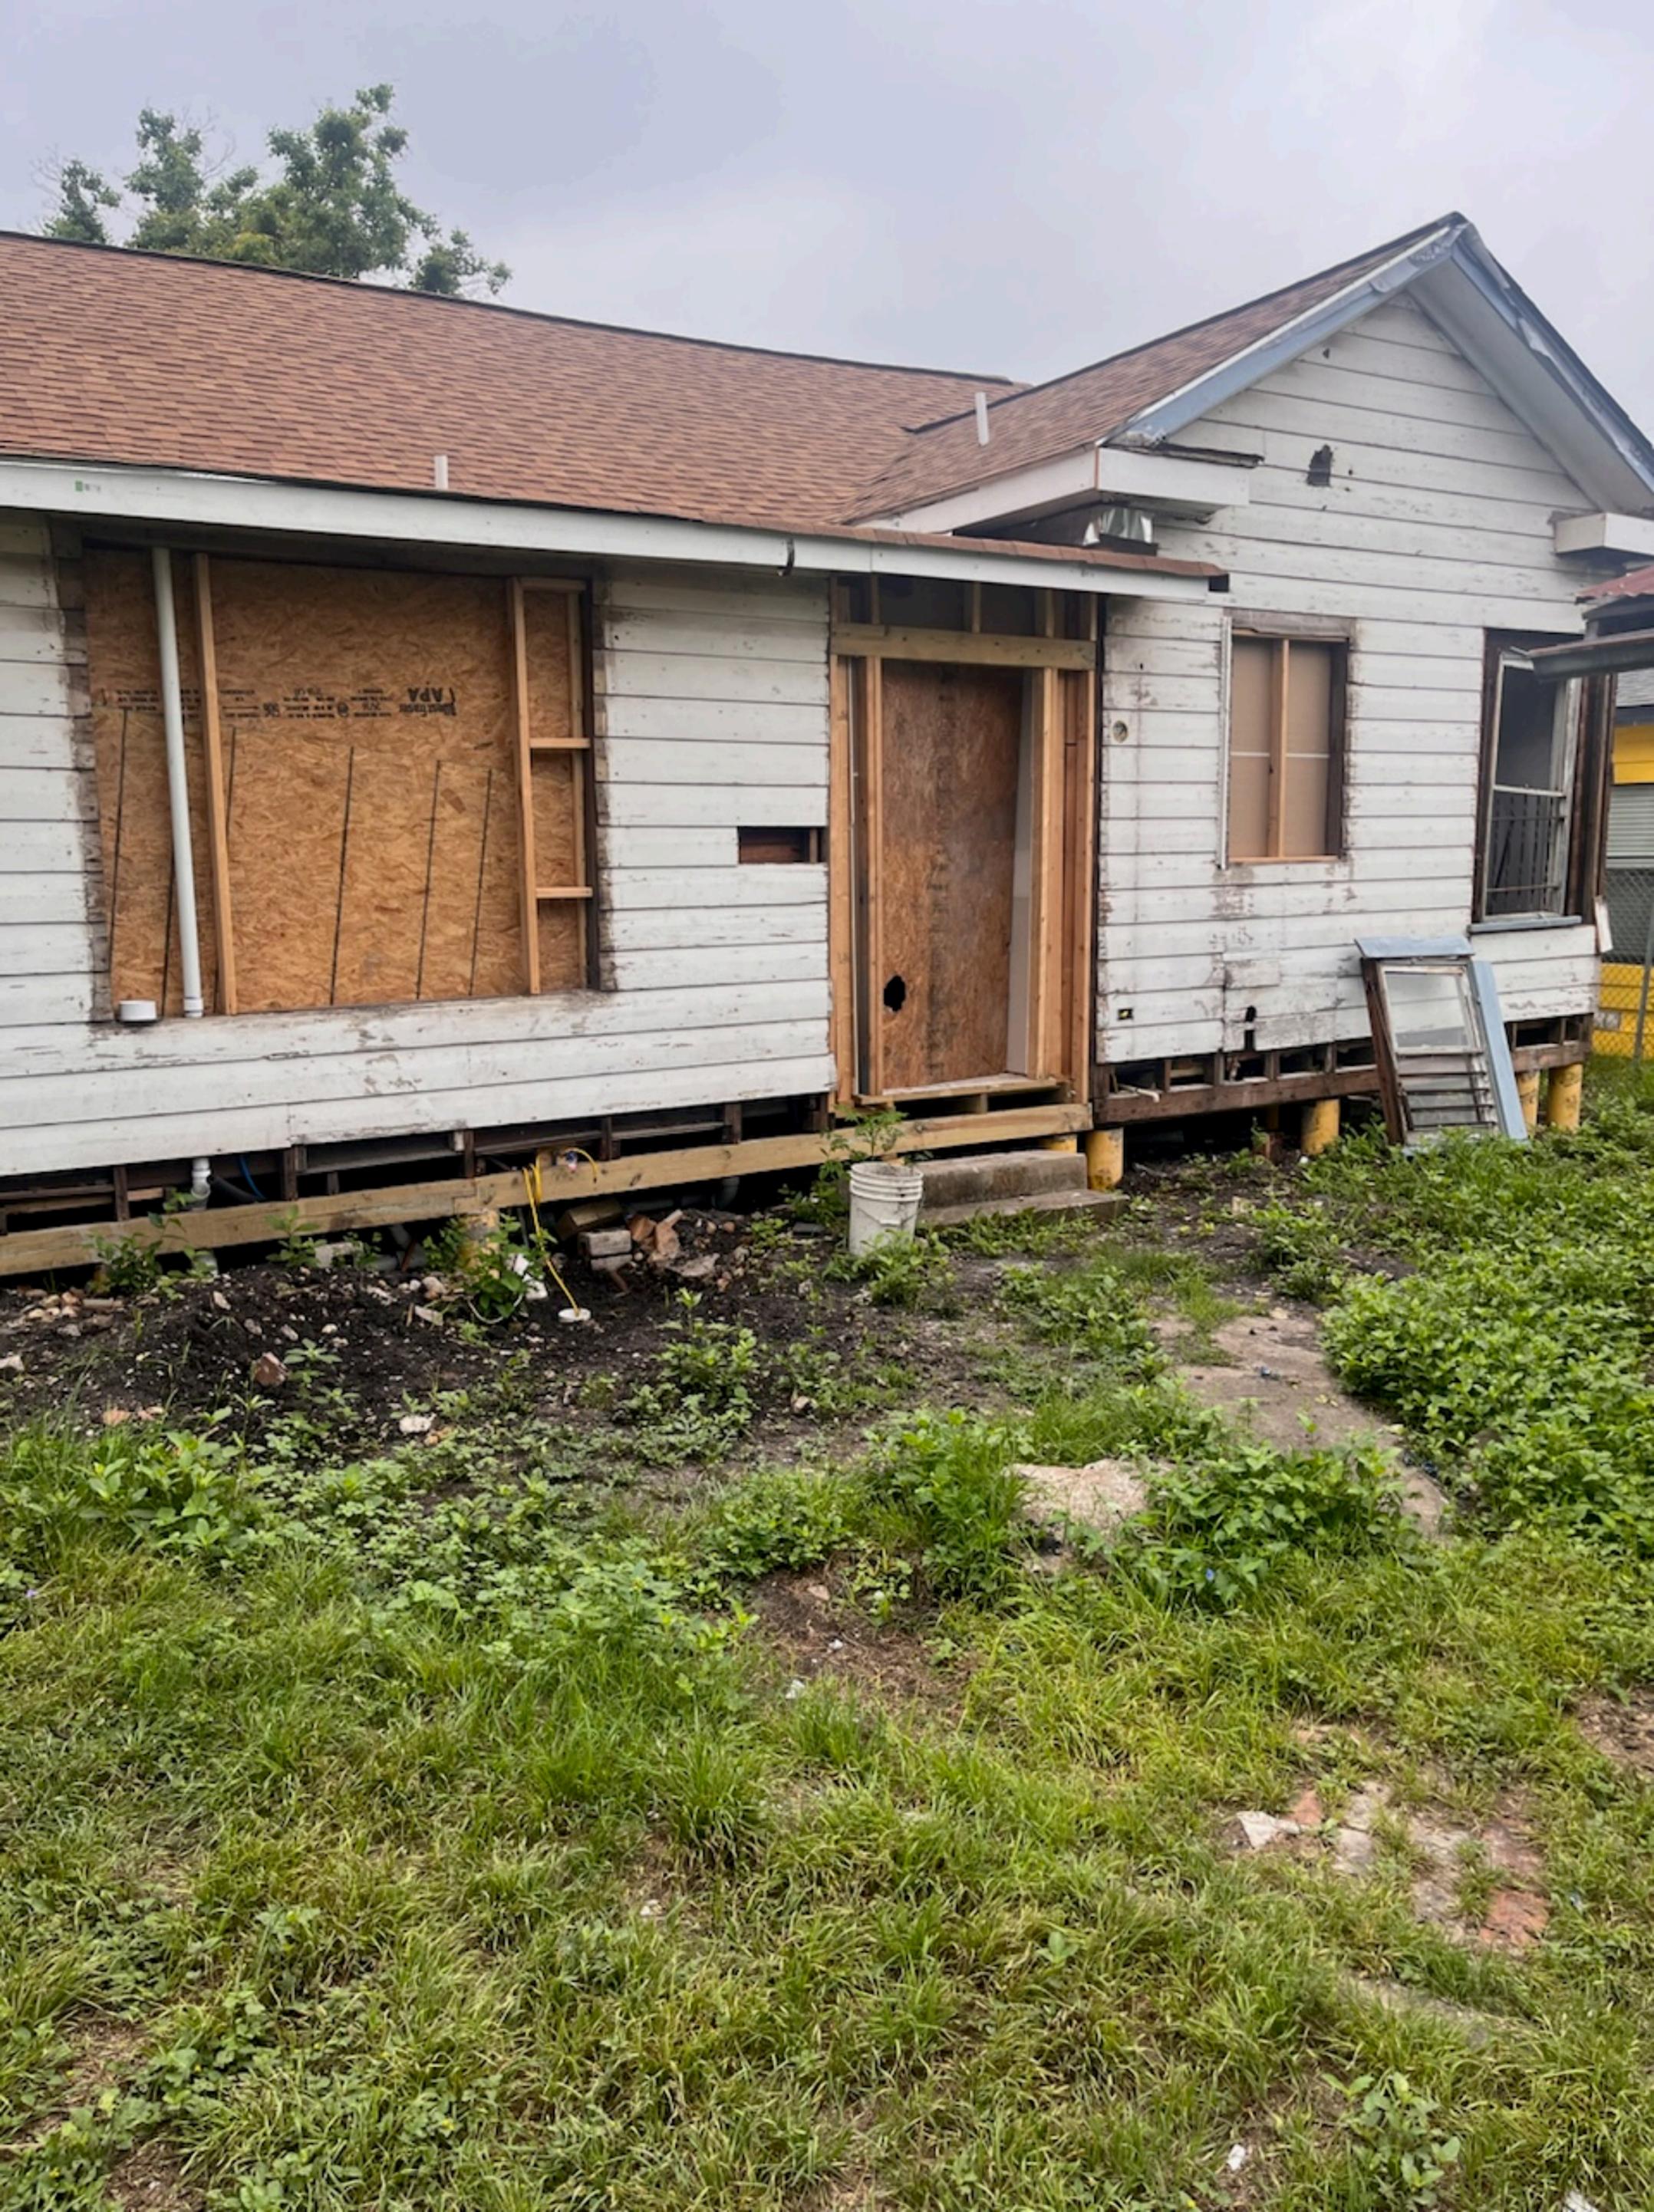
PHOTO OF REAR FACADE PRIOR TO WORK

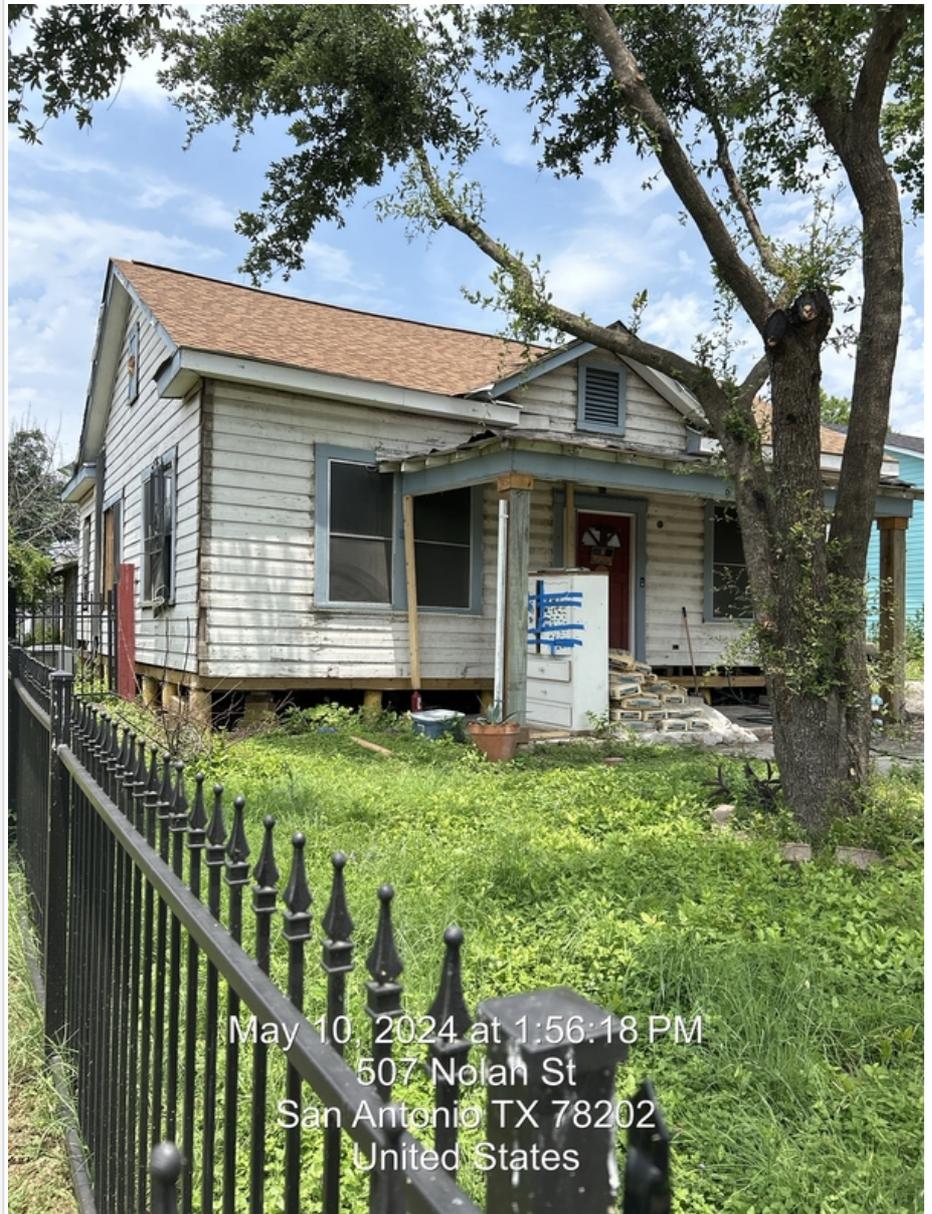
## Investigation Report

Date	05/10/2024
Time	02:01 PM (-5 GMT)
Context	citizen report, drive-by
Present Staff	Claudia Espinosa
Present Individuals	None
Contractor/Realtor Companies	JEVE CONSTRUCTION LLC
Types of Work Observed	Exterior Maintenance and Alterations
Amount of Work Completed	Initiated
Description of work	Window removal on East and west facades.
Description of interaction	Staff received a report of window removal on the east side of the property. Staff observed window removal on the rear of the east and west facades. No one was on site to discuss the reported violations or COA process. Staff left a SWO on the mailbox.

Violation Type	No Certificate of Appropriateness (Code 35-451a)
OHP Action	Posted additional "Stop Work Notice"
Will post-work application fee apply?	To be determined
