**HISTORIC AND DESIGN REVIEW COMMISSION
COMPLIANCE AND TECHNICAL ADVISORY BOARD**

June 20, 2025

HDRC CASE NO:	2025-134
ADDRESS:	617 E GUENTHER ST
LEGAL DESCRIPTION:	NCB 940 BLK 3 LOT 7&8
ZONING:	RM-4, H
CITY COUNCIL DIST.:	1
DISTRICT:	King William Historic District
APPLICANT:	Jorgeluis Espinoza/Blue Hammer Construction LLC
OWNER:	EM INVESTMENT GROUP LLC & THREE OAKS REALTY LLC
TYPE OF WORK:	Wood window replacement
APPLICATION RECEIVED:	May 08, 2025
60-DAY REVIEW:	July 07, 2025
CASE MANAGER:	Bryan Morales

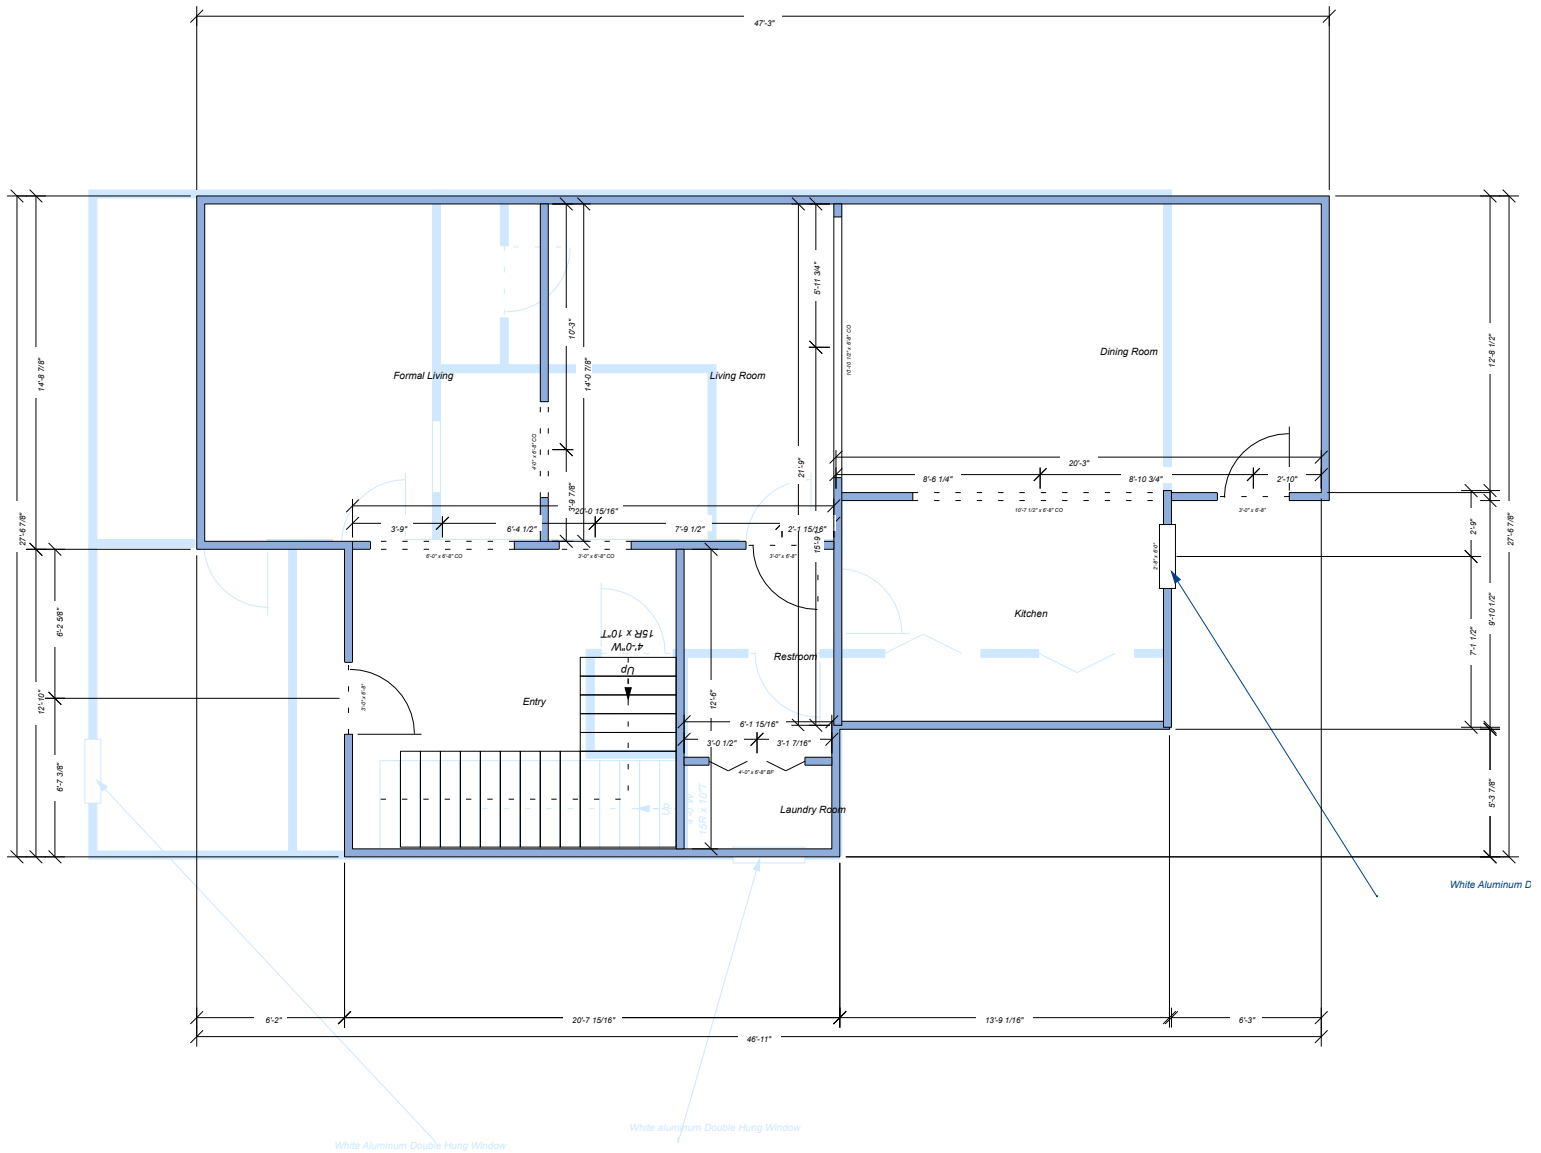
617 E Guenther 1st Level

- b. WINDOW REPLACEMENT: EXISTING CONDITION – Staff conducted a site visit on June 12, 2025, to assess the existing window condition and found that the first-floor's two-over-two wood window proposed for replacement is a good candidate for in-kind repair. The two one-over-one wood windows located on the second floor are missing their bottom halves and are eligible for replacement with an in-kind window product meeting staff's standard stipulation. Staff does not recommend replacement of the first-floor window. Staff may administratively approve replacement of the two one-over-one wood windows on the second floor provided the applicant replaces the

Staff does not recommend approval of the request, based on the findings. Staff recommends the applicant repair the first-floor wood window in-kind and replace the two one-over-one wood windows on the second floor with a salvaged wood window or a new fully wood window conforming to Guidelines.

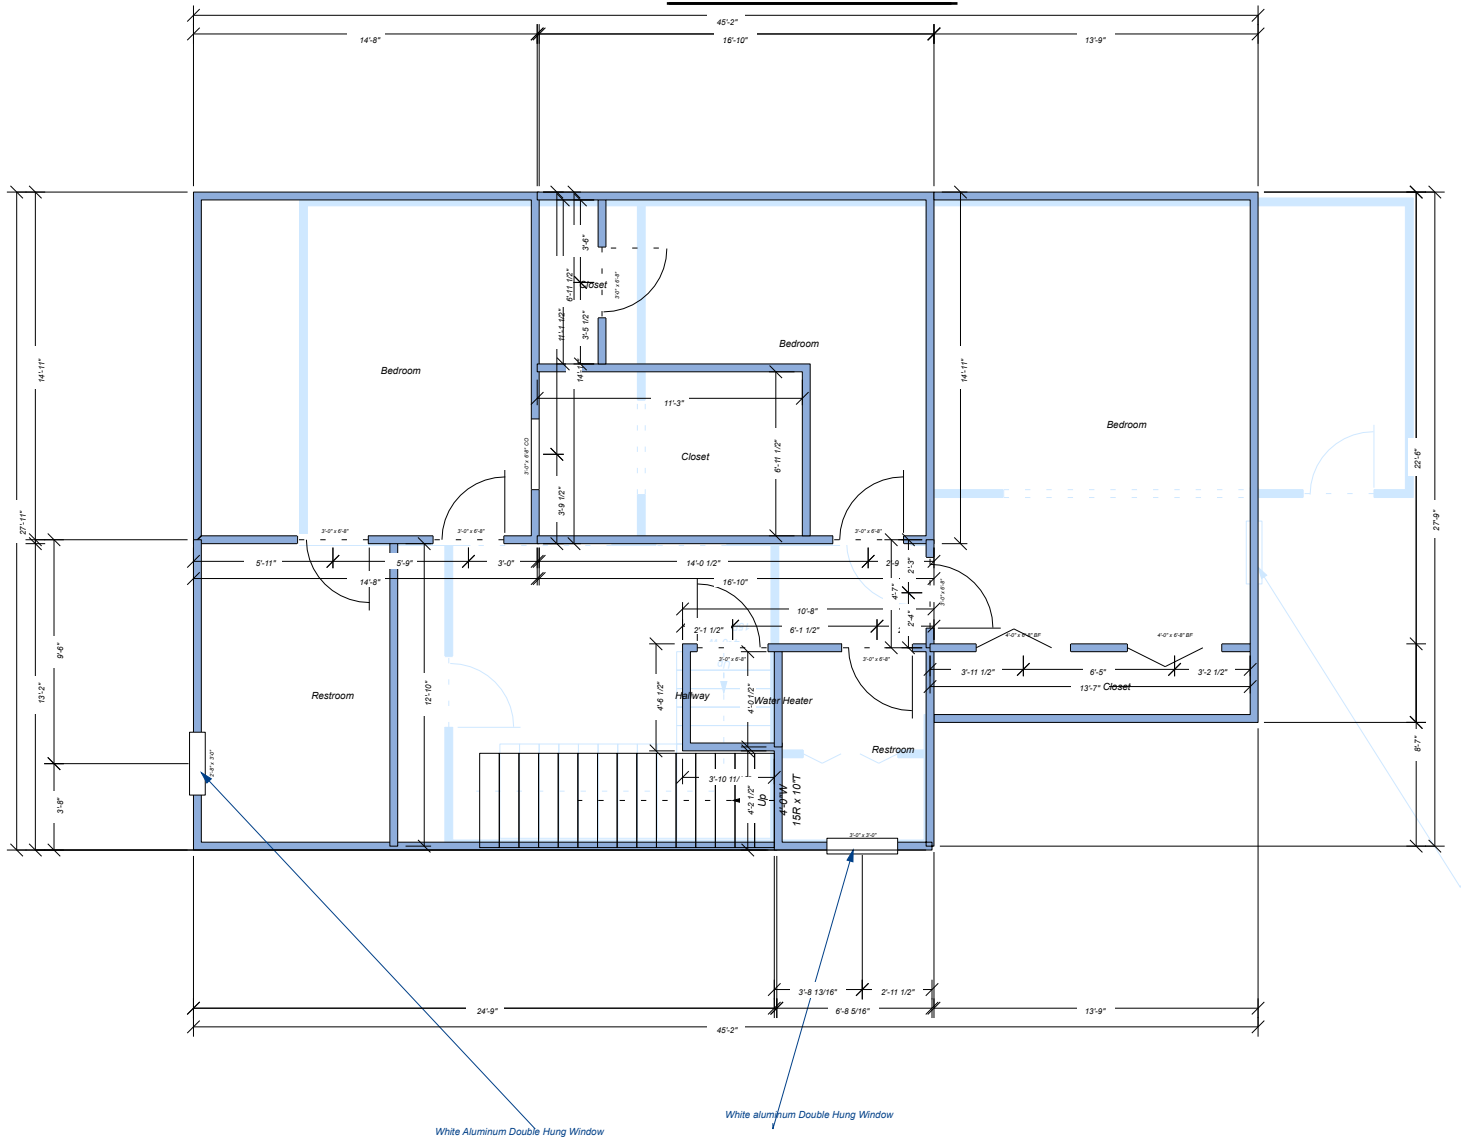
617 E Guenther 2nd Level

windows in-kind. Staff finds the replacement of three wood windows onsite with an aluminum window product to match previously replaced windows does not conform to Guidelines.
