HISTORIC AND DESIGN REVIEW COMMISSION

February 16, 2022

HDRC CASE NO: 2022-093
ADDRESS: 715 LABOR ST
LEGAL DESCRIPTION: NCB 729 BLK 3 LOT N 46.31 FT OF 8 & N IRRG 45.3 FT OF 9
ZONING: R-6, H
CITY COUNCIL DIST.: 1
DISTRICT: Lavaca Historic District
APPLICANT: Shawa Walker/ROC Acquisitions LLC
OWNER: Shawa Walker/ROC Acquisitions LLC
TYPE OF WORK: Historic Tax Verification
APPLICATION RECEIVED: February 04, 2022
60-DAY REVIEW: Not applicable due to City Council Emergency Orders
CASE MANAGER: Rachel Rettaliata

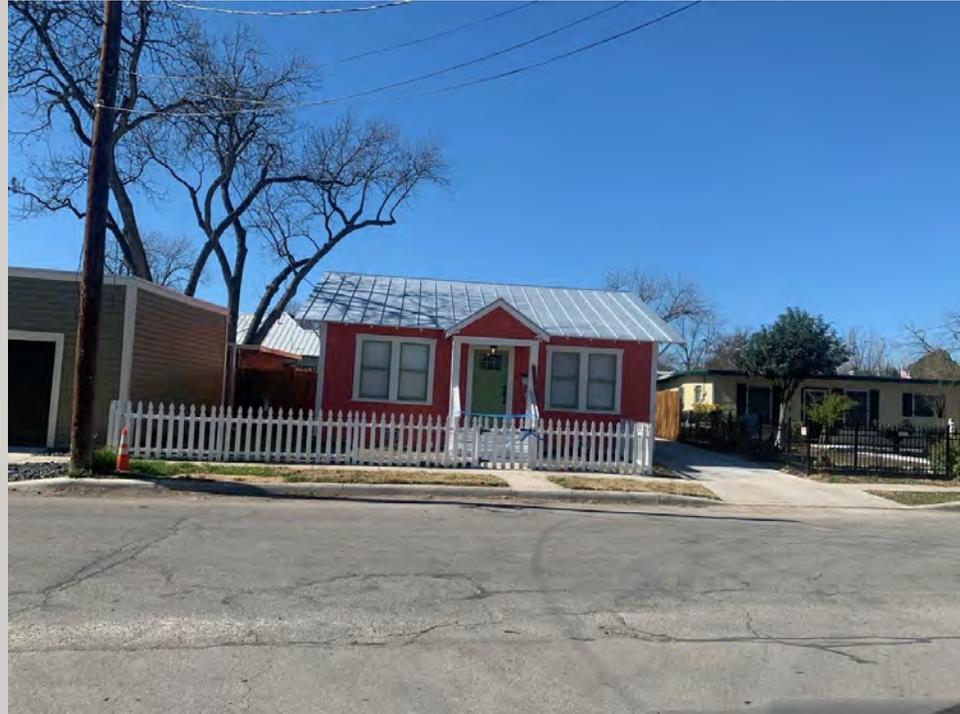
715 LABOR ST.

- NEW METAL ROOF
- ALL NEW PIER AND BEAM FOUNDATION
- REPAIRED EXTERIOR SIDING – SANDED AND PAINTED EXTERIOR
- NEW SOD
- NEW FENCE – STAINED WITH 10 YEAR SOLID STAIN
- NEW HVAC
- NEW PLUMBING – WATER AND SEWER LINES
- NEW ELECTRIC FROM THE POLE TO THE PANEL
- REMOVED TRUCKLOADS OF TRASH AND DEBRIS
- REPAIRED, SANDED, PAINTED ALL ORIGINAL WINDOWS
- NEW EXTERIOR AND INTERIOR LIGHT FIXTURES
- NEW CONCRETE DRIVEWAY
- NEW PRIVACY FENCE AROUND BACK OF PROPERTY.

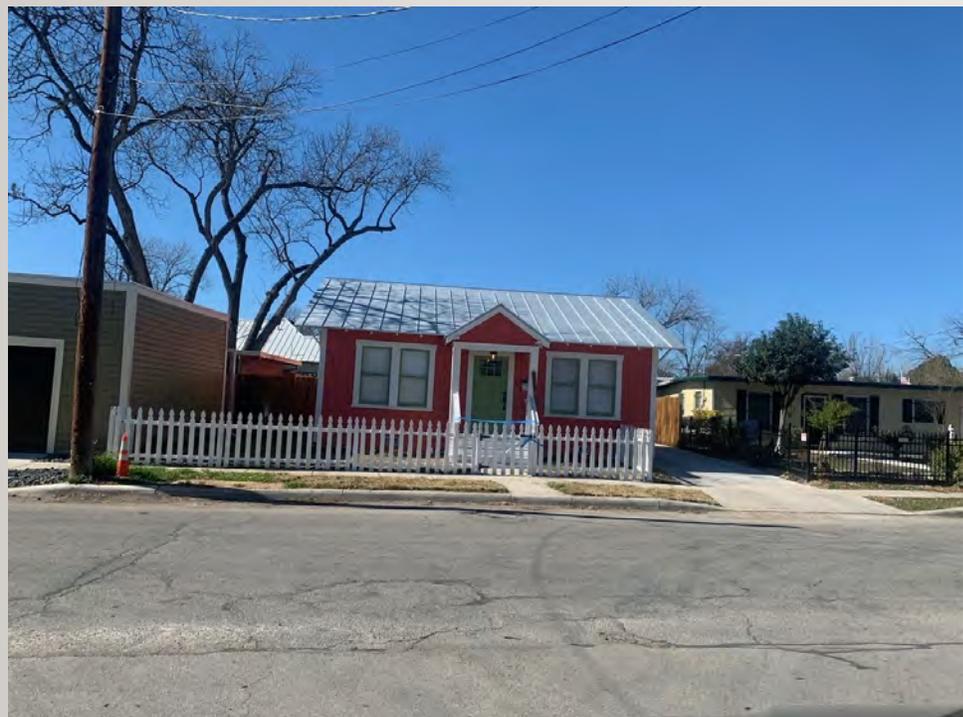
715 LABOR ST.

- REPAIRED, SANDED, PAINTED ALL ORIGINAL WINDOWS
- NEW EXTERIOR AND INTERIOR LIGHT FIXTURES
- NEW CONCRETE DRIVEWAY
- NEW PRIVACY FENCE AROUND BACK OF PROPERTY.
- REPAIRED, SANDED AND STAINED ORIGINAL LONG LEAF PINE FLOORS
- NEW SHEETROCK, MUD, TAPE, FLOW AND PAINT INTERIOR
- RESTORED AND EXPOSED
- SEVERAL SHIPLAP WALLS
- NEW TILE, VANITIES, BATHROOM FANS,
- INSULATION IN ALL THE WALLS
- ADDED PULL DOWN STAIRS FOR ATTIC ACCESS
- NEW TOILETS SHOWER FIXTURES
- USED ORIGINAL BATHTUB – HAD IT REFINISHED
- NEW GLASS INSTALLED ON SHOWER AND TUB

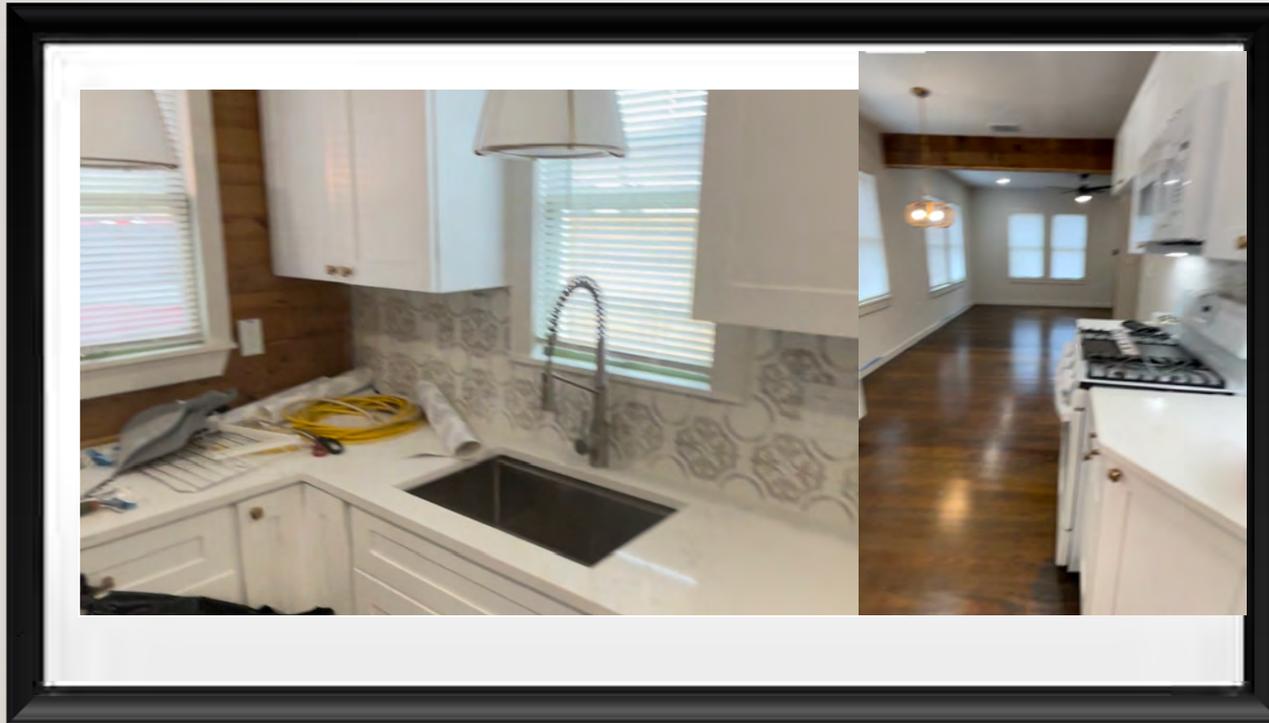
INTERIOR RESTORATION CONTINUED

- [REDACTED] Brand new HVAC to be added
- \$ [REDACTED] Brand new electric from the city pole to the panel inside
- [REDACTED] Brand new plumbing from the city connection to the fixtures inside to include new water lines, new sewer lines, new gas lines
