# HISTORIC AND DESIGN REVIEW COMMISSION

**HDRC CASE NO:** 2022-085  
**COMMON NAME:** Young Women's Leadership Academy  
**ADDRESS:** 2123 W HUISACHE AVE  
**LEGAL DESCRIPTION:** NCB 6827 BLK LOT 41 SAISD MANN MIDDLE SCHOOL SUB  
**ZONING:** R-6, H  
**CITY COUNCIL DIST.:** 7  
**DISTRICT:** Monticello Park Historic District  
**APPLICANT:** Mitchell Ford/Cox McLain Environmental Consulting, Inc. - now Stantec  
**OWNER:** Nkonye Adaikpoh/SAN ANTONIO ISD  
**TYPE OF WORK:** Partial demolition, new construction of additions, window replacement, exterior alterations, site work  
**APPLICATION RECEIVED:** May 27, 2022  
**60-DAY REVIEW:** Not applicable Due to City Council Emergency Orders  
**CASE MANAGER:** Rachel Rettaliata  
**REQUEST:**

#### **DRAFT REPORT**

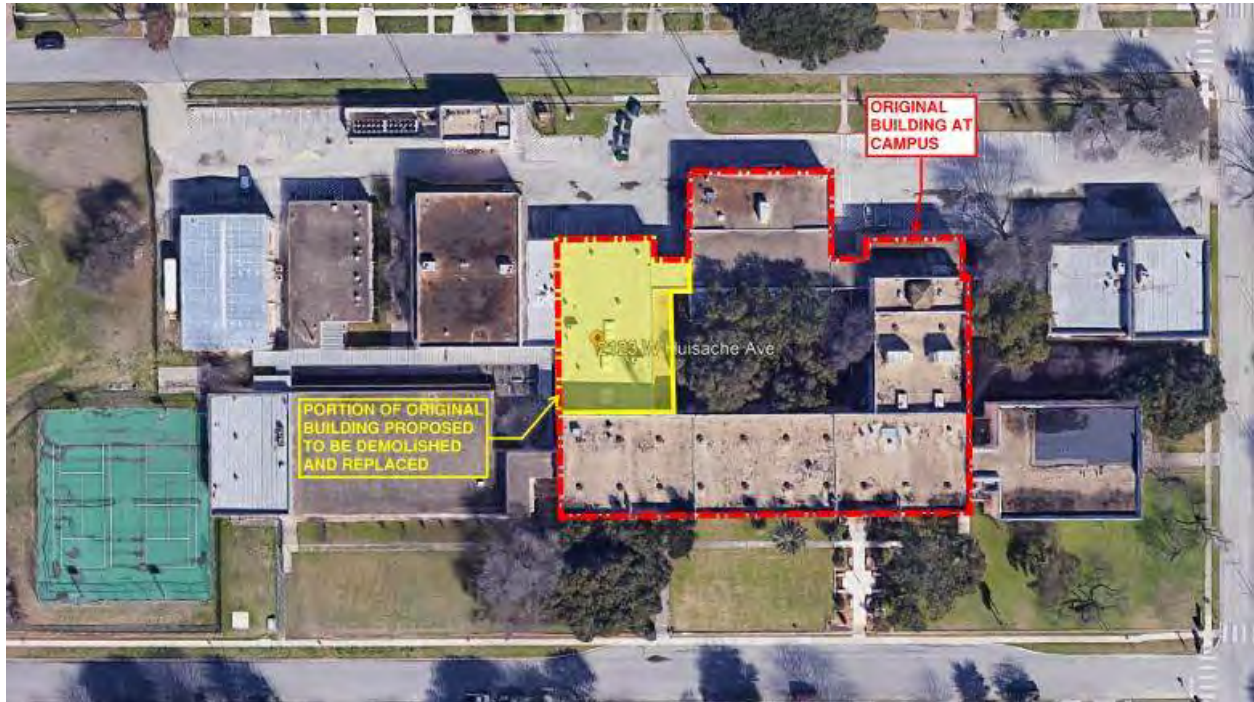
Figure 1. Aerial image of YWLA campus (north is up). The red outline depicts the original building on the school campus. The area highlighted in yellow is the single-story portion of the original building to be replaced as part of the proposed SAISD renovation.

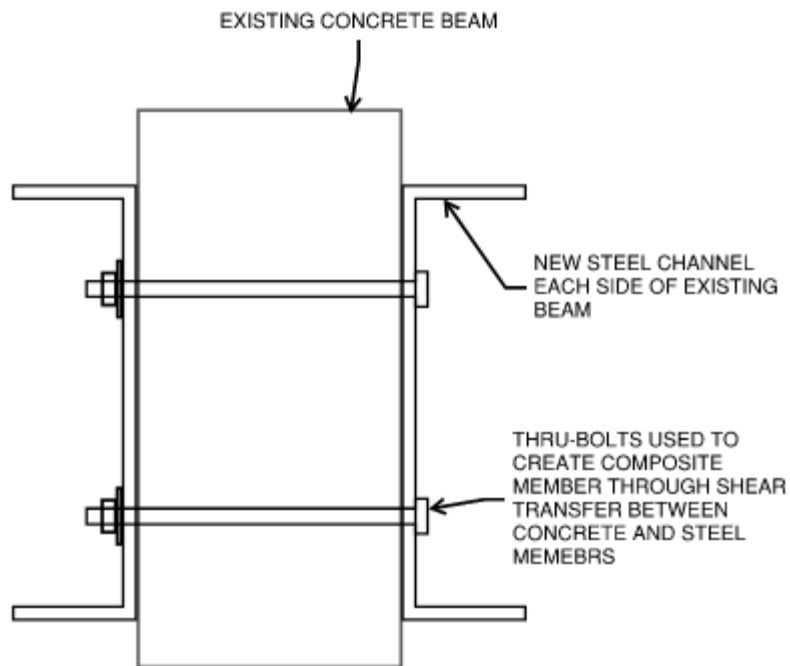
A third strengthening option considered by WJE was to install steel channels on each side of the existing concrete beam to create a steel flitch beam. Figure 2 provides a conceptual diagram of this strengthening measure. In general, this strengthening measure requires thru-bolting the concrete beam to provide shear transfer between the existing concrete member and the new steel members so that all members act compositely. This strengthening measure does require careful placement of the thru-bolts in order to avoid damaging existing steel reinforcing within the beam. The use of ground penetrating radar (GPR) would be required to ensure thru-bolt installation does not damage existing steel reinforcing.

Figure 2. Conceptual diagram of steel flitch beam with a channel on each side of the existing concrete beam

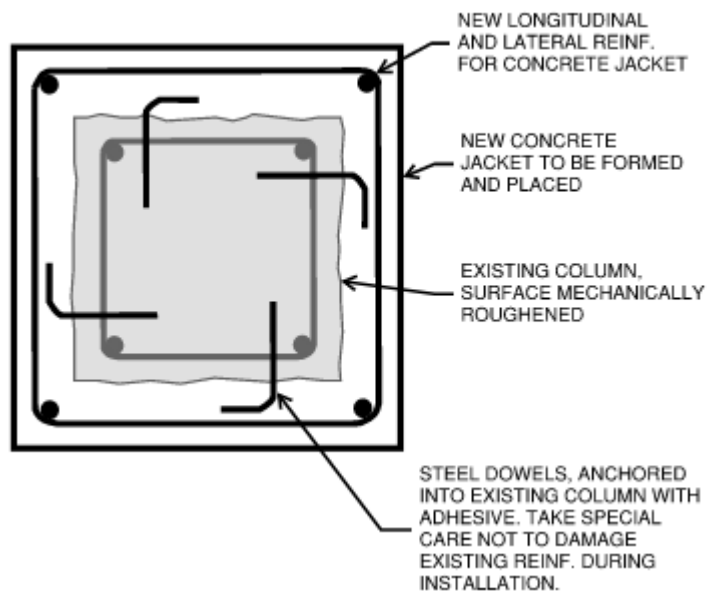
A strengthening measure that could be used to increase the capacity of the existing concrete columns in the library and locker room is jacketing the existing concrete columns. This strengthening technique increases the gross area of the column and provides additional longitudinal reinforcing by placing additional concrete around the existing column. Figure 3 includes a conceptual diagram of column jacketing. The design of this strengthening measure must ensure the new concrete acts compositely with the existing column. This composite behavior is typically achieved through surface preparation of the existing column surface (i.e., mechanical abrasion to provide a roughened surface for improved concrete bond) and the installation of dowels across the plane between new and existing concrete.

Figure 3. Conceptual diagram of concrete column jacketing

1. WJE recommends strengthening the piers by installing new battered micro piles around the existing piers to supplement the piers.
2. After pier strengthening has been completed, WJE recommends strengthening the existing columns by jacketing the columns to provide new columns with additional steel reinforcement and an increased gross area (reference Figure 3).

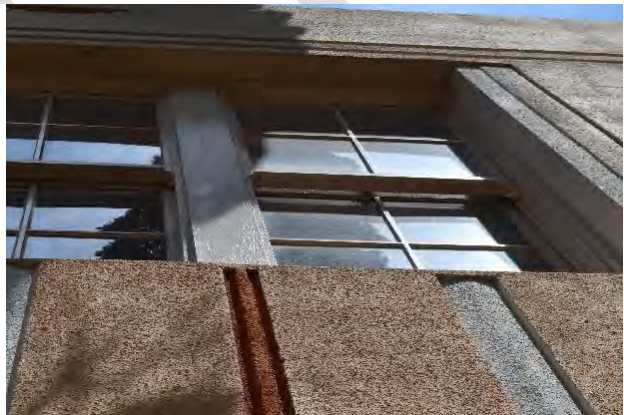
- One or more operable windows was not properly shut (Figure 17).
- Multiple windows at the south elevation contained sizeable gaps between the sashes at the meeting rail (Figure 18).

Figure 18. Large gap at meeting rail.

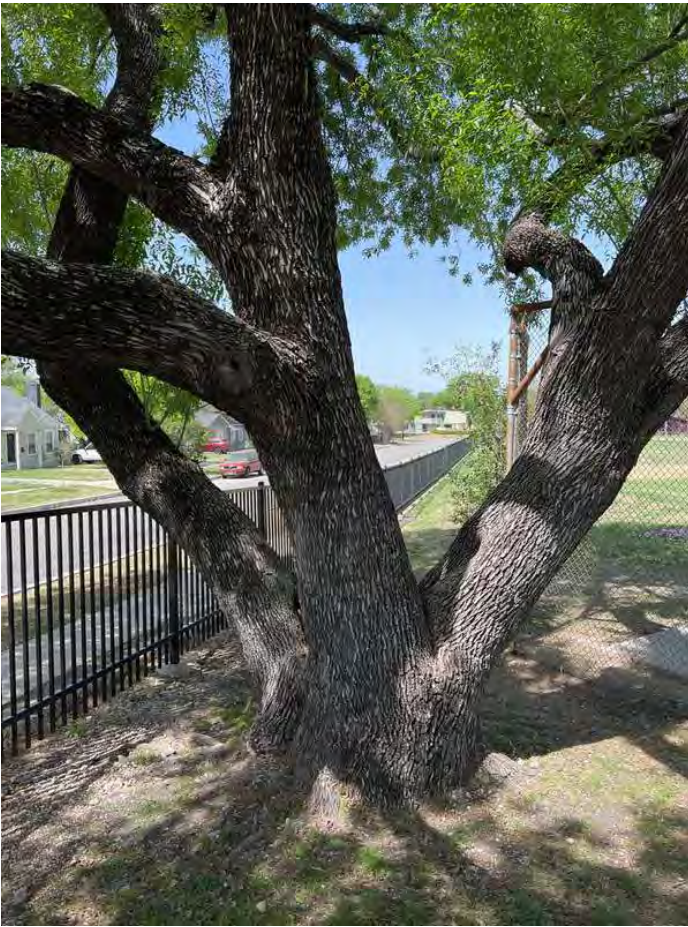
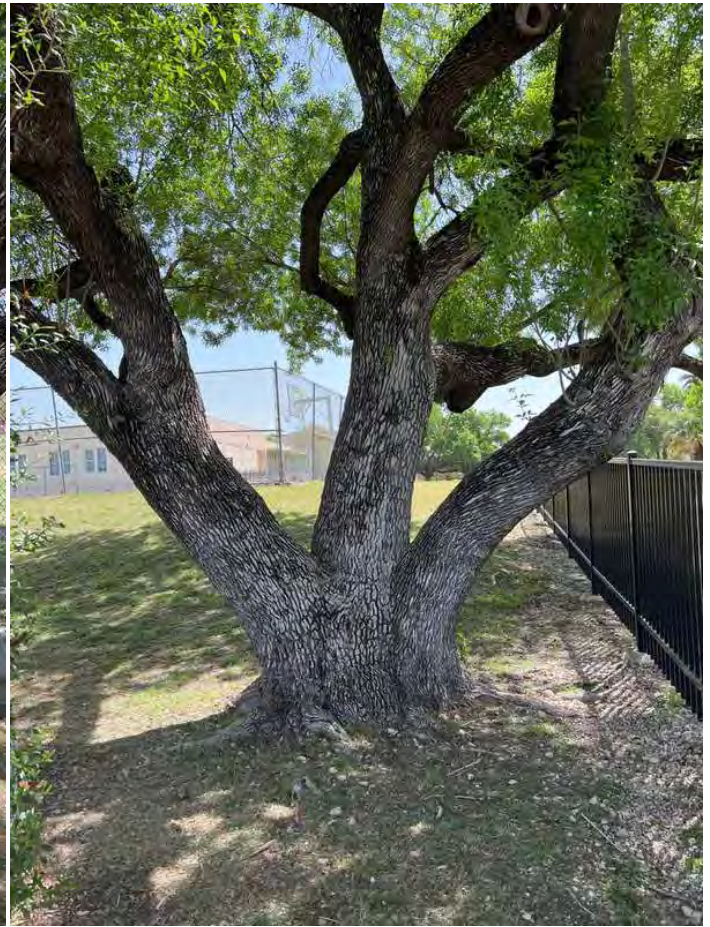
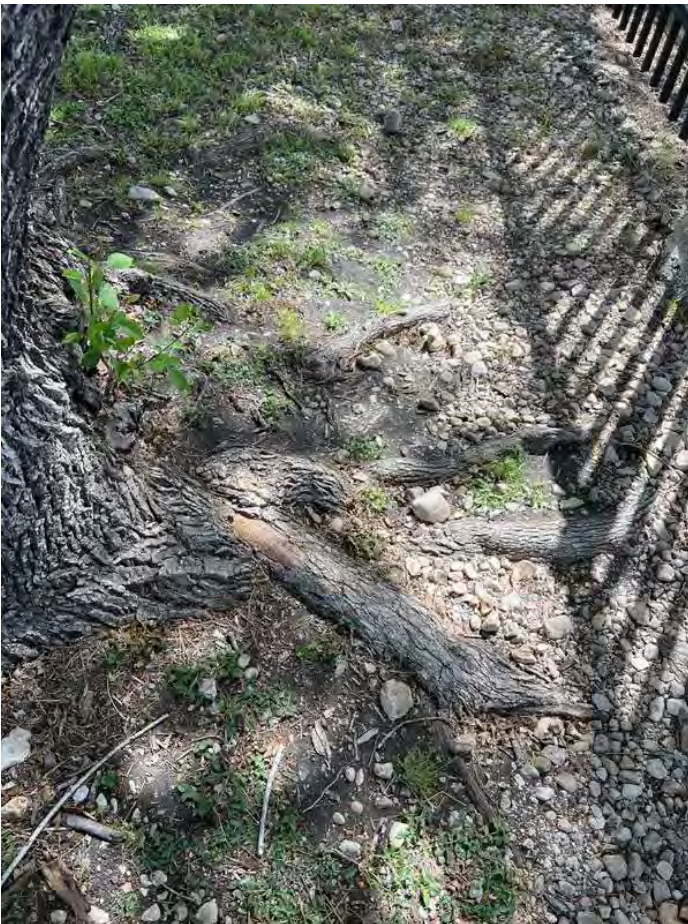
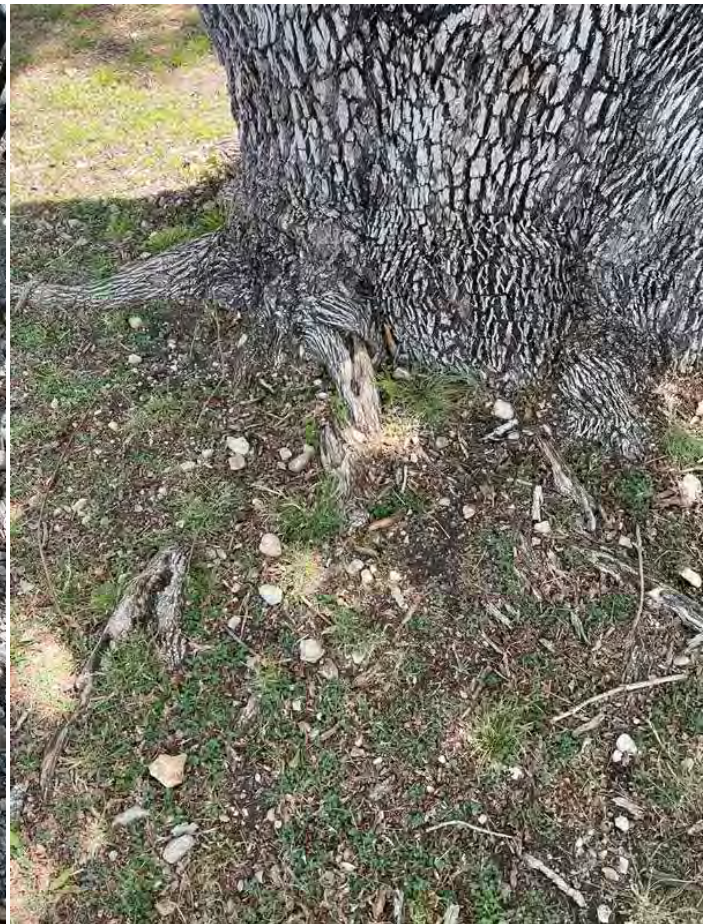
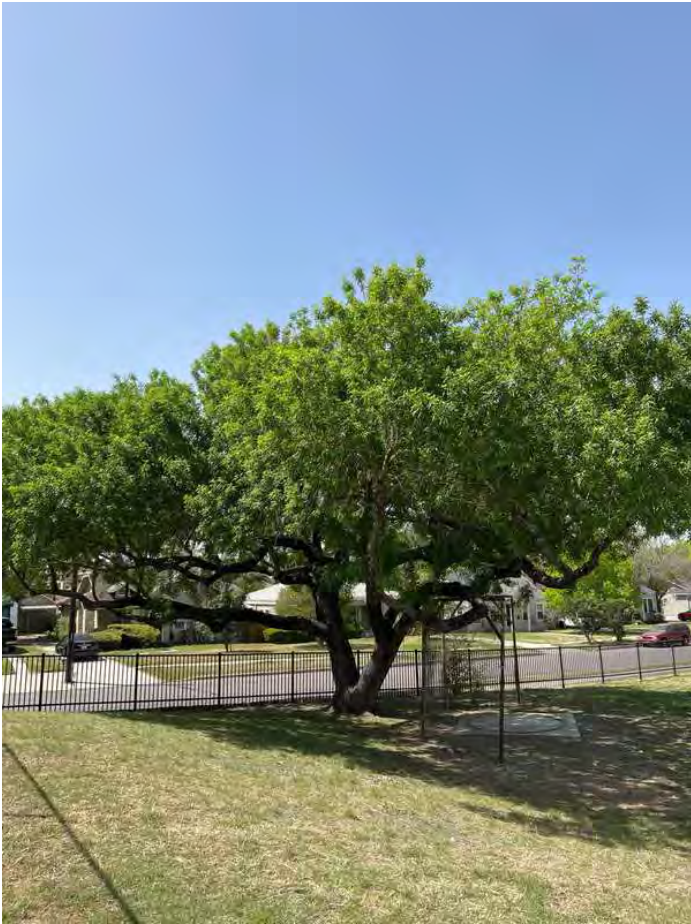
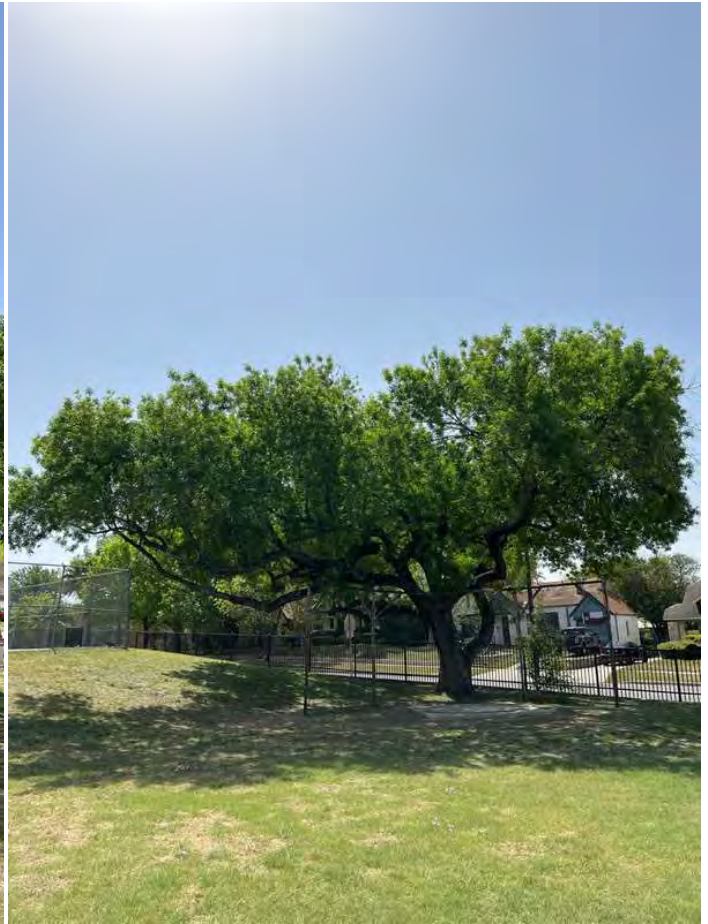
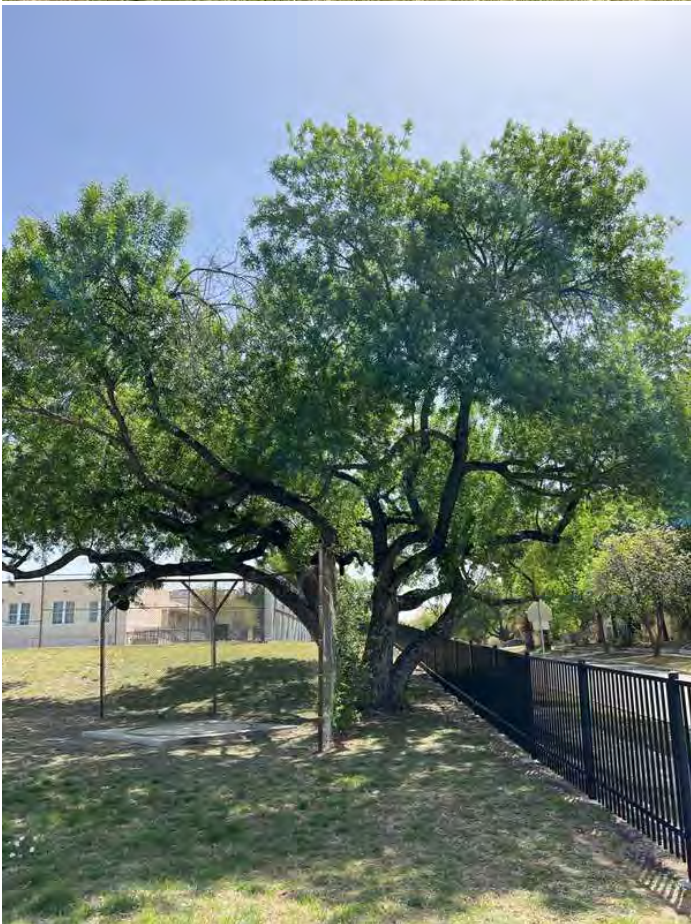
<b>Tree Number</b>	9001
<b>Tree Species</b>	Arizona Ash
<b>Diameter (DBH)</b>	27
<b>Multi Stem Notes</b>	27, 26, 18.5
<b>Condition</b>	Fair
<b>Summary</b>	Tree # 9001, a 27" Arizona Ash is in overall fair condition. Moderate root damage, good vigor and canopy greater than 75%. Deep root fertilization recommended for tree longevity. Fair candidate for preservation. Tree has some included unions at the base but overall healthy and appears to have fair structure at this time. Only the largest trunk is utilized for diameter at breast height measurement with this species.

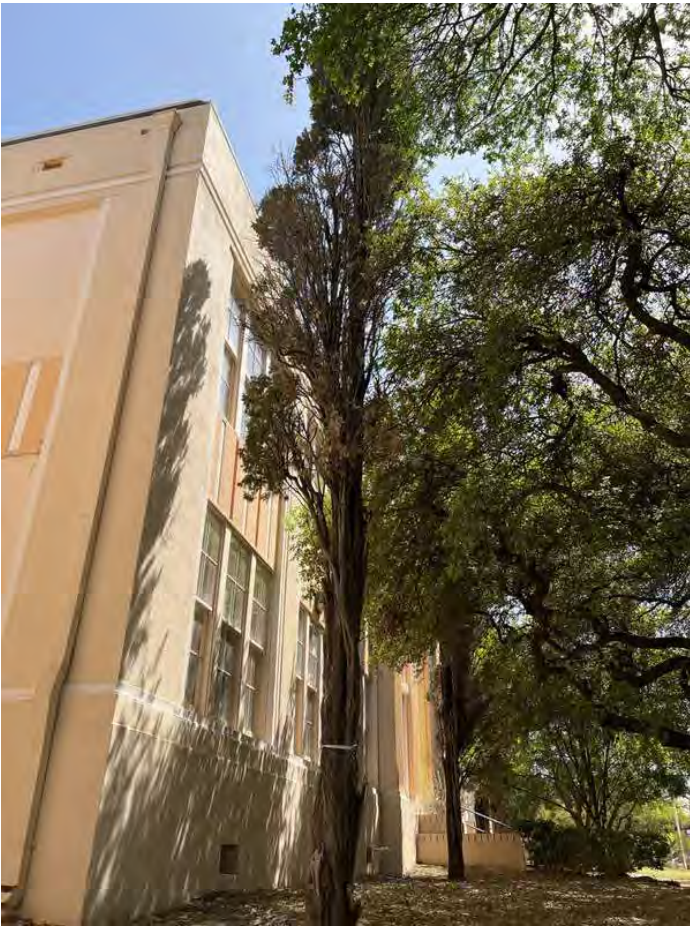
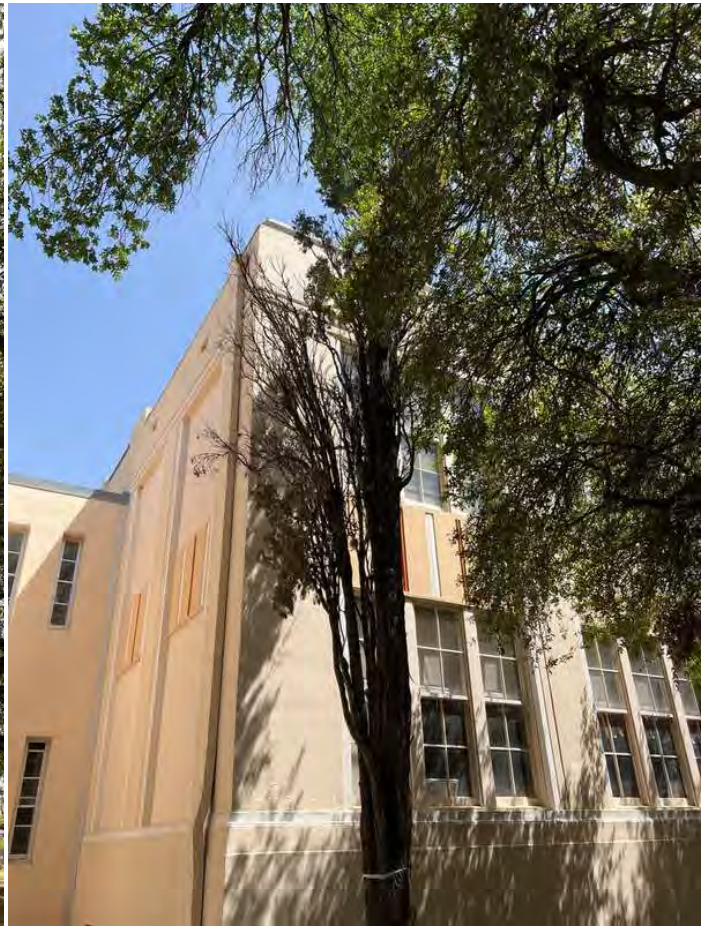
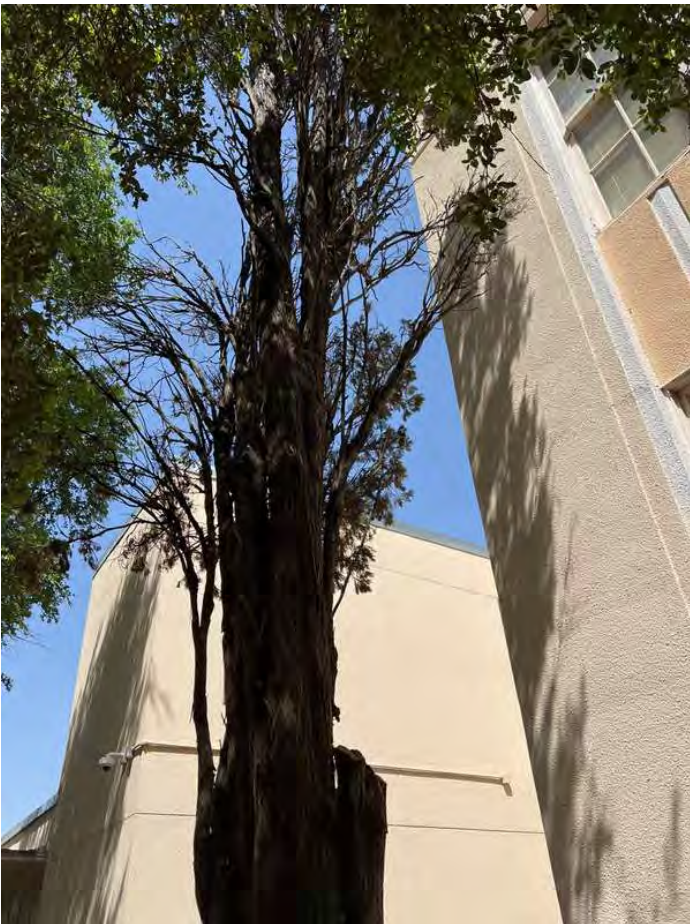
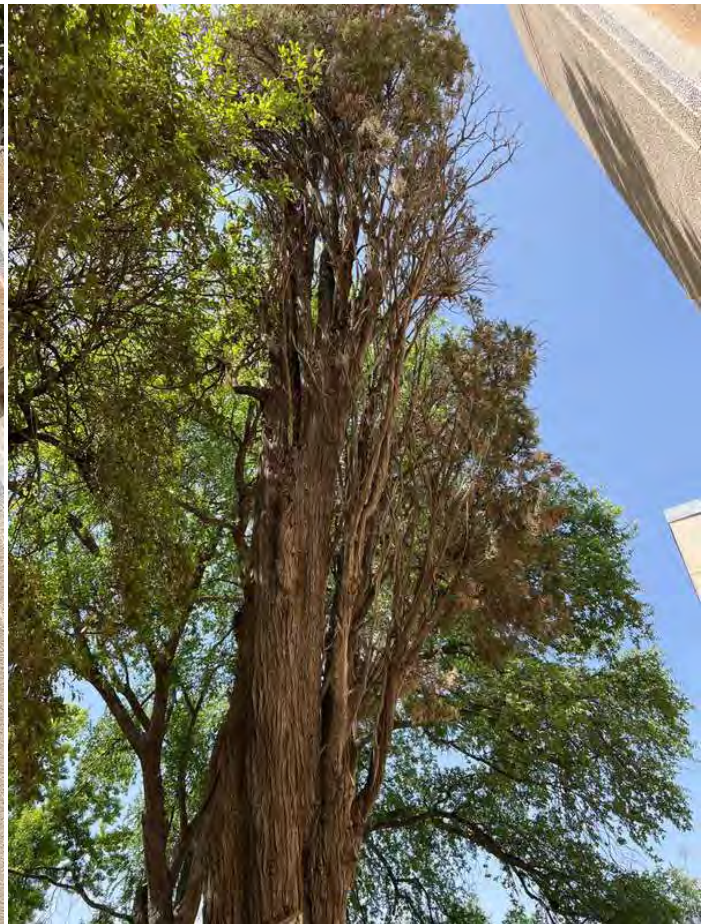
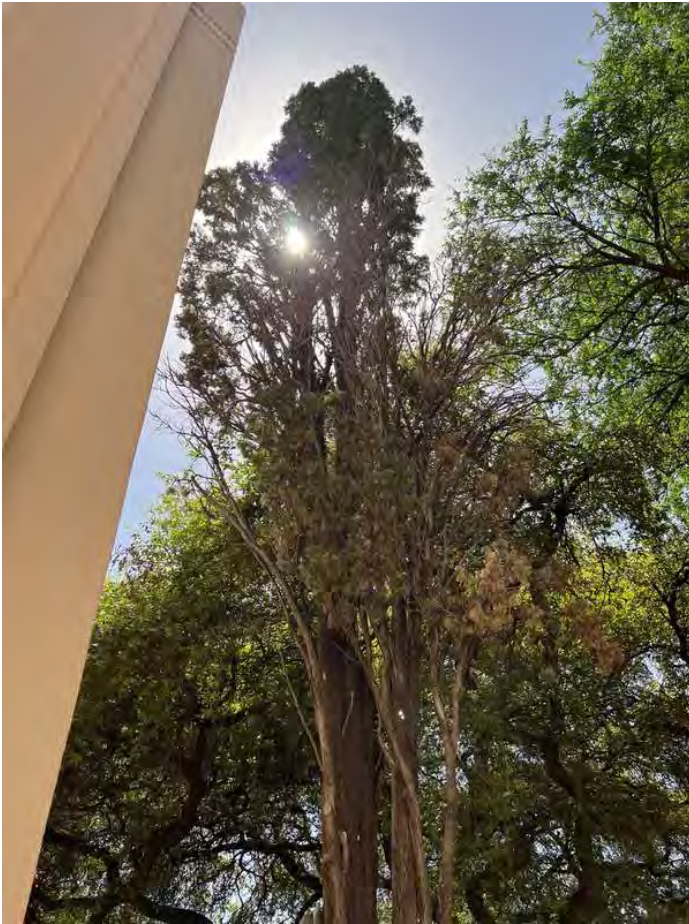
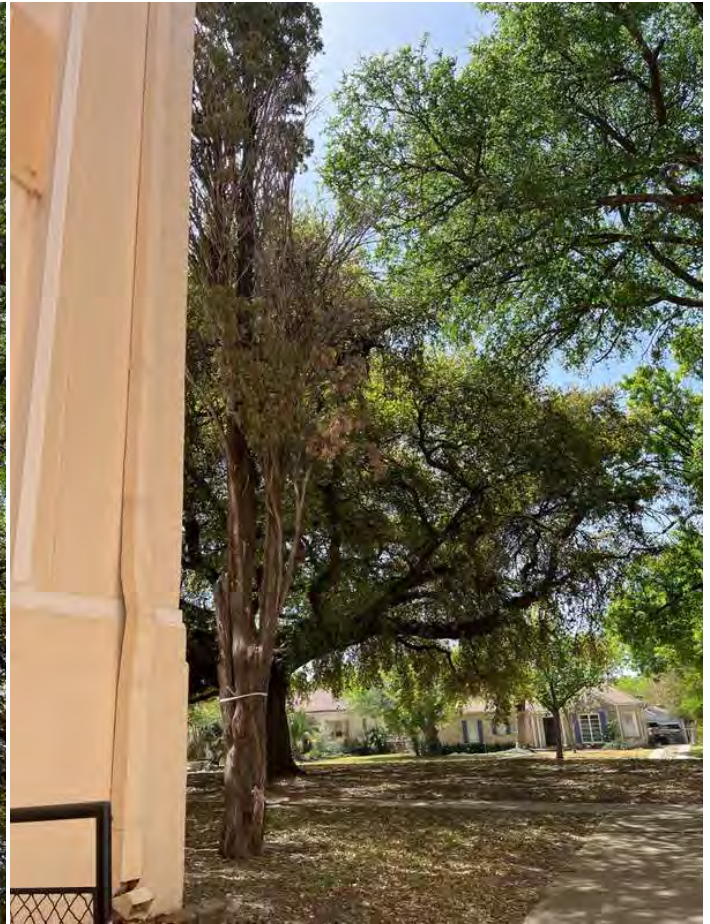
<b>Tree Number</b>	9002
<b>Tree Species</b>	Italian Cypress
<b>Diameter (DBH)</b>	14.5
<b>Multi Stem Notes</b>	
<b>Condition</b>	Poor
<b>Summary</b>	Tree # 9002, a 14.5" Italian Cypress, is in poor overall condition. Tree has significant decay and poor vigor, multiple dead stems and significant ball moss present. Much of the lower canopy has been shaded out and live crown ratio is very low. Recommend removal due to lack of competitiveness and very poor vigor.

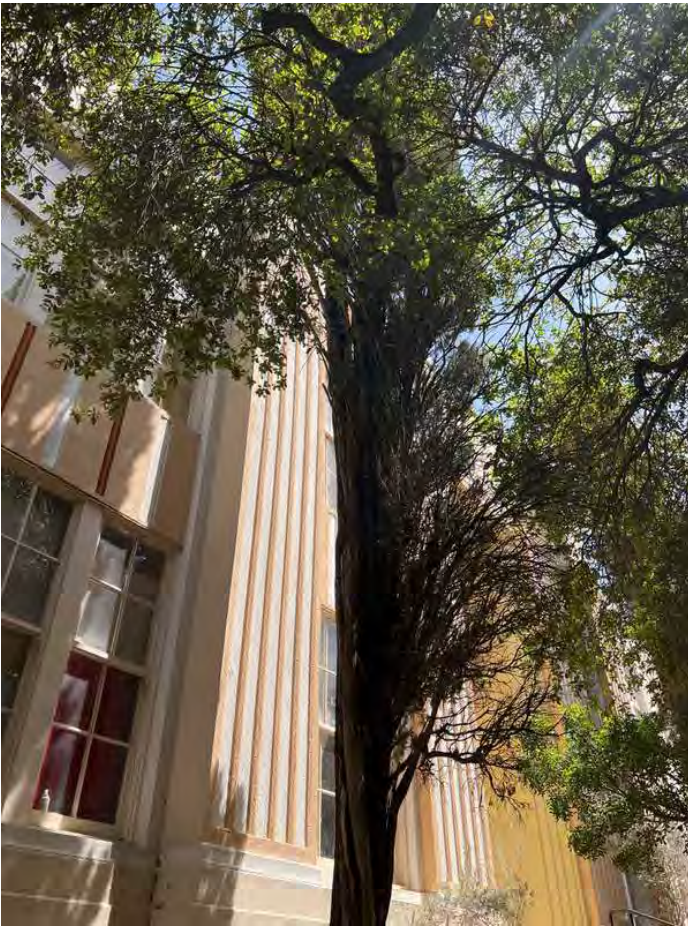
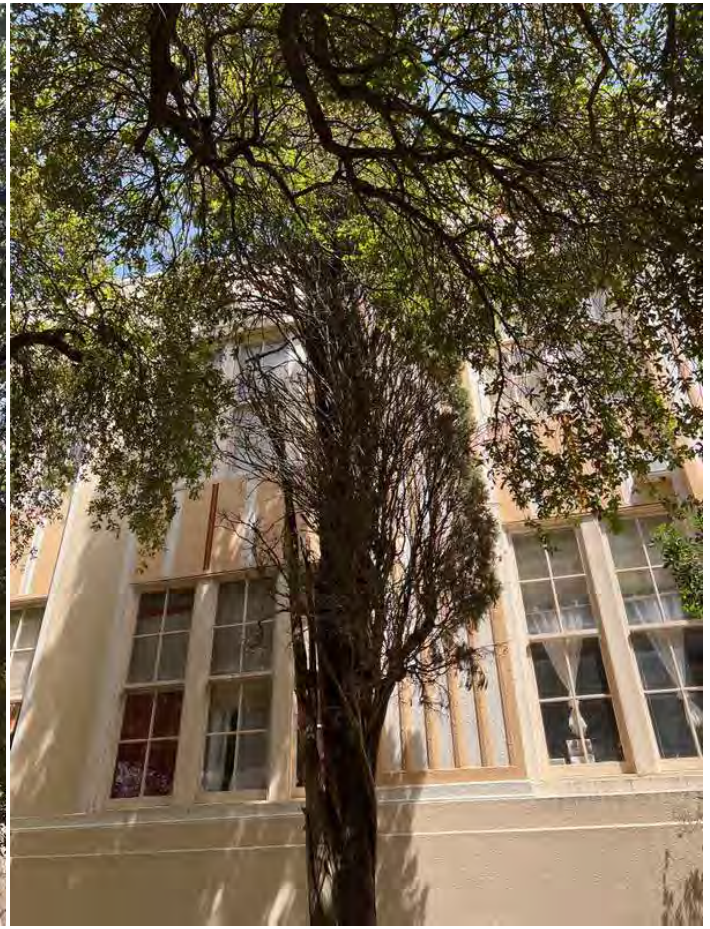
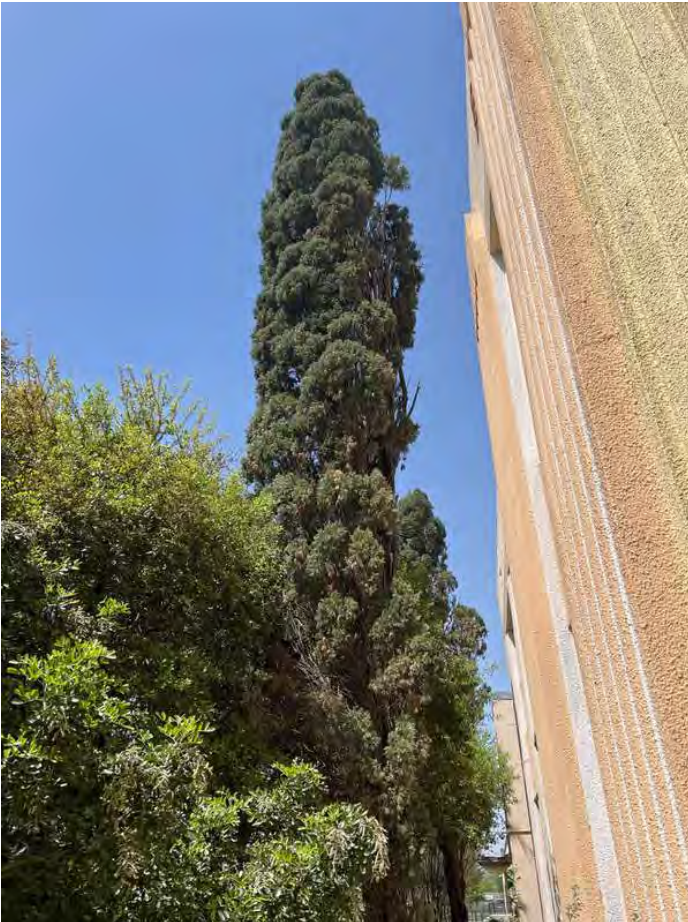
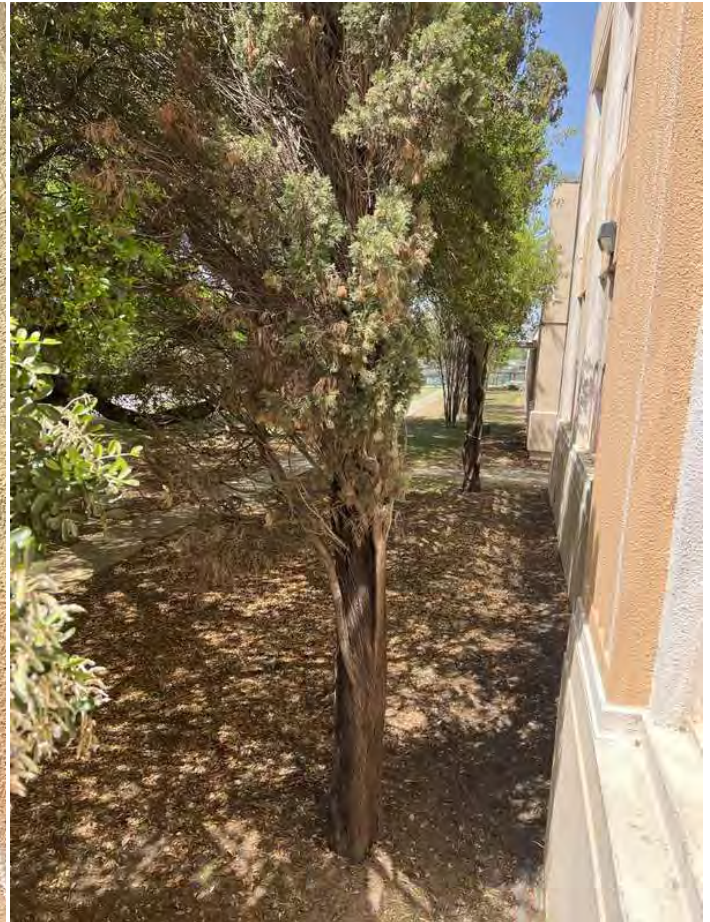
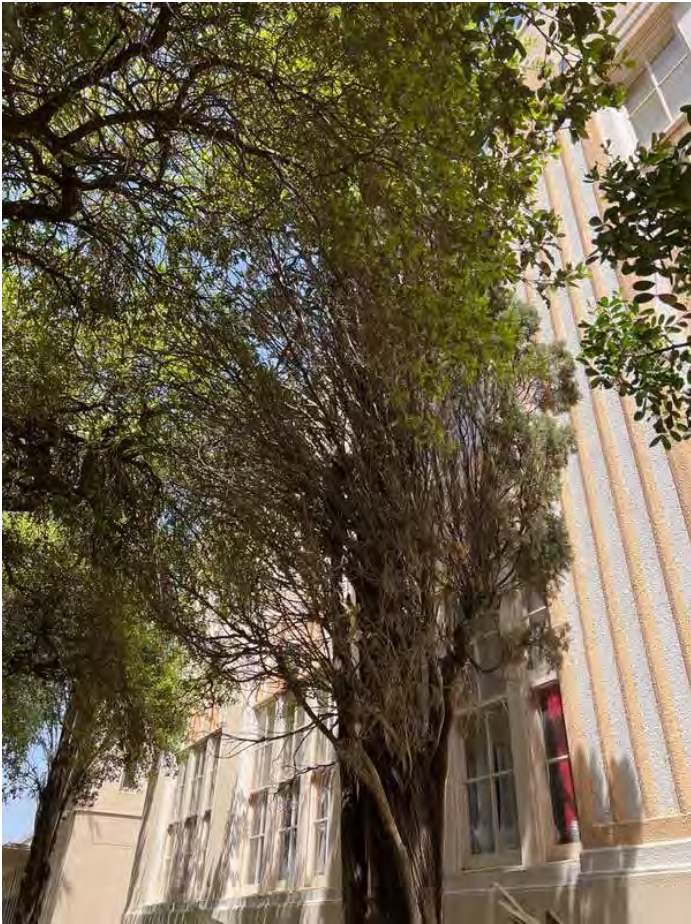
<b>Tree Number</b>	9003
<b>Tree Species</b>	Italian Cypress
<b>Diameter (DBH)</b>	16
<b>Multi Stem Notes</b>	
<b>Condition</b>	Fair
<b>Summary</b>	Tree # 9003, a 16" Italian Cypress, is in fair overall condition. Significant decay and dead stems in the understory. Tree has low live crown ratio due to being shaded out by adjacent canopies but overall fair condition and a fair candidate for preservation.

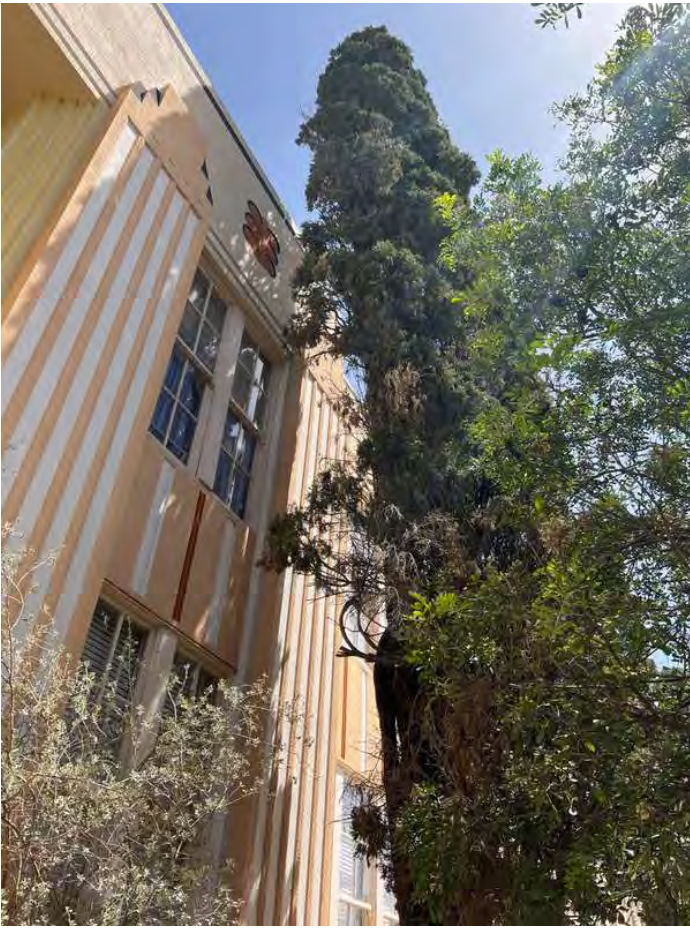
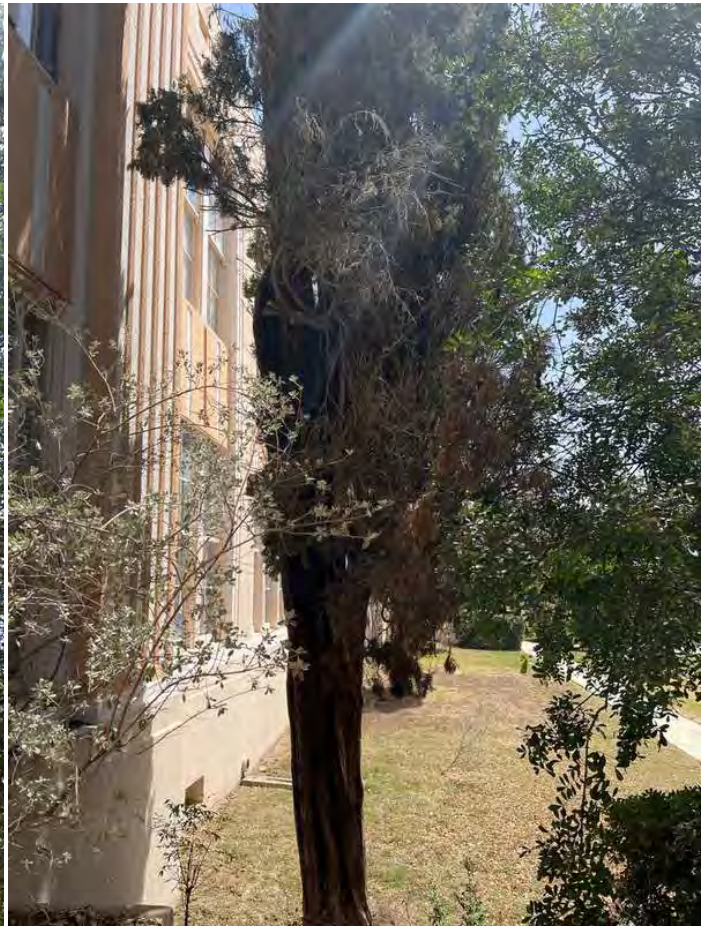
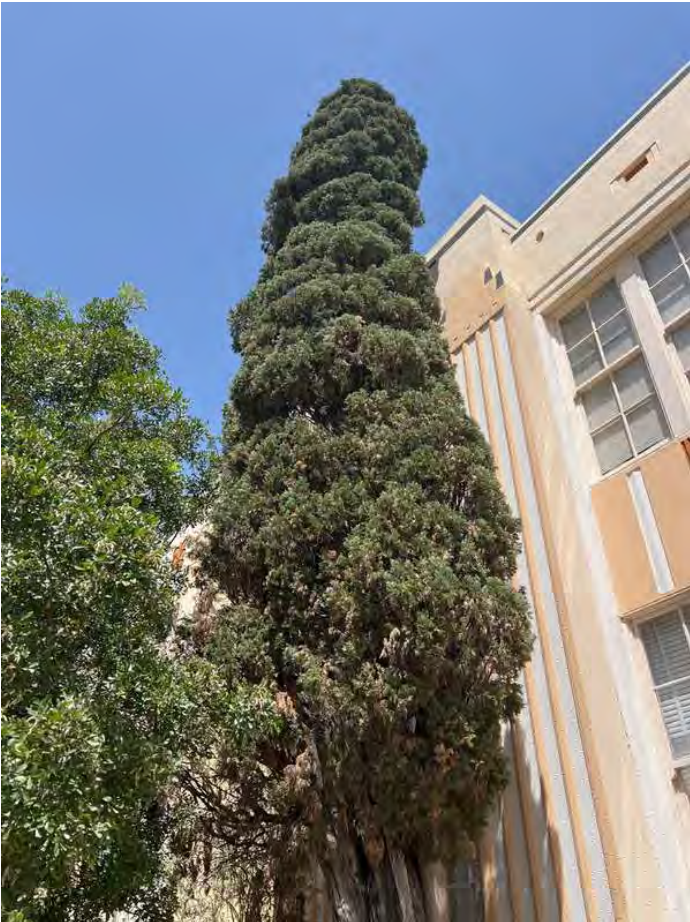
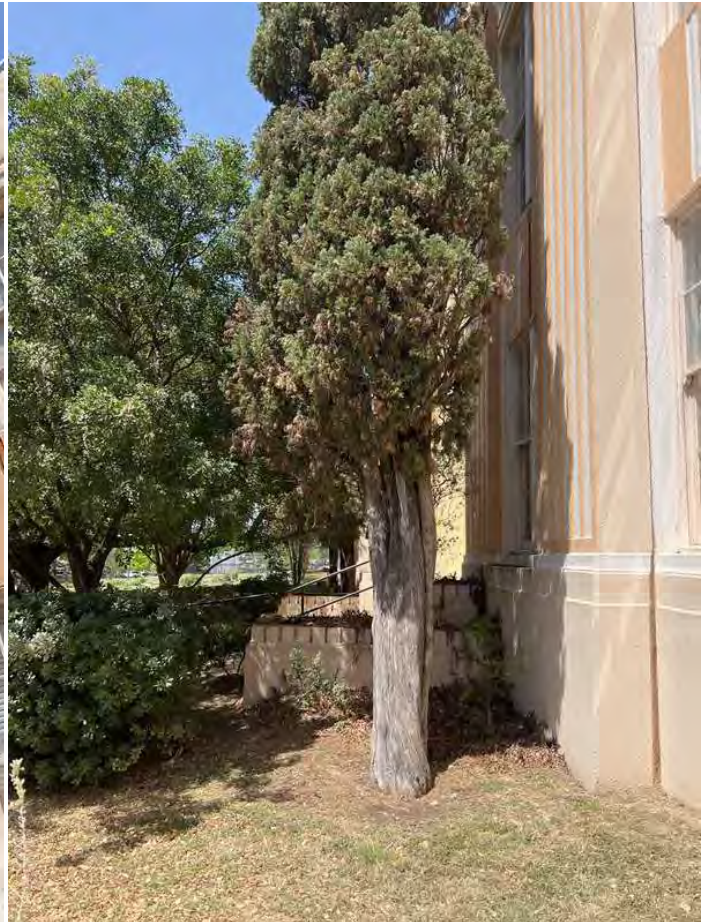
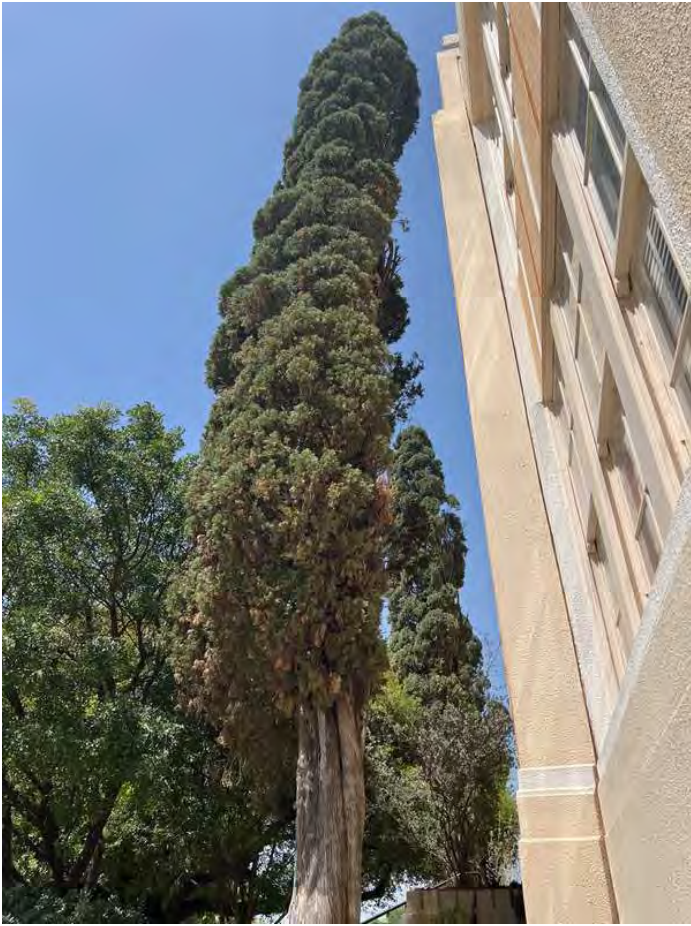
<b>Tree Number</b>	9004
<b>Tree Species</b>	Italian Cypress
<b>Diameter (DBH)</b>	18
<b>Multi Stem Notes</b>	
<b>Condition</b>	Fair
<b>Summary</b>	Tree # 9004, an 18" Italian Cypress, is in fair overall condition. Moderate decay and dead stems in the understory, recommend removing. Moderate lean towards the building. Fair candidate for preservation.

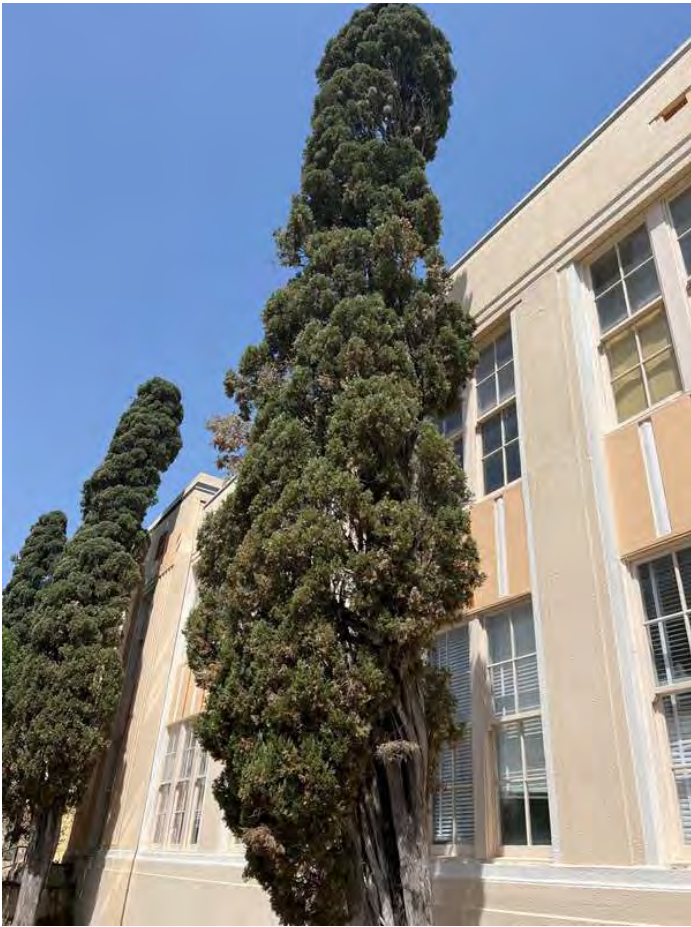
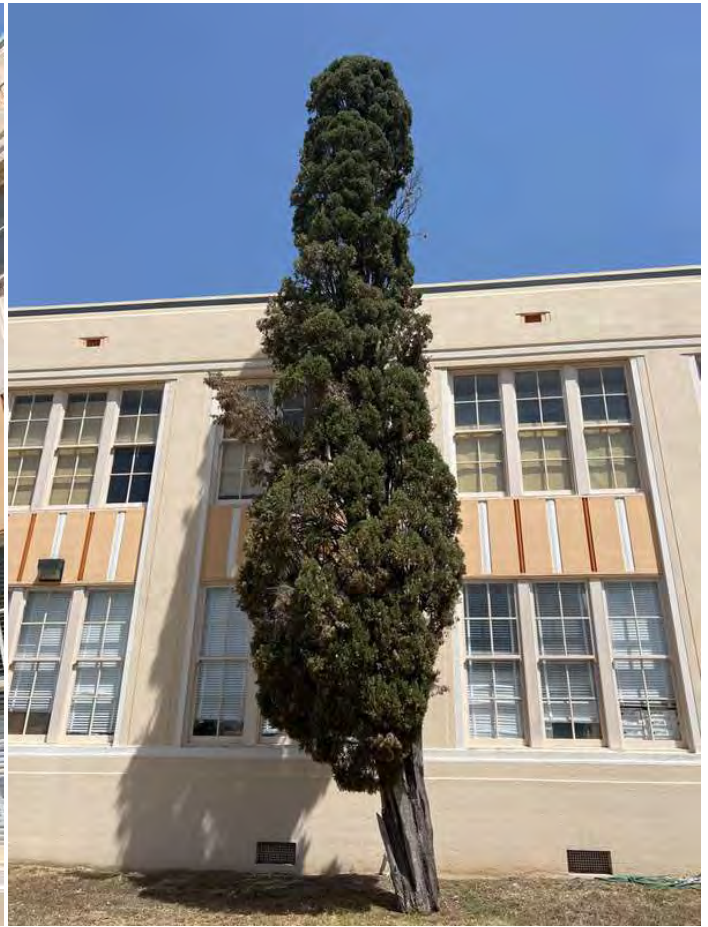
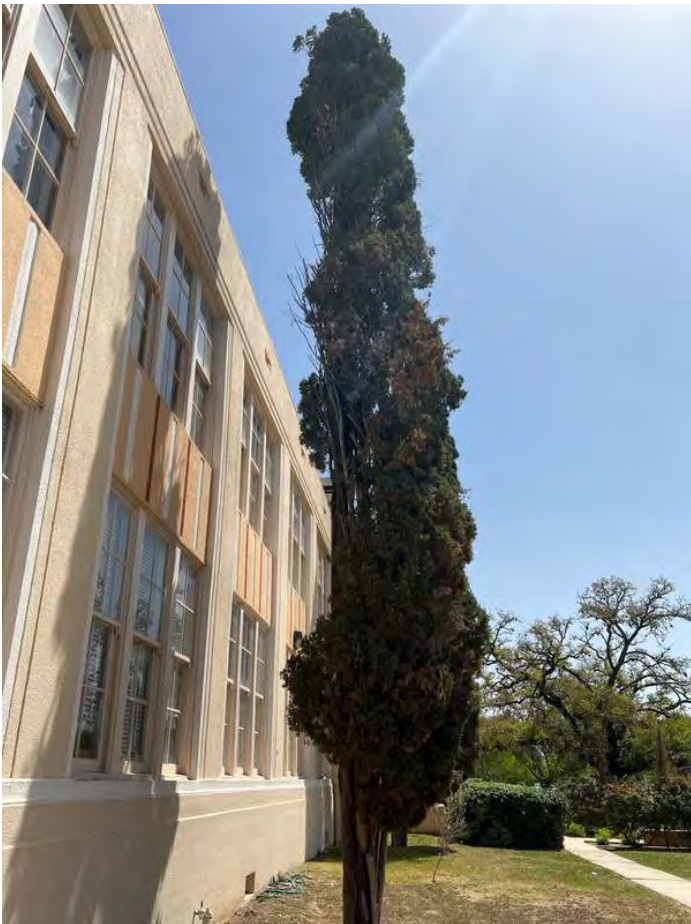
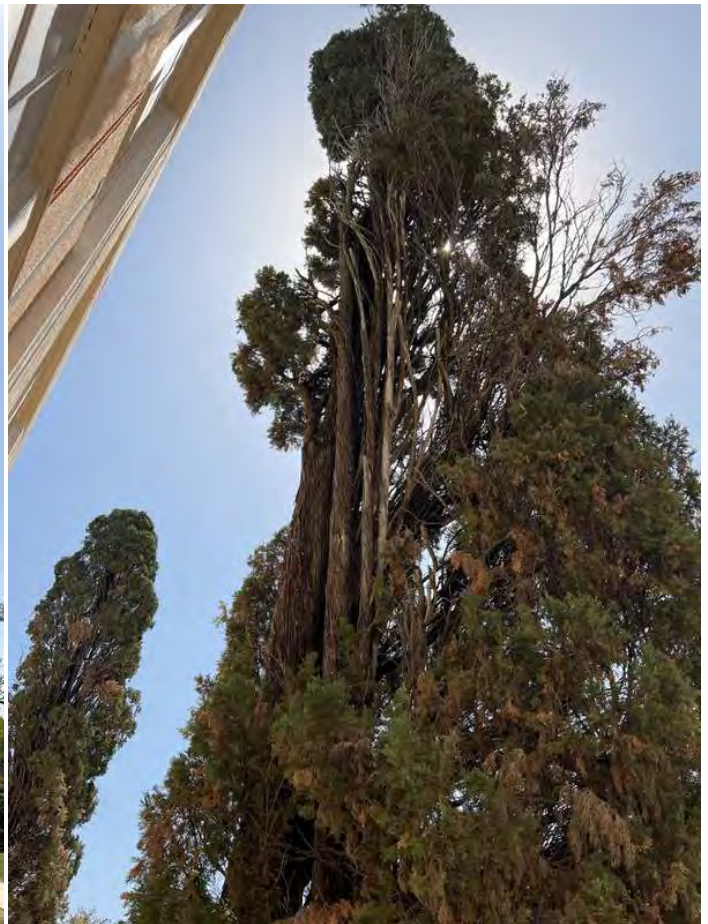
<b>Tree Number</b>	9005
<b>Tree Species</b>	Italian Cypress
<b>Diameter (DBH)</b>	20.5
<b>Multi Stem Notes</b>	
<b>Condition</b>	Fair
<b>Summary</b>	Tree # 9005, a 20.5" Italian Cypress, is in fair overall condition. Moderate decay and dead stems in the understory. Fair candidate for preservation.
