# HISTORIC AND DESIGN REVIEW COMMISSION

**HDRC CASE NO:** 2022-085  
**COMMON NAME:** Young Women's Leadership Academy  
**ADDRESS:** 2123 W HUISACHE AVE  
**LEGAL DESCRIPTION:** NCB 6827 BLK LOT 41 SAISD MANN MIDDLE SCHOOL SUB  
**ZONING:** R-6, H  
**CITY COUNCIL DIST.:** 7  
**DISTRICT:** Monticello Park Historic District  
**APPLICANT:** Mitchell Ford/Cox McLain Environmental Consulting, Inc. - now Stantec  
**OWNER:** Nkonye Adaikpoh/SAN ANTONIO ISD  
**TYPE OF WORK:** Partial demolition, new construction of additions, window replacement, exterior alterations, site work  
**APPLICATION RECEIVED:** May 27, 2022  
**60-DAY REVIEW:** Not applicable Due to City Council Emergency Orders  
**CASE MANAGER:** Rachel Rettaliata  
**REQUEST:**

#### **DRAFT REPORT**

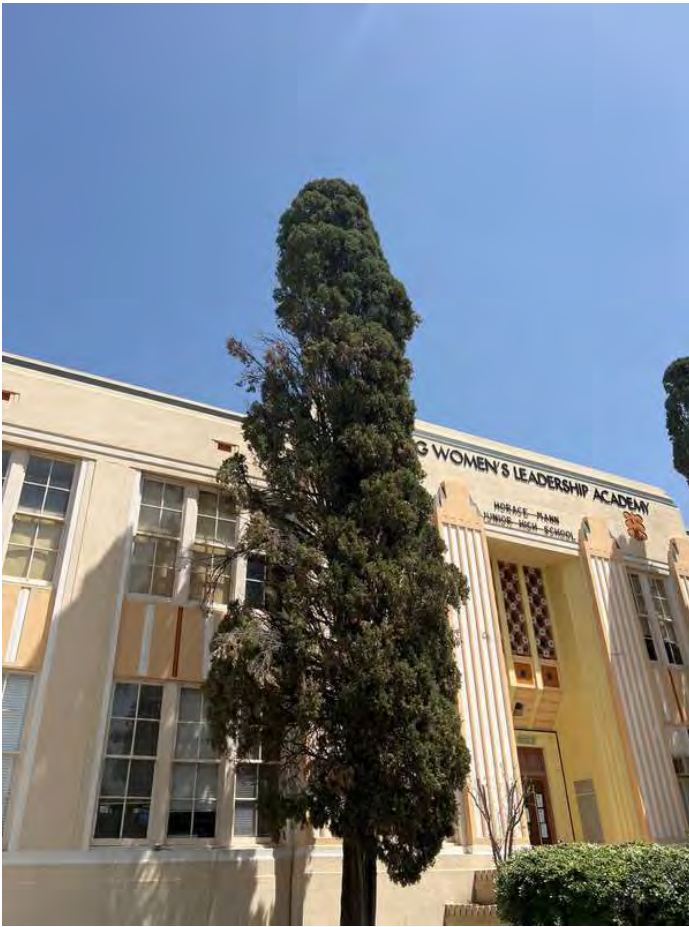
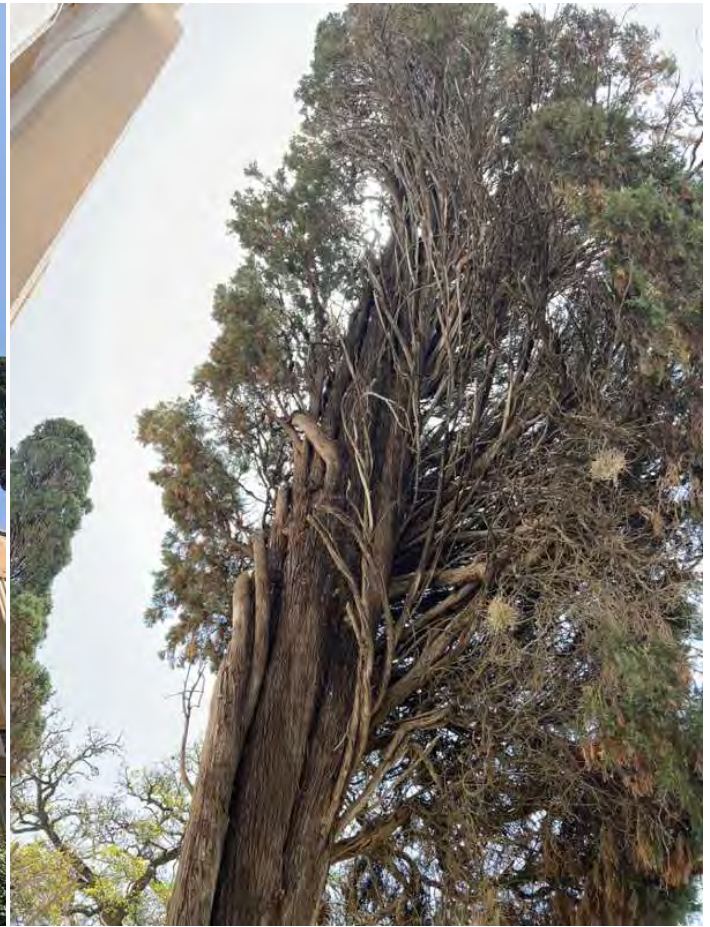
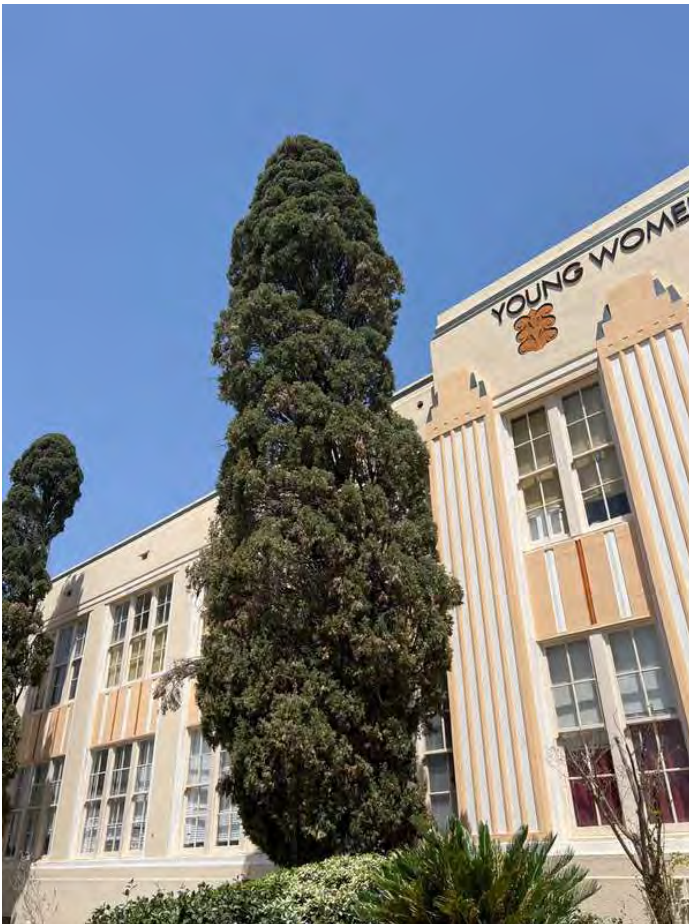
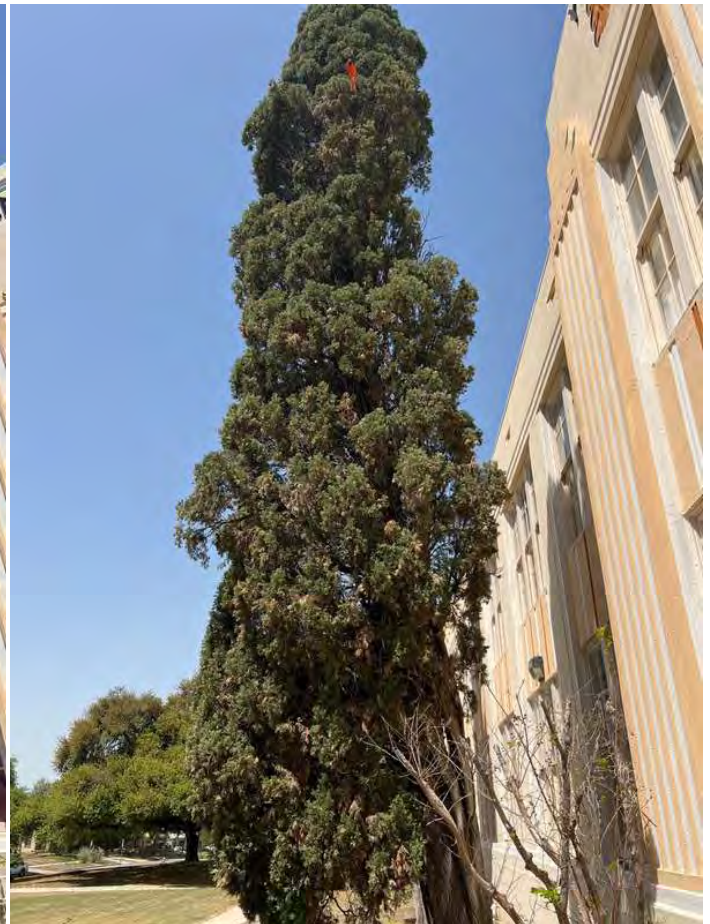
<b>Tree Number</b>	9006
<b>Tree Species</b>	Italian Cypress
<b>Diameter (DBH)</b>	18
<b>Multi Stem Notes</b>	
<b>Condition</b>	Fair
<b>Summary</b>	Tree # 9006, an 18" Italian Cypress, is in fair overall condition. Moderate decay and dead stems in the understory. Moderate lean to the south away from the building. Fair candidate for preservation.

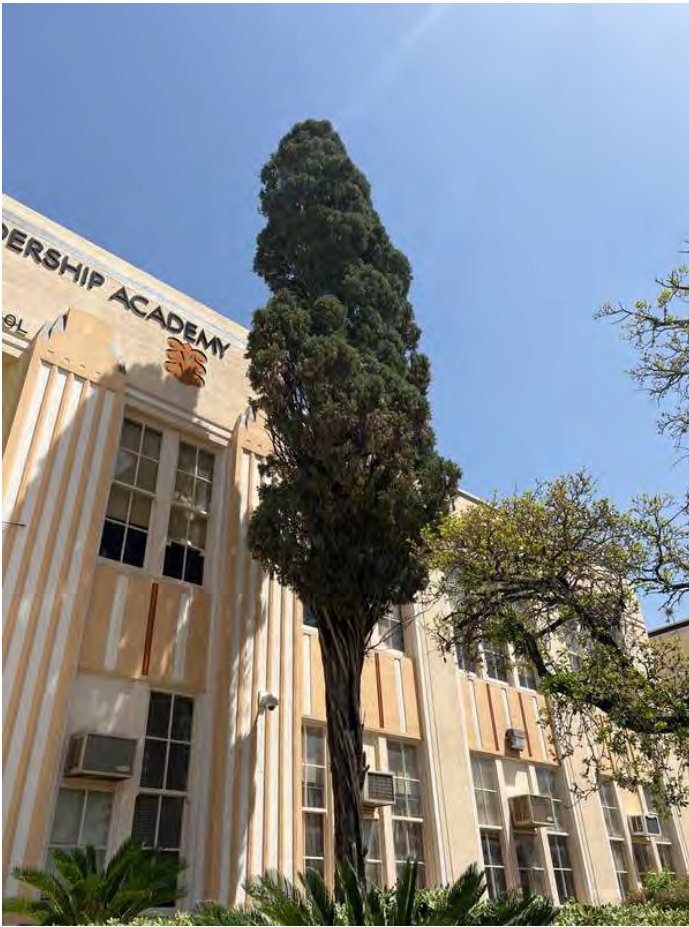
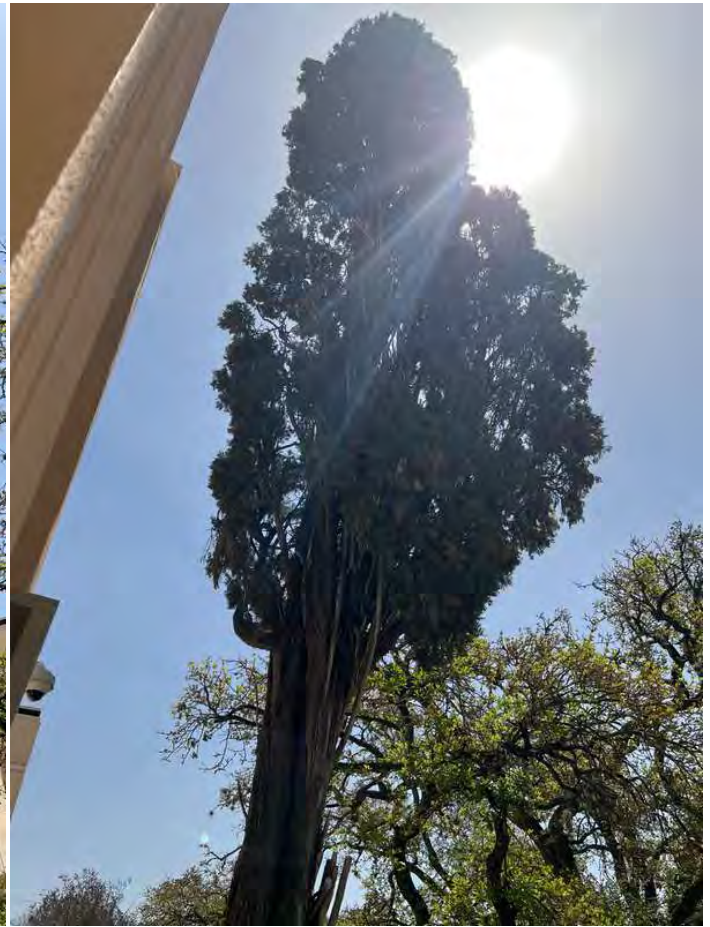
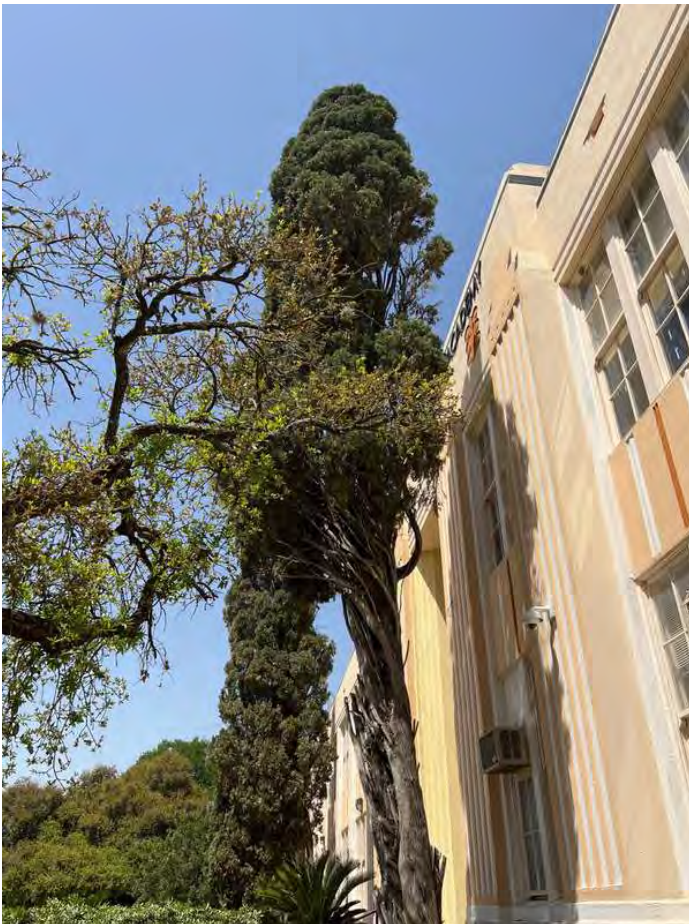
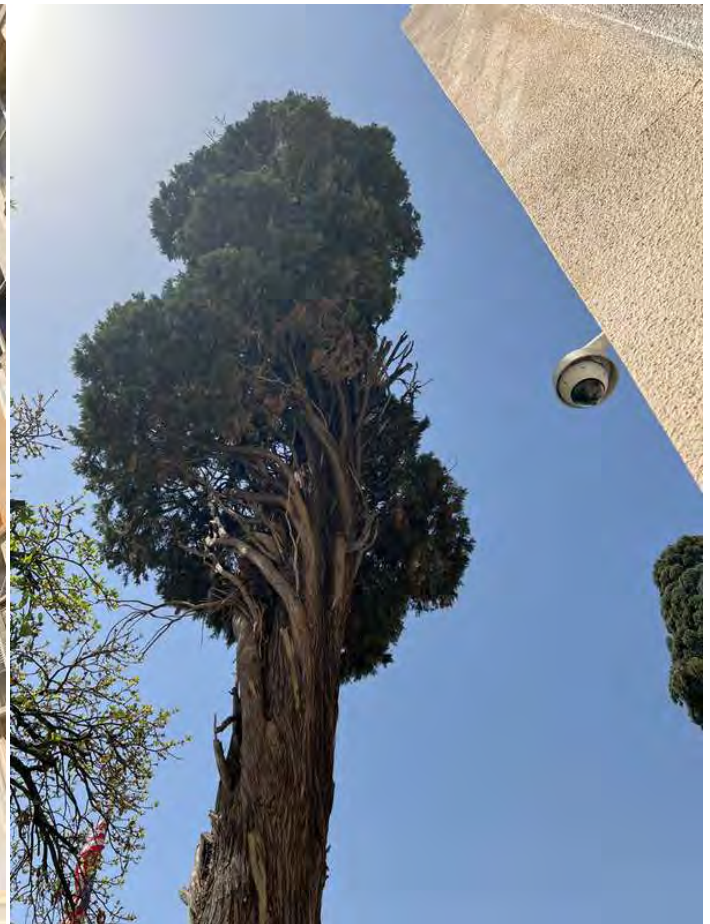
<b>Tree Number</b>	9007
<b>Tree Species</b>	Italian Cypress
<b>Diameter (DBH)</b>	15
<b>Multi Stem Notes</b>	
<b>Condition</b>	Fair
<b>Summary</b>	Tree # 9007, a 15" Italian Cypress, is in fair overall condition. Moderate lean to the south away from the building. Fair candidate for preservation. Tree has been overpruned and has low live crown ratio and poor vigor but overall fair condition.

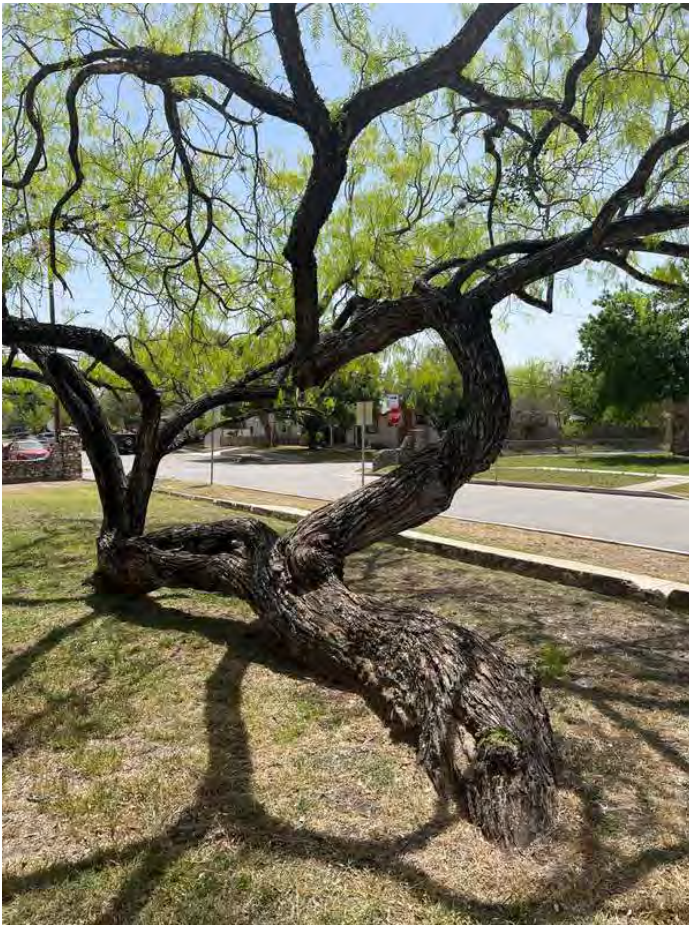
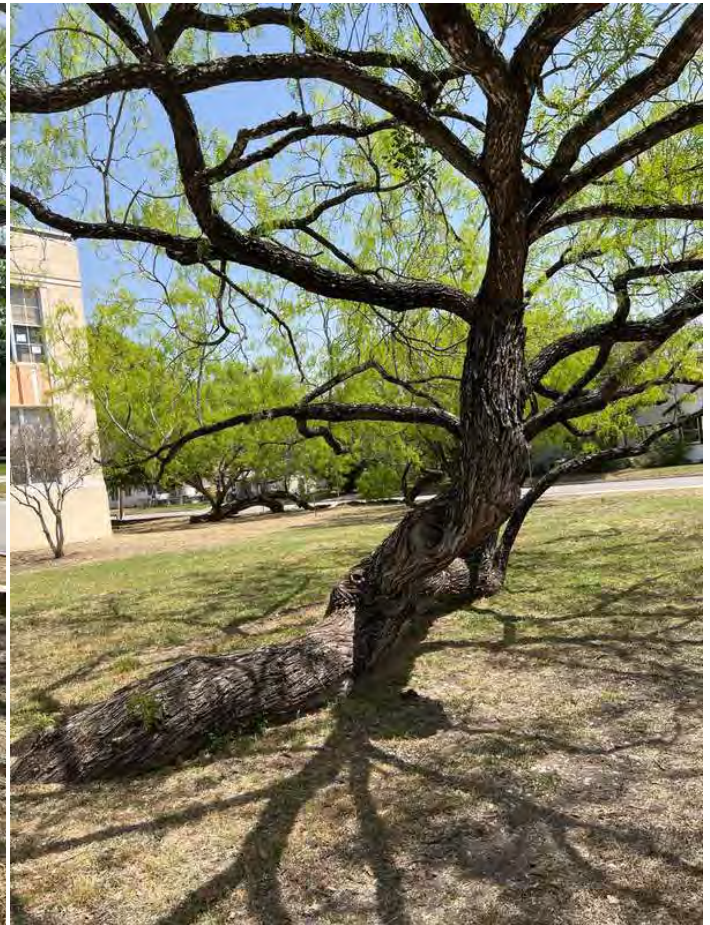
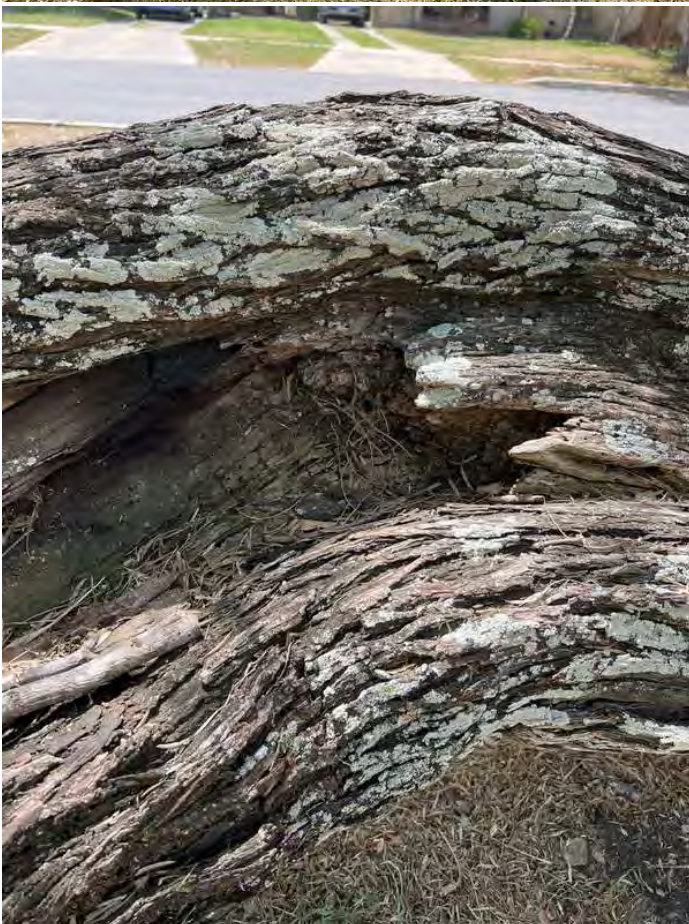
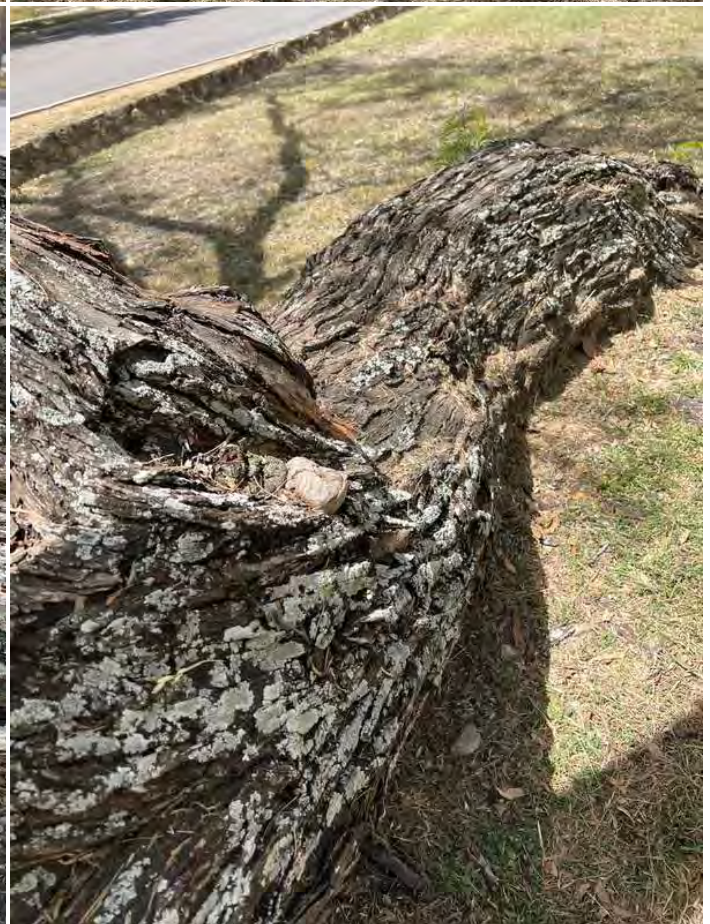
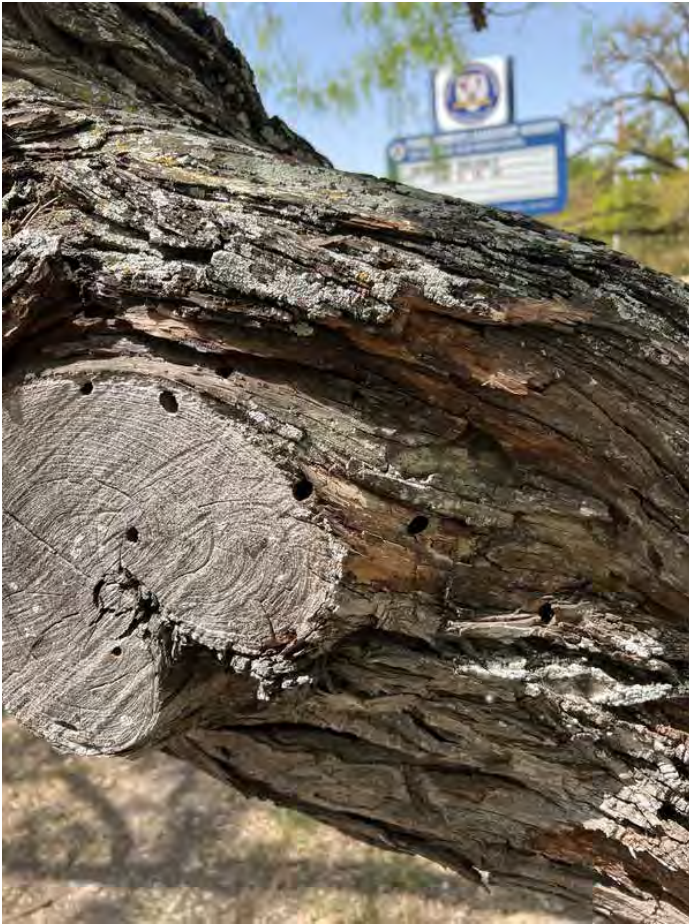
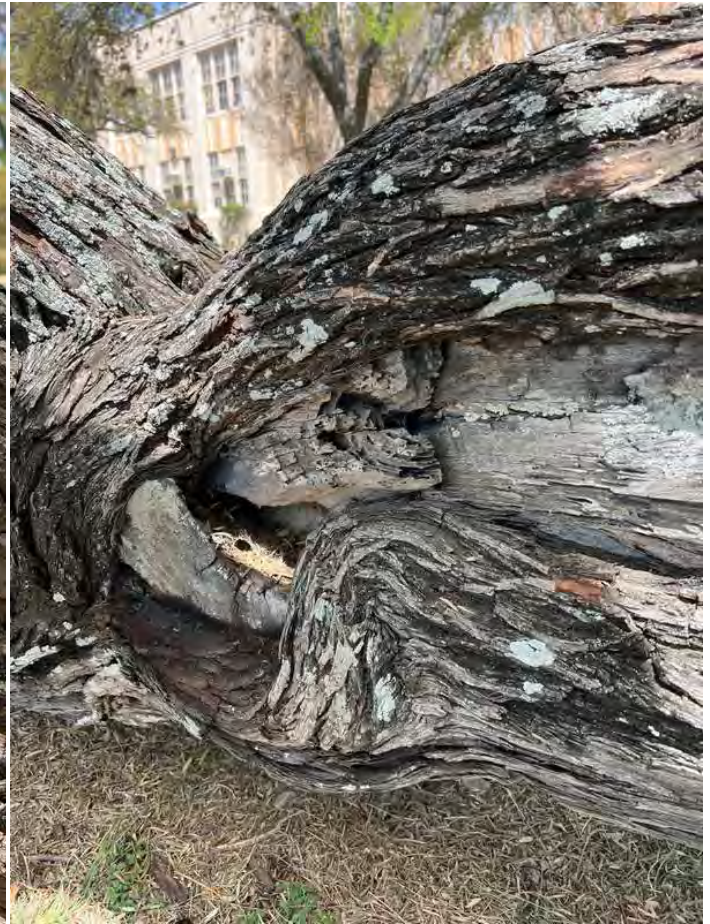
<b>Tree Number</b>	9008
<b>Tree Species</b>	Mesquite
<b>Diameter (DBH)</b>	21
<b>Multi Stem Notes</b>	
<b>Condition</b>	Very Poor
<b>Summary</b>	Tree # 9008, a 21" Mesquite, is in very poor condition due to excessive lean. Tree has failed and trunk is laying on the ground. Tree has significant cavities and decay with evidence of termites and wood borers. Surveyed as a 28", only largest trunk was required for measurement. Candidate recommended for removal. Only the largest trunk is utilized for diameter at breast height measurement with this species.

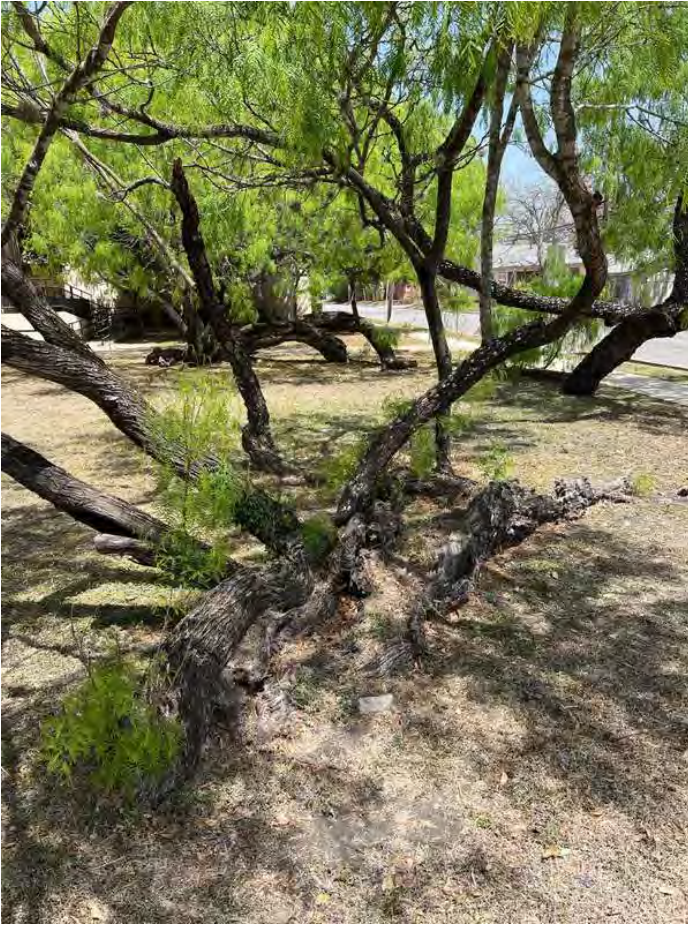
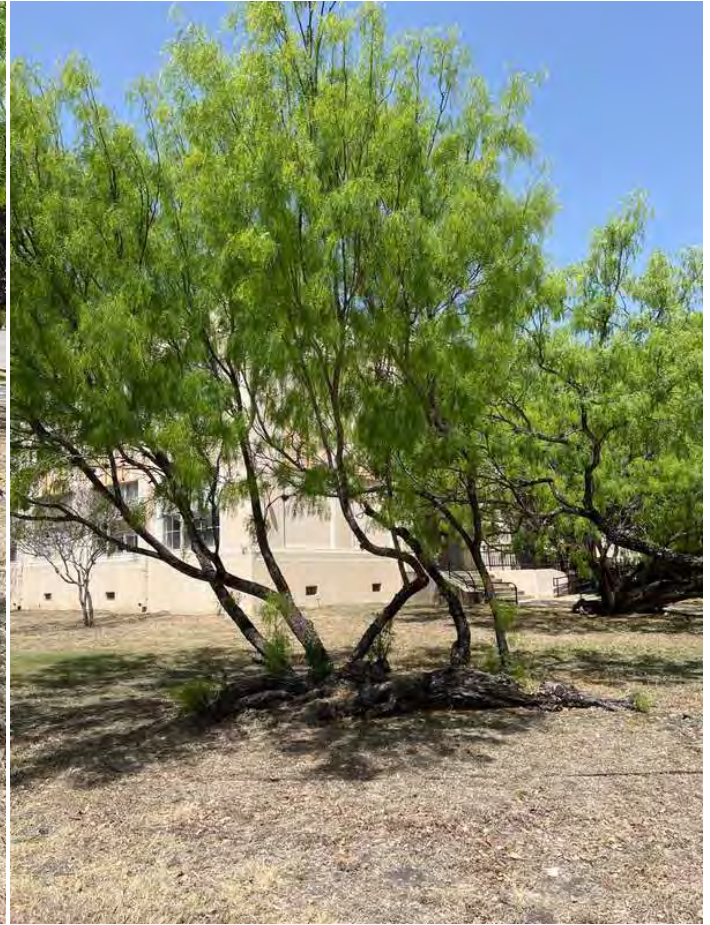
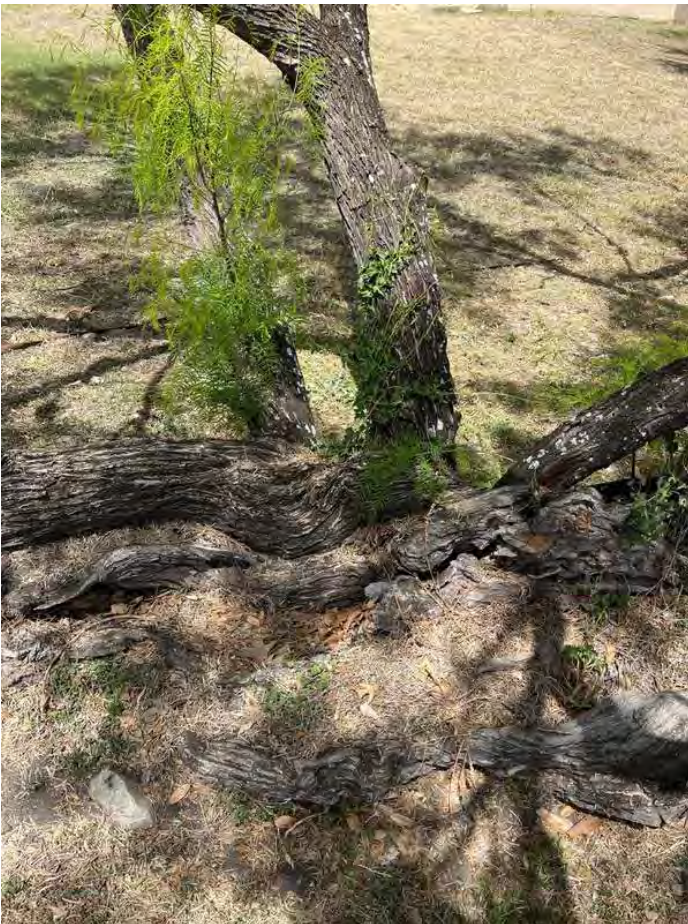
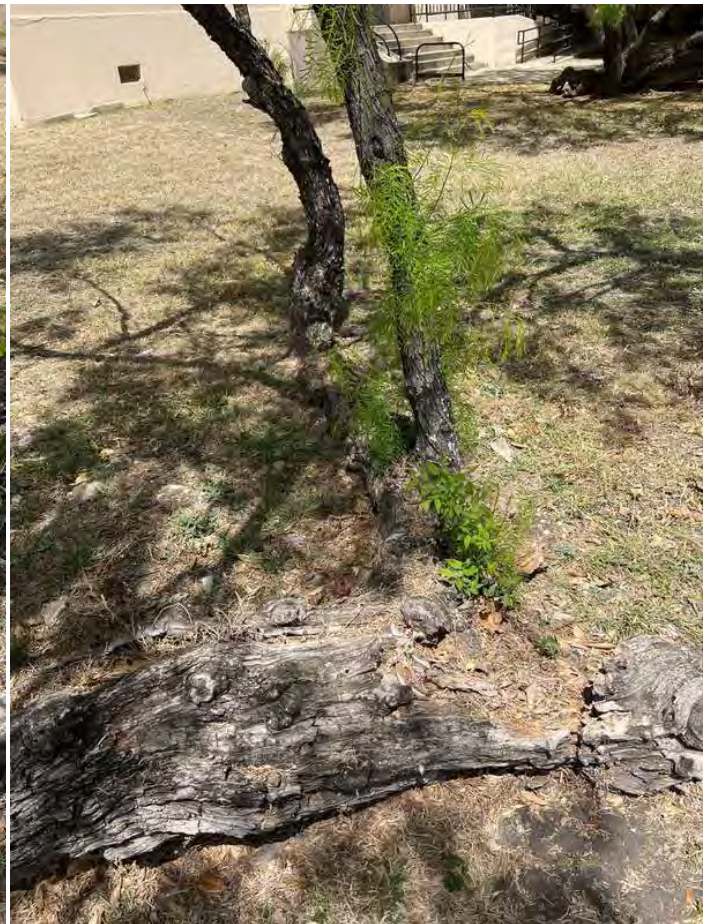
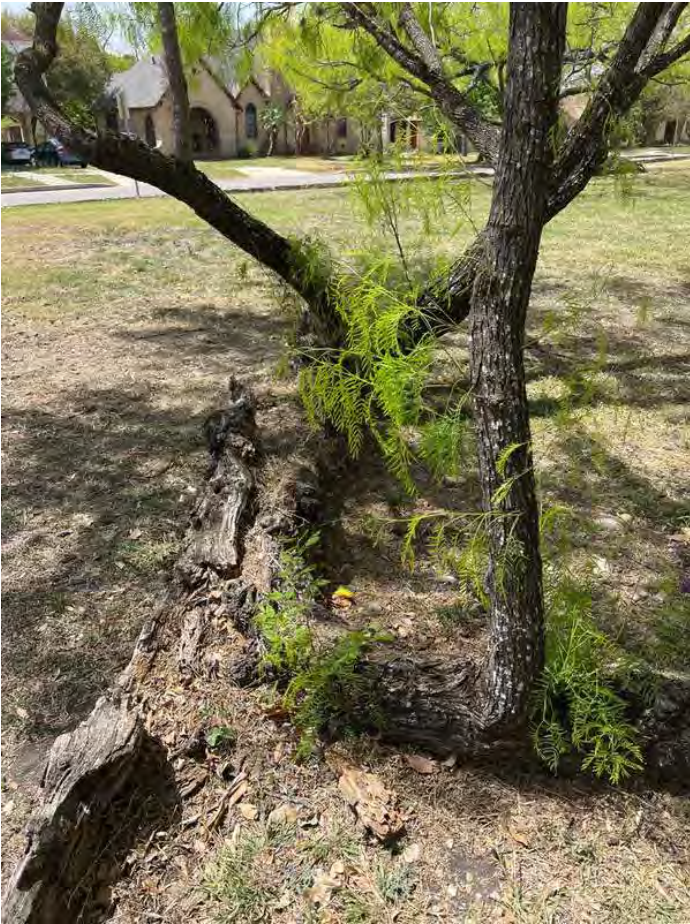
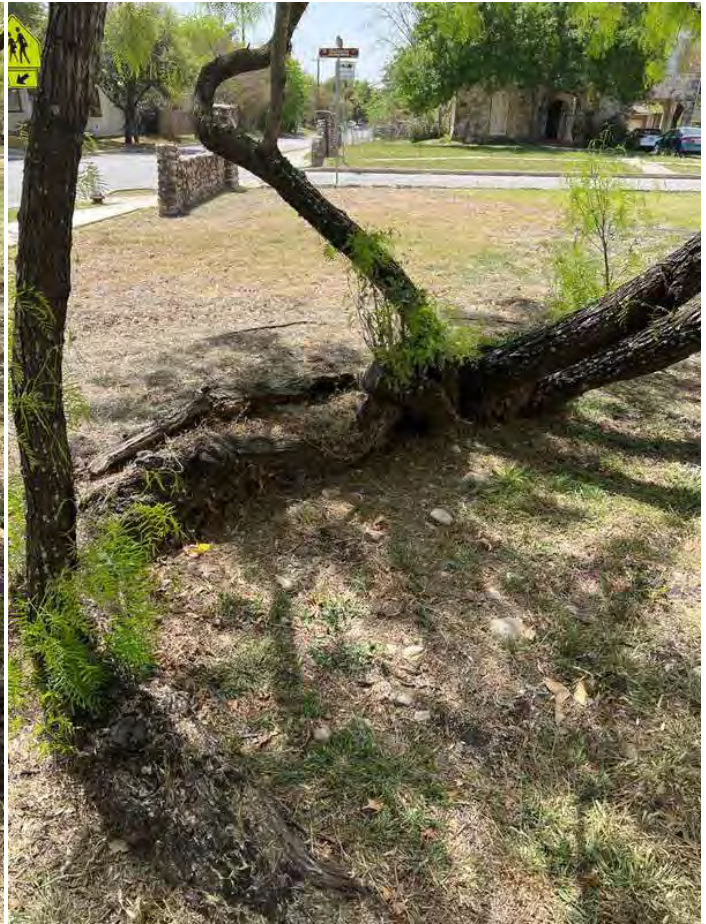
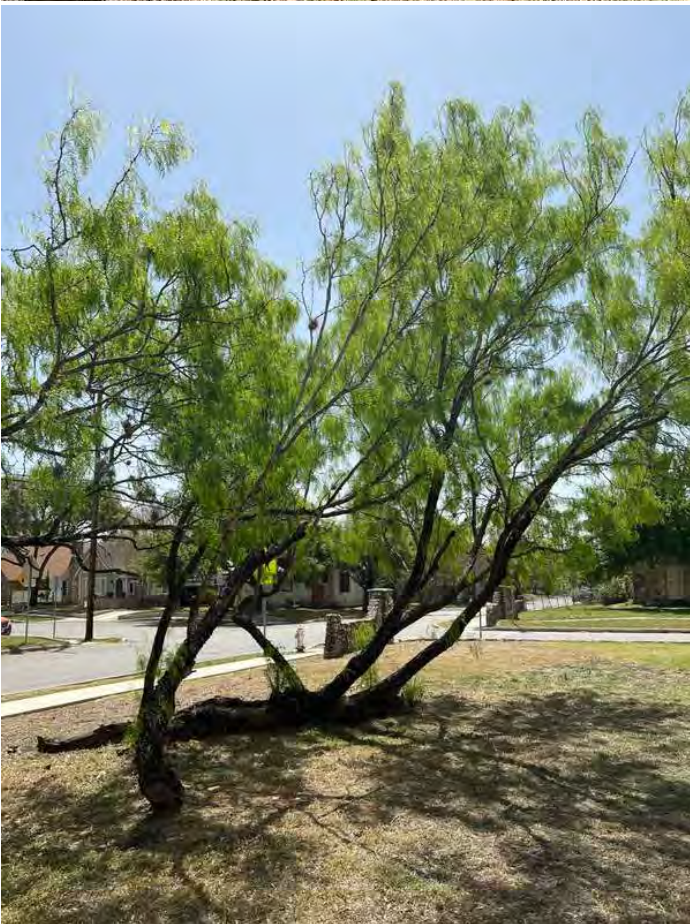
<b>Tree Number</b>	9009
<b>Tree Species</b>	Mesquite
<b>Diameter (DBH)</b>	7.5
<b>Multi Stem Notes</b>	
<b>Condition</b>	Very Poor
<b>Summary</b>	Tree # 9009, a 7.5" Mesquite, is in very poor condition due to excessive lean. Tree has failed and trunk is laying on the ground. Excessive cavities, decay and trunk rot. Largest stem was measured from main trunk at breast height and is does not meet the threshold for protection under City ordinance. Candidate recommended for removal. Only the largest trunk is utilized for diameter at breast height measurement with this species.

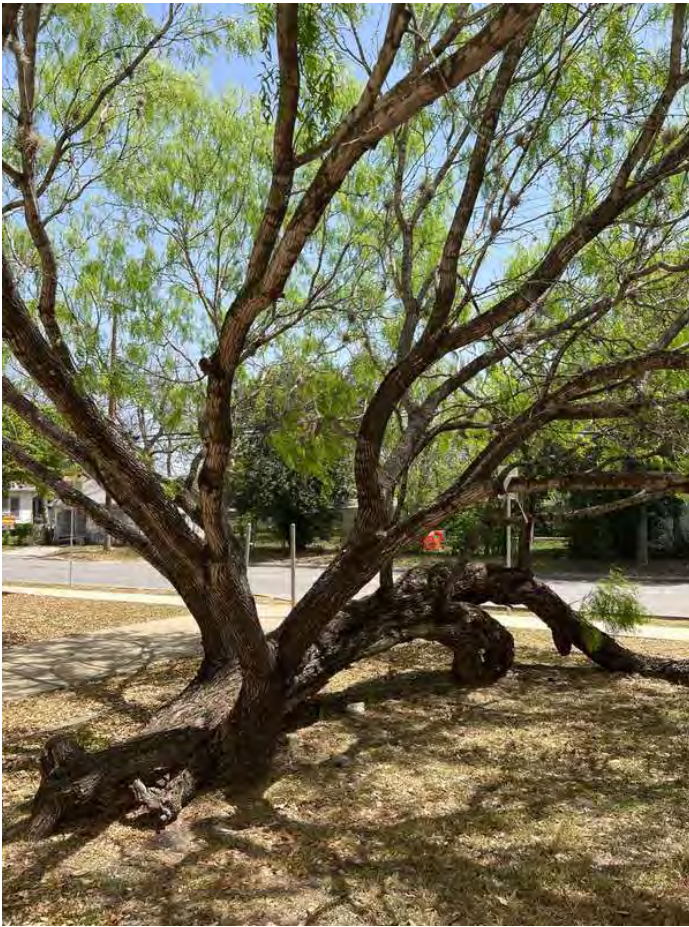
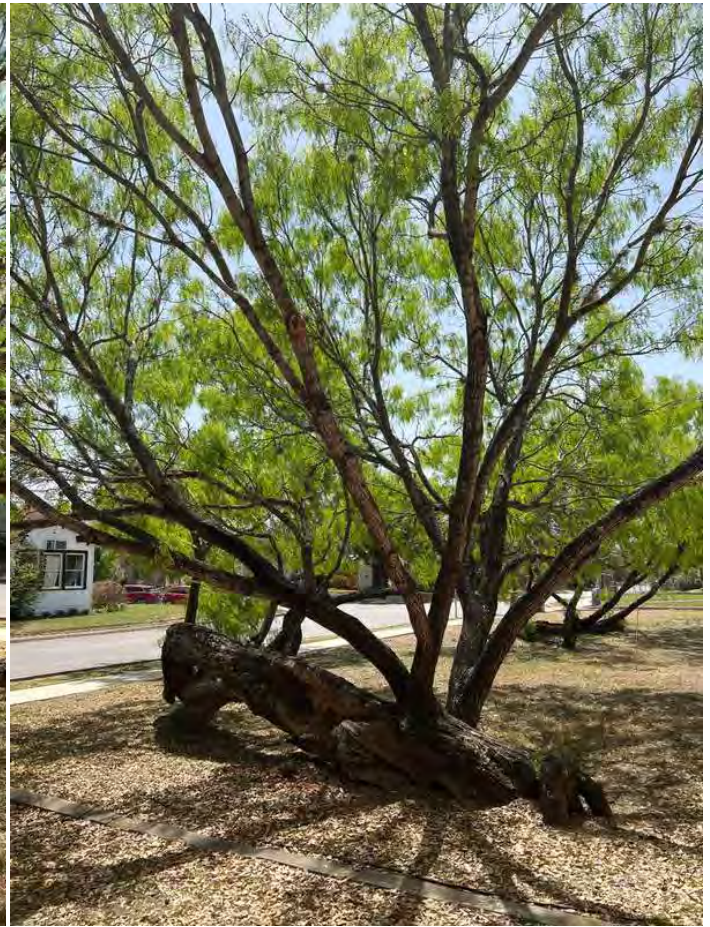
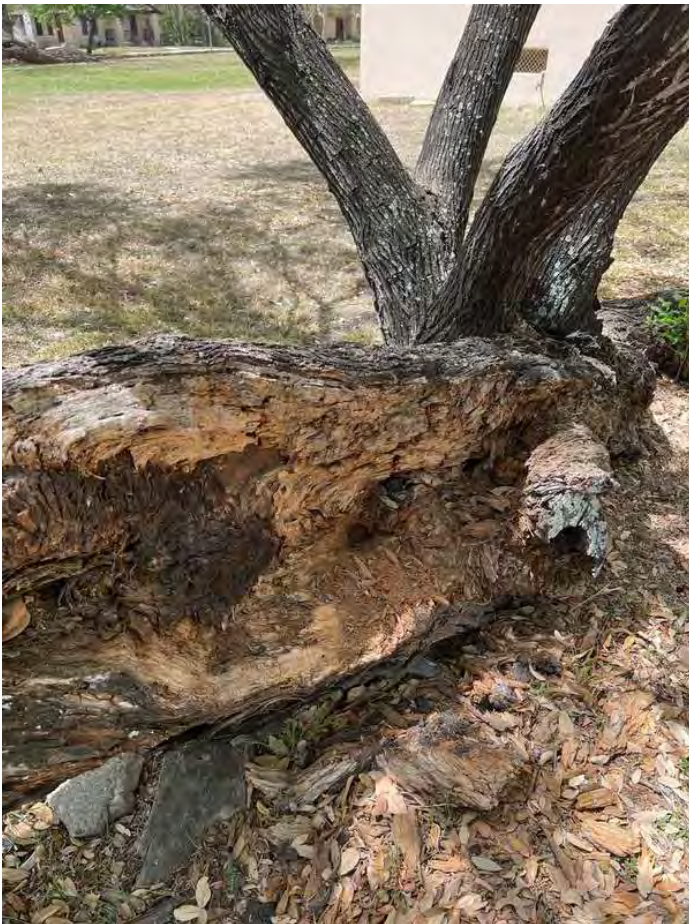
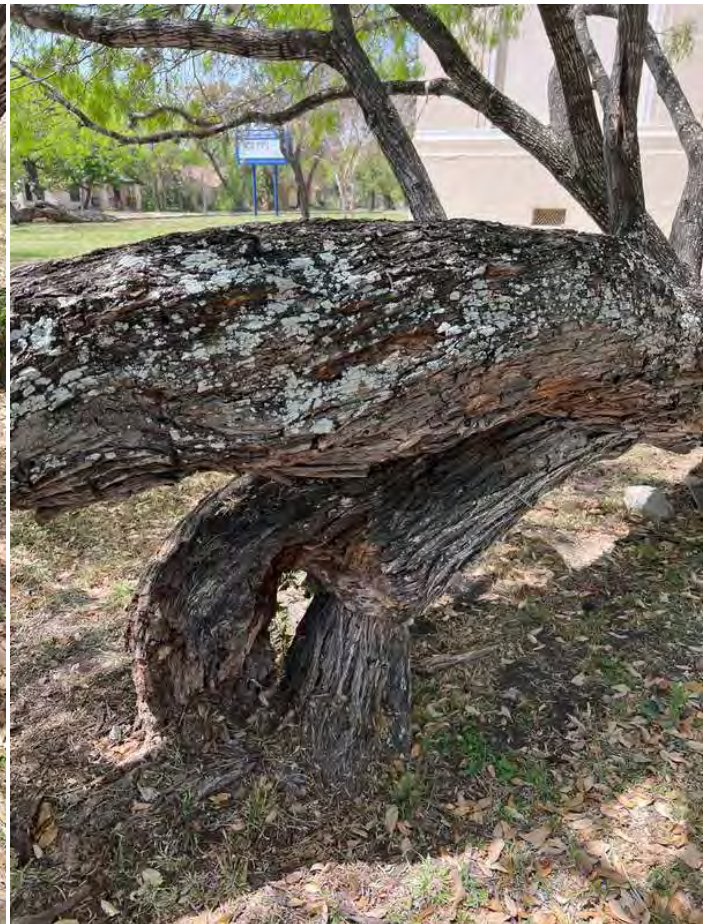
<b>Tree Number</b>	9010
<b>Tree Species</b>	Mesquite
<b>Diameter (DBH)</b>	20.5
<b>Multi Stem Notes</b>	
<b>Condition</b>	Very Poor
<b>Summary</b>	Tree # 9010, a 20.5" Mesquite, is in very poor condition due to excessive lean and very poor structure. Main trunk failed and is laying on the ground. Tree has excessive cavities, decay and trunk rot. Measured as a 20.5" at breast height but initially surveyed as a 38". Candidate recommended for removal. Only the largest trunk is utilized for diameter at breast height measurement with this species.
