HISTORIC AND DESIGN REVIEW COMMISSION

July 20, 2022

HDRC CASE NO: 2022-303
ADDRESS: 226 E HUISACHE AVE
LEGAL DESCRIPTION: NCB 3086 BLK 2 LOT 7
ZONING: R-4 CD, H
CITY COUNCIL DIST.: 1
DISTRICT: Monte Vista Historic District
APPLICANT: Nadav Givoni/GR-226 HUISACHE LLC
OWNER: Nadav Givoni/GR-226 HUISACHE LLC
TYPE OF WORK: Window replacement
APPLICATION RECEIVED: May 01, 2022
60-DAY REVIEW: Not applicable due to City Council Emergency Orders
CASE MANAGER: Hannah Leighner
REQUEST:

The applicant is requesting a Certificate of Appropriateness for approval to replace nineteen (19) existing wood windows with new wood windows.

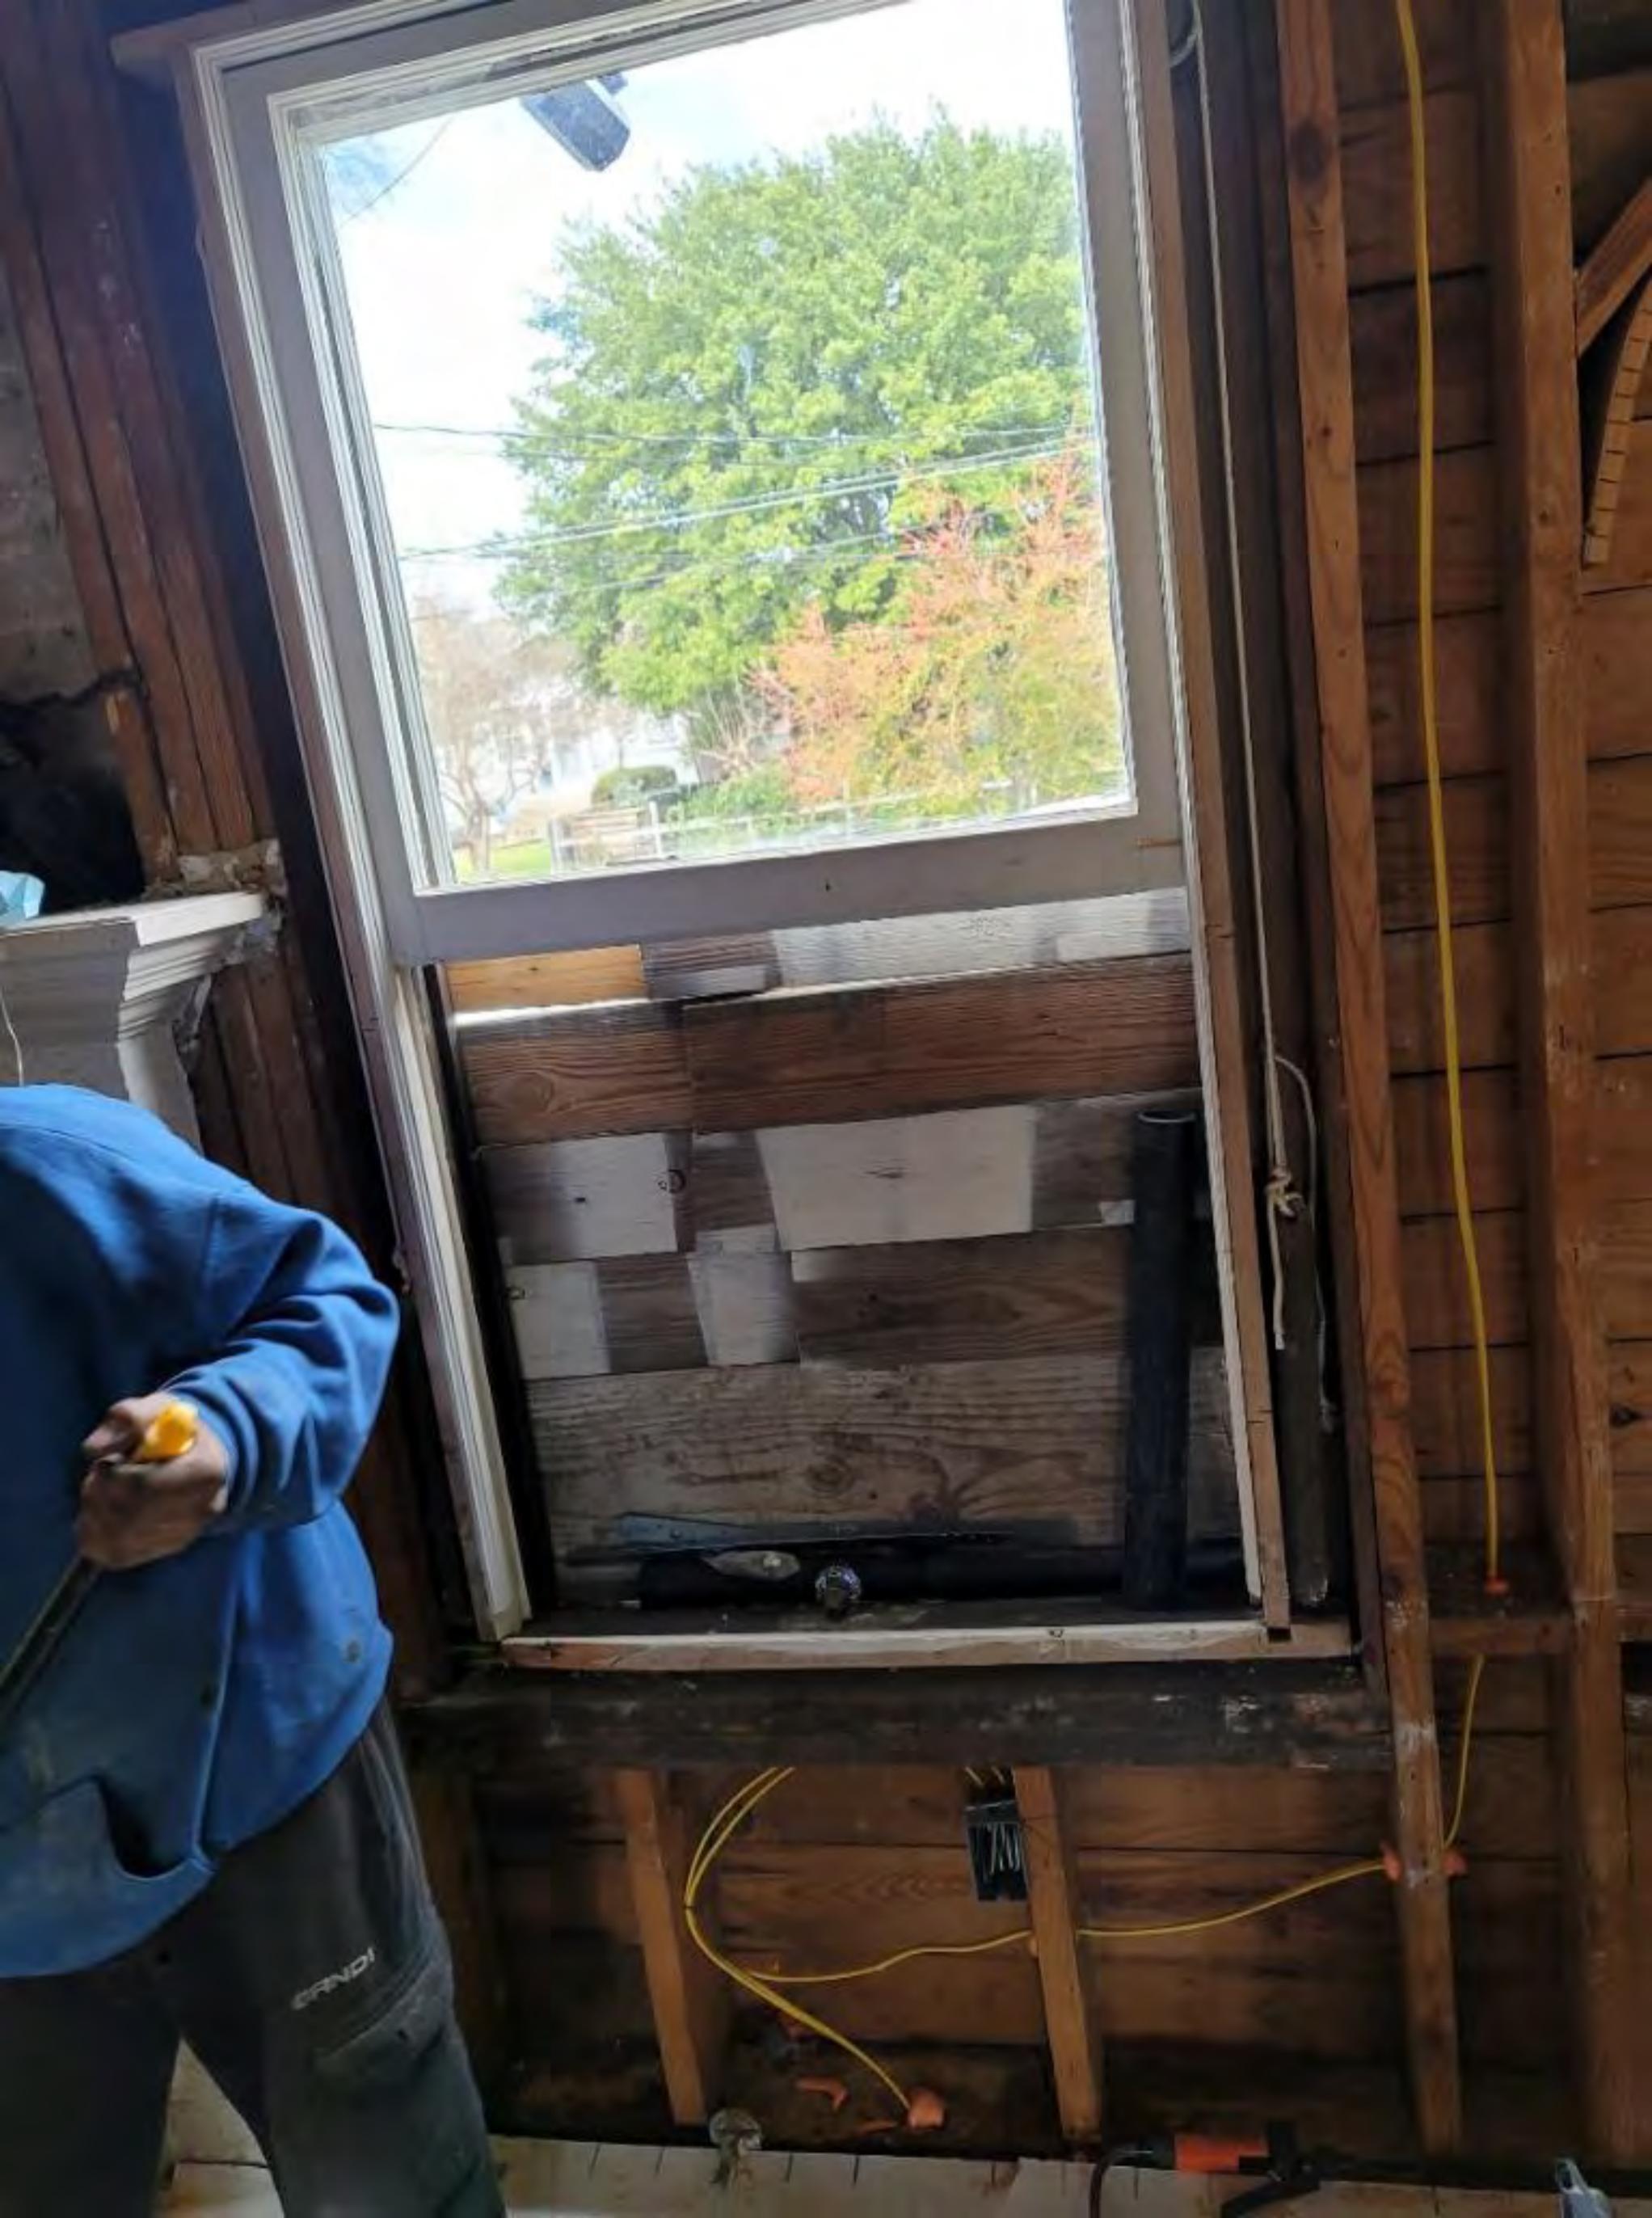
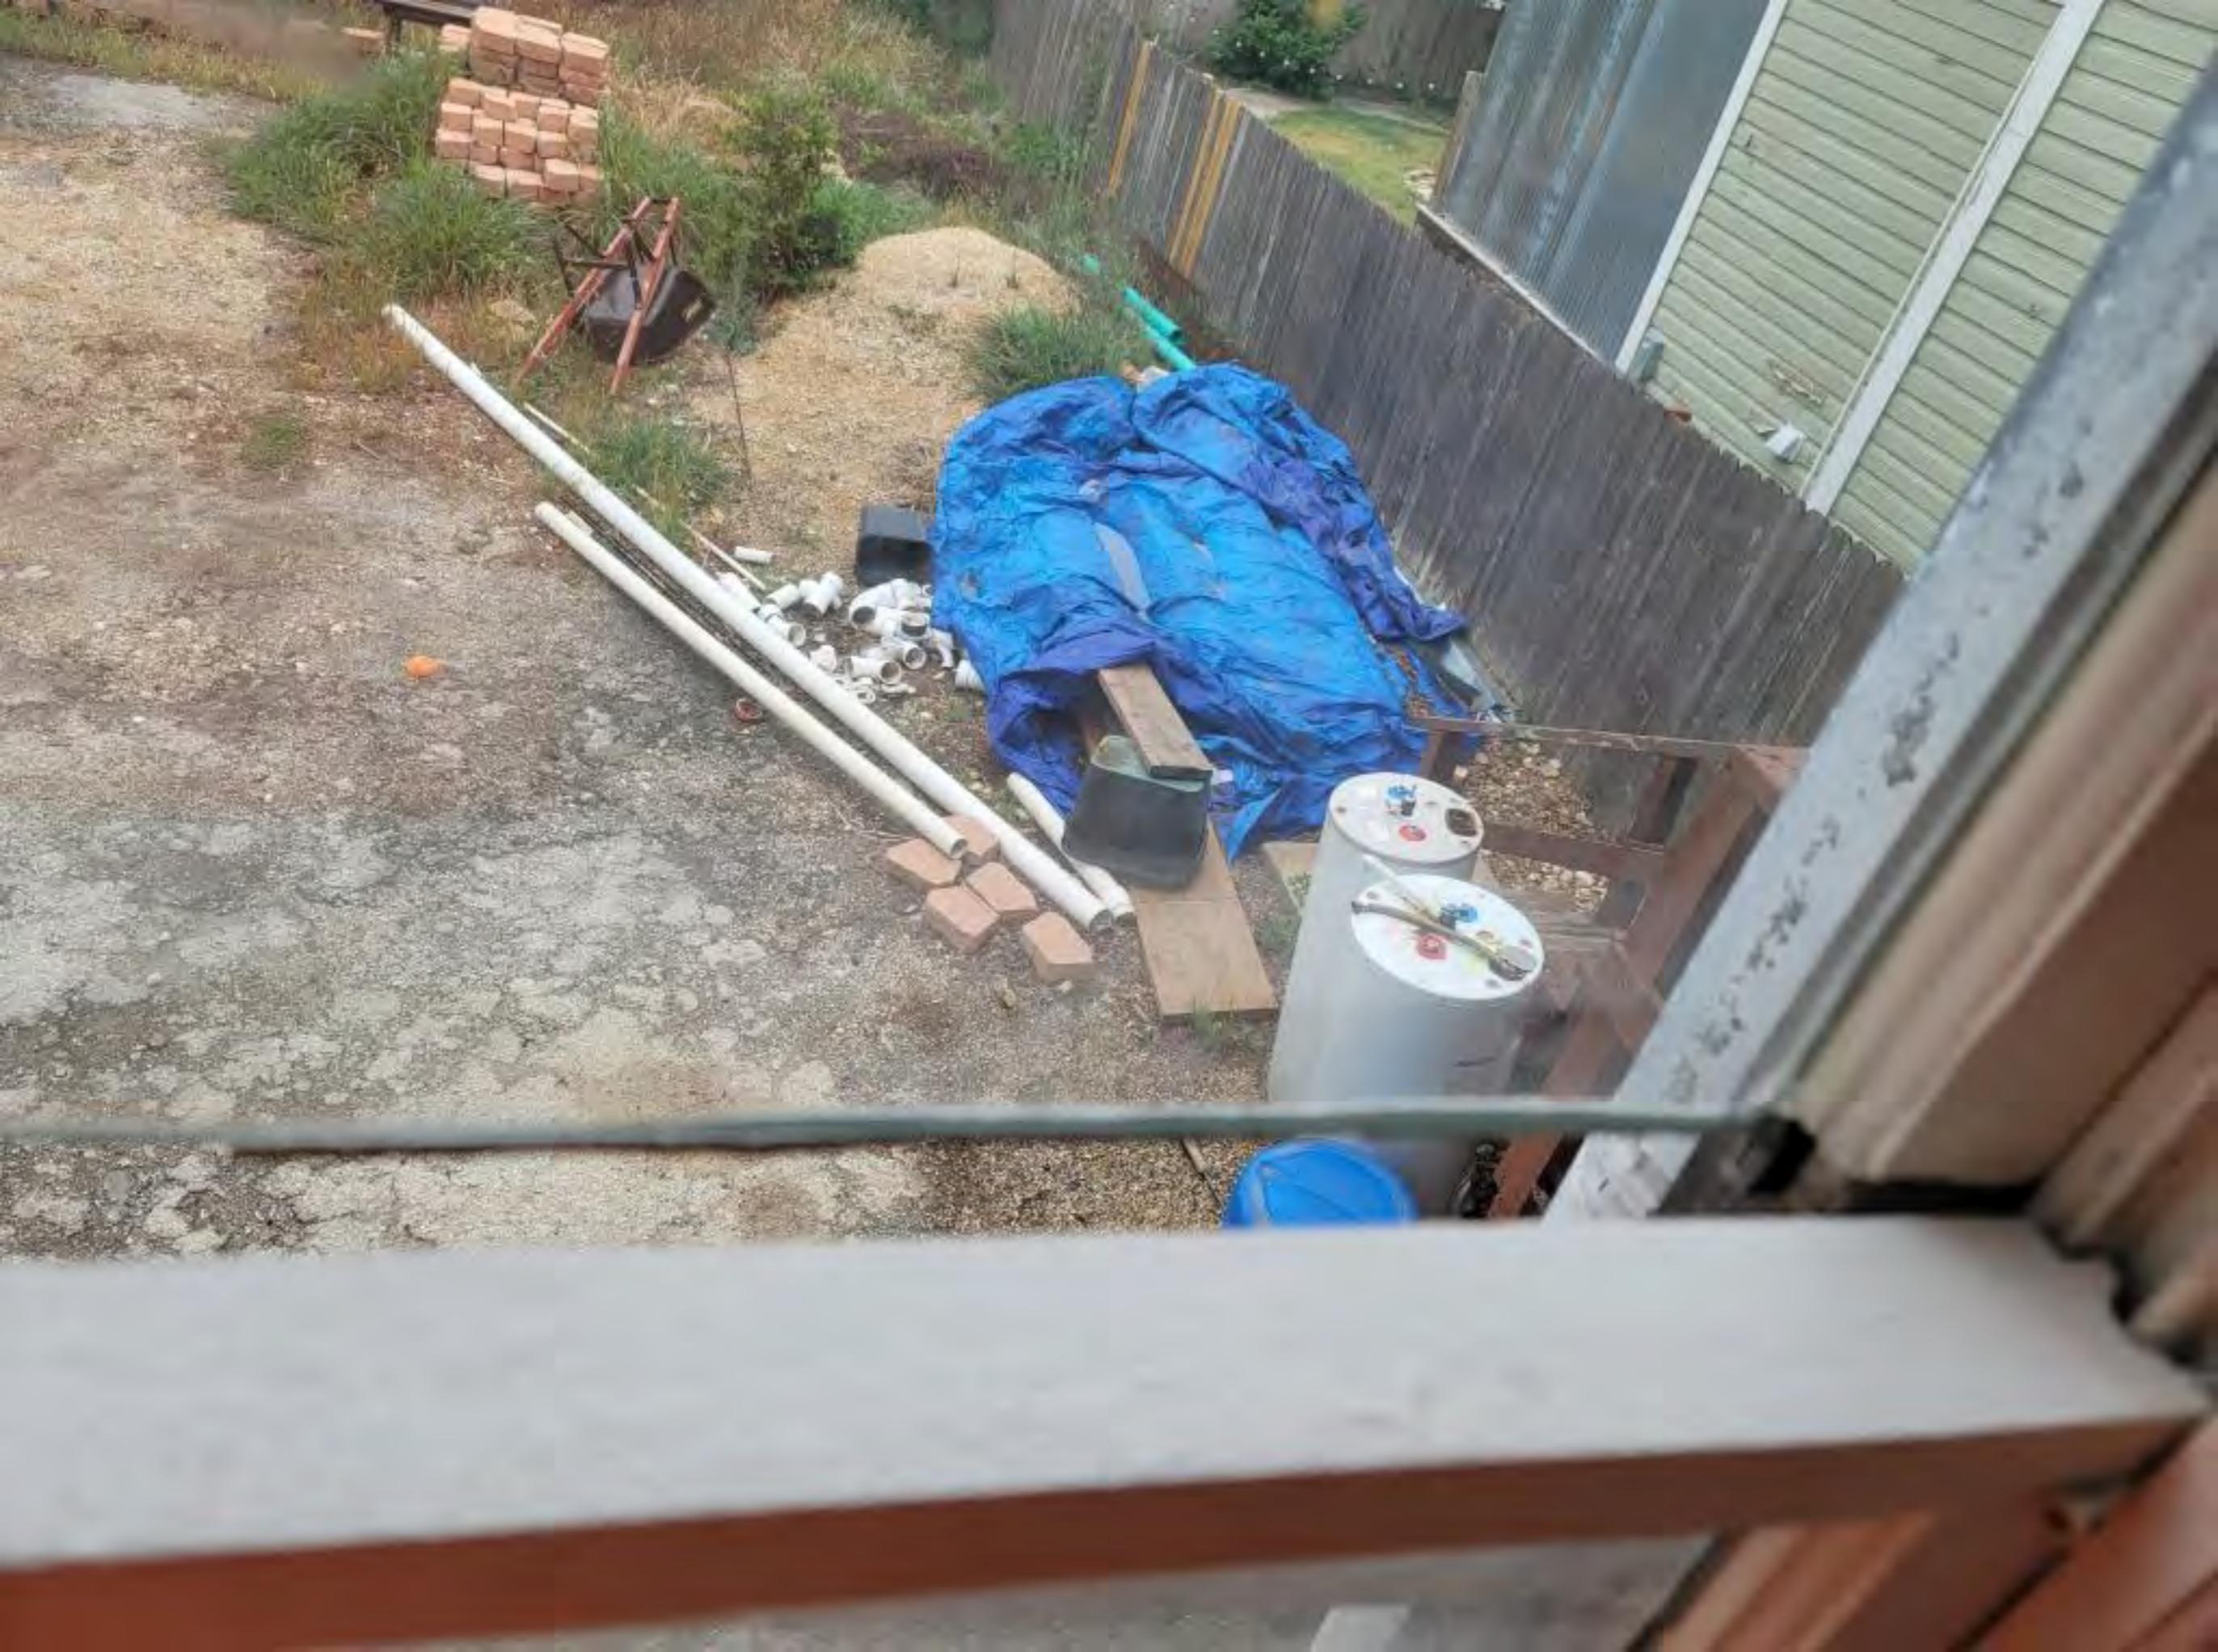
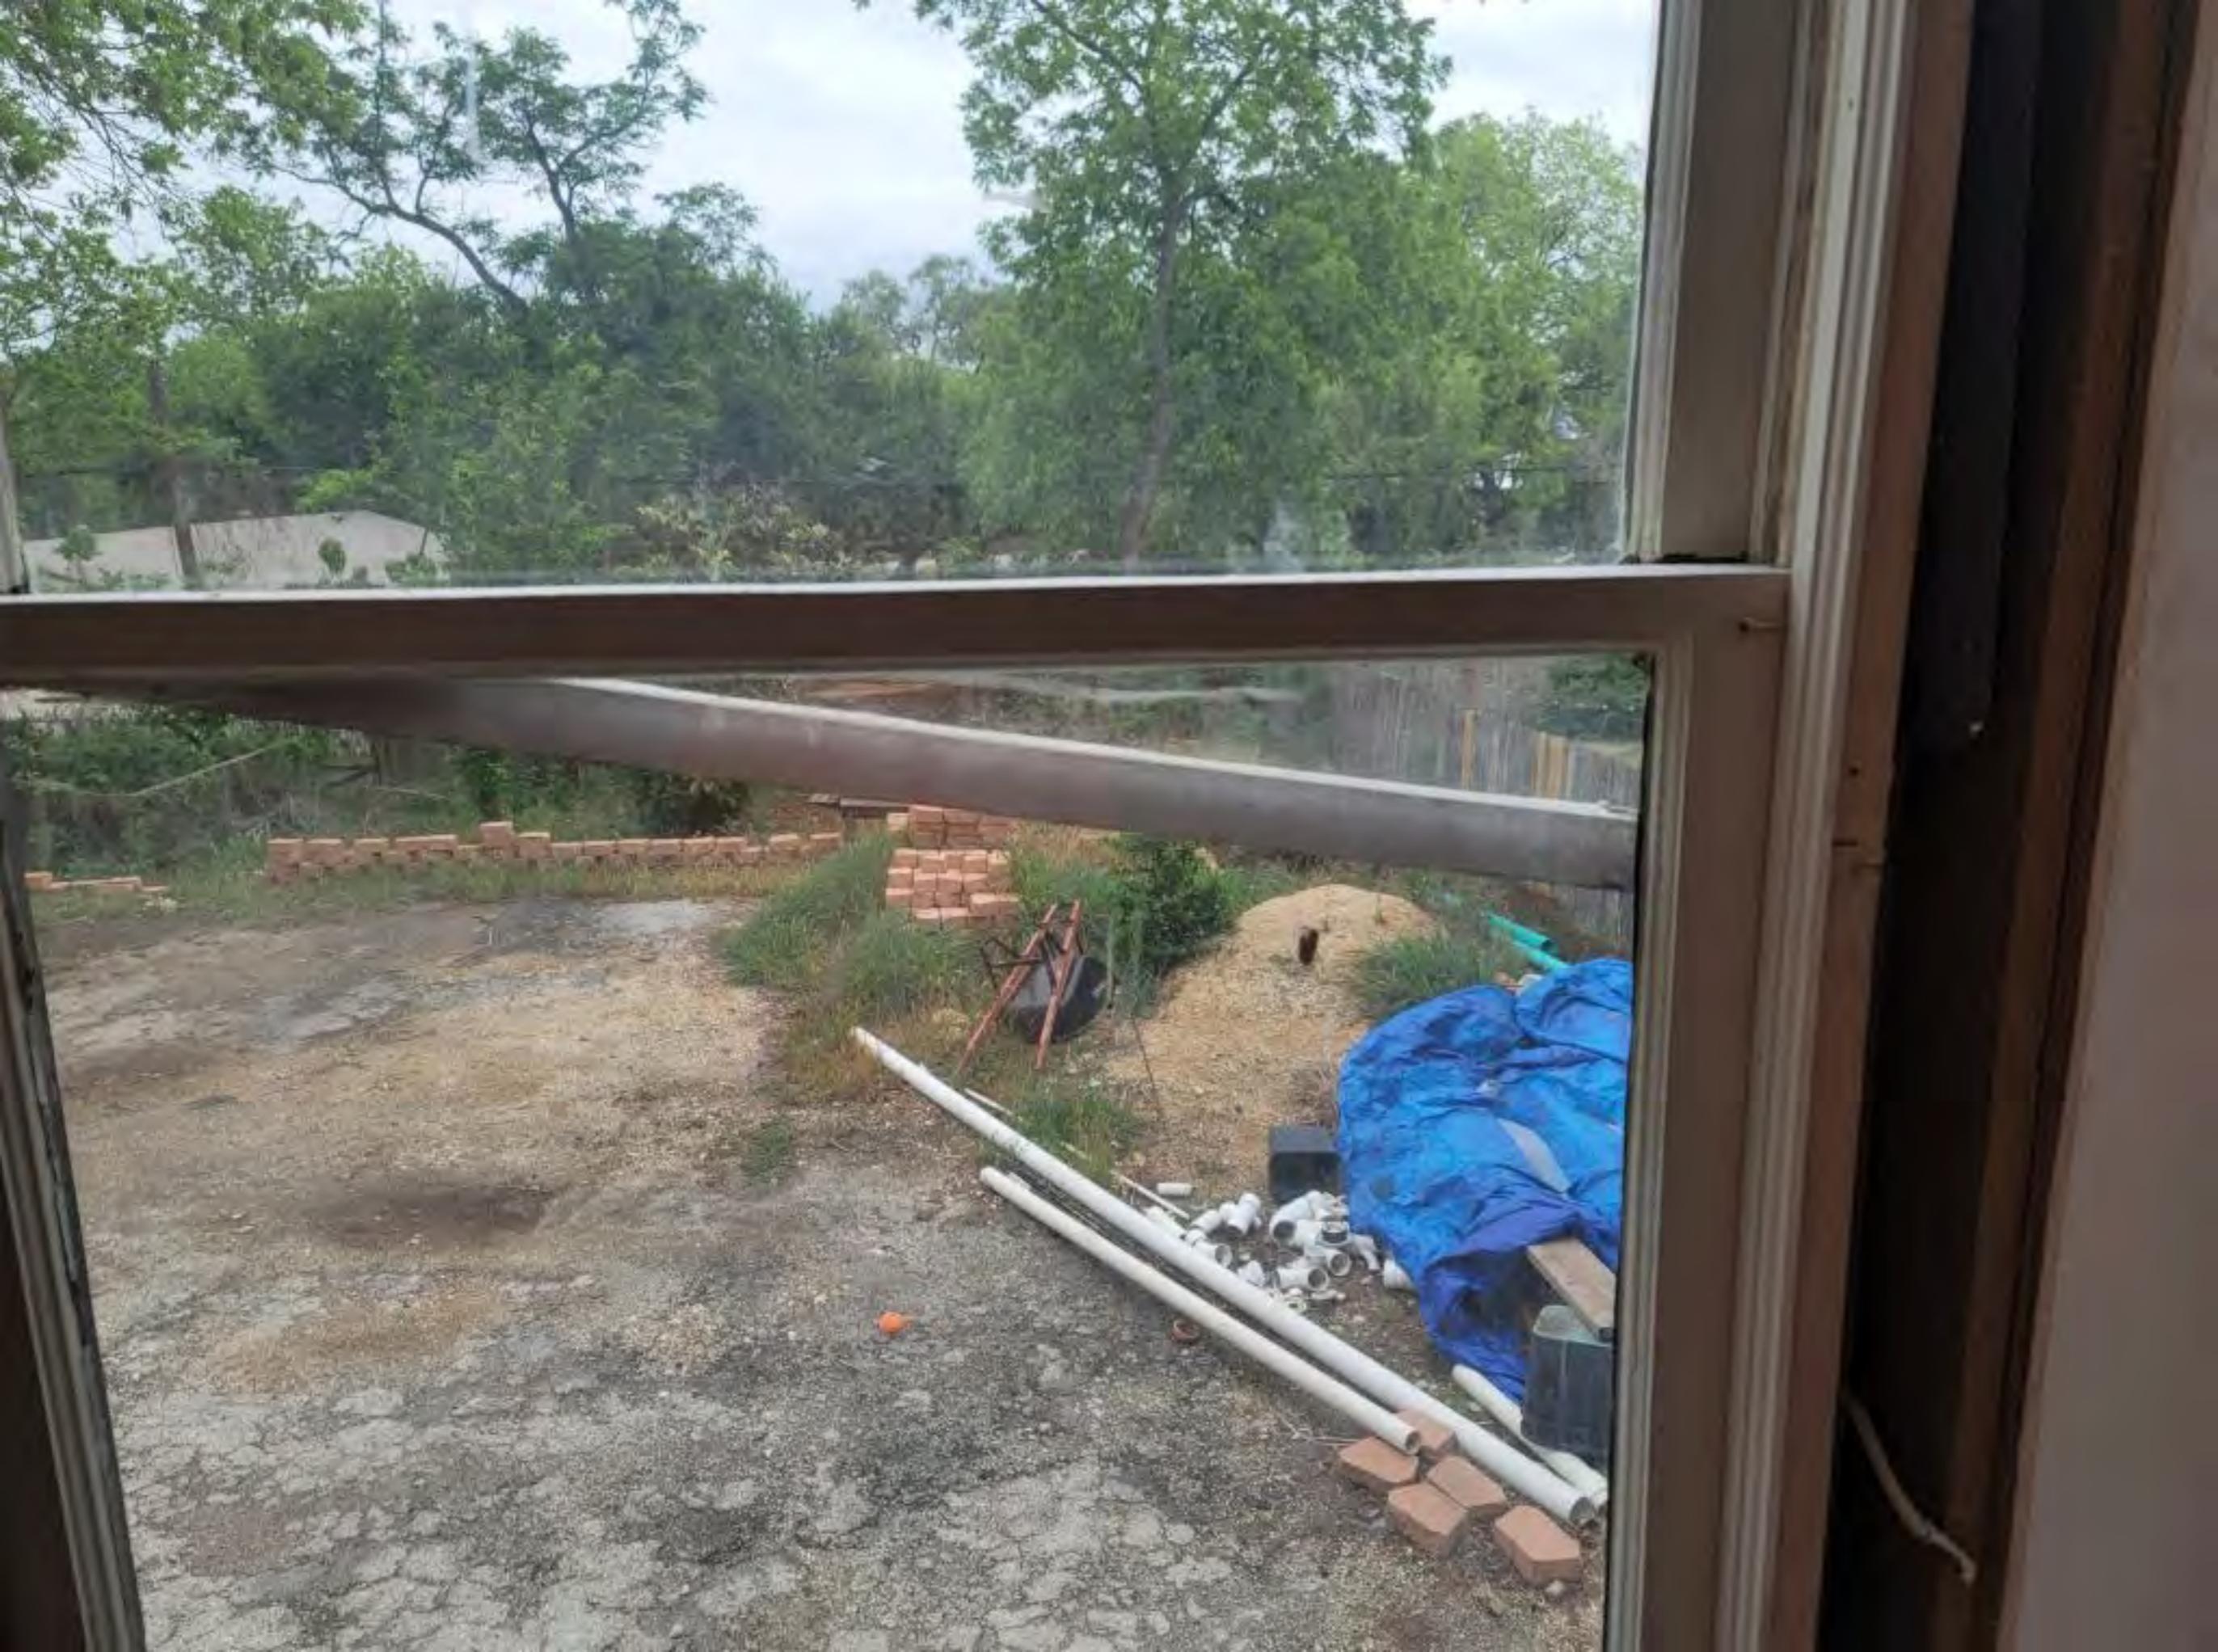
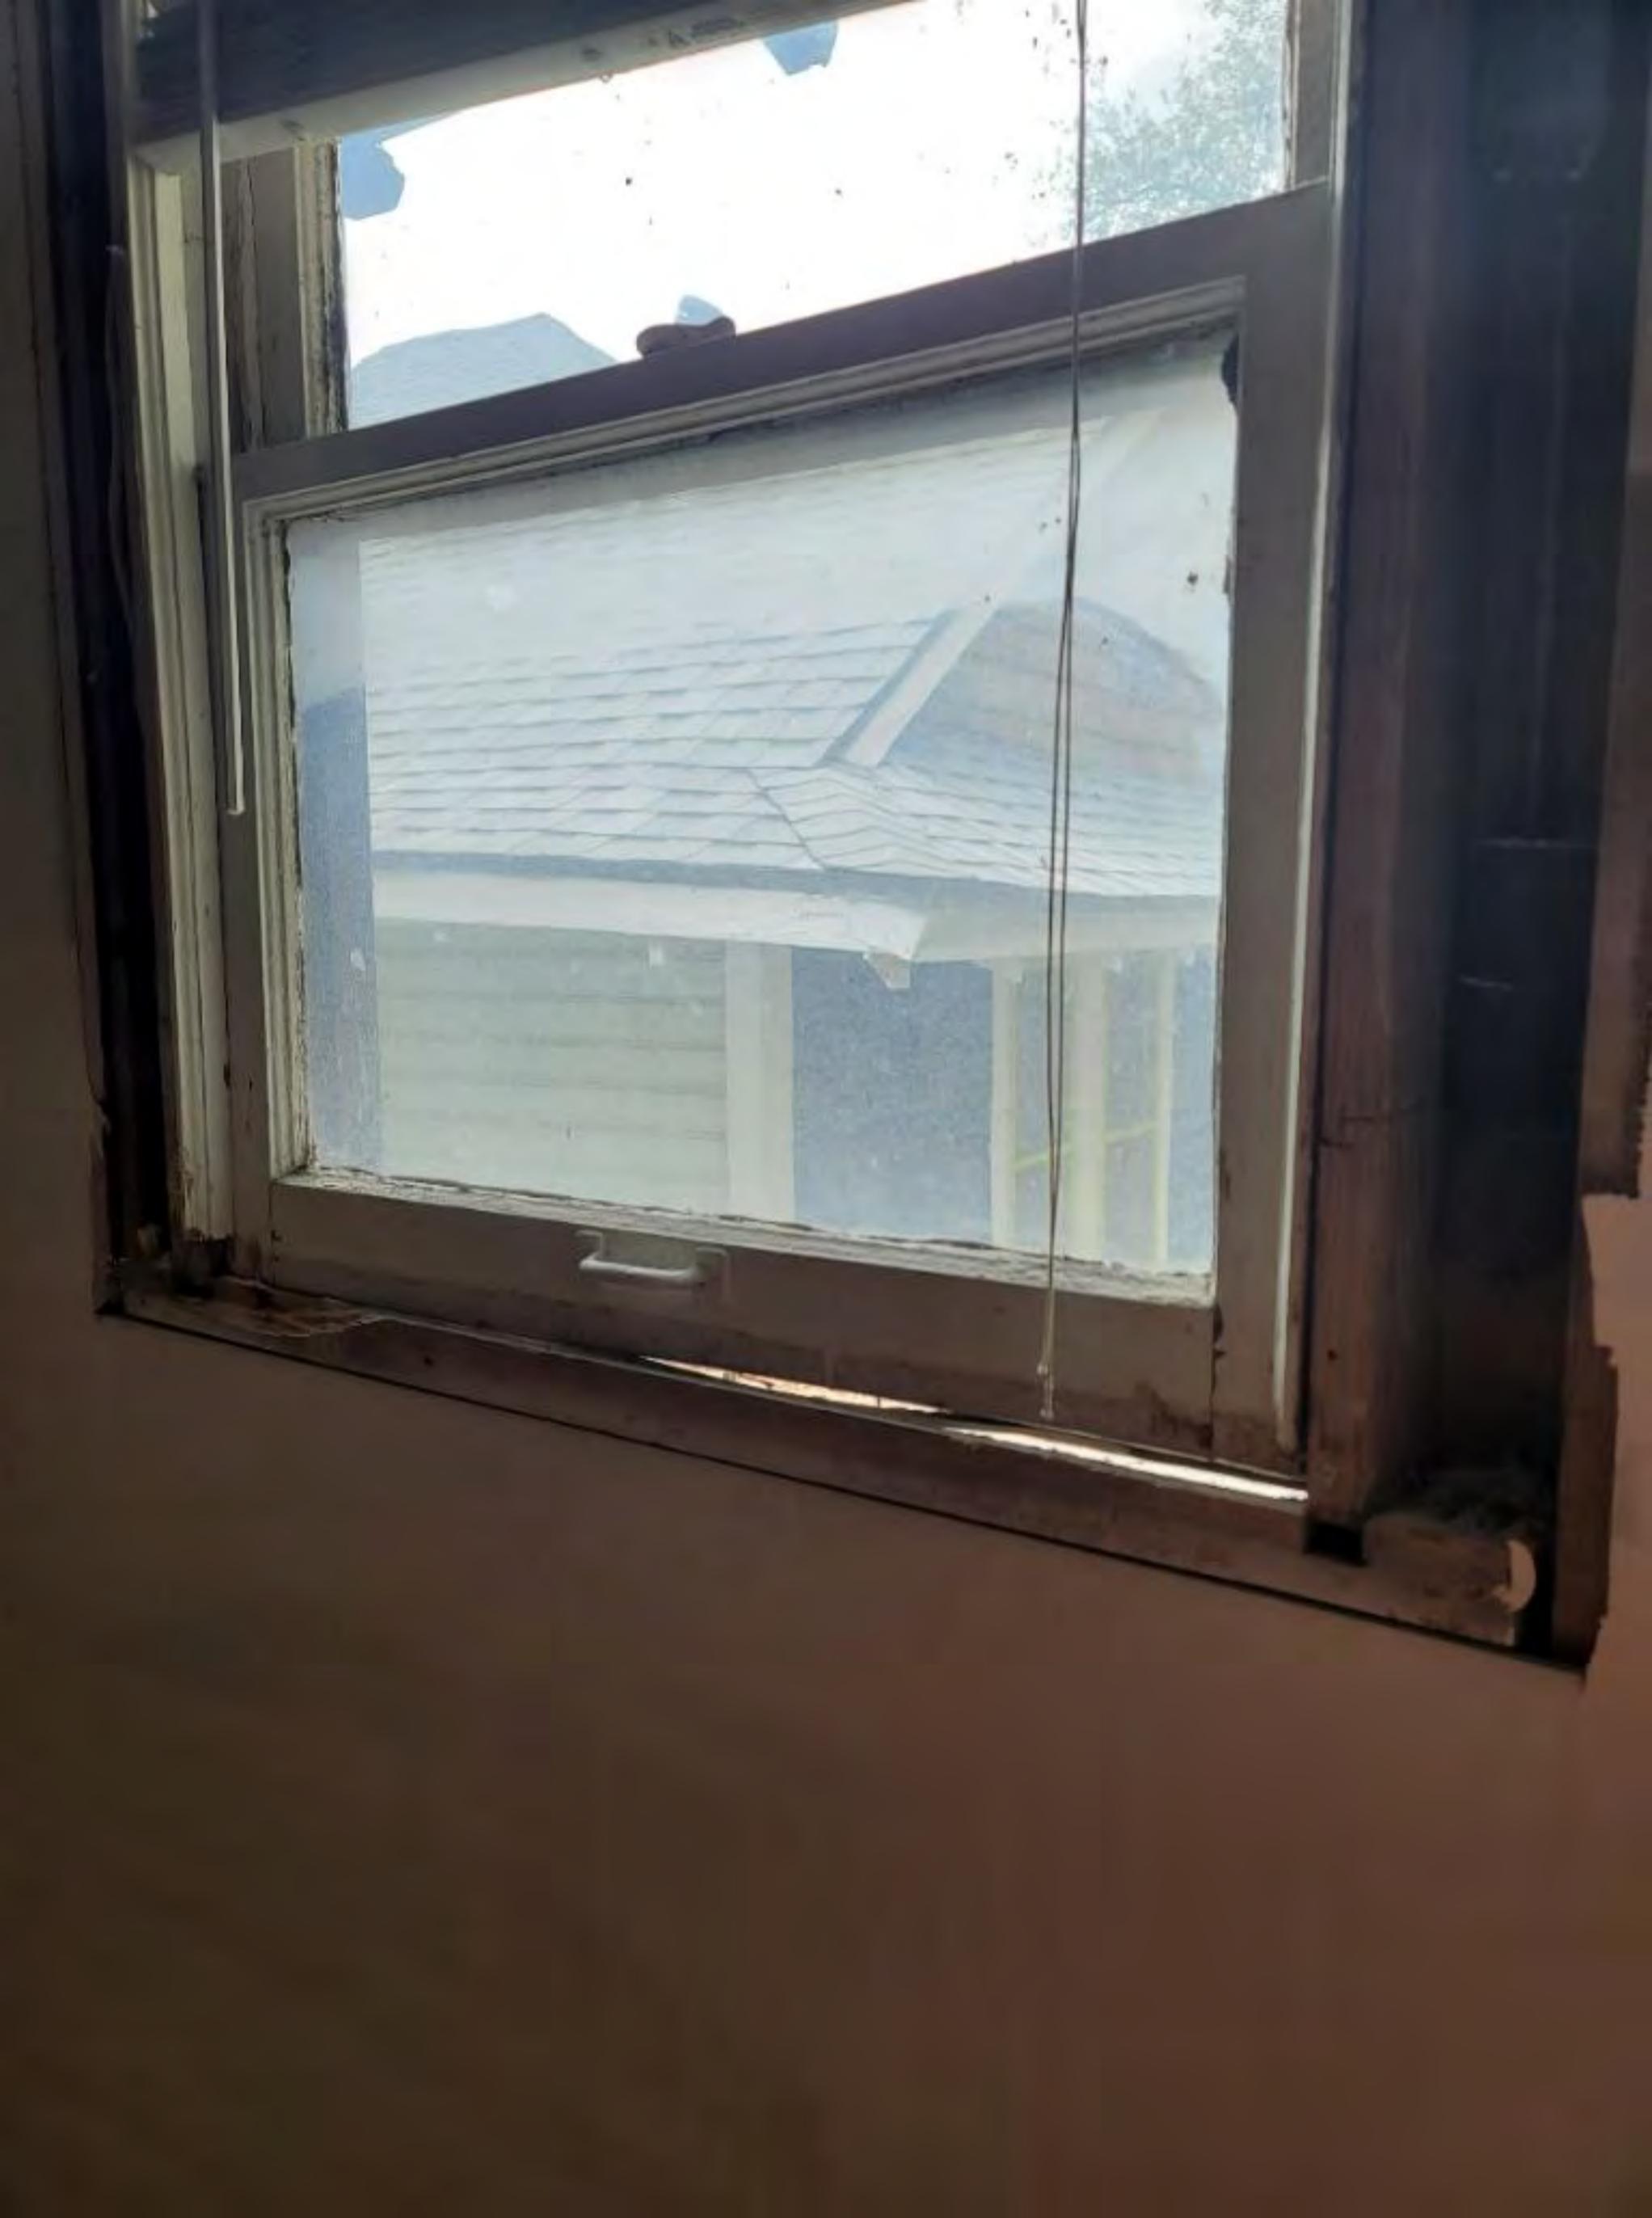
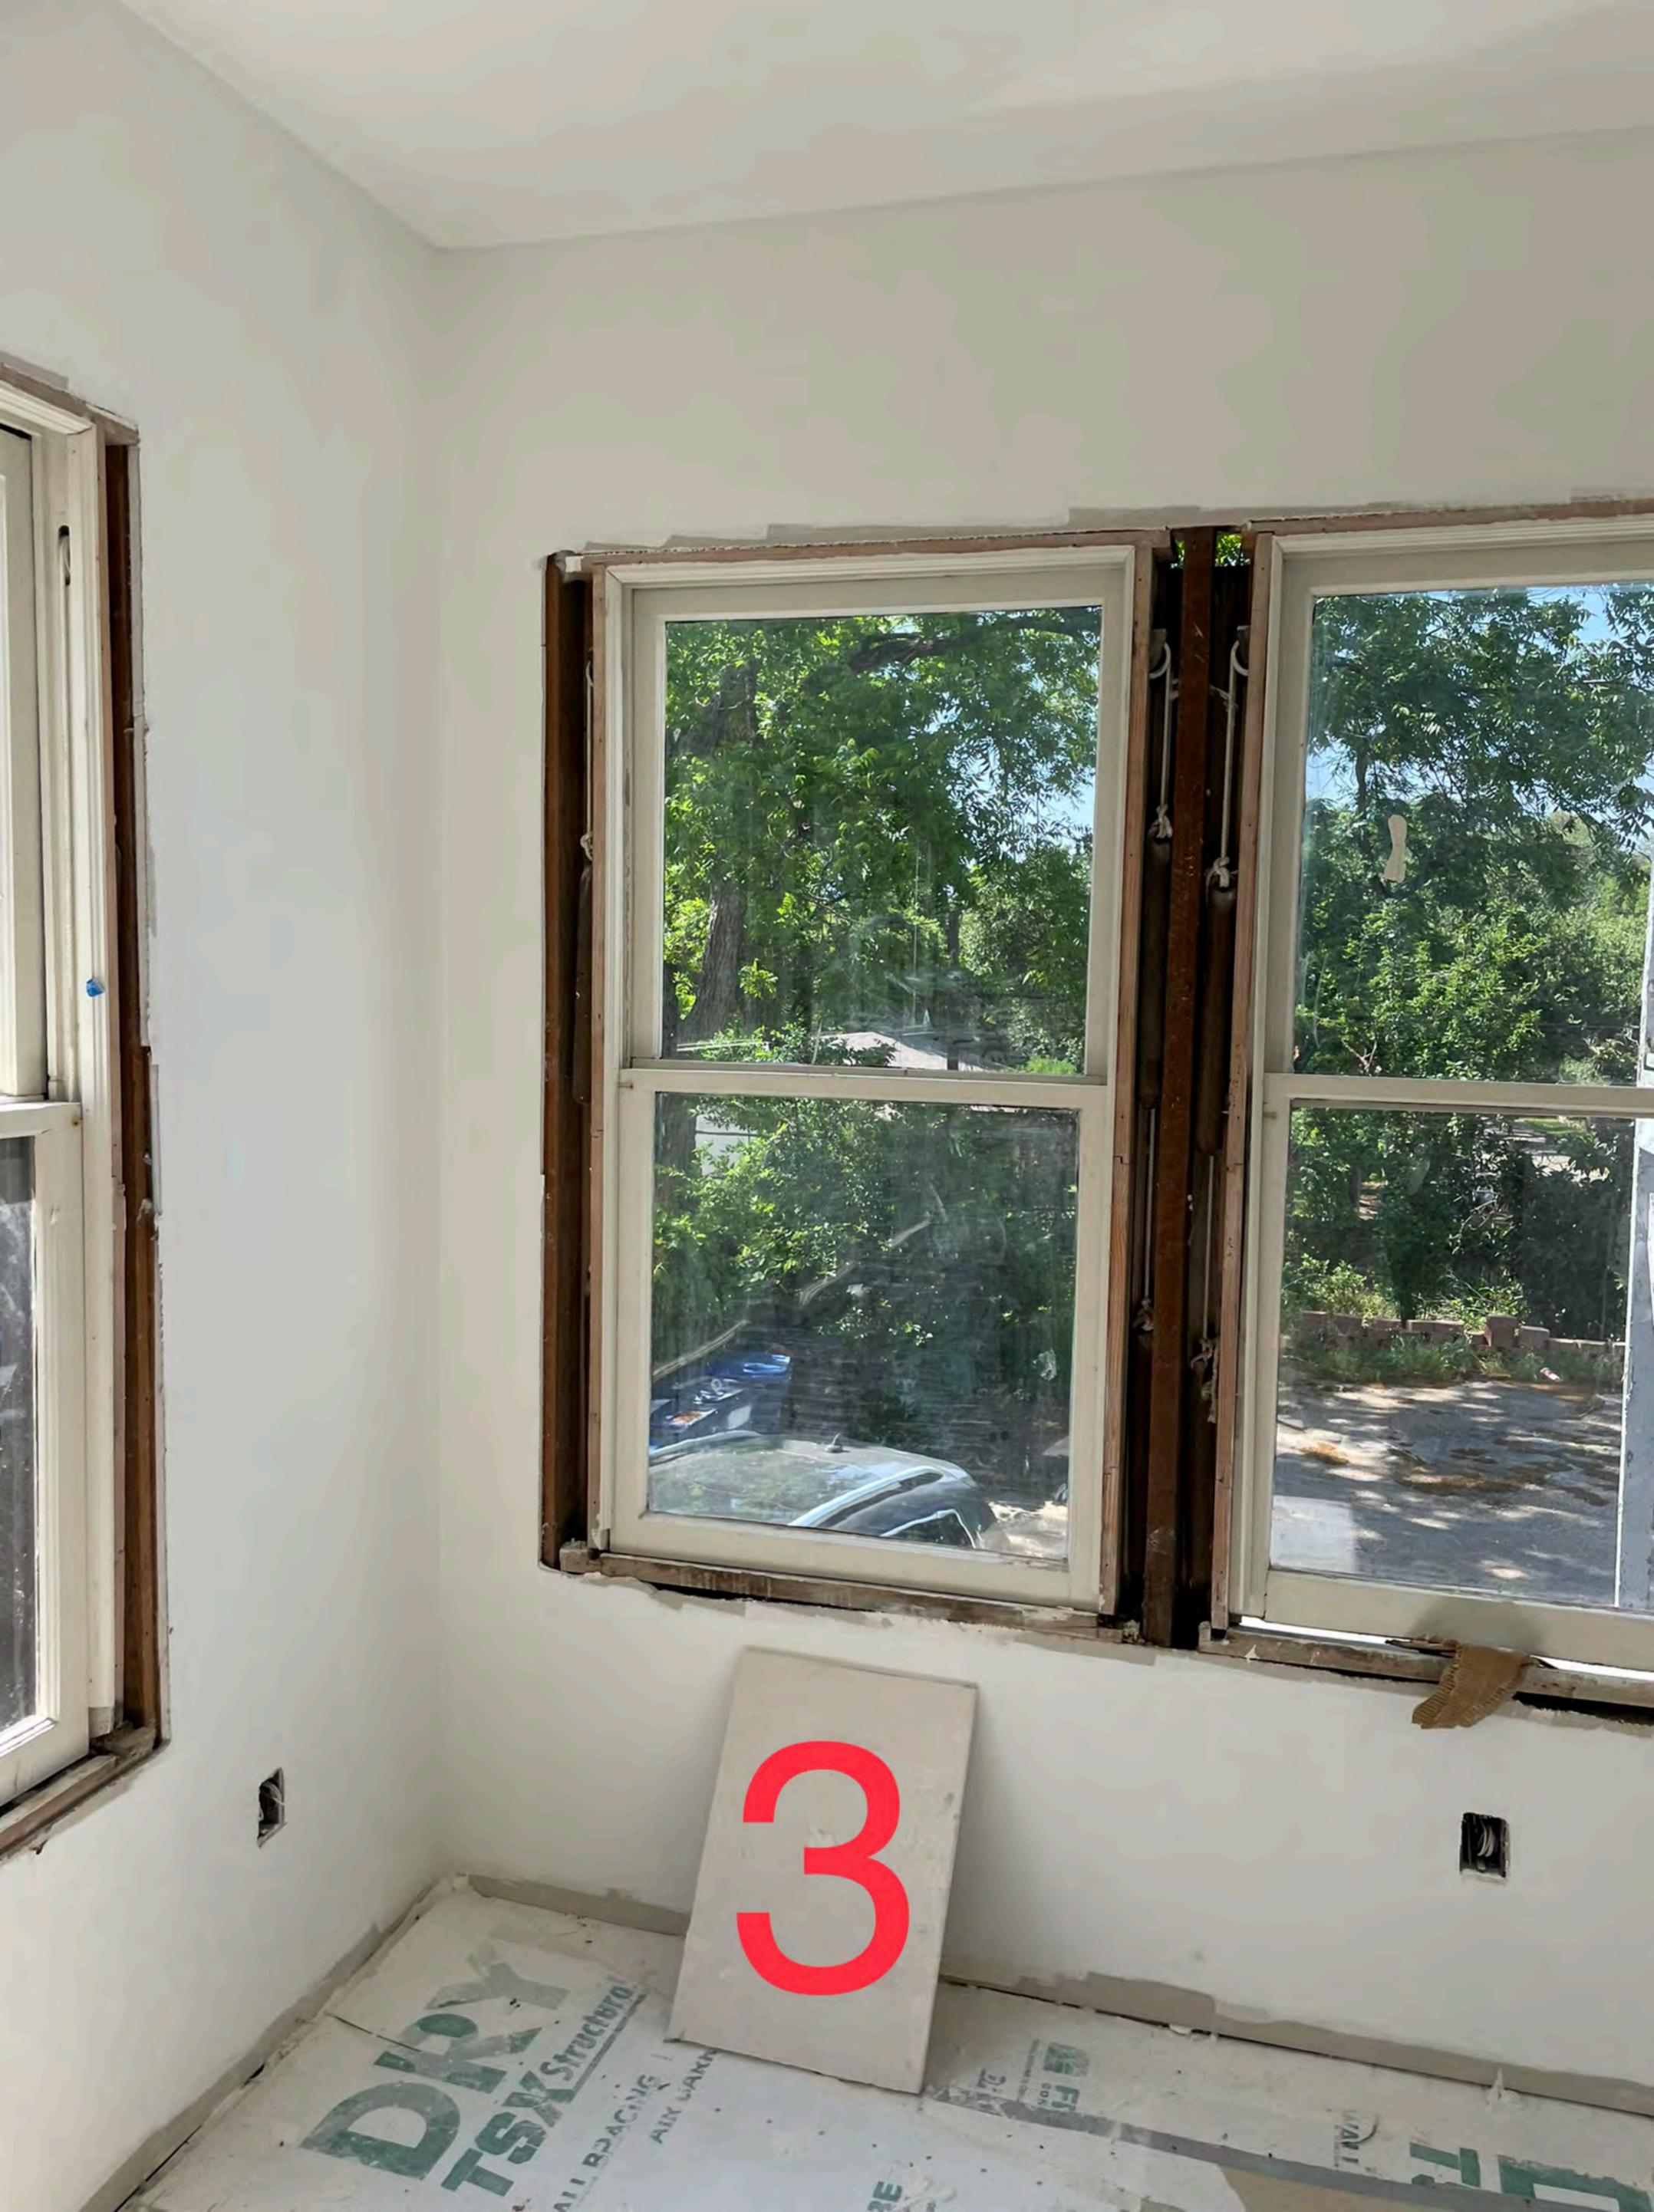
- c. **WINDOW REPLACEMENT: EXISTING CONDITION** – From the photos submitted to date, the wood windows proposed for replacement appear to be of historic-age, fully wood one-over-one windows. The windows do not show signs of significant wood rot, wood damage, or severe deterioration. Staff finds that the wood windows are in repairable condition based on the documentation provided, with most requiring minimal repair and intervention such as the reworking of the sashes and re-glazing, along with refitting into the trim and frames. Staff has scheduled a site visit with the applicant for Monday, May 30 and may be able to report additional information at the hearing.

The current condition of the windows is such that many are unrepairable. I've had multiple contractors visit the site and have commented as such. I need to replace them with comparable Marvin windows that are approved for historic window replacement.

Staff does not recommend approval based on findings b – e. Staff recommends that the applicant restore the deteriorated wood windows and preserve all original window openings.
