HISTORIC AND DESIGN REVIEW COMMISSION

April 19, 2023

HDRC CASE NO: 2023-106
ADDRESS: 501 E LOCUST
LEGAL DESCRIPTION: NCB 1736 BLK 10 LOT 1
ZONING: MF-33, H
CITY COUNCIL DIST.: 1
HIST. DIST. NAME: Tobin Hill Historic District
APPLICANT: Matthew Carson/Pella South Texas
OWNER: WOHLRABE SHANE & IRENE
TYPE OF WORK: Window replacement
APPLICATION RECEIVED: March 01, 2023
60-DAY REVIEW: Not applicable due to City Council Emergency Orders
CASE MANAGER: Jessica Anderson

The applicant requests a Certificate of Appropriateness for approval to replace 18 one-over-one wood windows with aluminum-clad wood windows.

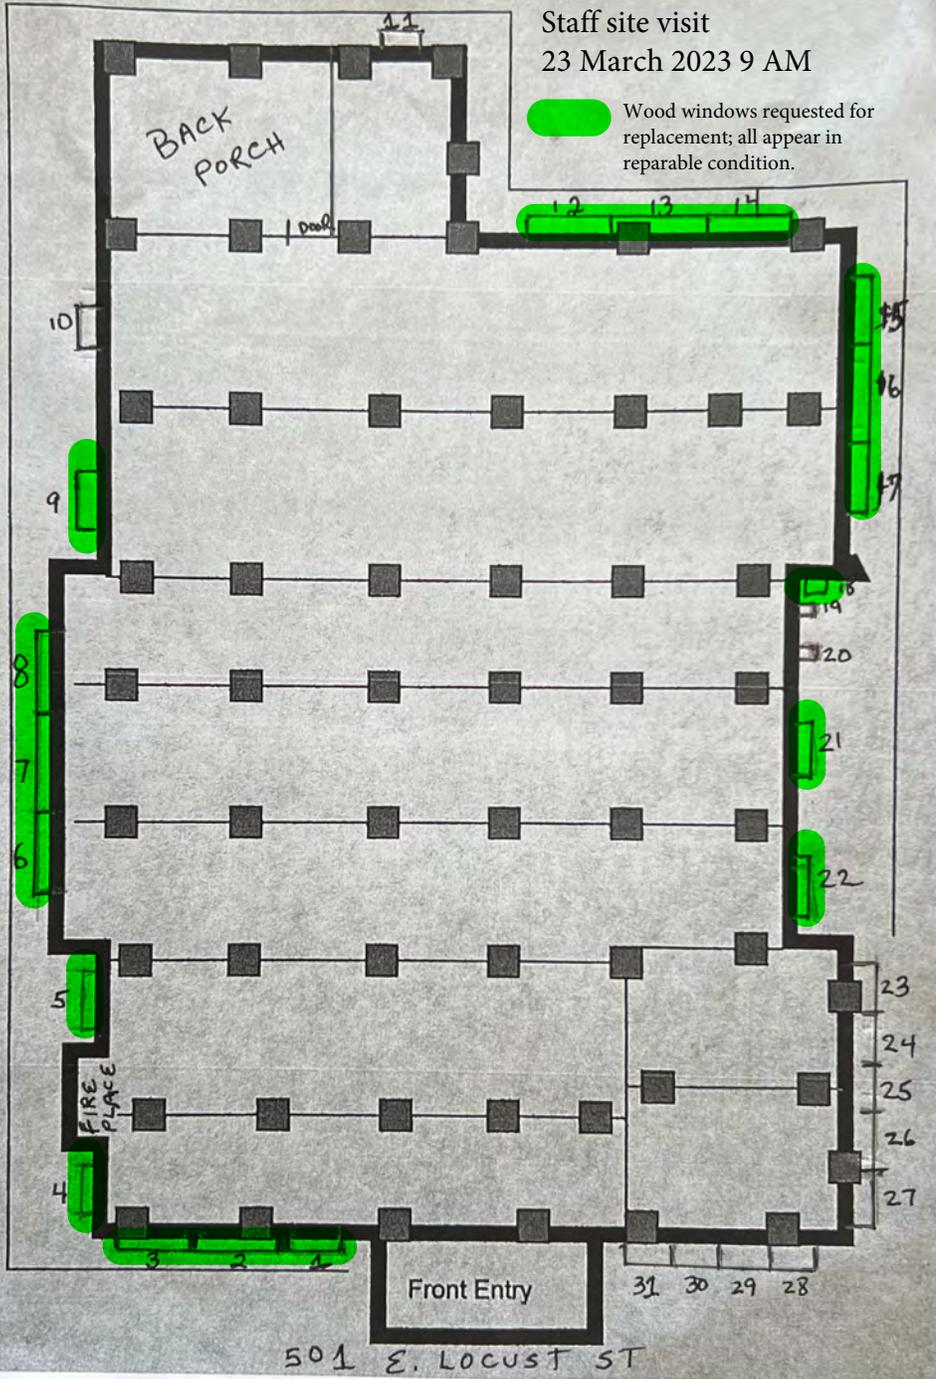
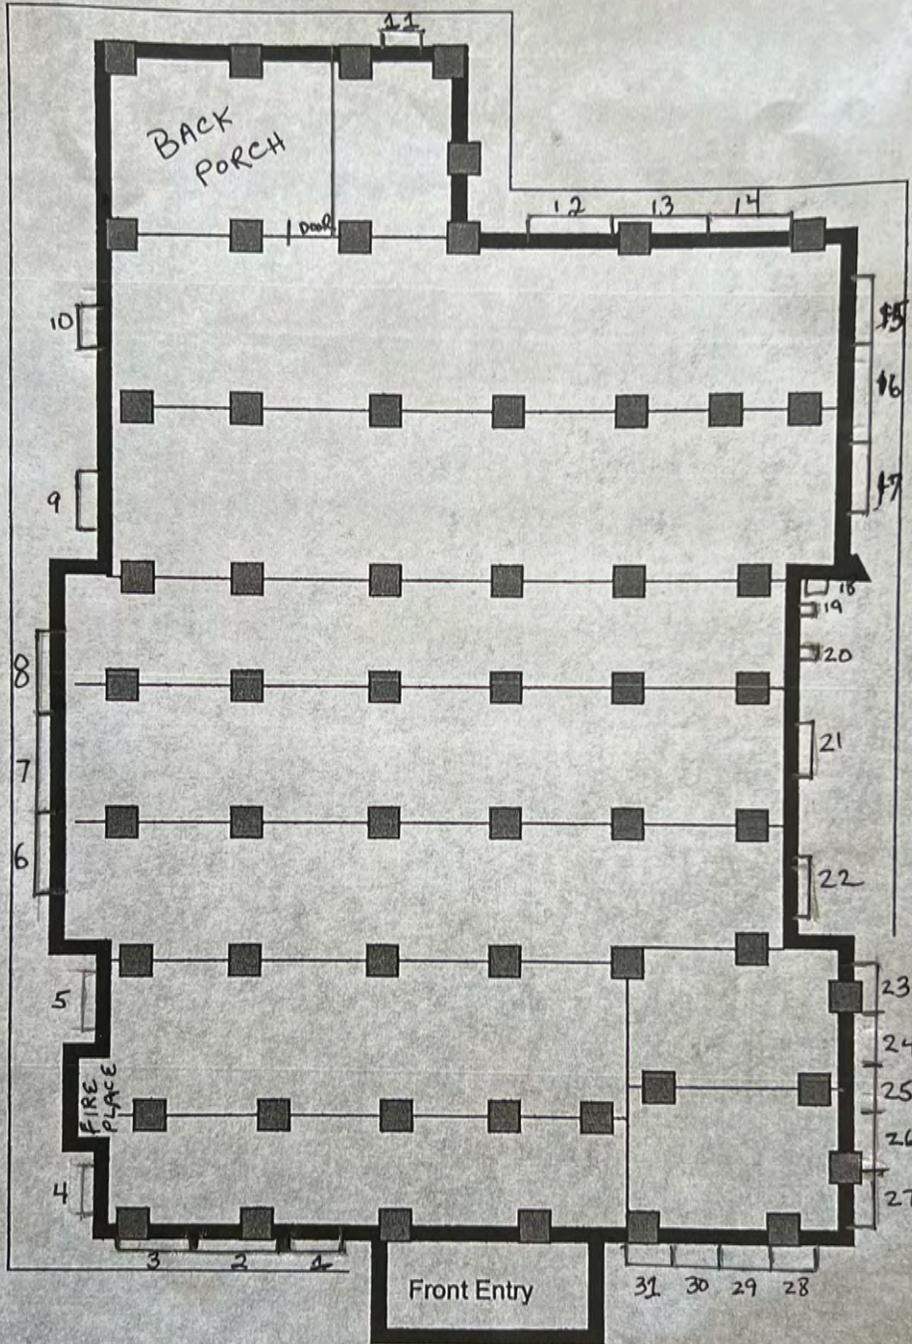
b. WINDOW REPLACEMENT: EXISTING CONDITION: Staff conducted a site visit on March 24, 2023, to assess the condition of the existing windows and found that all 18 wood windows proposed for replacement are in repairable condition. Most require minimal repair and intervention such as scraping and repainting or replacing damaged sash cords.

Wood windows requested for replacement; all appear in reparable condition.

Staff does not recommend approval based on findings c through f. Staff recommends that all existing wood windows are retained and repaired.
