HISTORIC AND DESIGN REVIEW COMMISSION

HDRC CASE NO: 2023-327
ADDRESS: 1023 N PINE ST
LEGAL DESCRIPTION: NCB 522 BLK 15 LOT 1 TO 18
ZONING: RM-4, H
CITY COUNCIL DIST.: 2
DISTRICT: Dignowity Hill Historic District
APPLICANT: Brian Sowell/WestEast Design Group, LLC
OWNER: Cathleen Crabb/CITY OF SAN ANTONIO
TYPE OF WORK: Demolition of one (1) structure and conceptual review of schematic replacement plans
APPLICATION RECEIVED: October 11, 2023
60-DAY REVIEW: December 2, 2023
CASE MANAGER: Rachel Rettaliata

1. A Certificate of Appropriateness for approval to demolish one (1) structure at the Ella Austin campus.
2. Conceptual approval of schematic replacement plans.

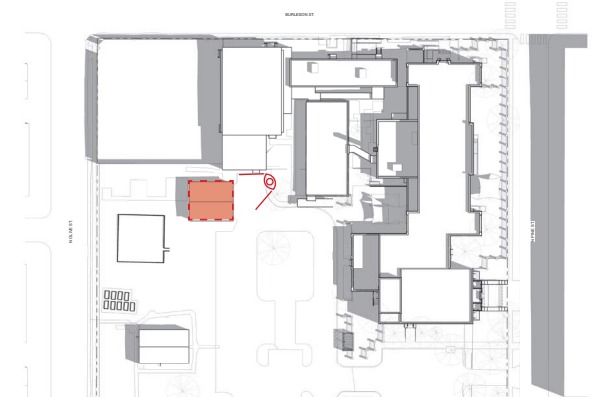
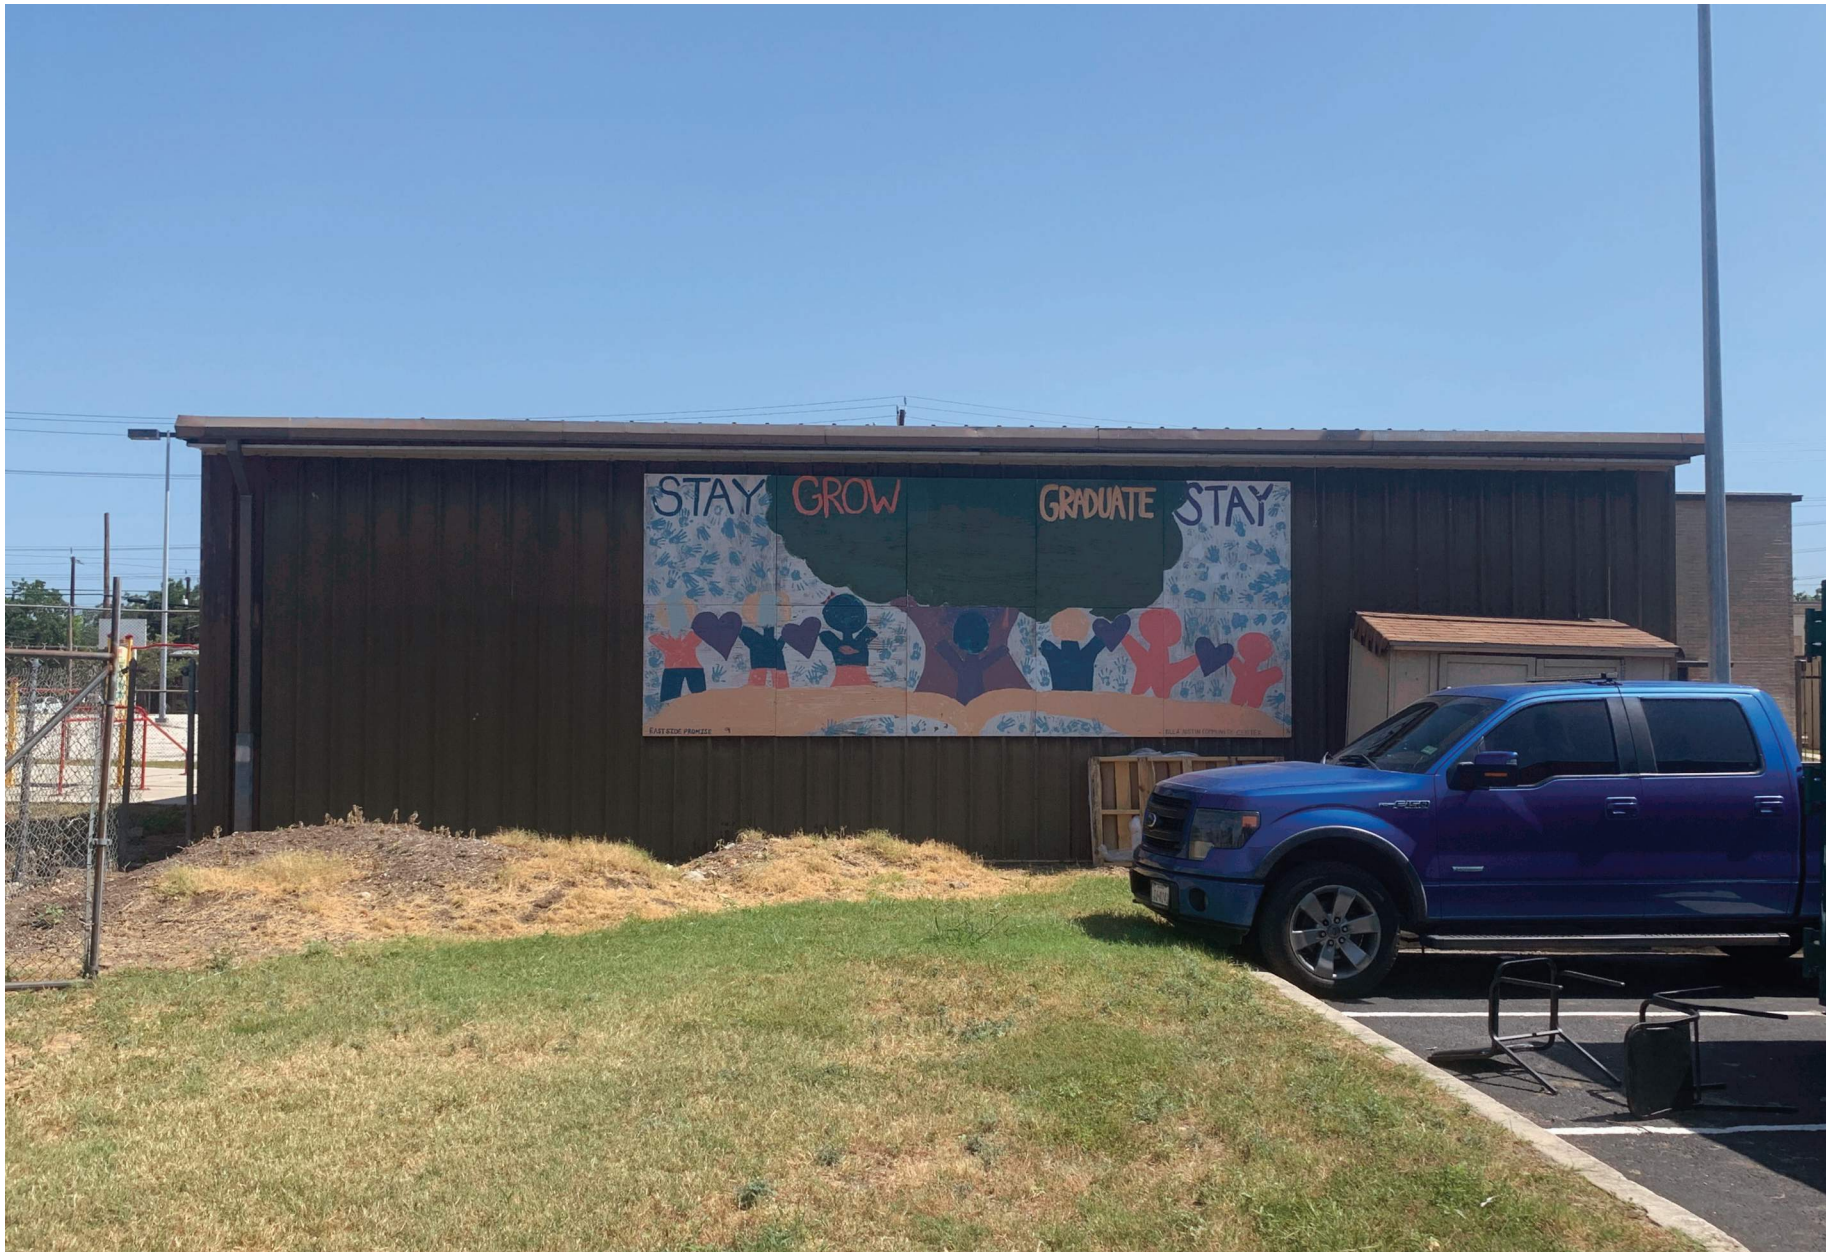
- Pre-engineered metal building located South of the Gymnasium.
- Aerial images suggest the building was constructed in 1985
- The storage building suffers from infrastructural issues including significant leaks.
- Significant corrosion is visible on structural supports

- The building is 1,687 SF
- Review by architects and engineers has confirmed this building is at the end of its servicable life due to the infrastructural damage.

- A new structure is not proposed for this location. Rather, this area will become part of the landscape and circulation for the new campus.
- The quantity of storage provided by this building is not expected to be required in the final design. Site maintenance materials and equipment will not be stored on-site.

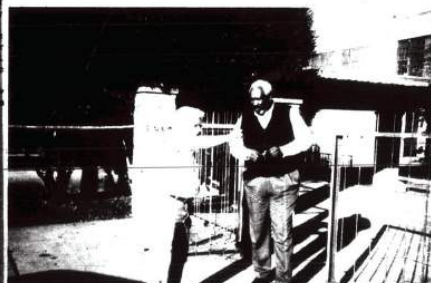
Top Photo concerned citizens at Ella Austin Community Center. Middle burned part of the senior citizens activity center. Bottom photo Anthony Hargrove talks with worker outside of burned building. Damage was \$300,000.

The cause of the blaze which gutted the brick building, which is housed in the rear of the building, is unknown.

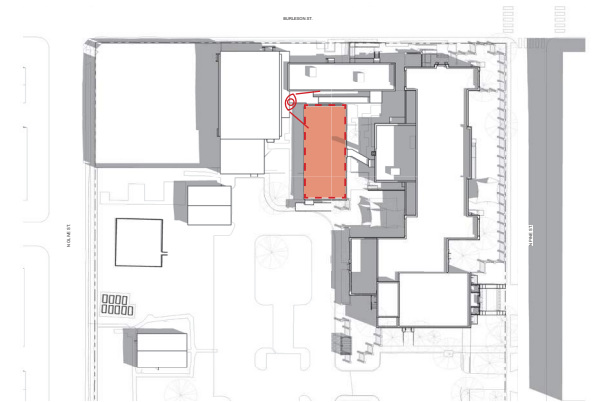
- No major deficiencies were noted in the building assessment, although the general finishes of the building are showing their age.
- The building is served by a drop-off loop in the parking lot. Because the floor level is below the entry grade however, the access is generally poor, especially for the intended audience of seniors due to the ramp.

- The Senior's Building is proposed to be replaced with a new, relocated senior's building which will provide improved access, additional program, and increased functionality for the campus and community.
- Details of replacement project are at the end of this presentation

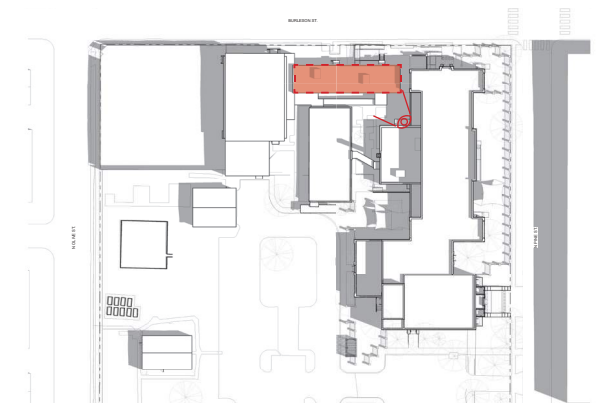
- The building exhibits some of the worst structural degradation on the entire site.
- A structural engineer's assessment identified significant settling and damage to the existing foundations and slab due to water migration
- Heaving and drops in the sub grade have created valleys in the floor slab exceeding a 2" differential.
- The foundation cannot be salvaged and must be replaced to make the building usable.

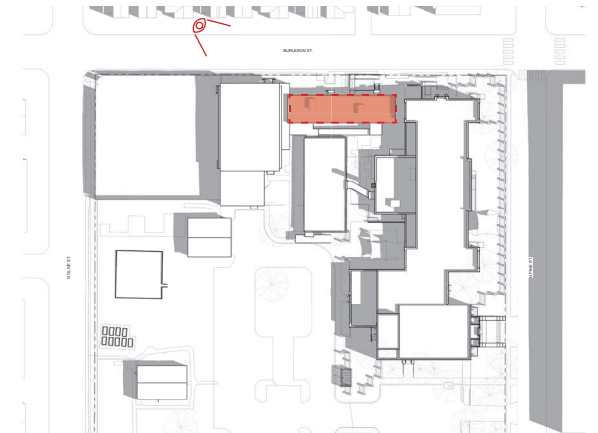
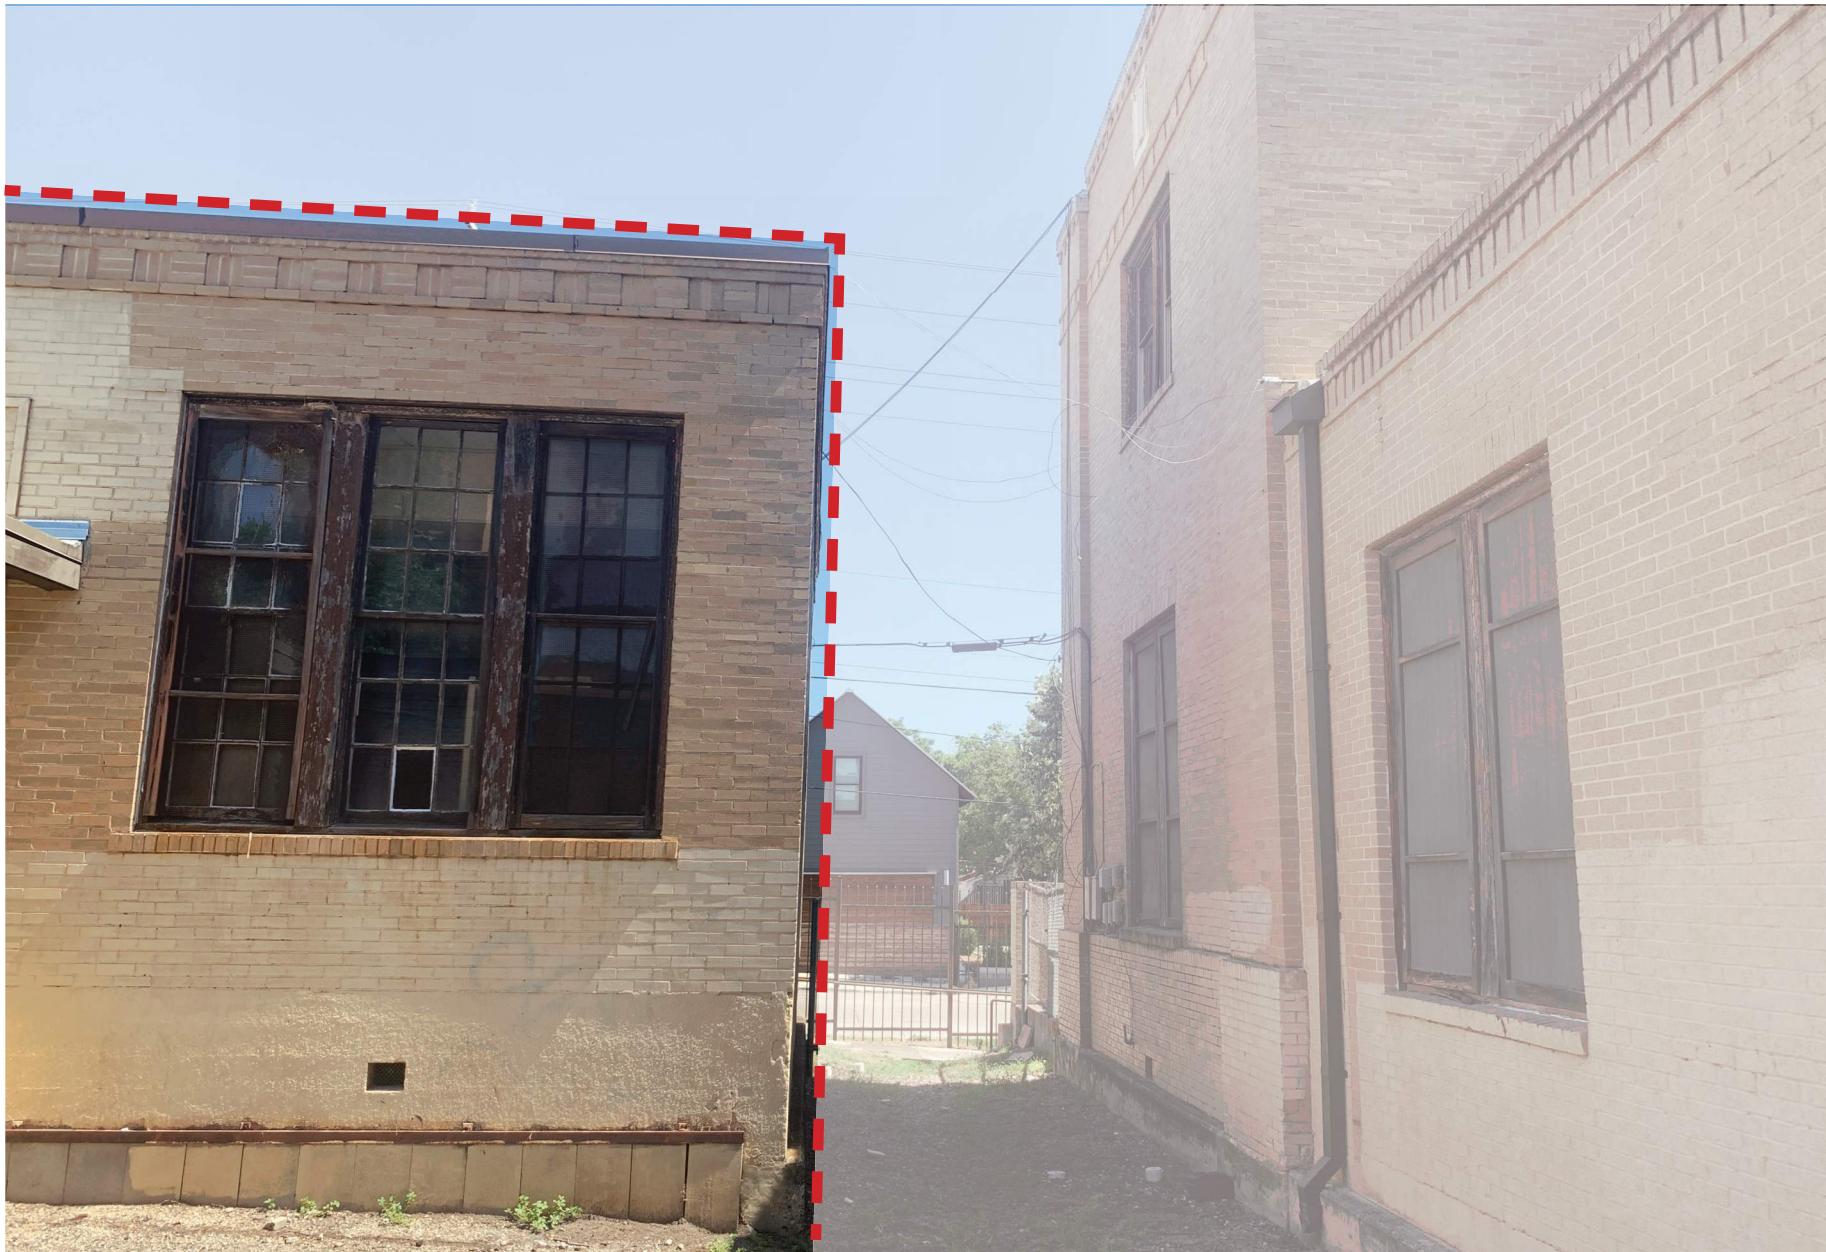
- In addition to foundation issues, the engineer's report identified corrosion on the roof deck and joists due to leaks. The report suggests the entire roof structure will have to be replaced.
- In addition to structural issues, all of the windows on the building require repair or replacement as they have succumbed to rot and damage.
- The brickwork requires significant cleaning and repointing

- The scope of repairs required is such that the entire building would have to be gutted.
- Initial cost estimates for the required repairs and re-work it would create total over \$2,160,000. This represents a premium of \$642/SF

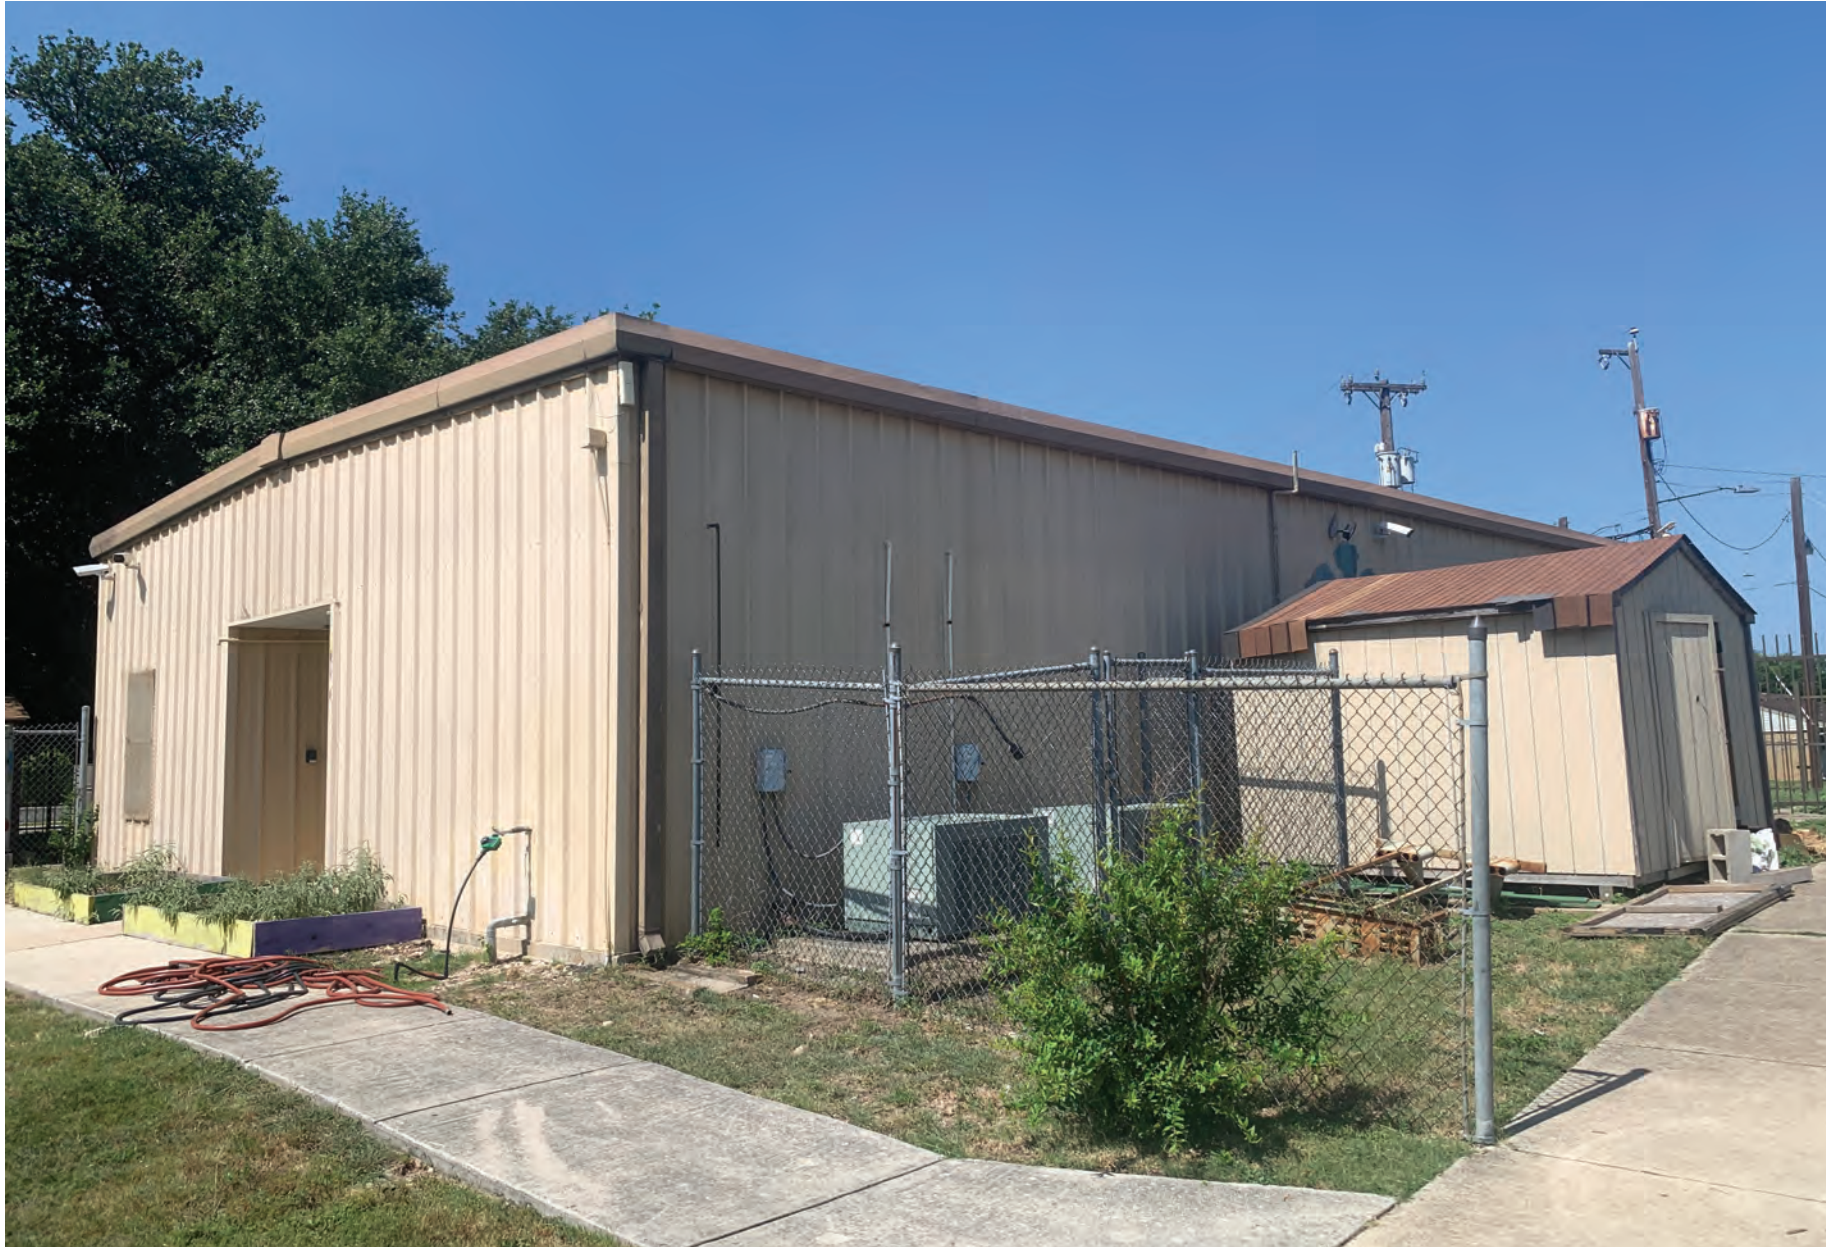
Classroom Building (Circa 1985)

The Classroom building is a pre-engineered metal building located in the Southwest corner of the campus, below the community gardens. Aerial images from [Historicaerials.com](https://historicaerials.com) suggest the building was constructed in 1985.

The building is in poor condition and suffers from many issues including significant leaks

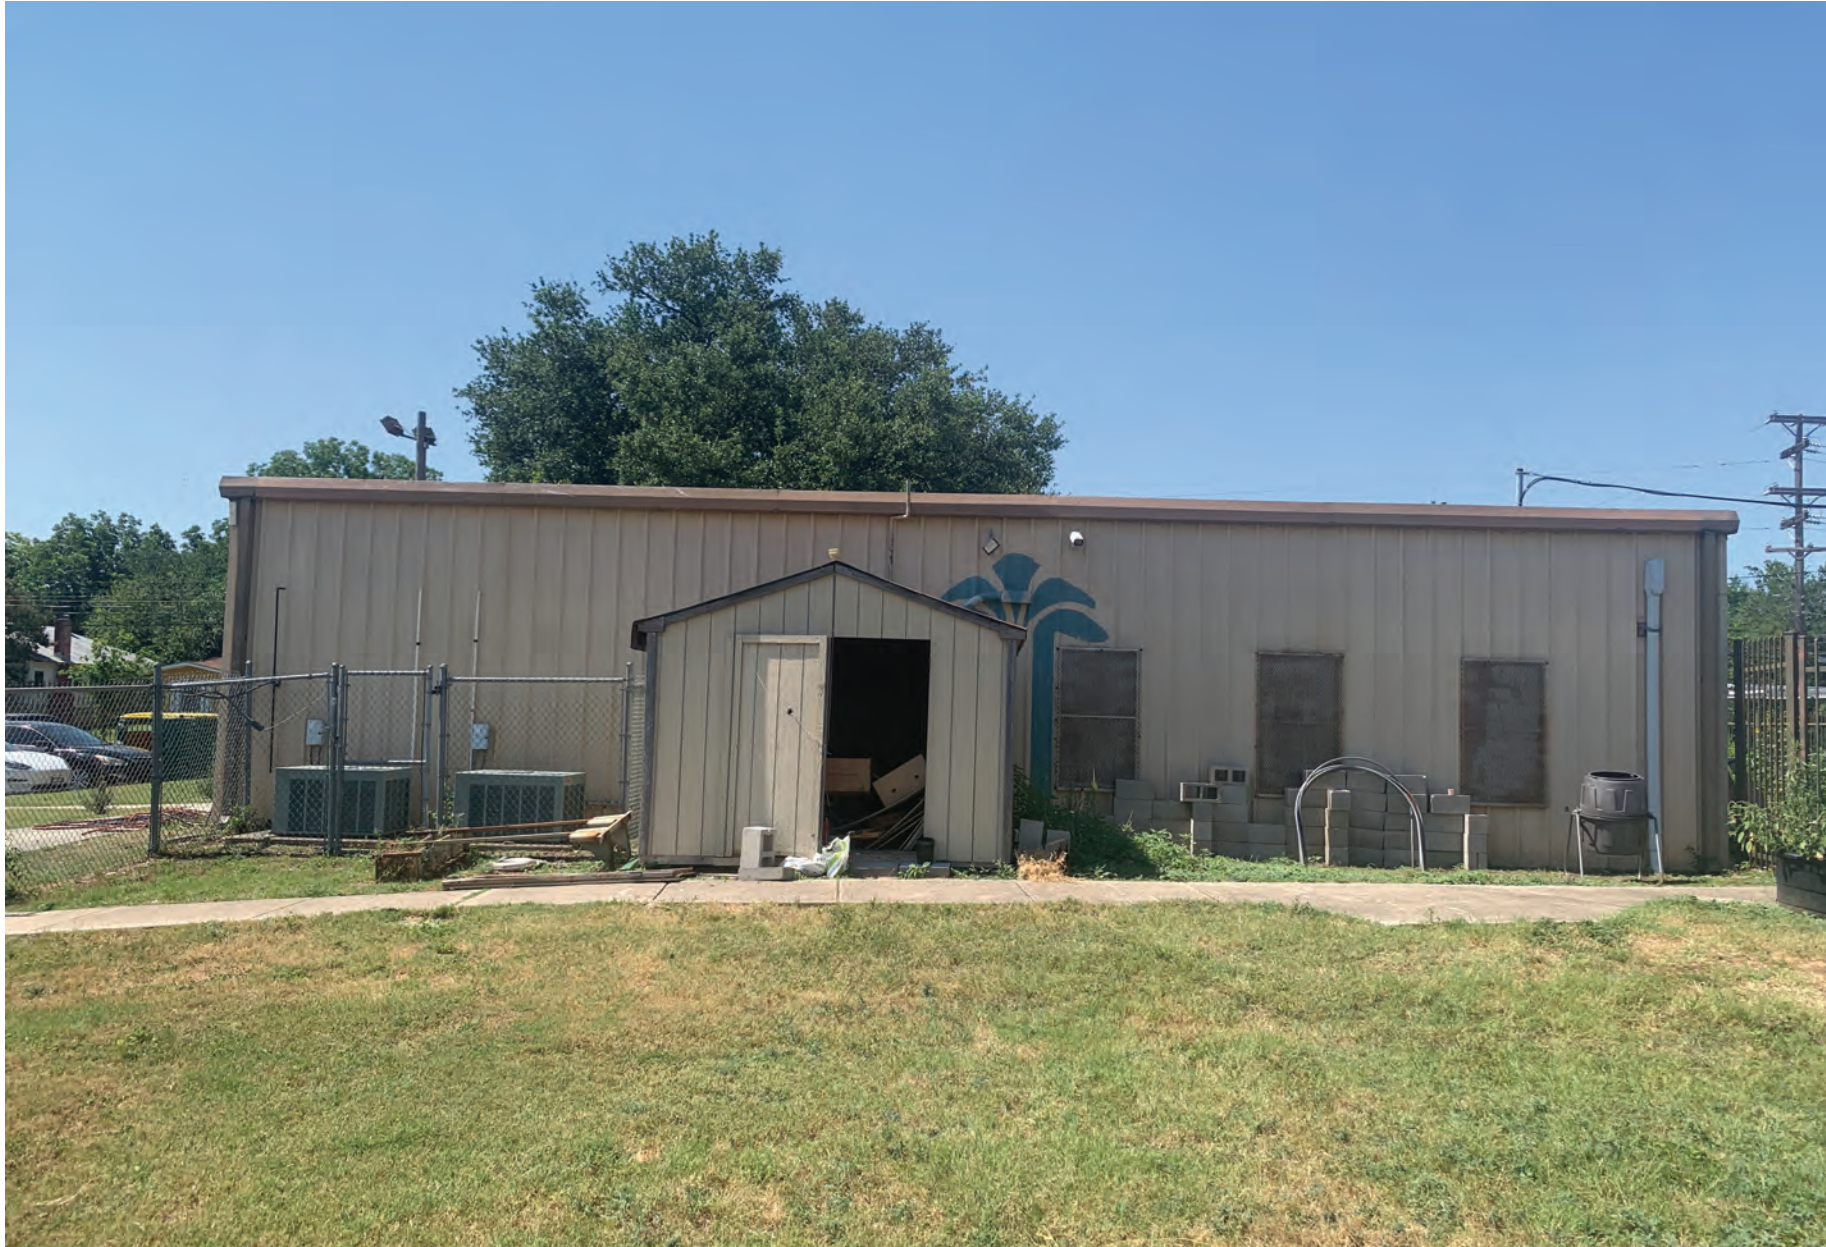
Classroom Building (Circa 1985)

- The building is 1,910 SF.
- It contains several classrooms that have been used for adult education and youth programs.

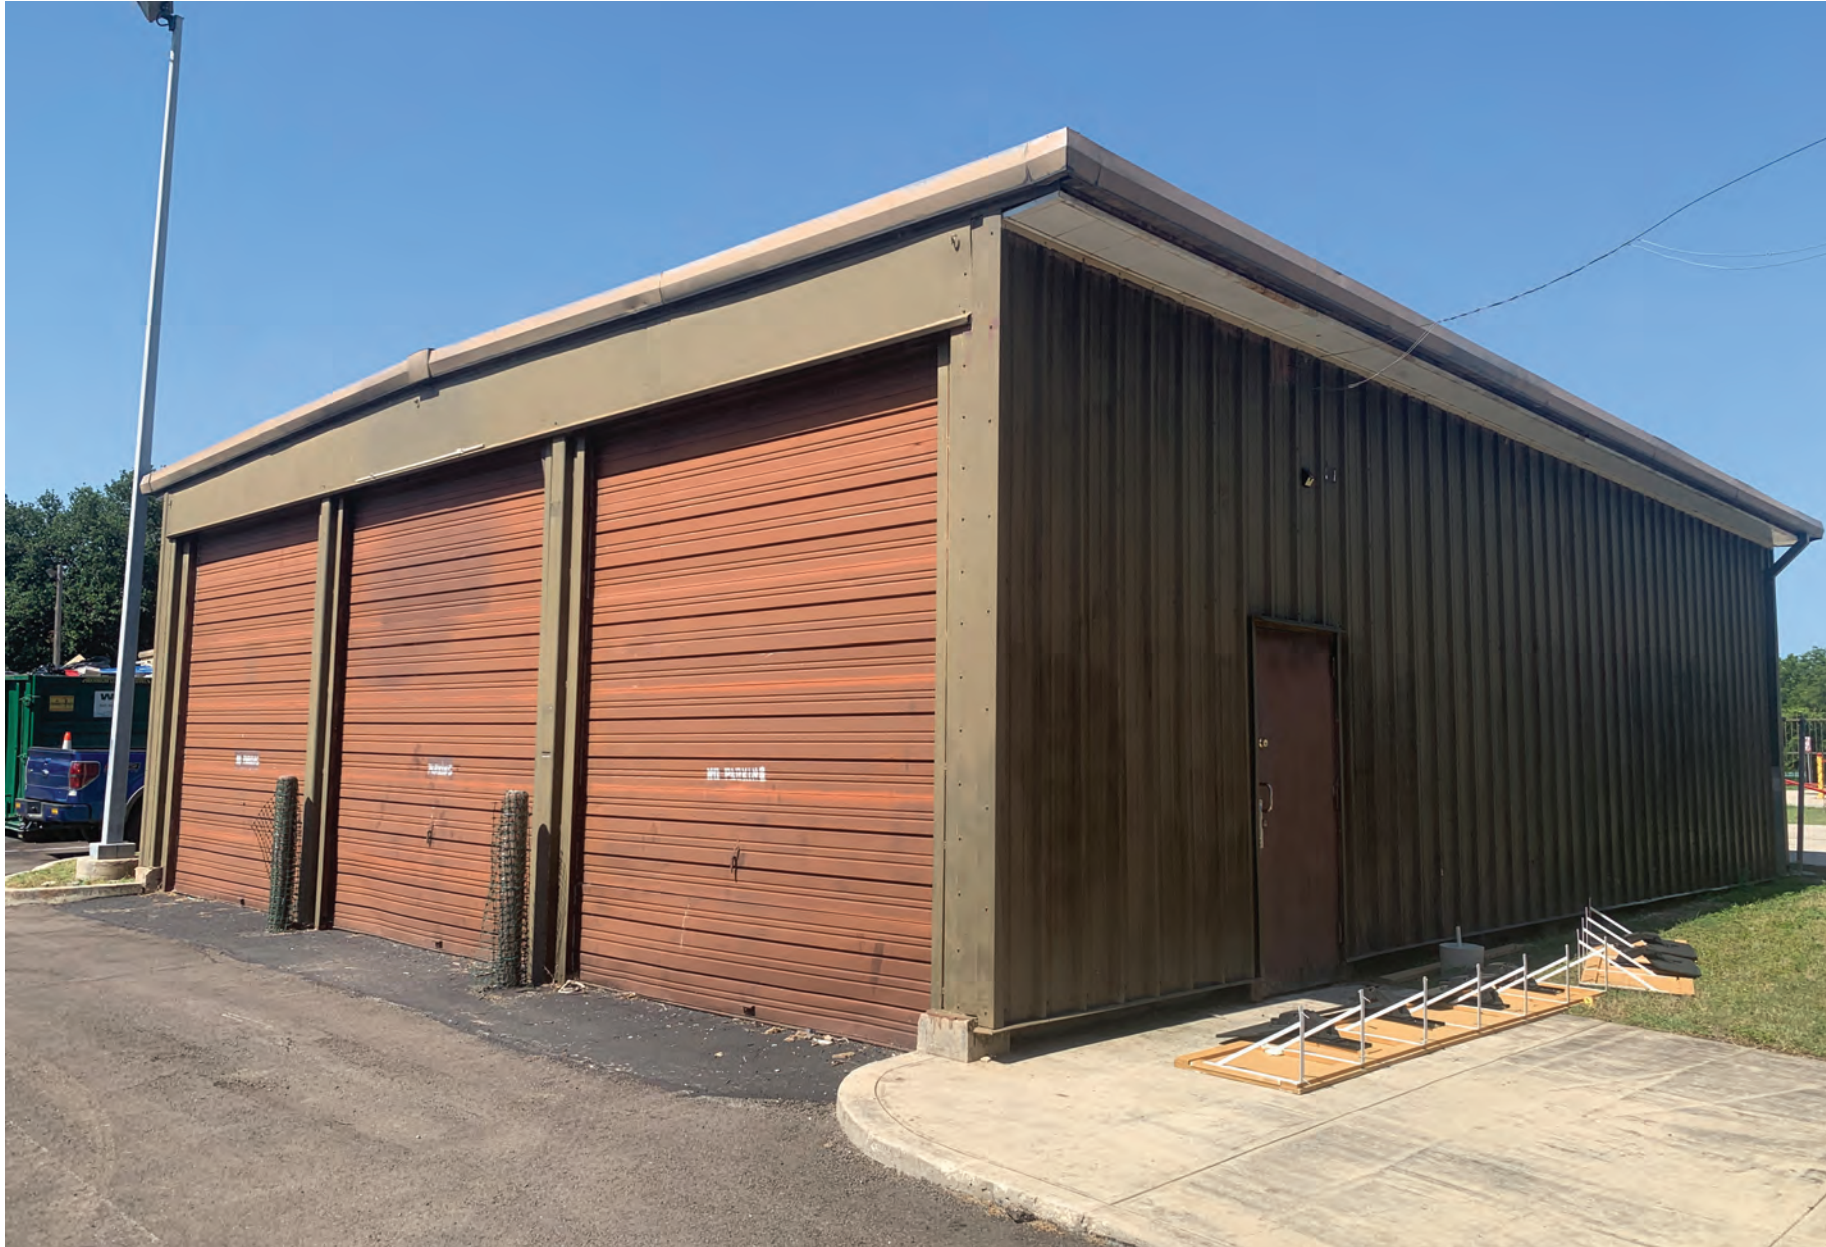
Site Storage (Circa 1985)

The Site Storage building is a pre-engineered metal building located South of the Gymnasium. Aerial images suggest the building was constructed in 1985

Like the classroom building, the Site Storage building suffers from infrastructural issues including leaks, which have caused corrosion to the structural supports.

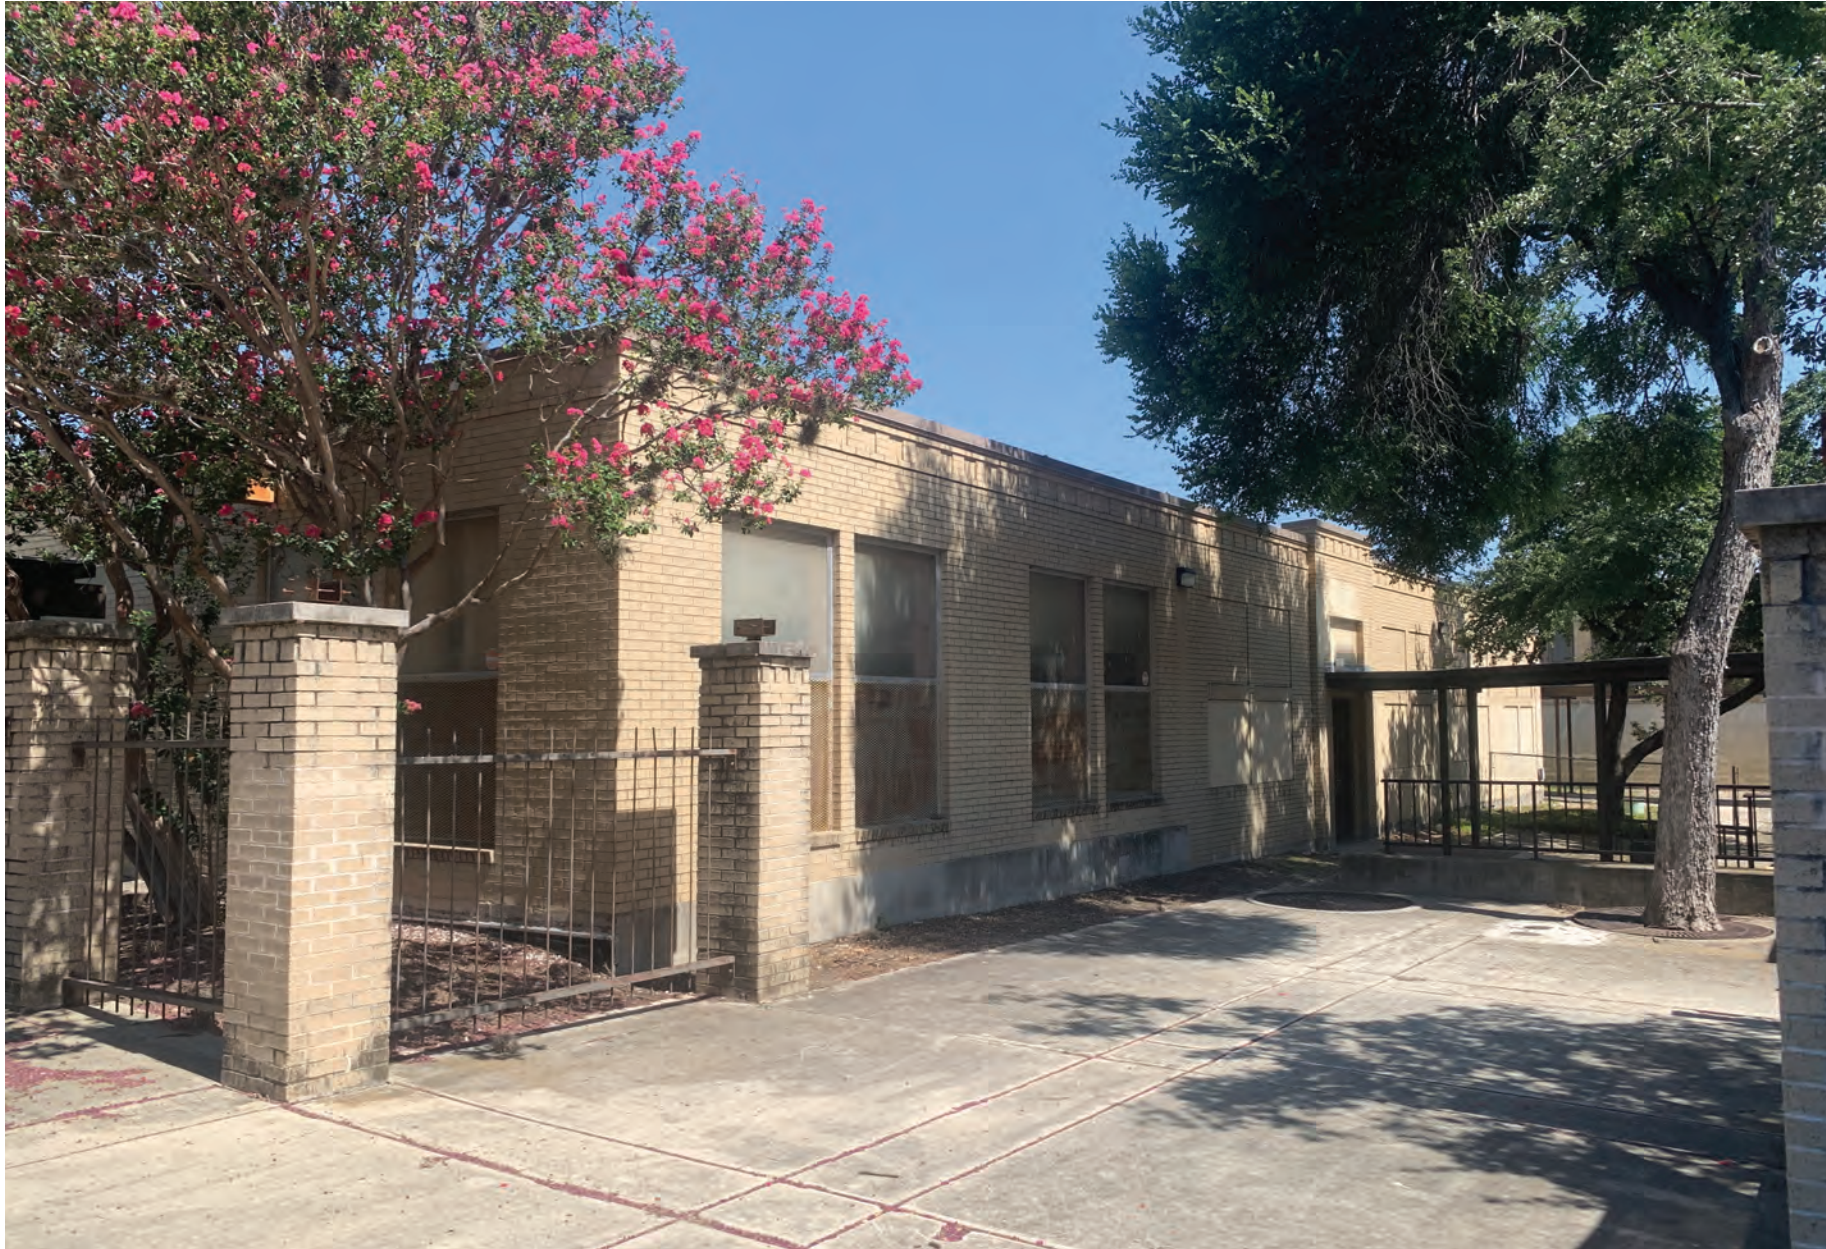
1998 Senior Center

The Senior Center was constructed in 1998 to replace the 1932 Manual Training Building, which was destroyed by a fire in October of 1997. The current structure occupies the same footprint as the previous building, but is a complete replacement - nothing was salvaged from the fire.

The existing building is roughly 4,600 SF and was designed by Chesney Morales & Associates.

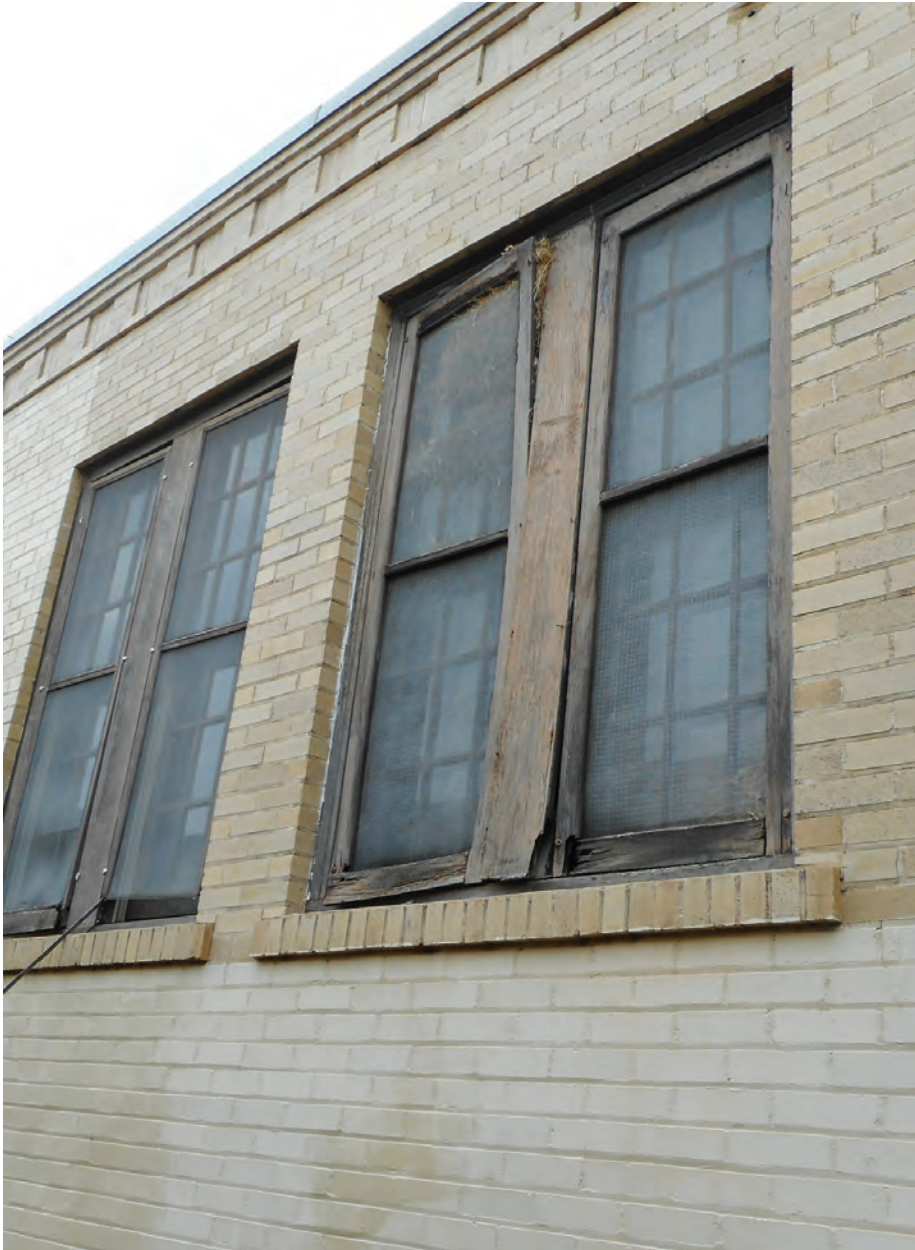
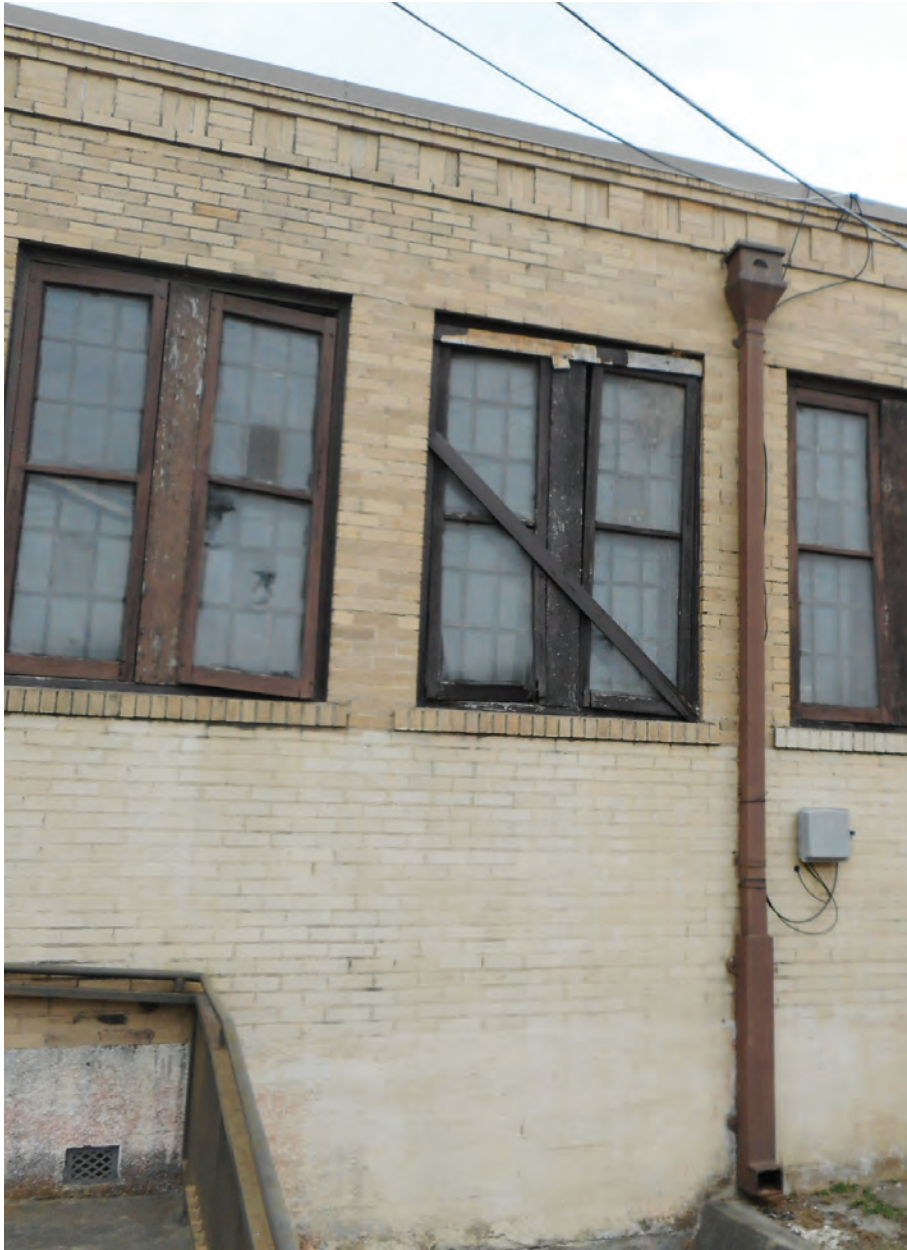
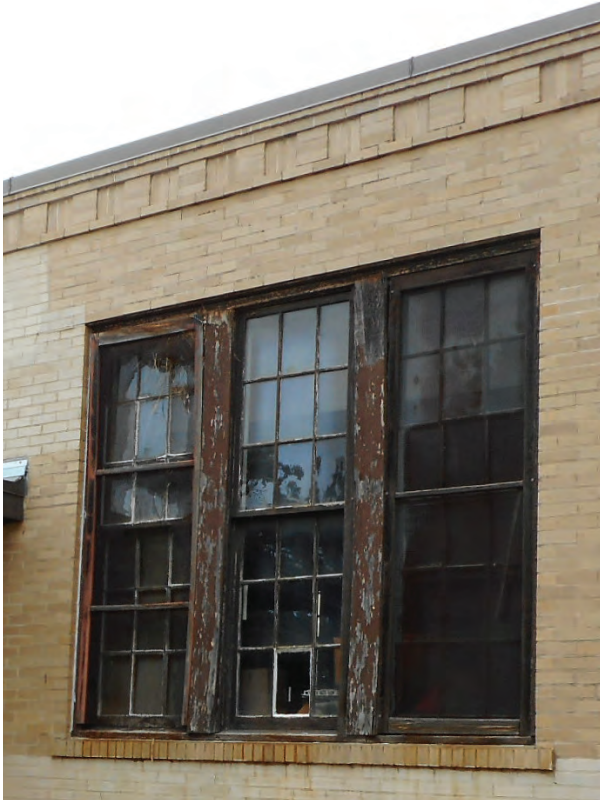
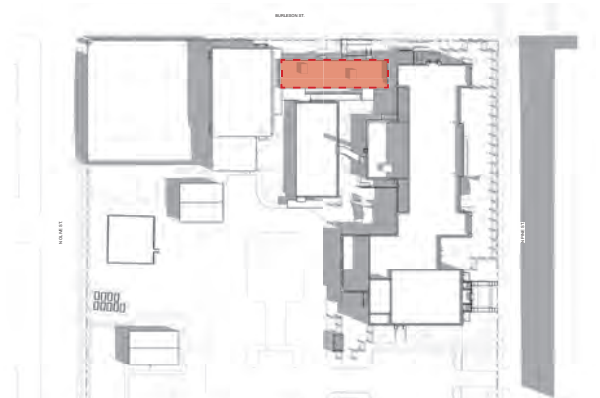
Physical Culture Building (Gym Annex) › Building Conditions

An assessment of the structure was performed by a structural engineer, who produced their findings in a report dated May 19th, 2023. In the report, the Structural Engineer identified significant settling and damage to the existing foundation and slab due to water migration under the slab, creating valleys in the floor slab with differentials exceeding 2".

In addition to the foundation issues, the structural engineer identified corrosion on the roof deck and joists due to leaks, and the report suggests that the entire roof structure will have to be replaced, including any damaged joists.

Outside of the structural issues, all the existing windows must be replaced as they have succumbed to rot and damage, and are no longer functional.

The scope of repairs required for the building is such that the entire structure would have to be gutted, and the only portion of the building that could be salvaged are the exterior walls. However, the exterior walls are in poor condition as well, as the settling of the slab has caused cracks to form in the brick joints.

The foundation cannot be salvaged and must be replaced in order to make the building usable.

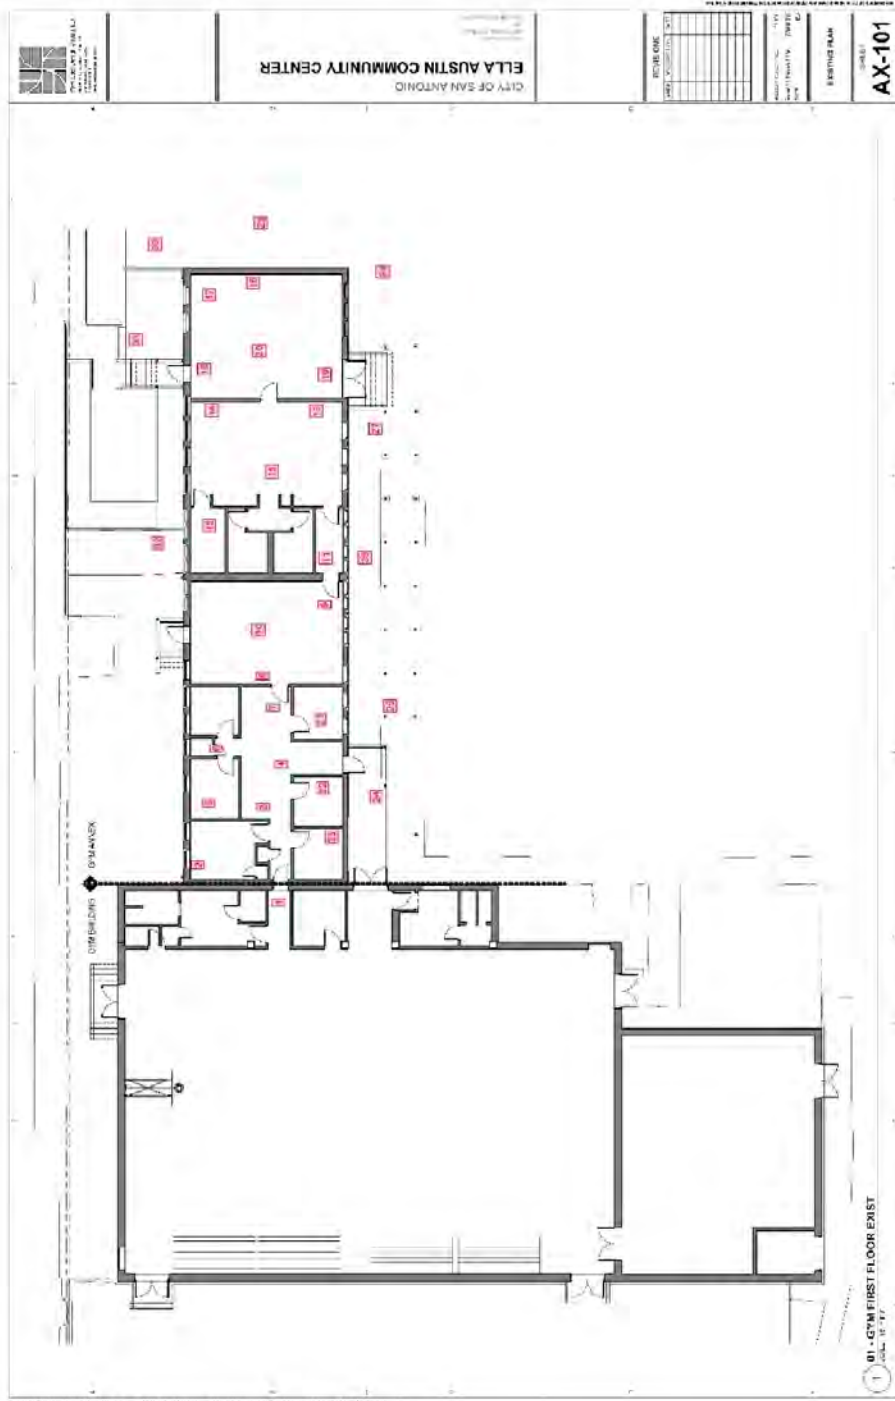
Issue #1 – OPEN (1/1)

Foundational differential 1 1/2" +/- Photo left to right slope of foundation

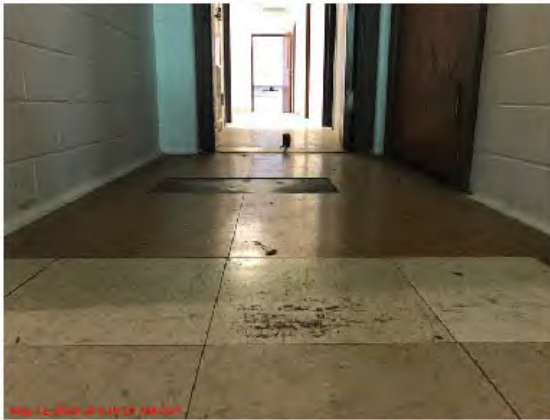
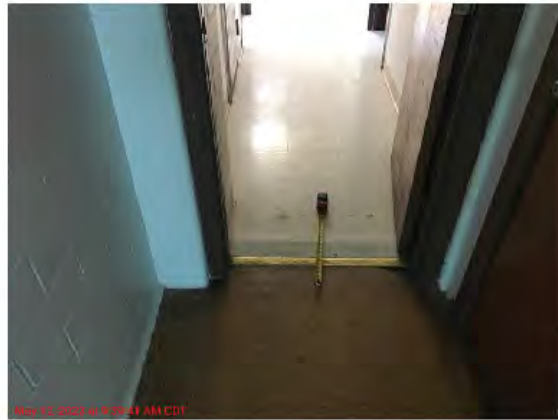
Issue #2 – OPEN (1/1)

Exterior CMU walls w/ steel joists running plan N/S Foundation sloping in 2 directions photo left to right and far to near photo 2 Drop ceiling removed and view of structure above obstructed in room with duct and insulation

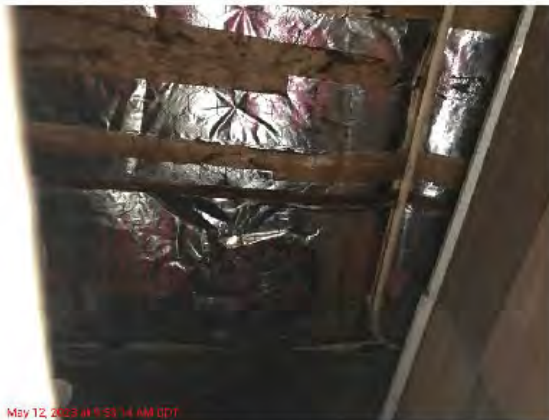
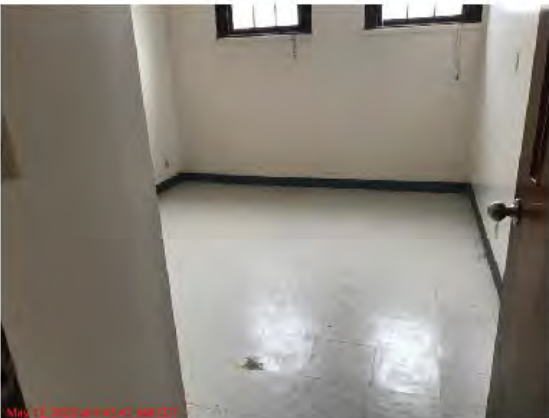
Issue #3 – OPEN (1/1)

Heave in middle of corridor. See photo 2 at wall on right side of hall way left end of wall separating from the floor

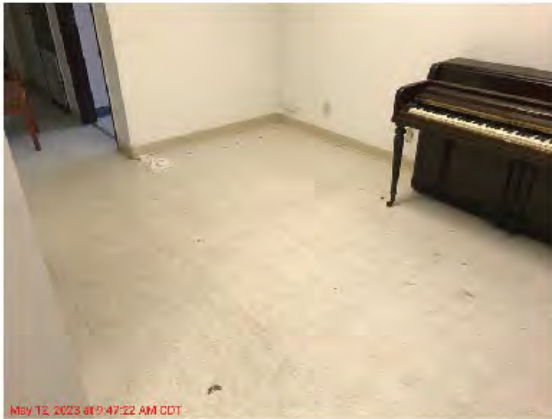
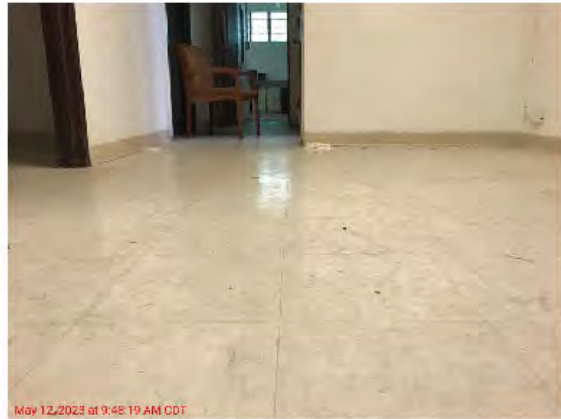
Issue #4 – OPEN (1/1)

Drop in slab about 1/2" to 1" from corridor to exit door area at threshold cover

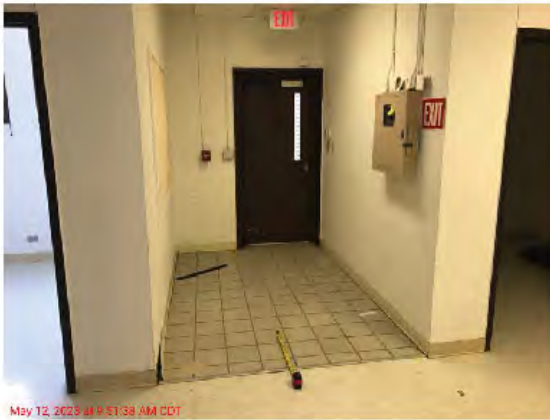
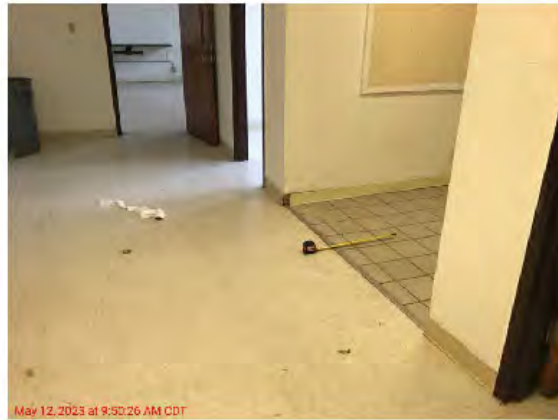
Issue #5 – OPEN (1/1)

Multiple foundational valleys w/in room from 1/2" approx to 2" + Red masonry 5 1/4-1/2" x 12wide cmu

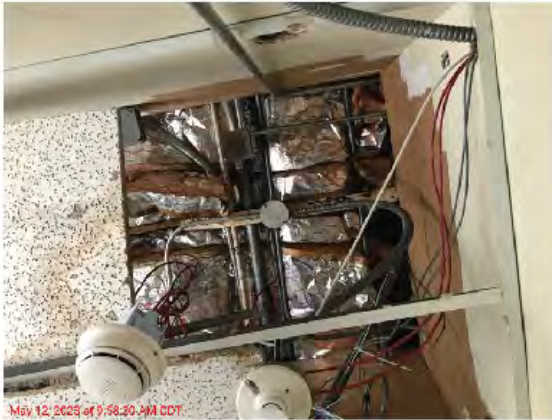
Issue #6 – OPEN (1/1)

Exposed joist soffit within insulation. Paint on joist peeling, cannot determine if it is steel that is delaminating or rusted.
