HISTORIC AND DESIGN REVIEW COMMISSION

HDRC CASE NO: 2023-327
ADDRESS: 1023 N PINE ST
LEGAL DESCRIPTION: NCB 522 BLK 15 LOT 1 TO 18
ZONING: RM-4, H
CITY COUNCIL DIST.: 2
DISTRICT: Dignowity Hill Historic District
APPLICANT: Brian Sowell/WestEast Design Group, LLC
OWNER: Cathleen Crabb/CITY OF SAN ANTONIO
TYPE OF WORK: Demolition of one (1) structure and conceptual review of schematic replacement plans
APPLICATION RECEIVED: October 11, 2023
60-DAY REVIEW: December 2, 2023
CASE MANAGER: Rachel Rettaliata

1. A Certificate of Appropriateness for approval to demolish one (1) structure at the Ella Austin campus.
2. Conceptual approval of schematic replacement plans.

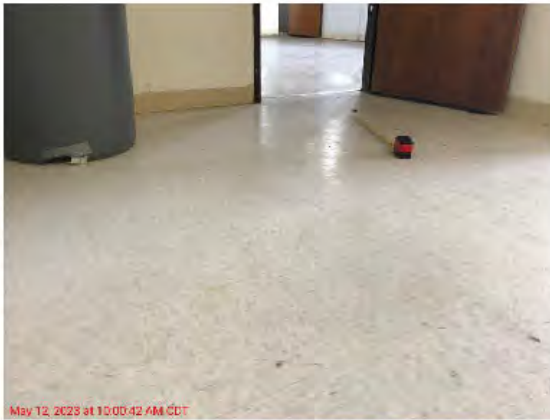
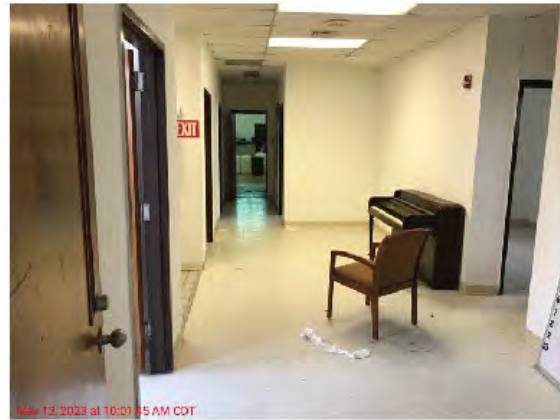
Issue #7 – OPEN (1/1)

Continued heave photo left to right (plan north to south)

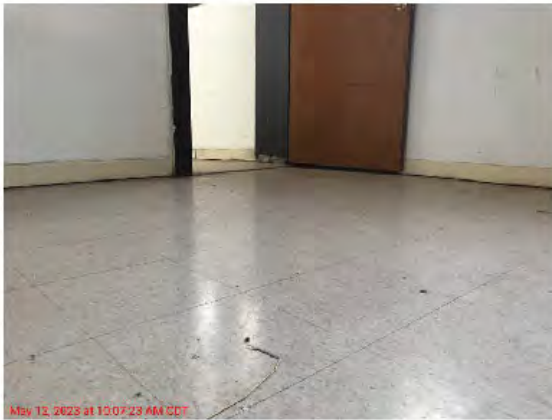
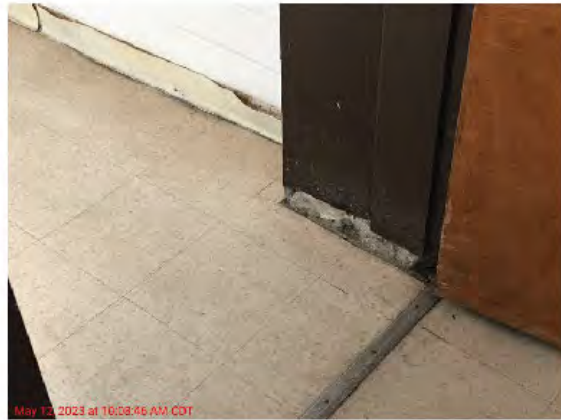
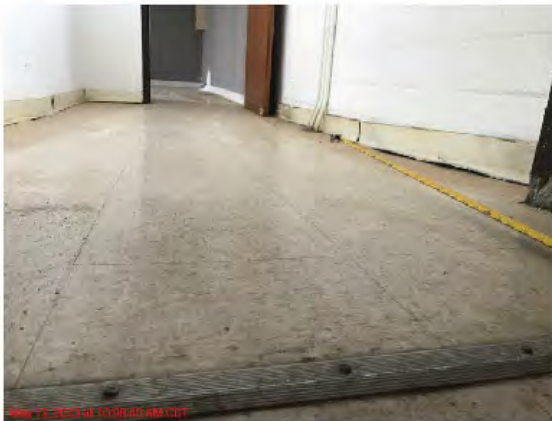
LOCATION: 1st Large Room
PRIORITY: Normal
DUE DATE: No due date
DISCIPLINES:
ASSIGNEE:

Slope down at threshold from room to corridor Exposed concrete structure about 2 1/2"

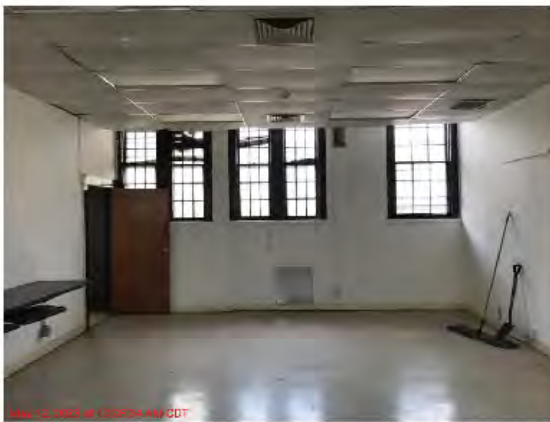
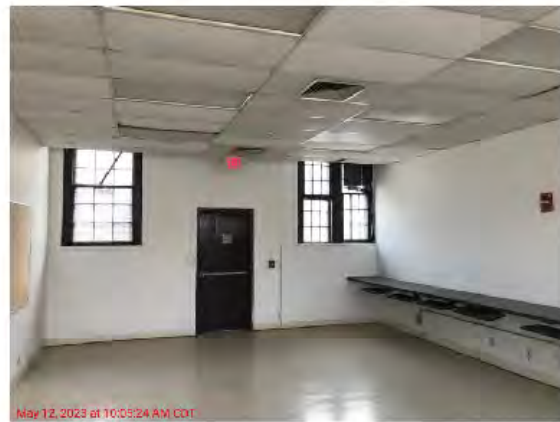
Issue #10 – OPEN (1/1)

Duct, electrical and insulation obscuring the structural frame above. Known steel joists spanning plan north to south wall to wall no intermediate supports

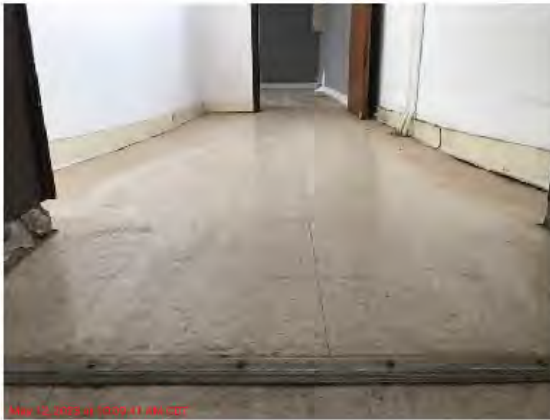
Issue #11 – OPEN (1/1)

Slab warped right to left or plan south high plan north low

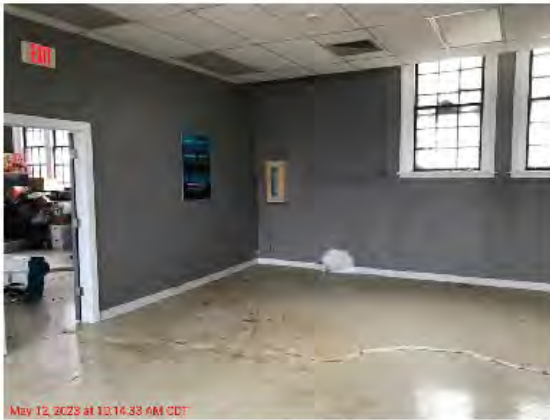
Issue #13 – OPEN (1/1)

Multiple foundational valleys and heaves

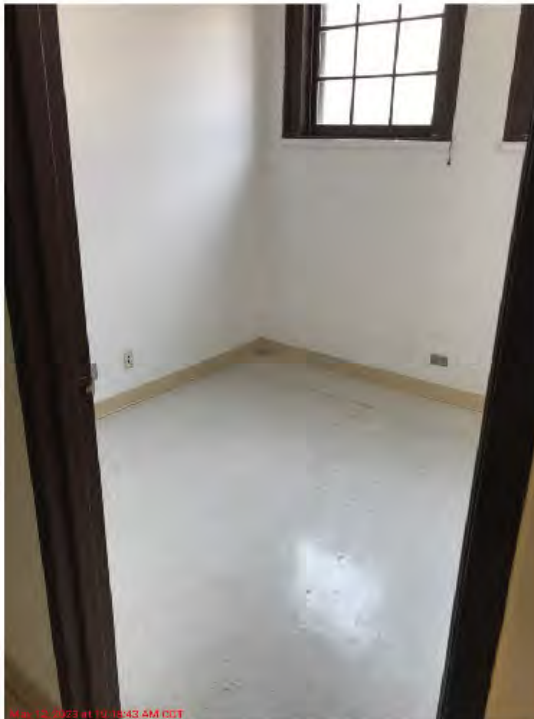
Issue #21 – OPEN (1/1)

Slopes of 1/2" + into photo plan north to south

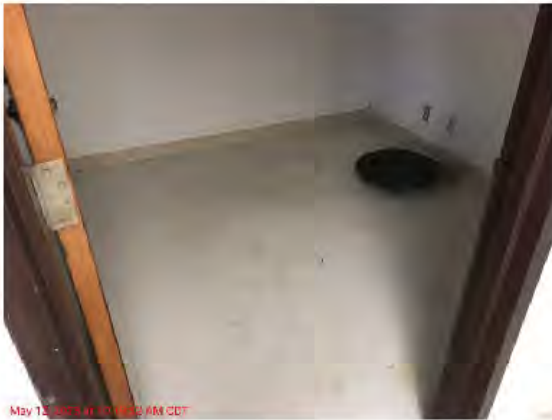
Issue #22 – OPEN (1/1)

Foundational valley middle of room heave at exterior wall

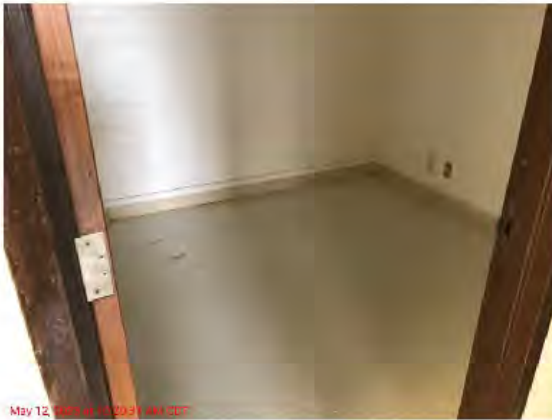
Issue #23 – OPEN (1/1)

Valley in room separation at exterior wall exterior falling

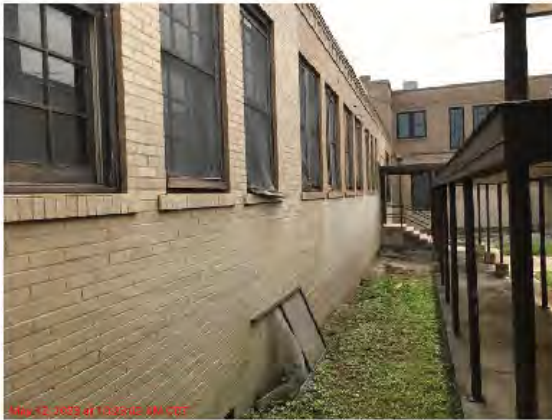
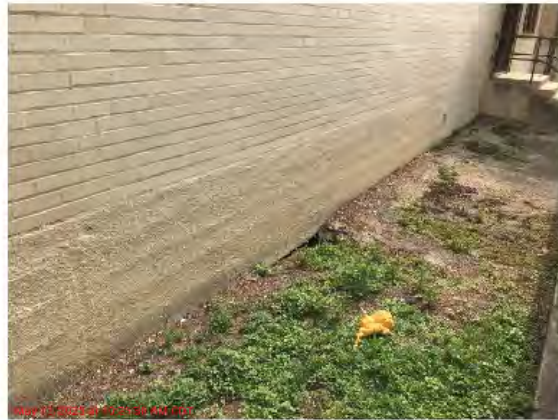
Issue #26 – OPEN (1/1)

lack of area ways some beam exposed at grade

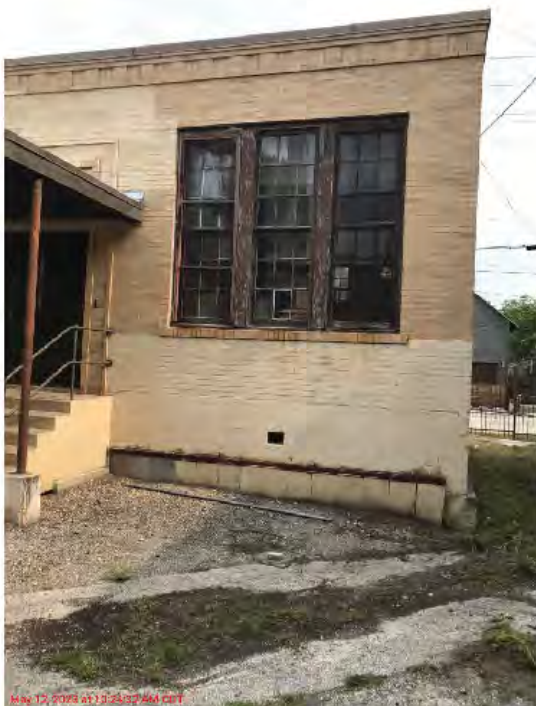
LOCATION: Exterior South
PRIORITY: Normal
DUE DATE: No due date
DISCIPLINES:
ASSIGNEE:

exposed earth retainers and beam soffit. looks to be post installed(around time of construction completion)

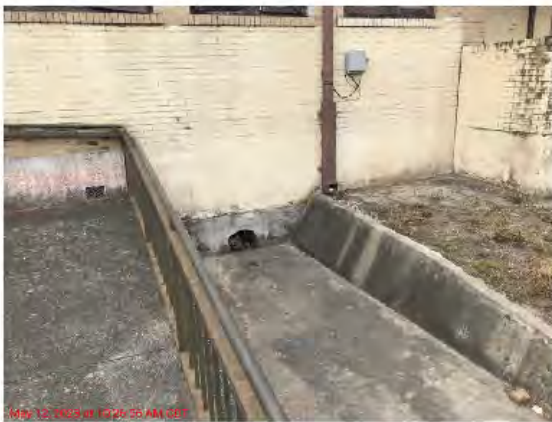
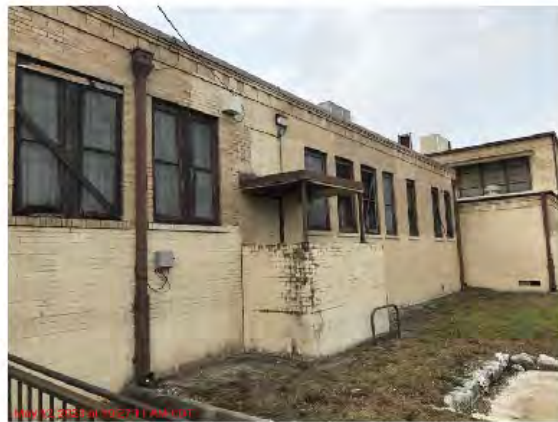
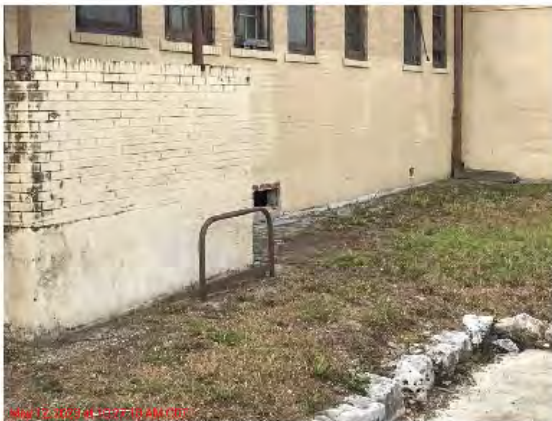
LOCATION: Exterior North
PRIORITY: Normal
DUE DATE: No due date
DISCIPLINES:
ASSIGNEE:

culvert to drain opening IN(?) to building crawlspace visual appears to show this. open area way further down building.
