# HISTORIC AND DESIGN REVIEW COMMISSION

October 06, 2021

**HDRC CASE NO:** 2021-472  
**ADDRESS:** 114 PARKVIEW DR  
**LEGAL DESCRIPTION:** NCB 6919 BLK LOT E 20 FT OF 12 & W 15 FT OF 13  
**ZONING:** R-5, H  
**CITY COUNCIL DIST.:** 3  
**DISTRICT:** Mission Historic District  
**APPLICANT:** HMI Homes, LLC  
**OWNER:** HMI Homes, LLC  
**TYPE OF WORK:** Fenestration modifications, siding modifications  
**APPLICATION RECEIVED:** September 09, 2021  
**60-DAY REVIEW:** Not applicable due to City Council Emergency Orders  
**CASE MANAGER:** Katie Totman

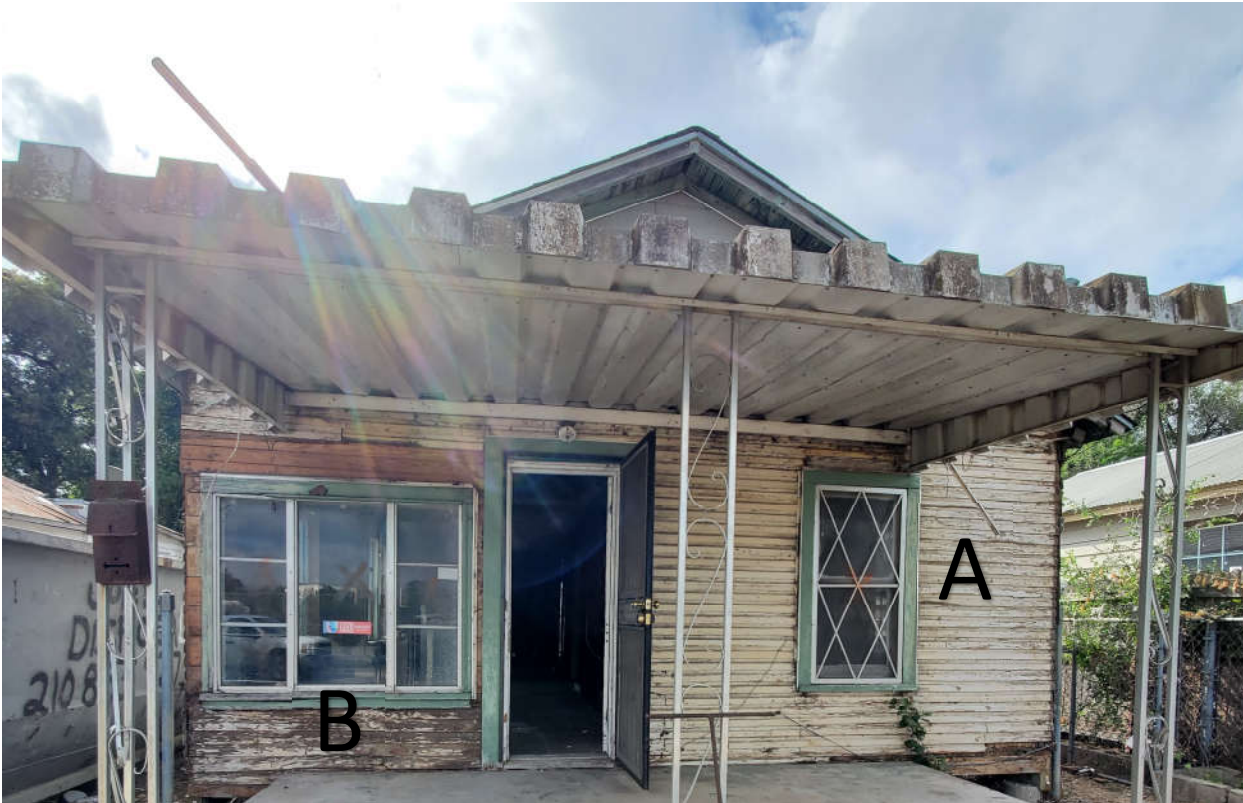
Pic 17

In the front of the home, there are two windows facing the street. One of the windows is 28" x 48" and of wood material. It is an original window of the home (window A). This window will stay as-is. The second window is a recent replacement, measures 72" x 48" and is of aluminum material (window B). This window is not original to the home as is evident in the re-framing of the window and the replacement siding installed around it. I request to replace this window with one that will match window A. The replacement window will have a painted wood exterior finish, clear glass, and exhibit trim details that align with the OHP's recommended specifications. By replacing window B with one that matches window A, the front of the home will be transformed to its original historical appearance.

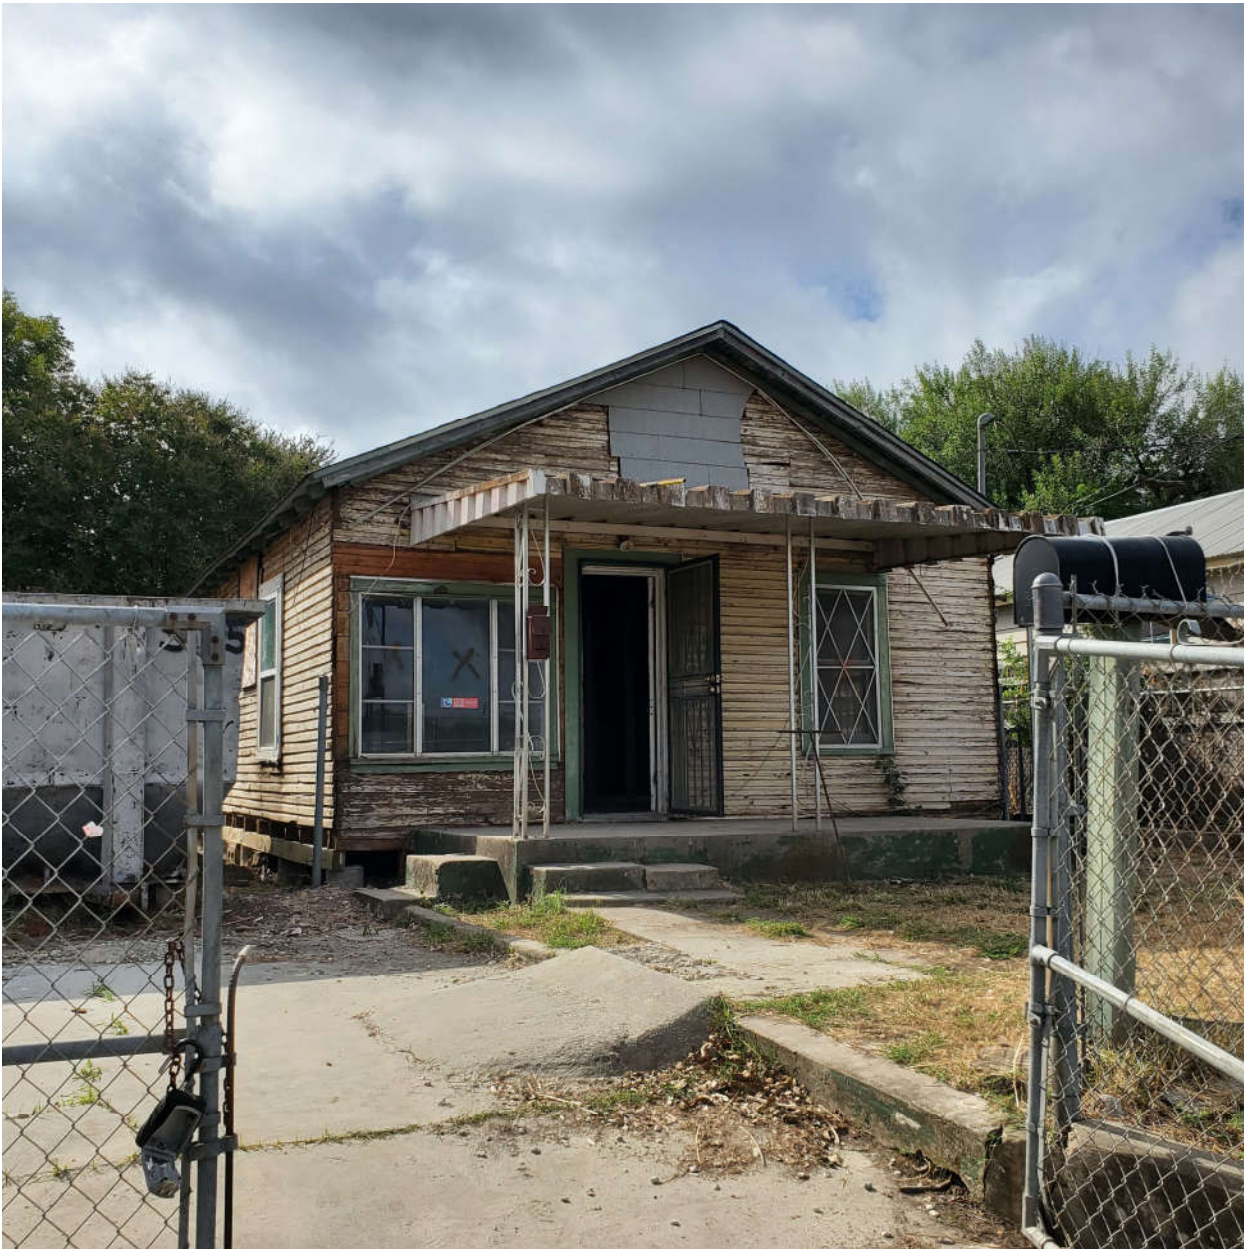
Pic 27

The existing porch cover is a recent addition to the home. It has a flat aluminum roof with metal posts. I request to remove this cover and replace it with one constructed of wood posts, wood covering and a gable style roof. The proposed porch cover is consistent with the other homes in the neighborhood.

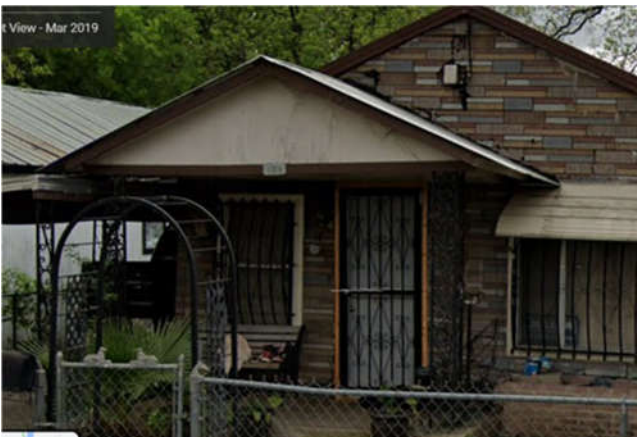
Pic 28

An example of the proposed new porch cover.

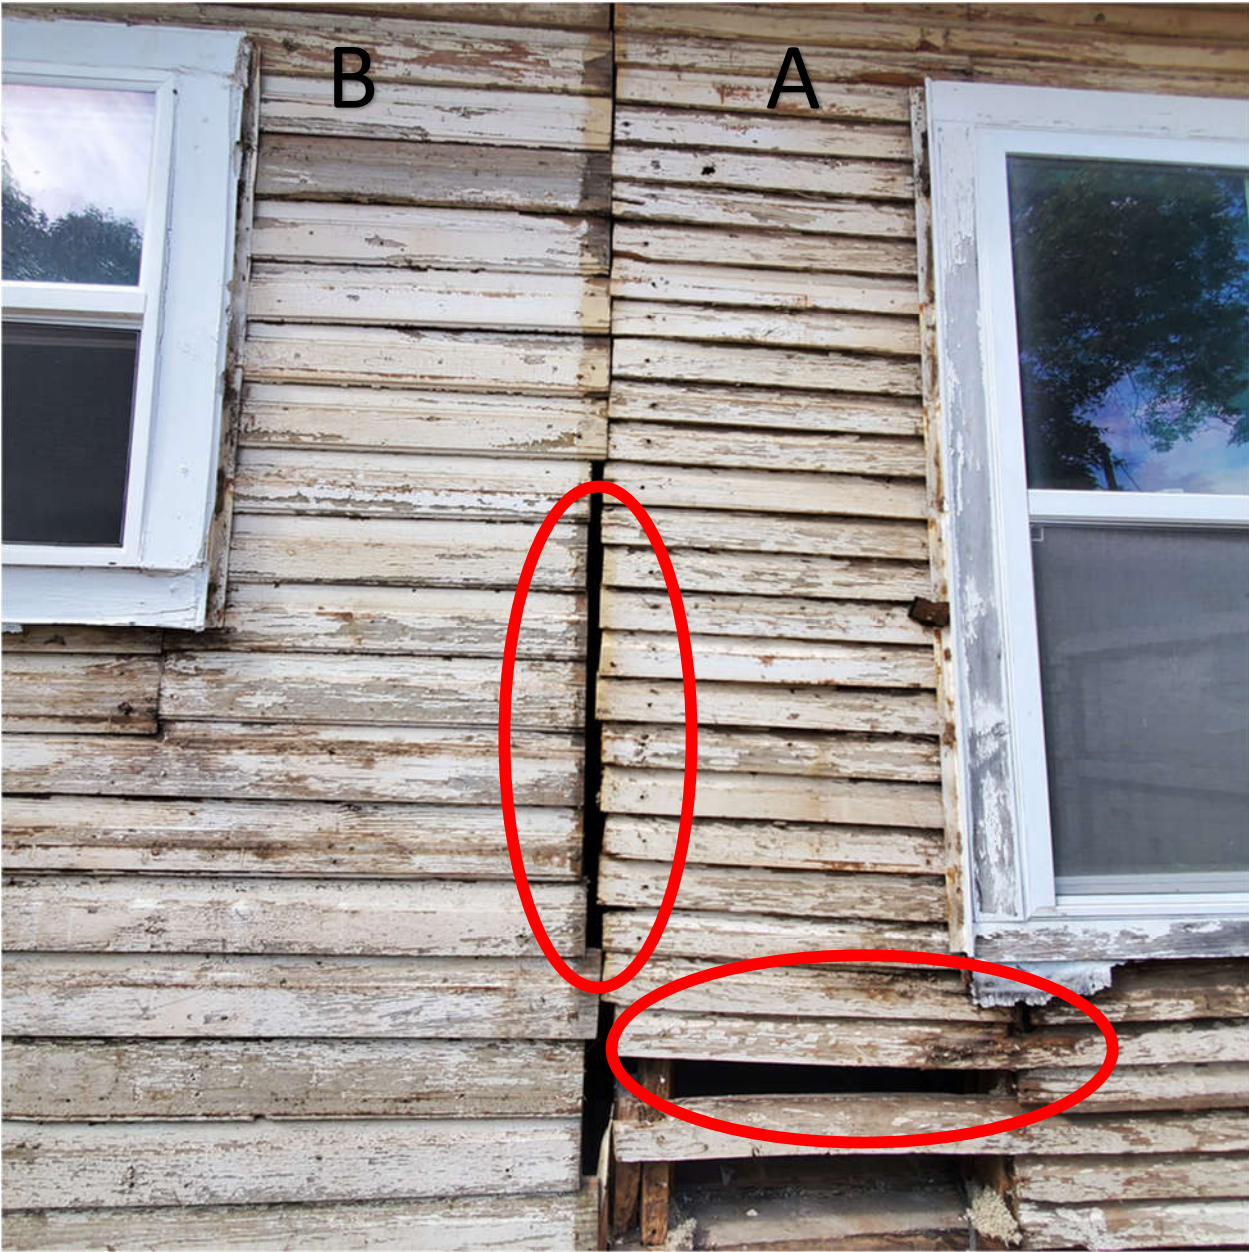
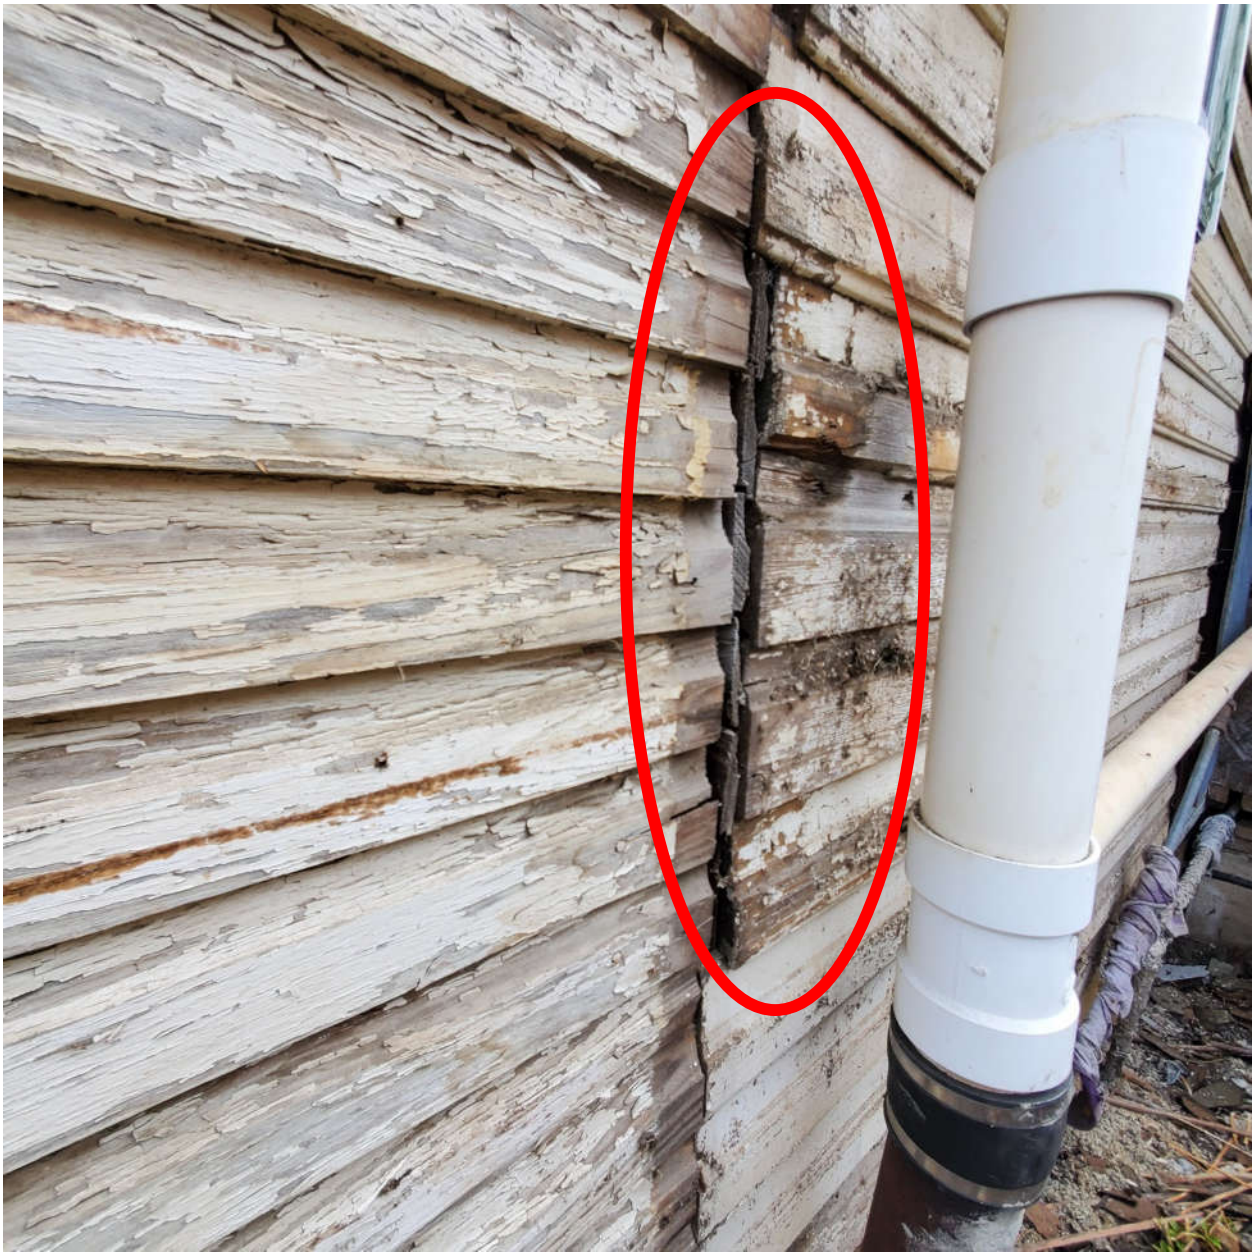
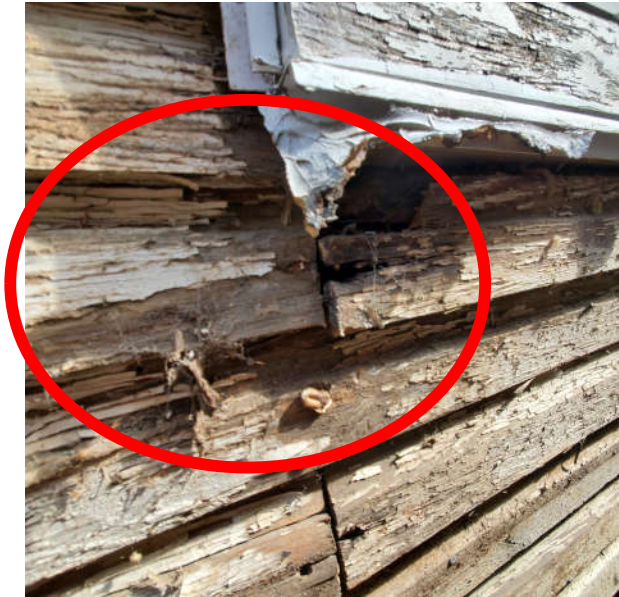
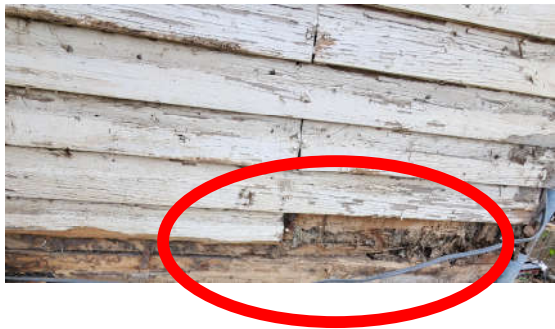
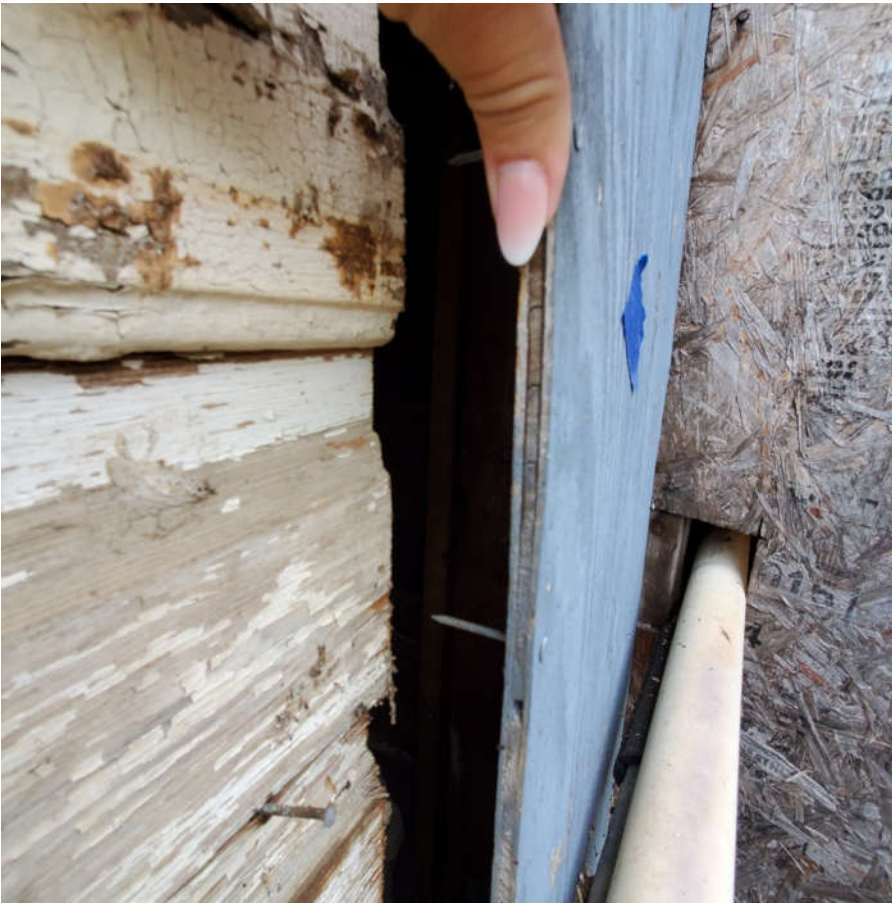
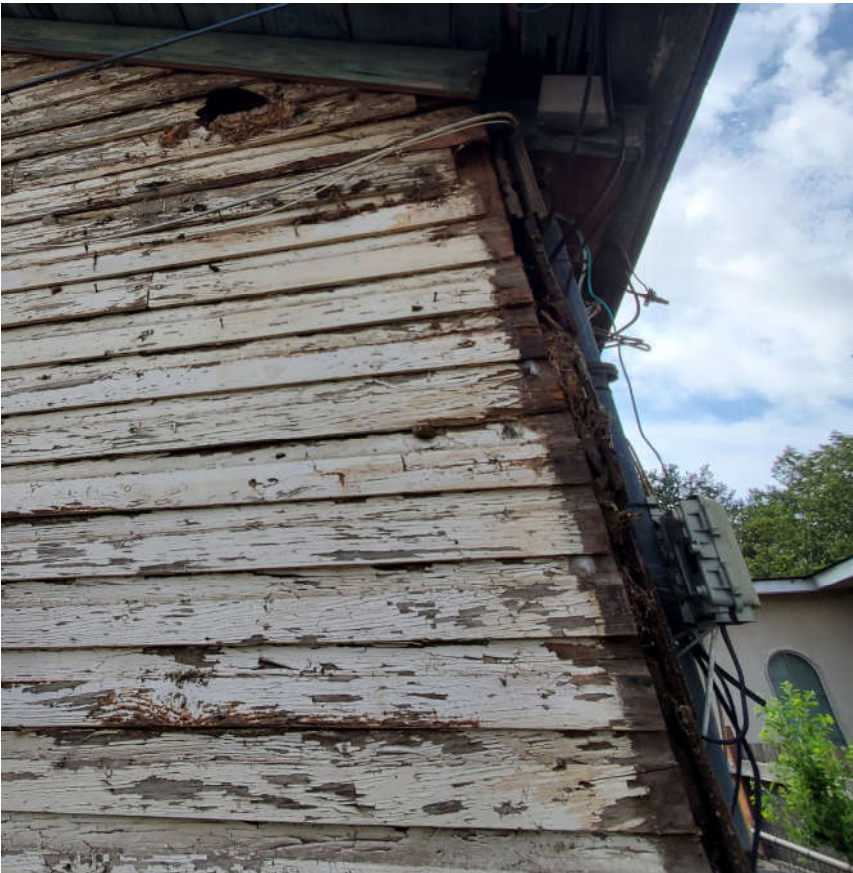
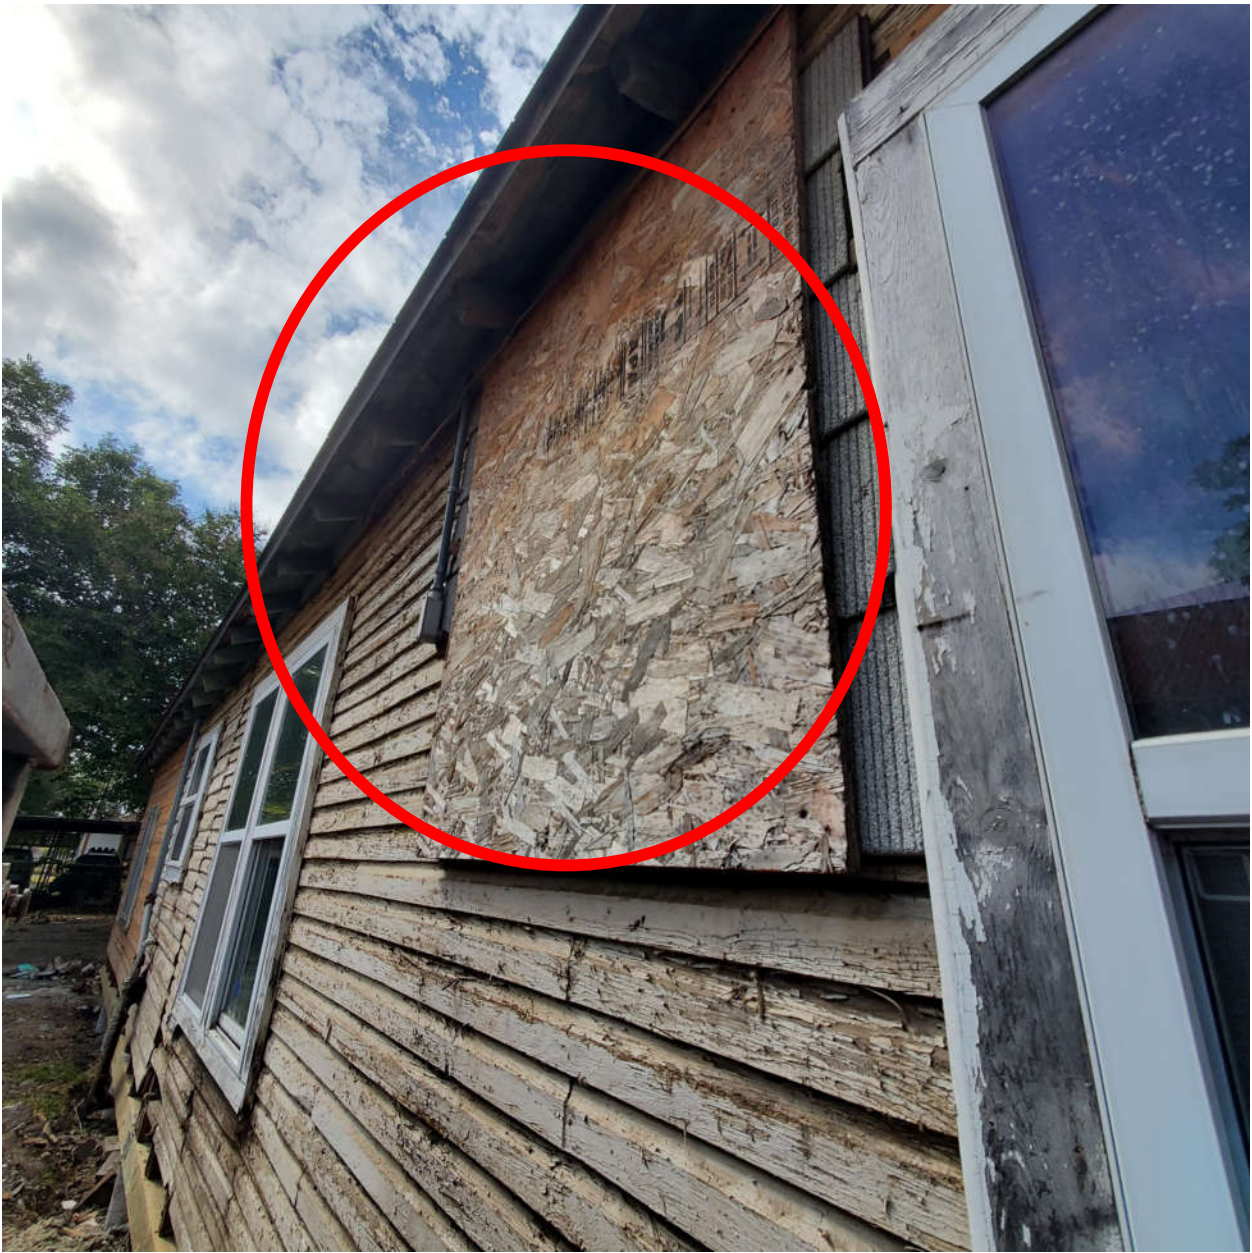
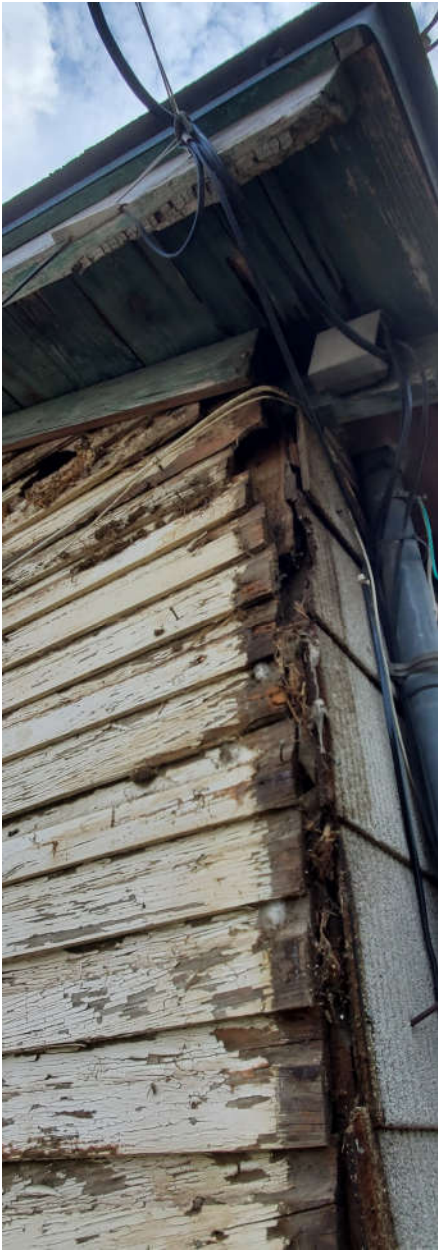
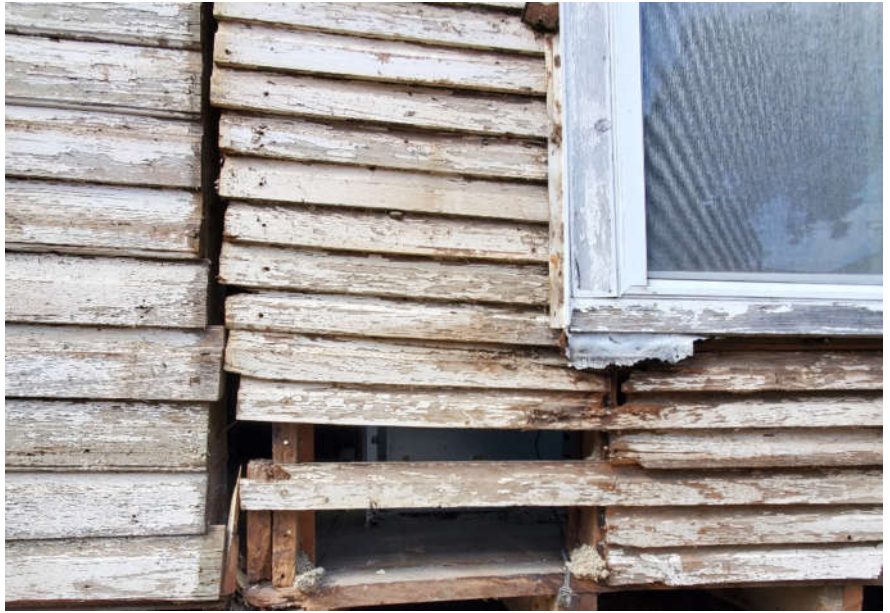
The front half of the home is covered in a 4" dutch lap siding (siding A) and is in the most damaged condition. The siding covers approximately 50% of the home. A majority of the boards are damaged and show signs of extreme rotting. There are large gaping holes throughout the siding that the previous homeowners have covered with plywood. To only spot repair/replace damaged boards in this section would require replacing approximately 60% of these boards.

I understand that the Office of Historic Preservation would prefer to repair and spot replace the existing wood siding, yet I respectfully request an alternative method that will stay in line with the OHP's vision of maintaining the historical appearance of the home. I request to install 4" dutch lap style wood siding over all three profiles. This will give a consistent look to the property, as well as provide strong and durable protection to the structure.

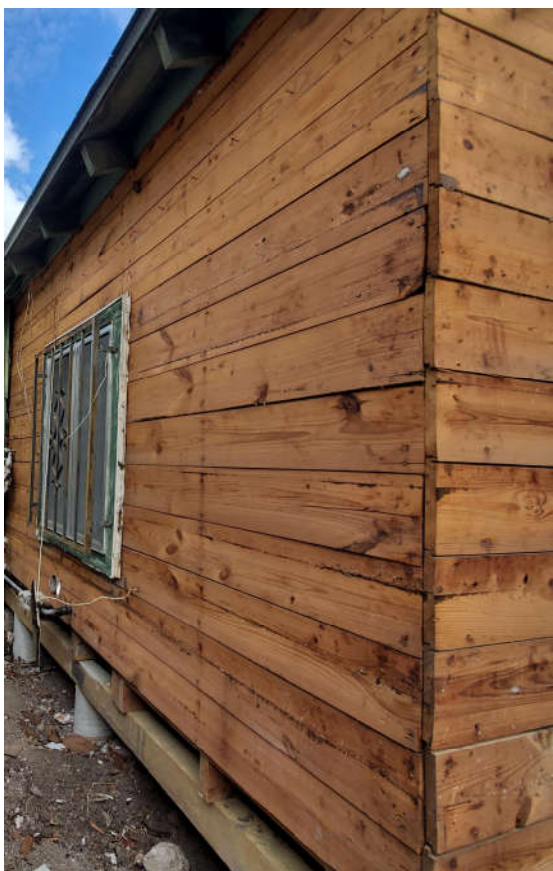
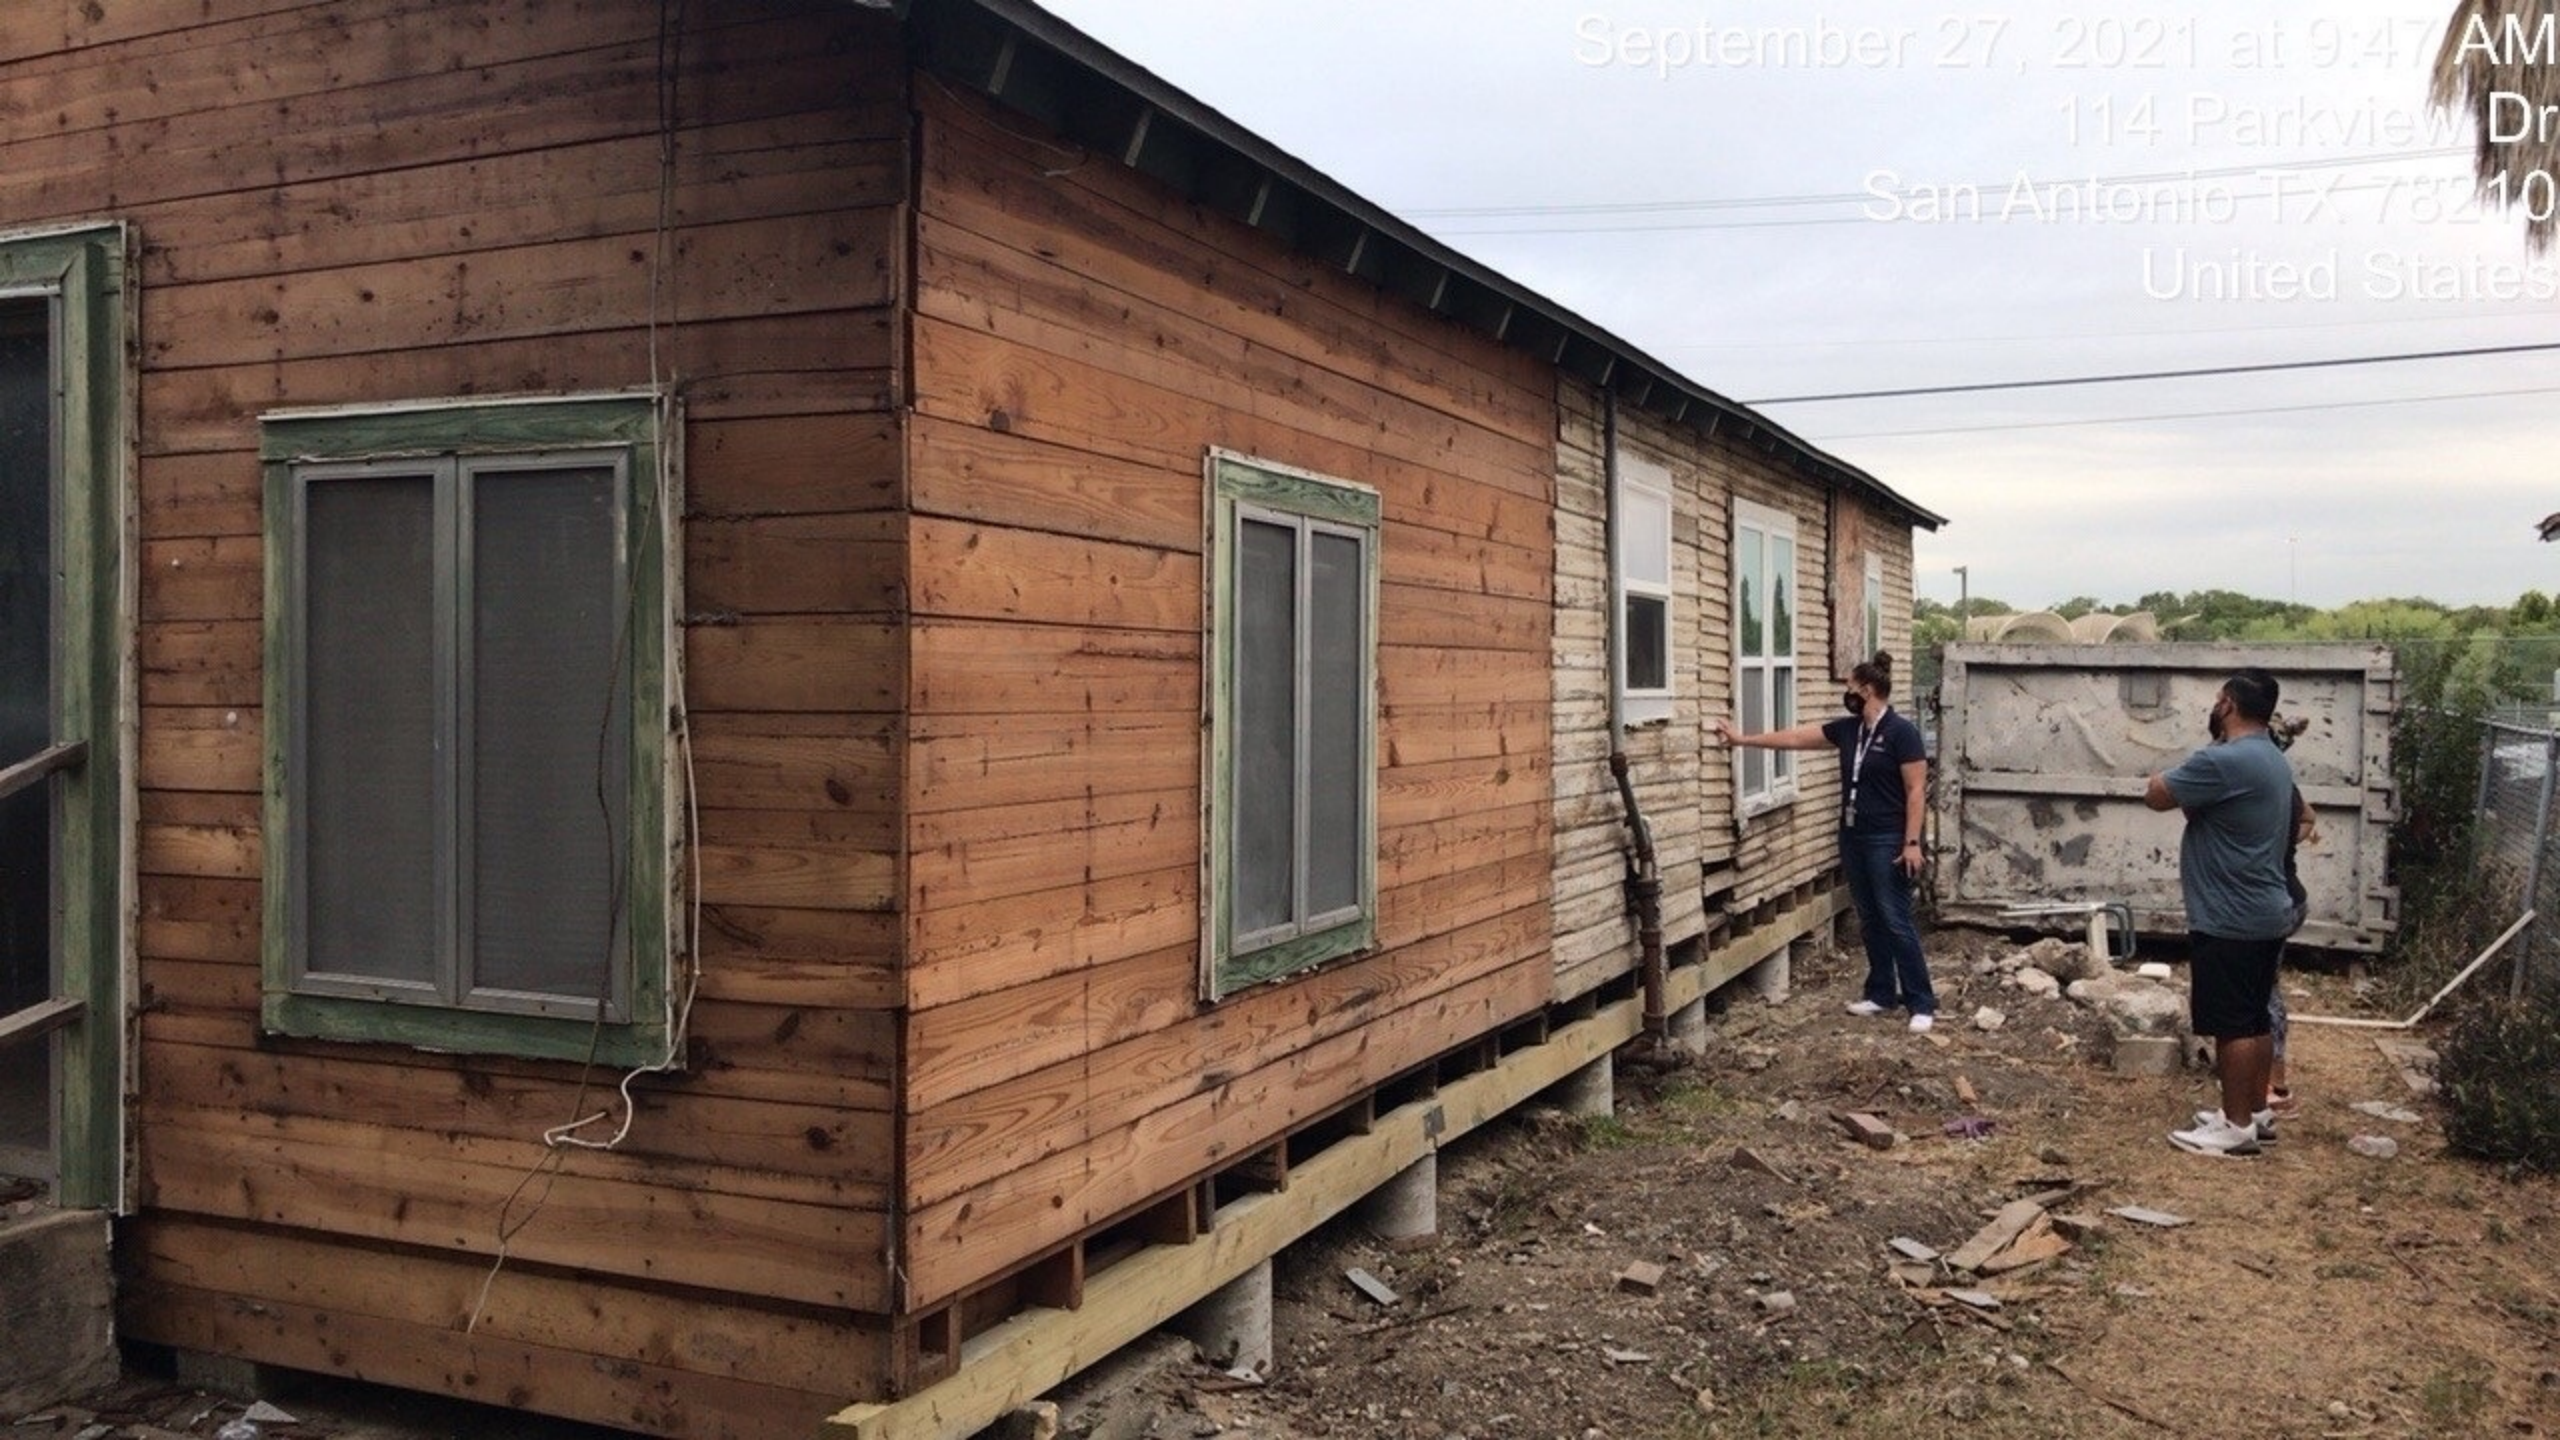
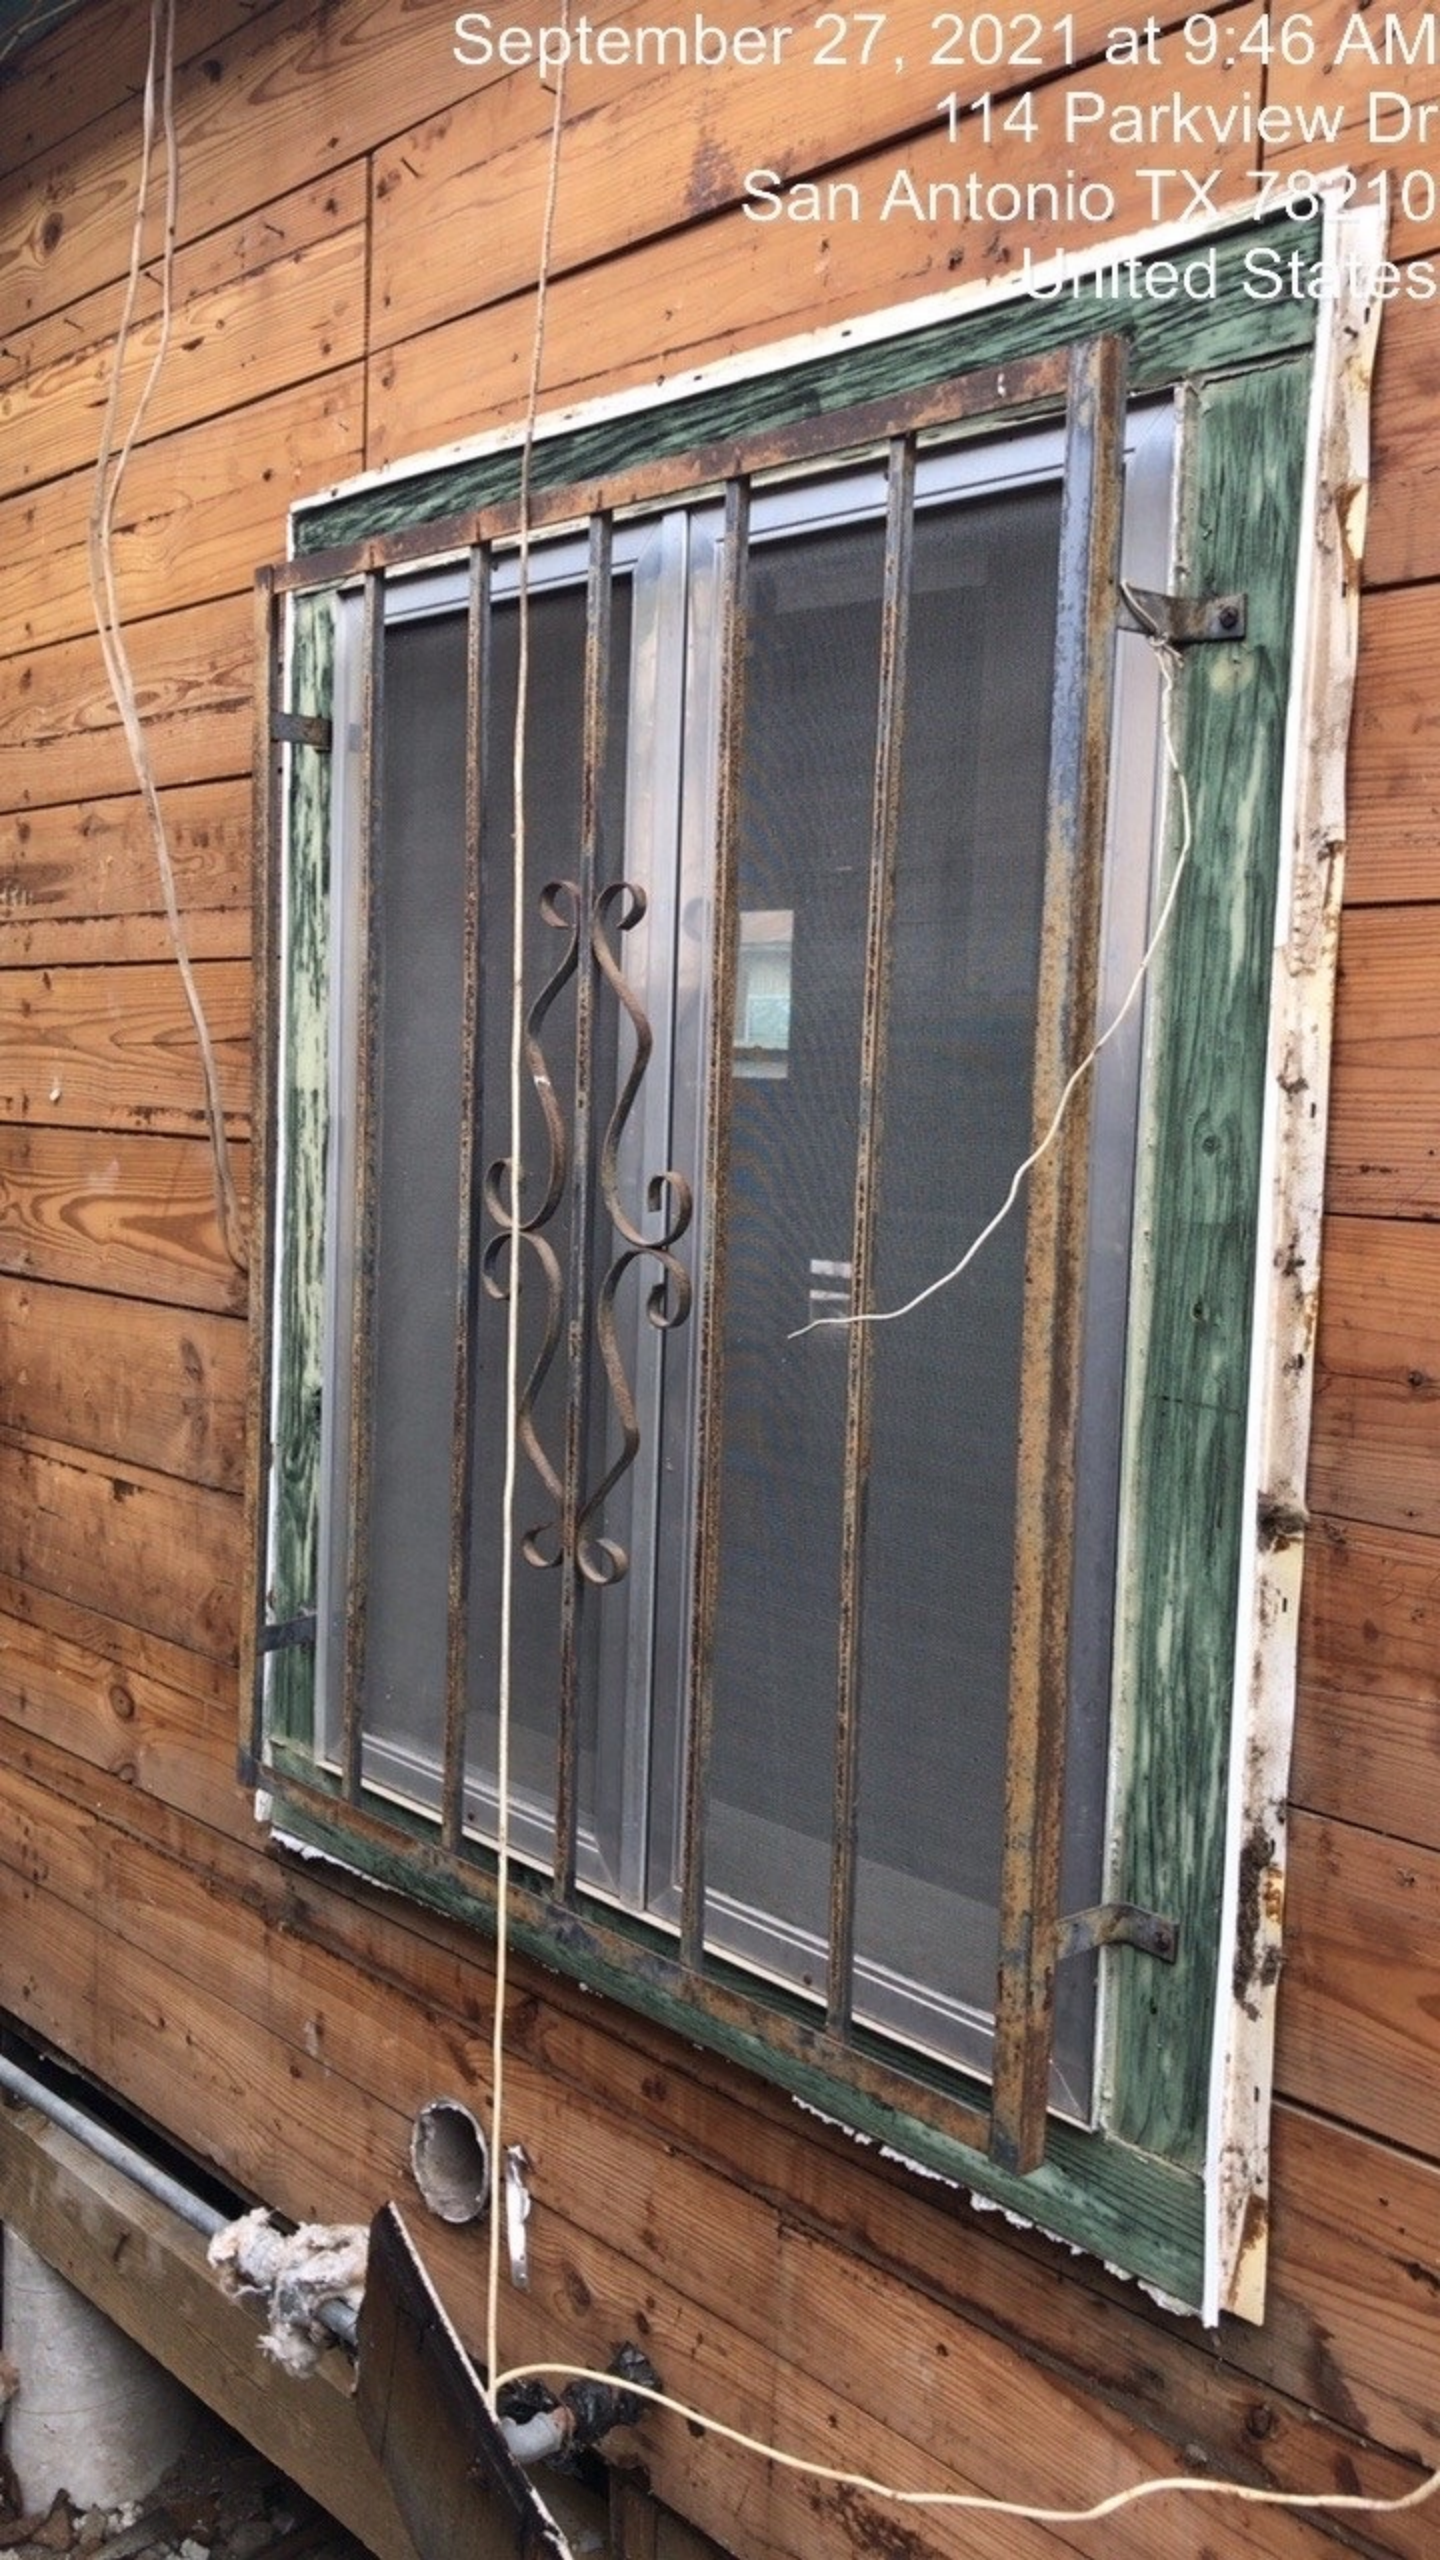
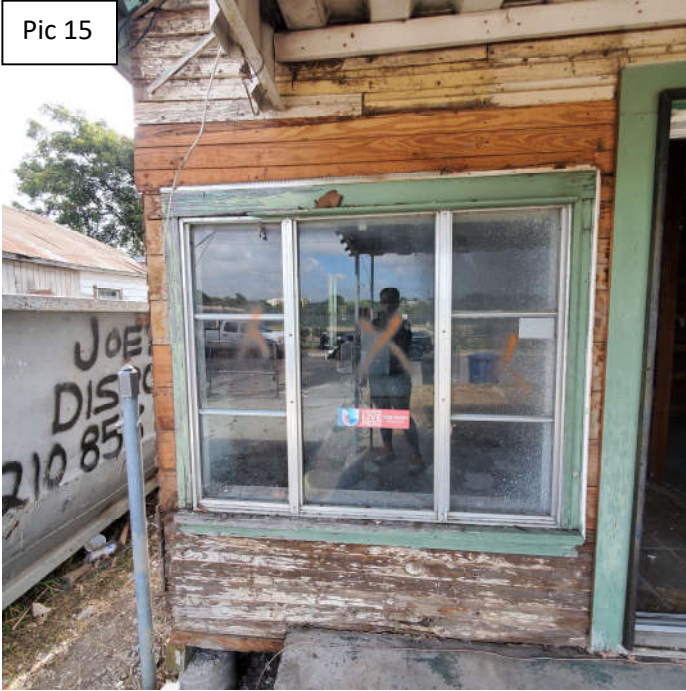
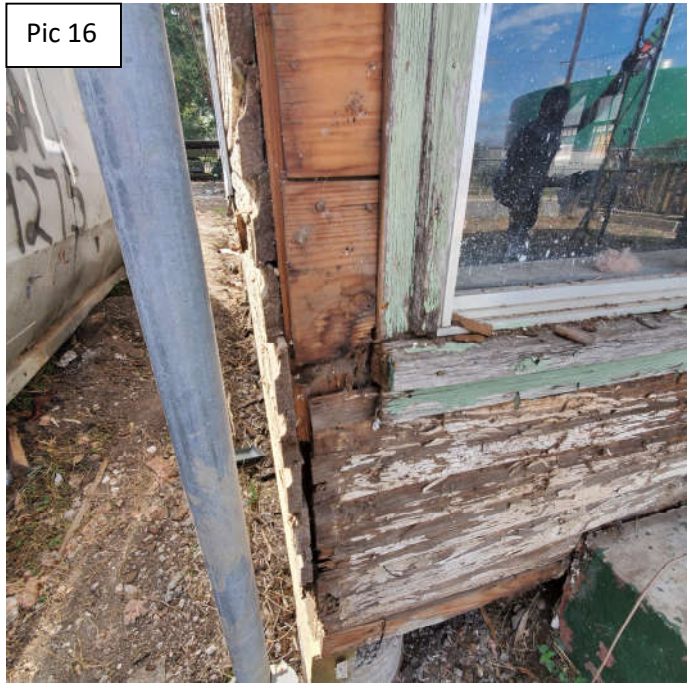
The third style are 1" x 6" boards (siding C) and covers the remaining 35% of the home. This siding is in the best condition of all three siding profiles yet does not provide contributing status to the home. This siding was added the most recently of the three. This siding was also used to frame around the street facing windows in the front of the home, see picture below.

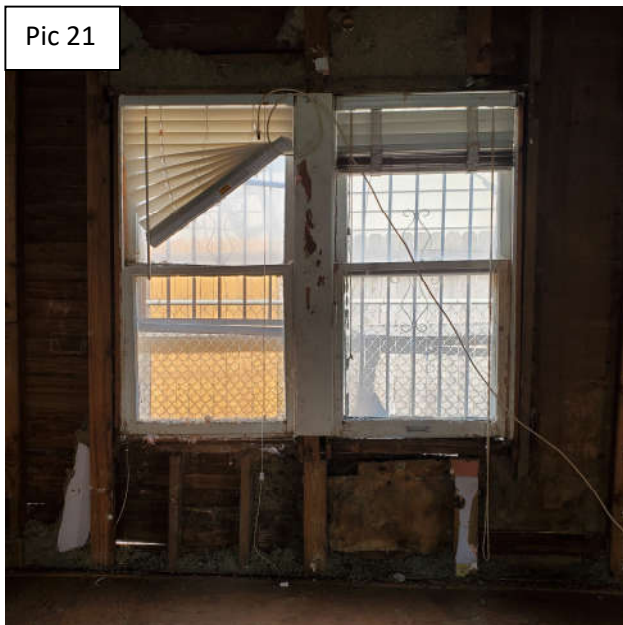
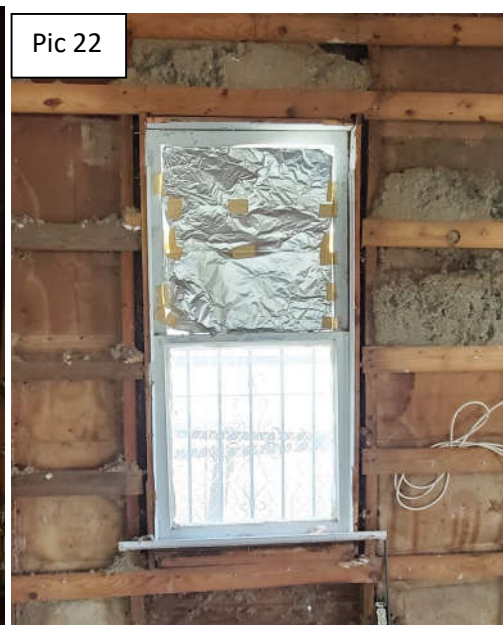
There are three wood windows along the right side of the home that are likely from the original construction of the home. These three windows and window A (front of the house) are missing the counterweights and sash cords. The windows will be renovated with no changes to material or sizes.

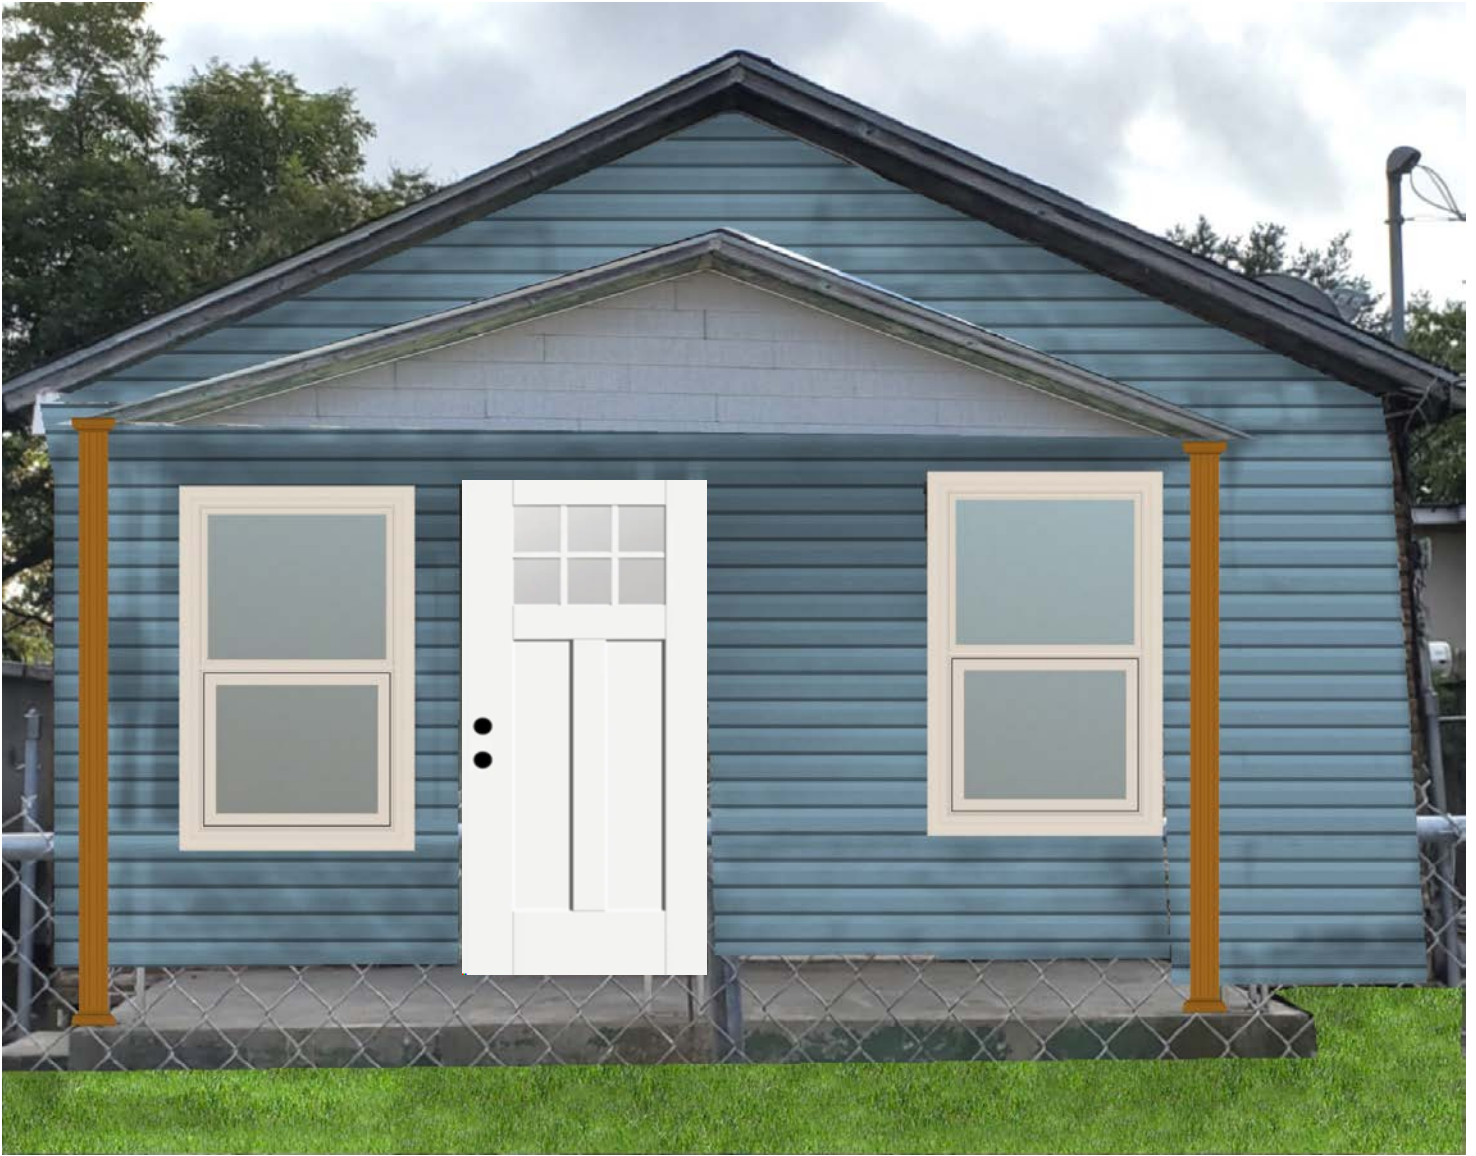
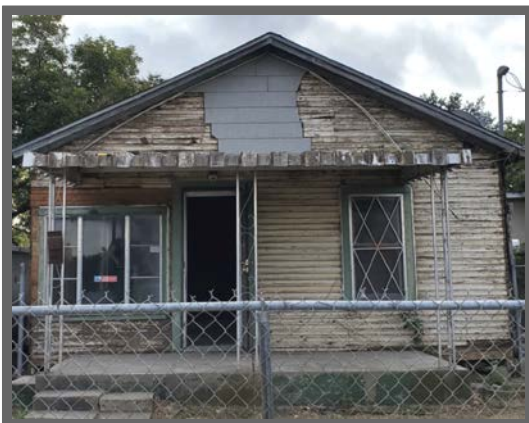
## 114 Parkview Drive - Front

The proposed repairs: replace the left window to match the existing right wooden window; replace the front door, install 4" dutch lap siding, replace the porch cover with a wooden patio cover with a gable style roof.
