# HISTORIC AND DESIGN REVIEW COMMISSION

October 06, 2021

**HDRC CASE NO:** 2021-472  
**ADDRESS:** 114 PARKVIEW DR  
**LEGAL DESCRIPTION:** NCB 6919 BLK LOT E 20 FT OF 12 & W 15 FT OF 13  
**ZONING:** R-5, H  
**CITY COUNCIL DIST.:** 3  
**DISTRICT:** Mission Historic District  
**APPLICANT:** HMI Homes, LLC  
**OWNER:** HMI Homes, LLC  
**TYPE OF WORK:** Fenestration modifications, siding modifications  
**APPLICATION RECEIVED:** September 09, 2021  
**60-DAY REVIEW:** Not applicable due to City Council Emergency Orders  
**CASE MANAGER:** Katie Totman

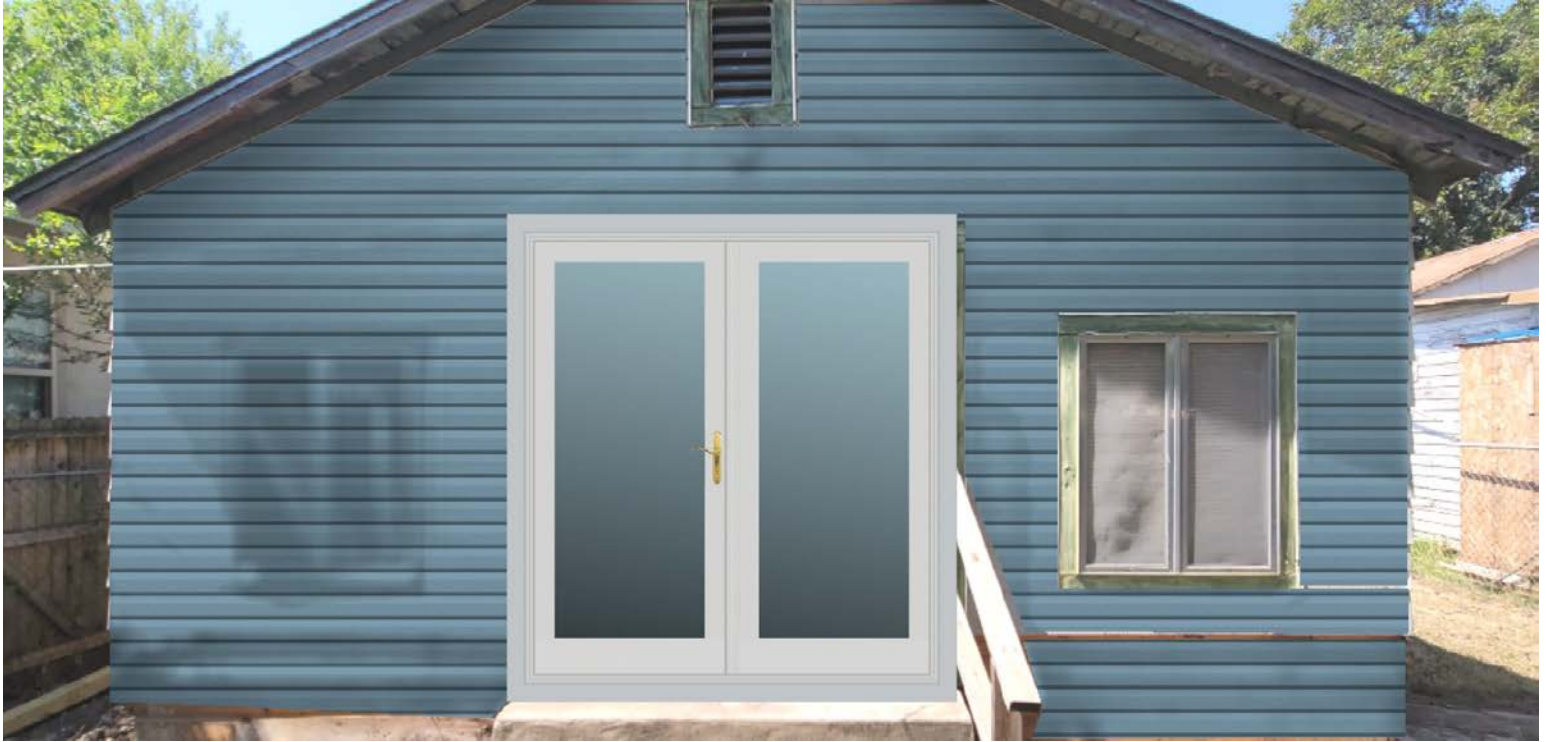
## 114 Parkview Drive - Rear

Proposed changes to rear of home: close out left aluminum window to make room for a new bathroom for the primary bedroom, install 4" dutch lap siding all around the home.

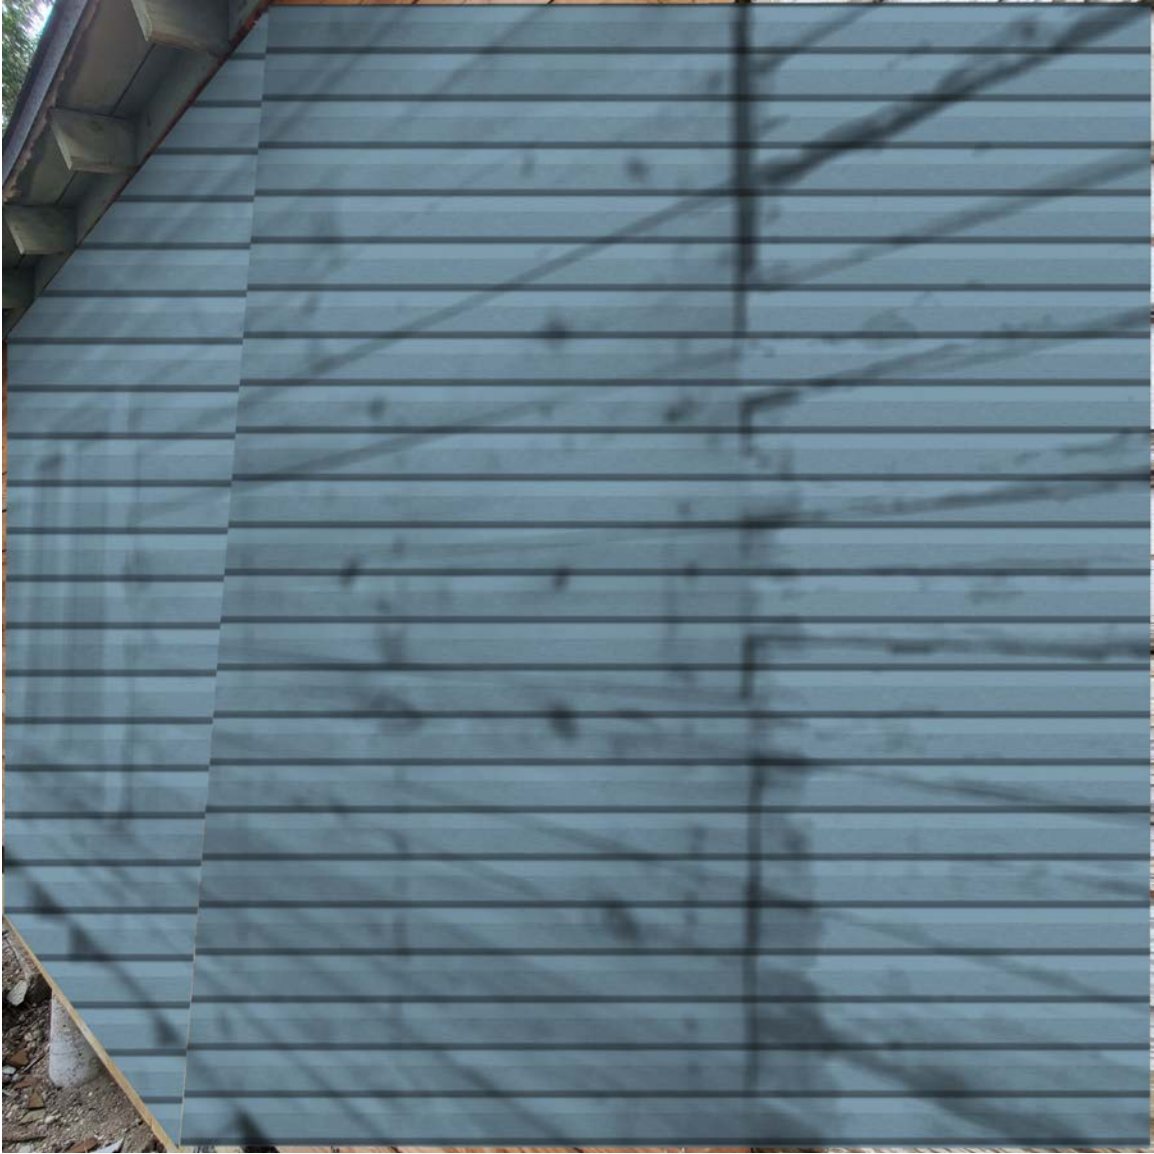
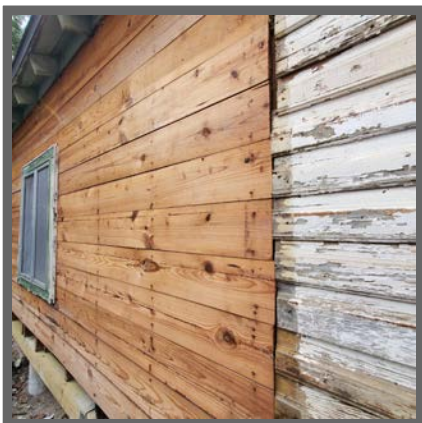
## 114 Parkview Drive - left side rear

Proposed repairs: install 4" dutch lap siding all around the house, omit the rear aluminum window on the left side of the home to make room for a full bath.

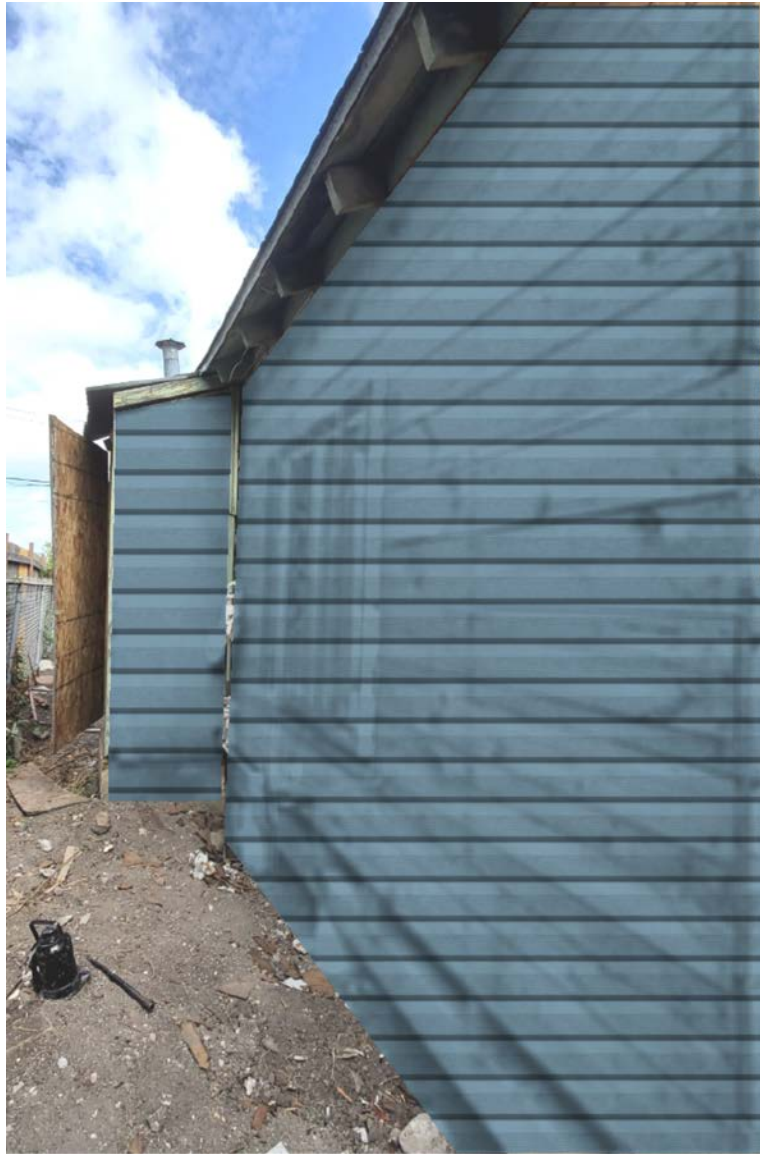
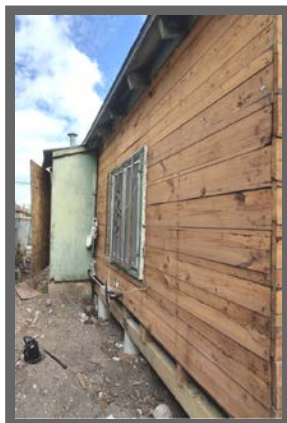
## 114 Parkview Drive - right side rear

Proposed changes: install 4" dutch lap siding all around the home, omit the rear aluminum window on the right side of the home to make room for a new primary bedroom.
