## HISTORIC AND DESIGN REVIEW COMMISSION

November 17, 2021

**HDRC CASE NO:** 2021-562  
**ADDRESS:** 324 E MYRTLE  
**LEGAL DESCRIPTION:** NCB 1751 BLK 6 LOT 3  
**ZONING:** MF-33  
**CITY COUNCIL DIST.:** 1  
**DISTRICT:** Tobin Hill Historic District  
**APPLICANT:** Michael Castro/CASTRO MICHAEL &  
**OWNER:** Michael Castro/CASTRO MICHAEL &  
**TYPE OF WORK:** Window replacement, exterior alterations  
**APPLICATION RECEIVED:** October 26, 2021  
**60-DAY REVIEW:** Not applicable due to City Council Emergency Orders  
**CASE MANAGER:** Katie Totman  
**REQUEST:**

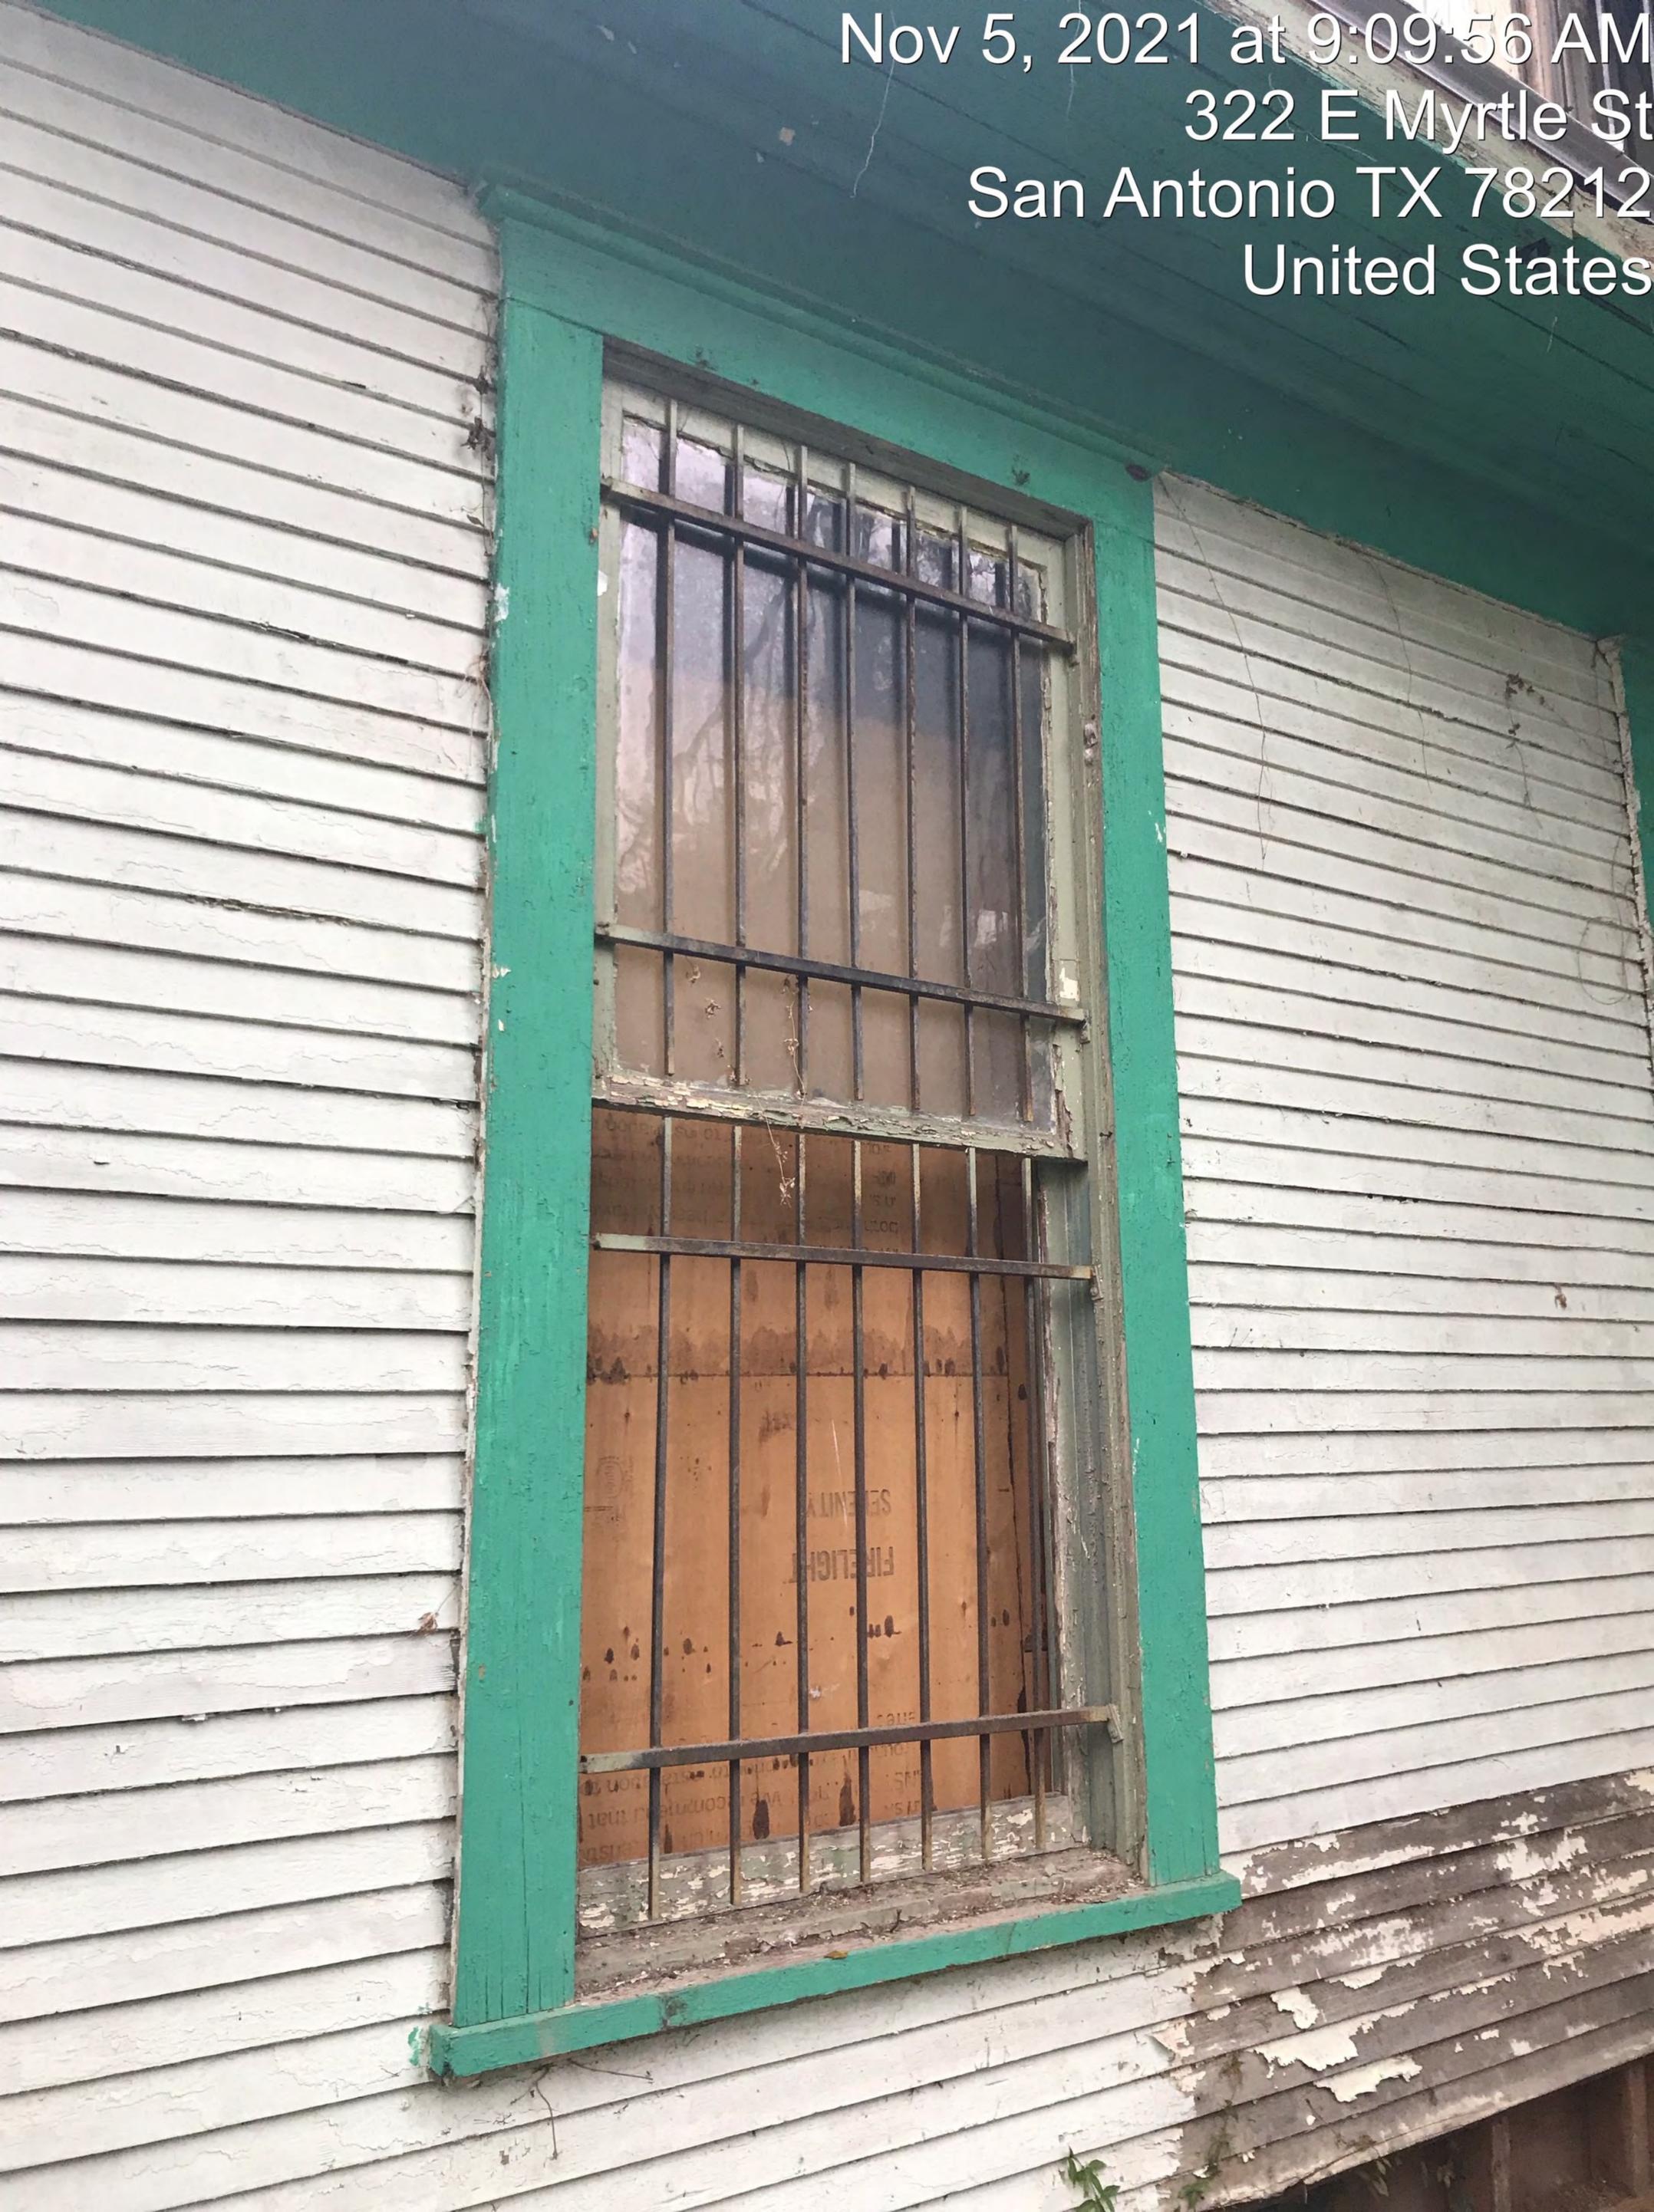
**Not an original window , to be removed.  
aluminum window added by previous  
owner**

Staff recommends approval of the removal of the non-conforming window located on the first-floor east elevation as submitted.
