# HISTORIC AND DESIGN REVIEW COMPLIANCE AND TECHNICAL ADVISORY BOARD

February 23, 2024

**HDRC CASE NO:** 2024-032  
**ADDRESS:** 103 FIR  
**LEGAL DESCRIPTION:** NCB 2966 BLK 1 LOT 9  
**ZONING:** RM-4, H  
**CITY COUNCIL DIST.:** 1  
**DISTRICT:** King William Historic District  
**APPLICANT:** Otoniel Trevino/STATT PROPERTIES INC  
**OWNER:** Otoniel Trevino/STATT PROPERTIES INC  
**TYPE OF WORK:** Conversion of an original window opening to a door opening  
**APPLICATION RECEIVED:** January 07, 2024  
**60-DAY REVIEW:** March 07, 2024  
**CASE MANAGER:** Edward Hall

# 103 FIR

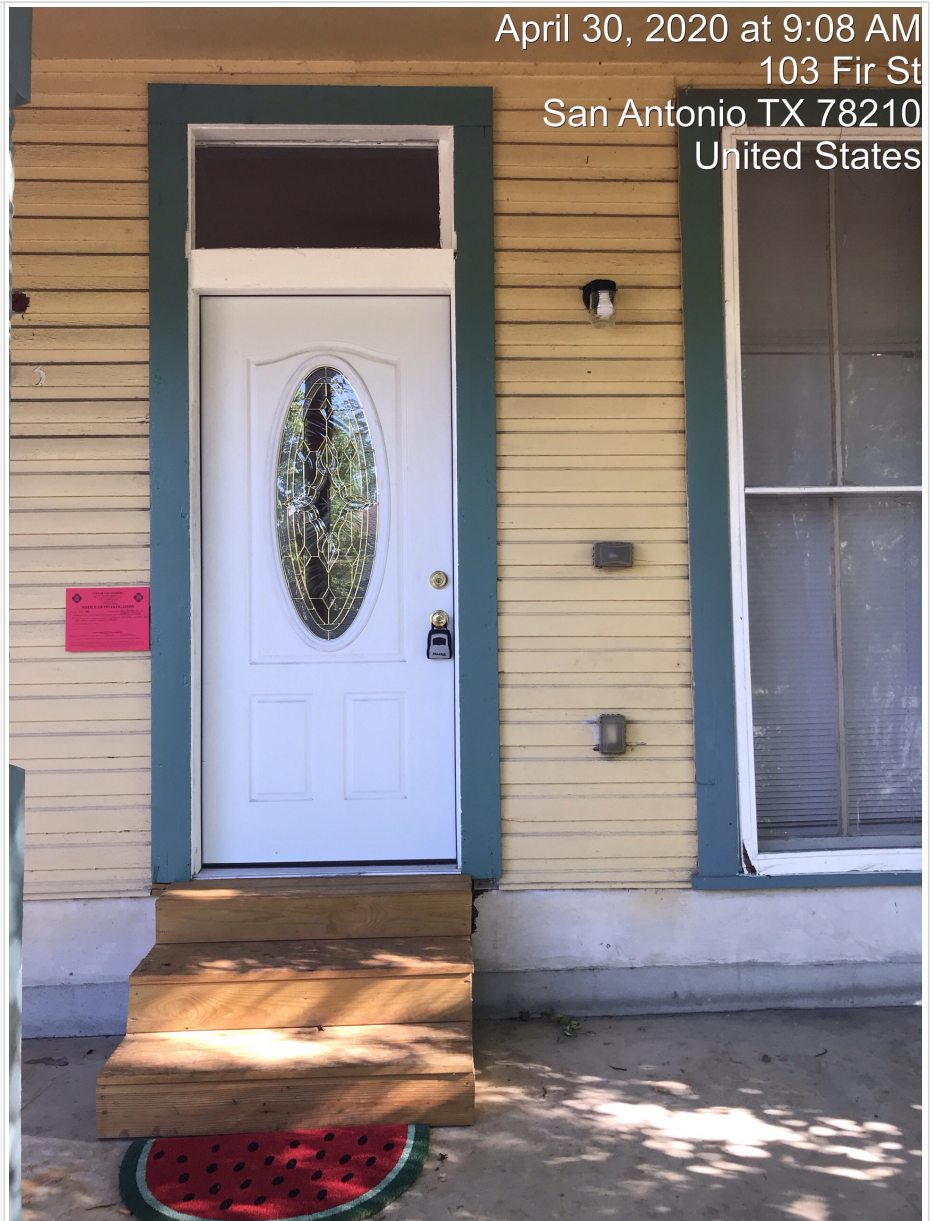
## Investigation Report

- b. COMPLIANCE – On a site visit conducted on April 30, 2020, staff found that a front-facing two-over-two wood sash window was replaced with a door and wood steps of the approximate same size. The applicant submitted an application on June 14, 2020 to be heard at the next available Historic and Design Review Commission hearing.
