HISTORIC AND DESIGN REVIEW COMMISSION

May 18, 2022

HDRC CASE NO: 2022-267
ADDRESS: 1502 BUENA VISTA ST
LEGAL DESCRIPTION: NCB 2340 BLK 7 LOT N 101.25 FT OF 1
ZONING: C-2, HL
CITY COUNCIL DIST.: 5
LANDMARK: Individual Landmark
APPLICANT: Alberto Mejia
OWNER: Alberto Mejia
TYPE OF WORK: Historic Tax Verification
APPLICATION RECEIVED: May 04, 2022
60-DAY REVIEW: Not applicable due to City Council Emergency Orders
CASE MANAGER: Rachel Rettaliata

The applicant is requesting Historic Tax Verification for the property at 1502 Buena Vista.

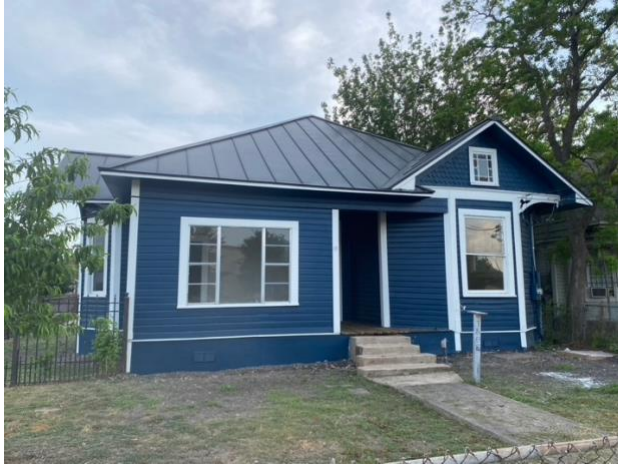
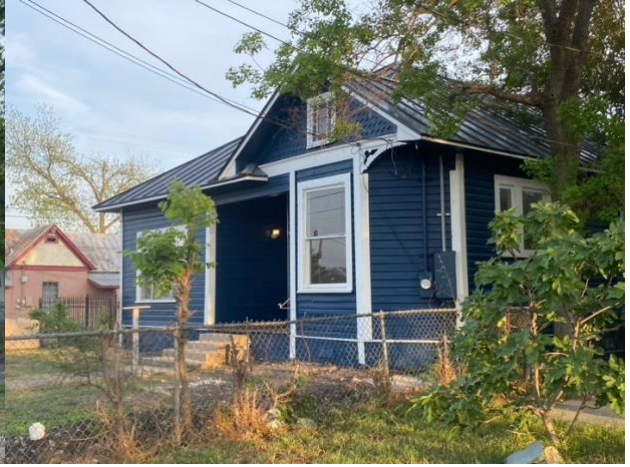
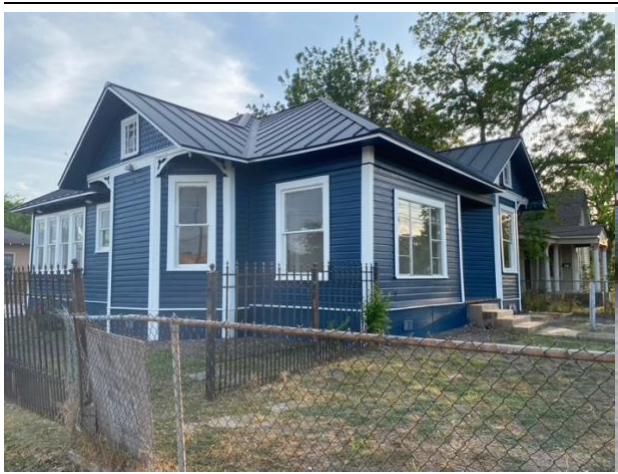
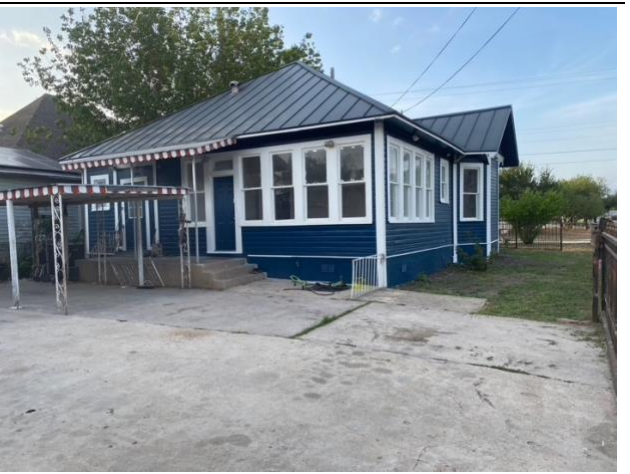
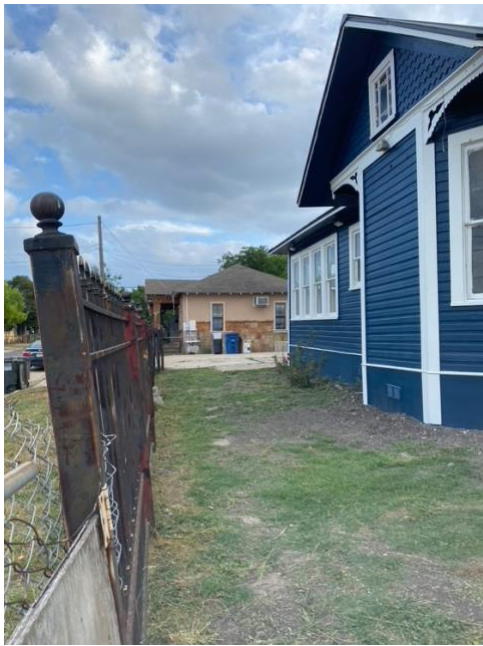
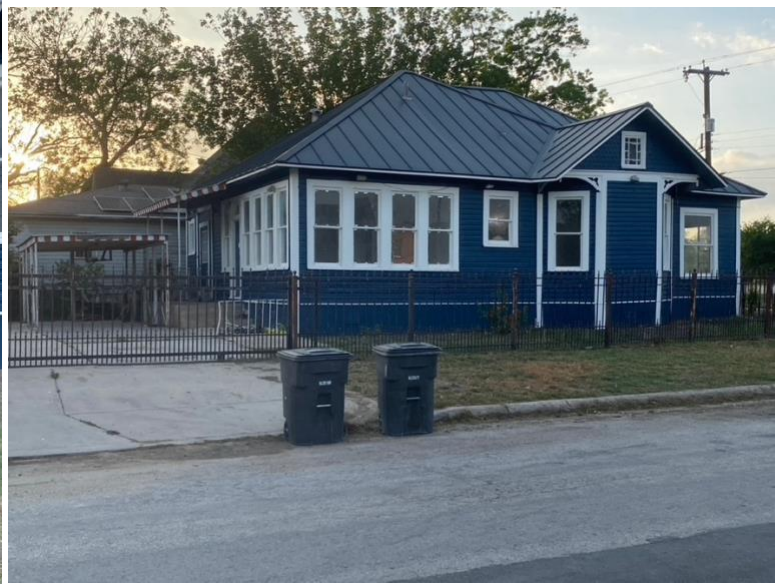
Photos: Exterior

Work Needed: Paint was peeling and chipping on all sides of the home, with some damage to soffits and trim. original siding as it appears in to be left intact . There are also no plans to modify any of the original distinguishing features and/or ornamentation of the homes folk Victorian character.

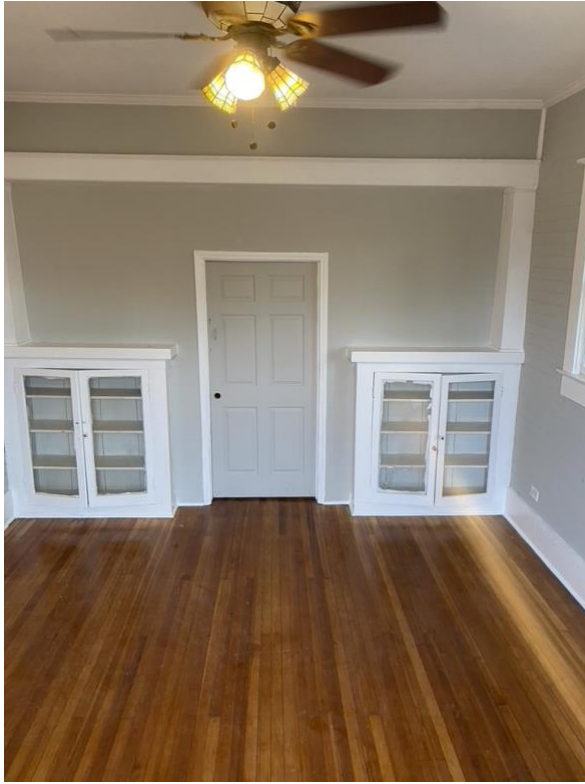
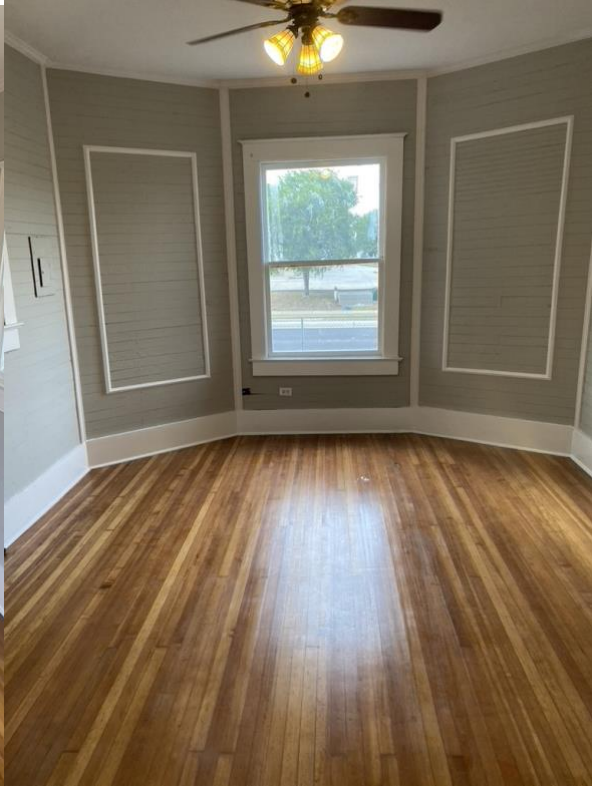
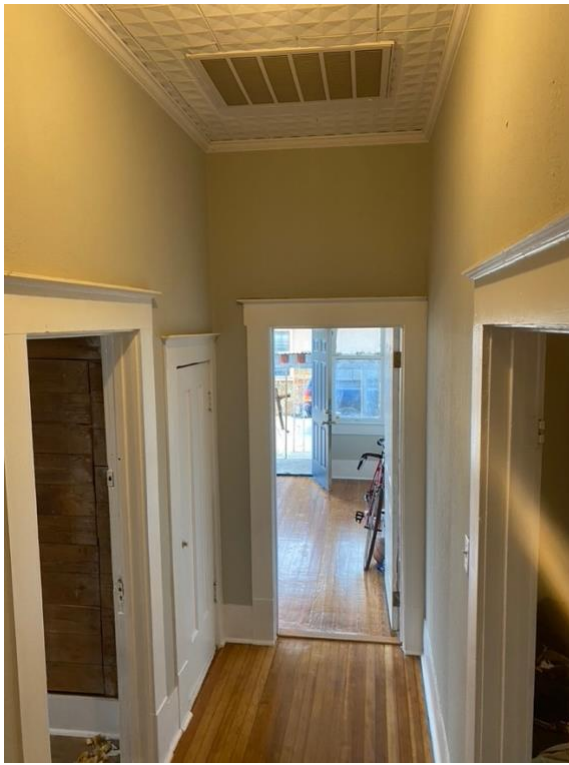
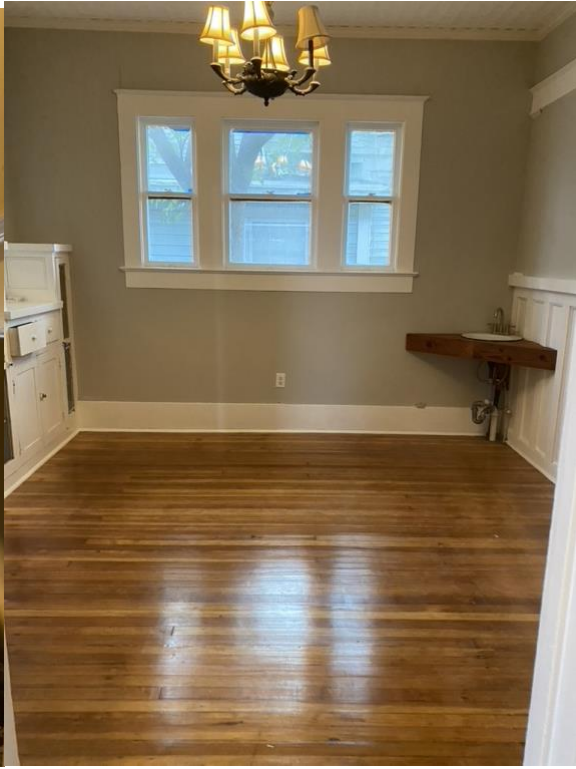
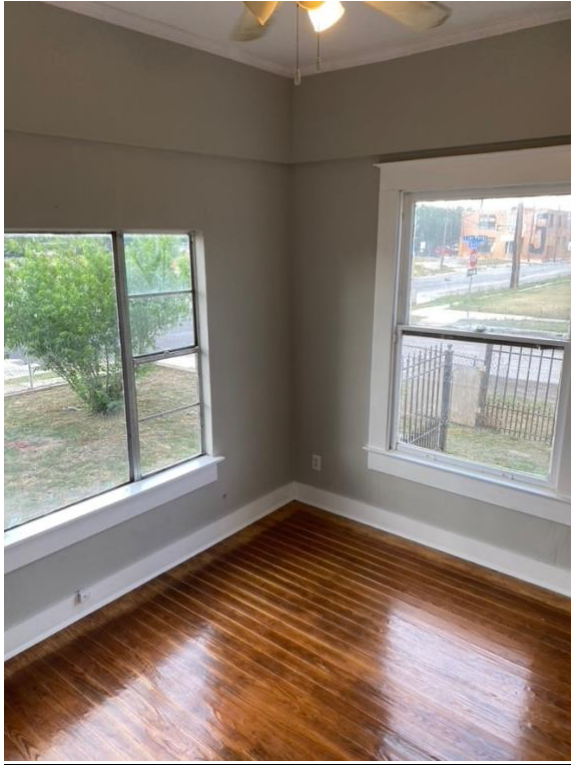
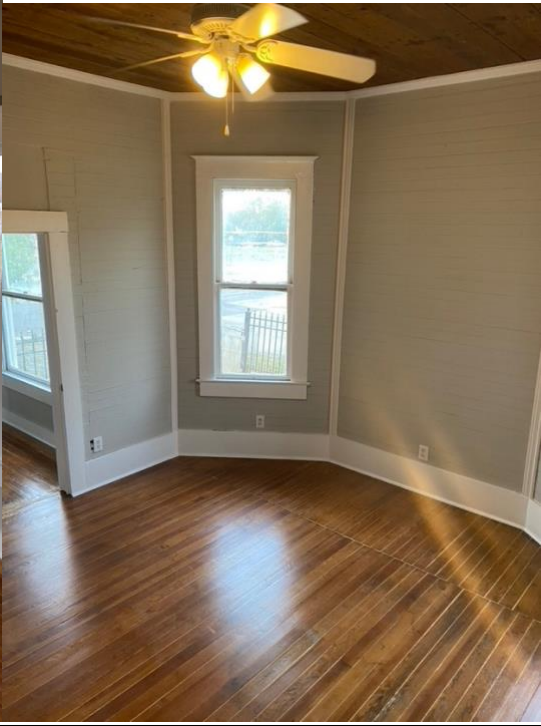
Photos Interior:

Work needed: Walls are stained and or damaged throughout the house, all interior walls to be repaired and repainted in a uniform way, likely flat/subtle grays and whites.

Work completed: Most walls and ceilings required demolition and removal, all walls and ceilings repaired, prepped and painted throughout entire home. Sweat Equity : _____ **Total** _____ Custom Texas Living (contractor) installed crown molding and new wall trim throughout home: **Total** : _____ All Work completed on 4/15/2022

Work completed: original wood flooring repaired, refinished throughout all rooms in the home. Work completed by Custom Texas Living work completed on 3/25/2022, **Total** :
