HISTORIC AND DESIGN REVIEW COMMISSION June 01, 2022

HDRC CASE NO: 2022-303

ADDRESS: 226 E HUISACHE AVE **LEGAL DESCRIPTION:** NCB 3086 BLK 2 LOT 7

TYPE OF WORK: Window replacement

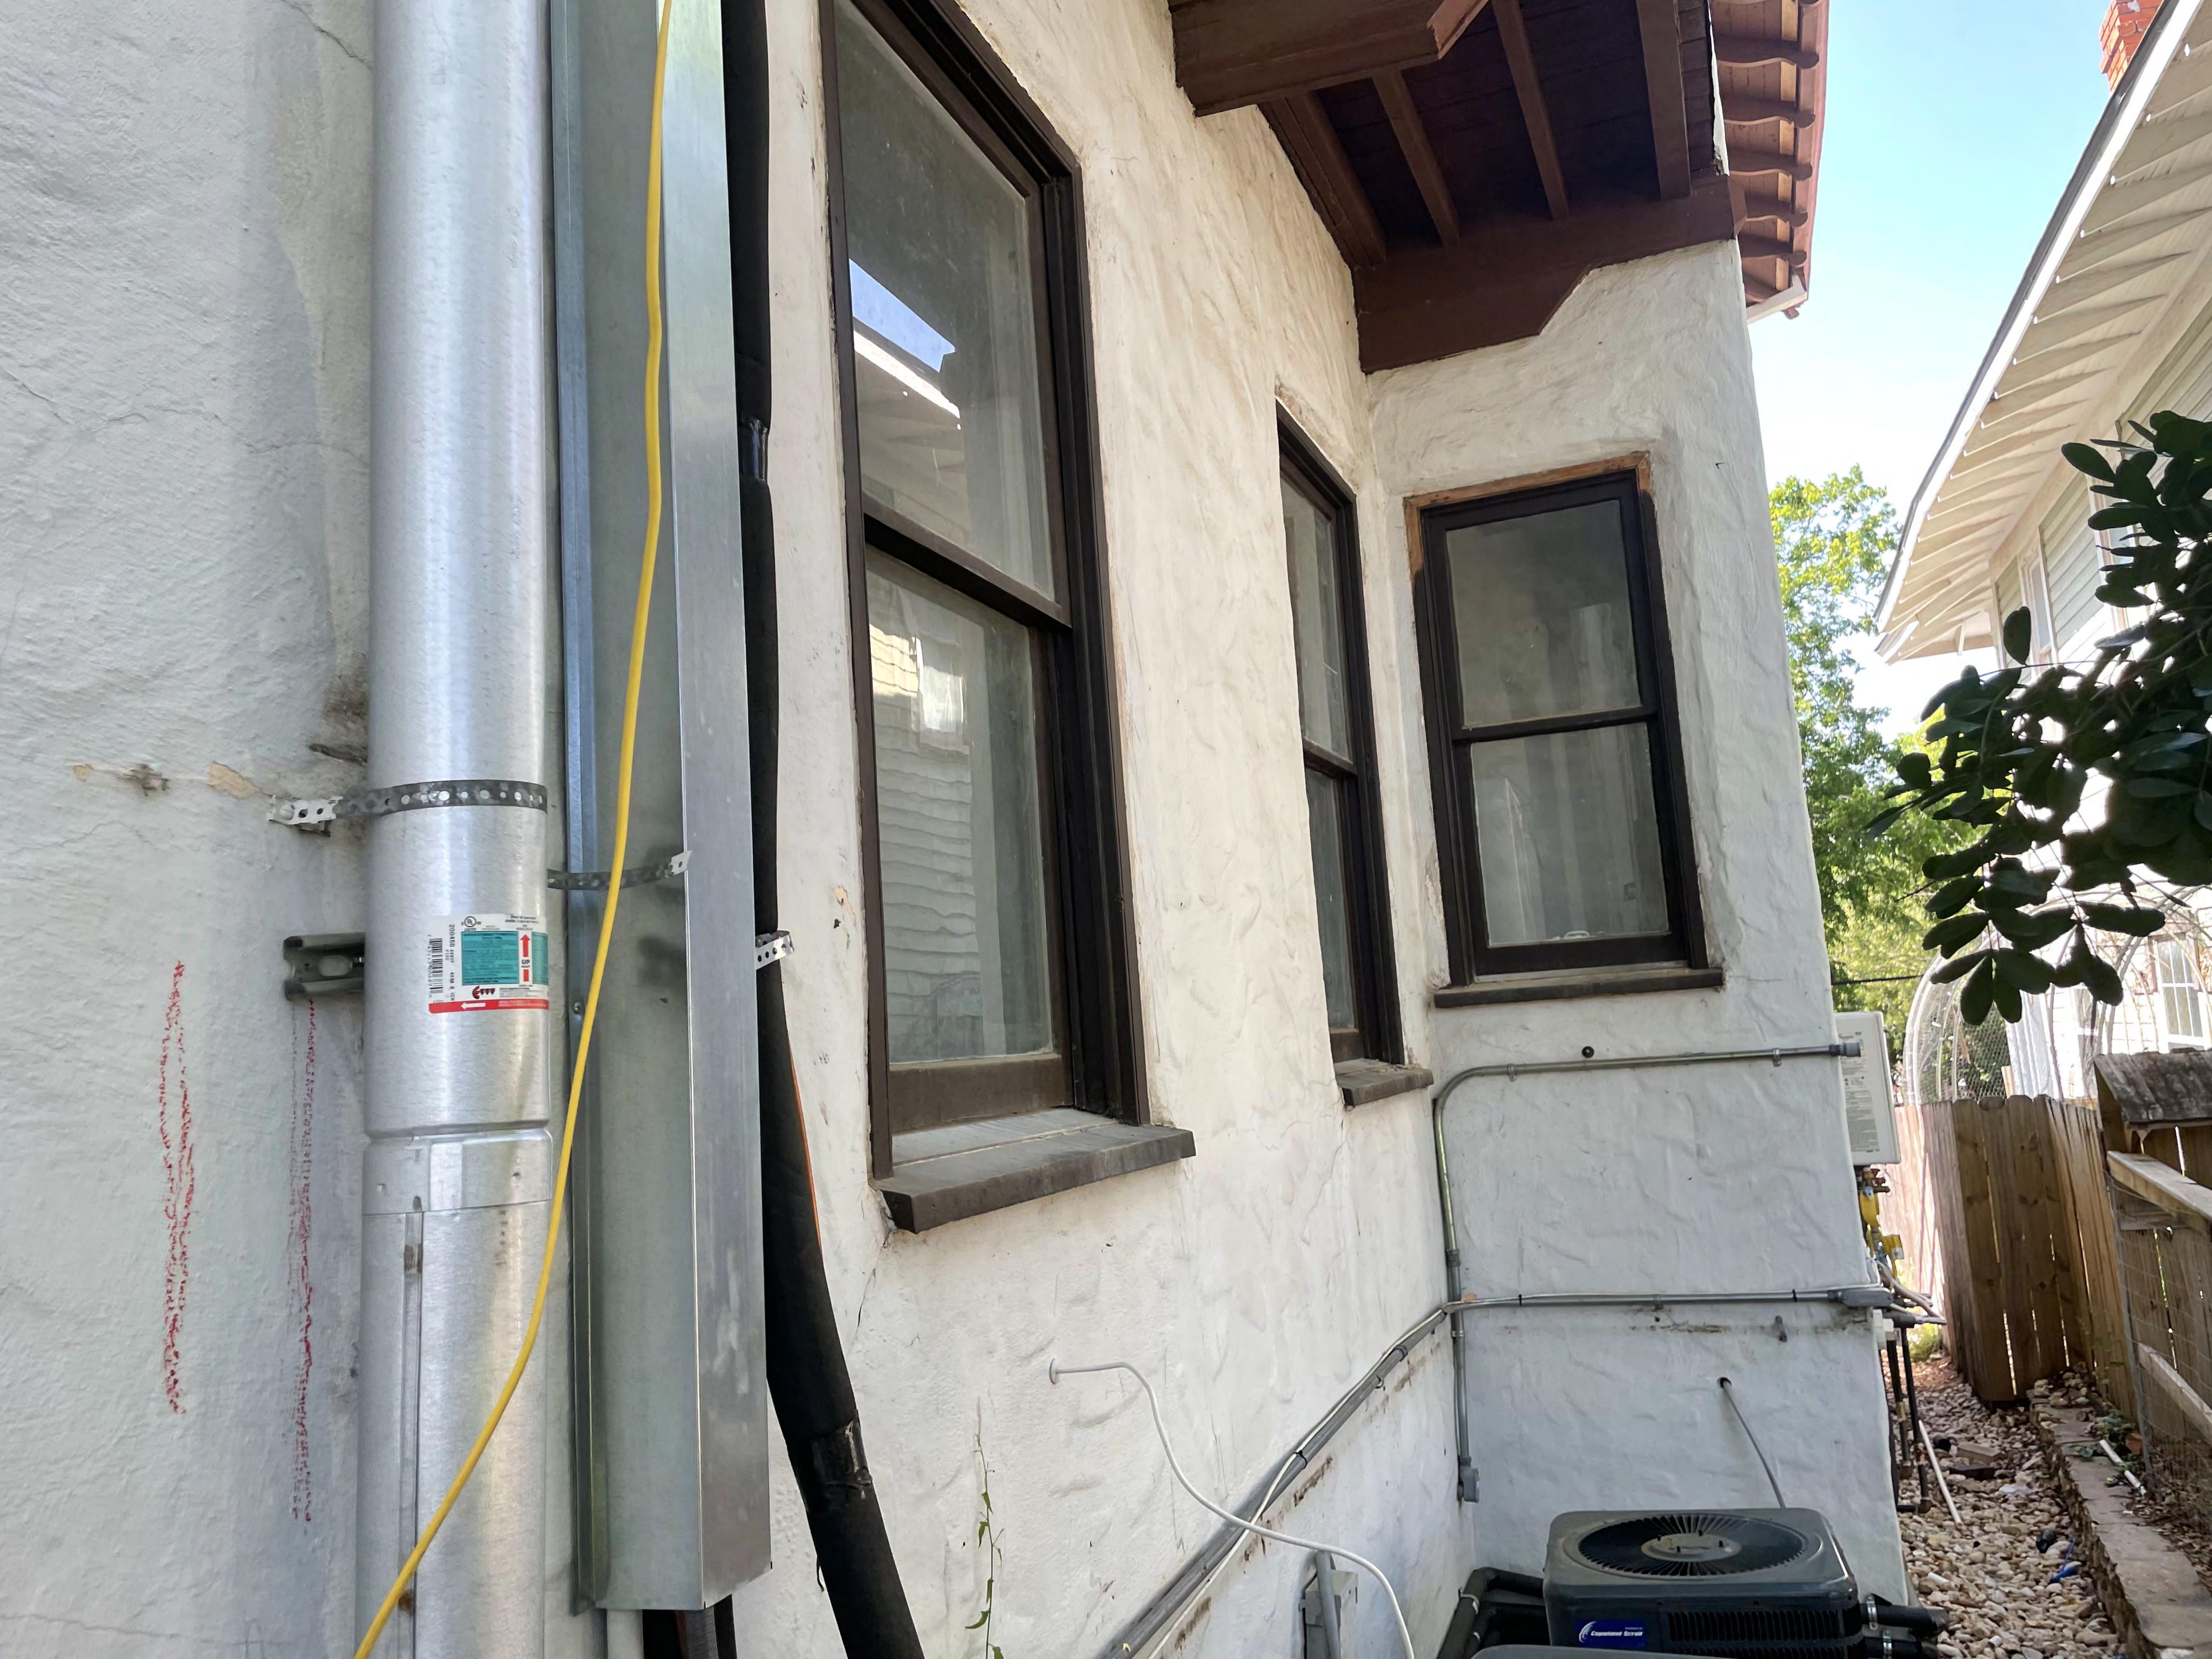
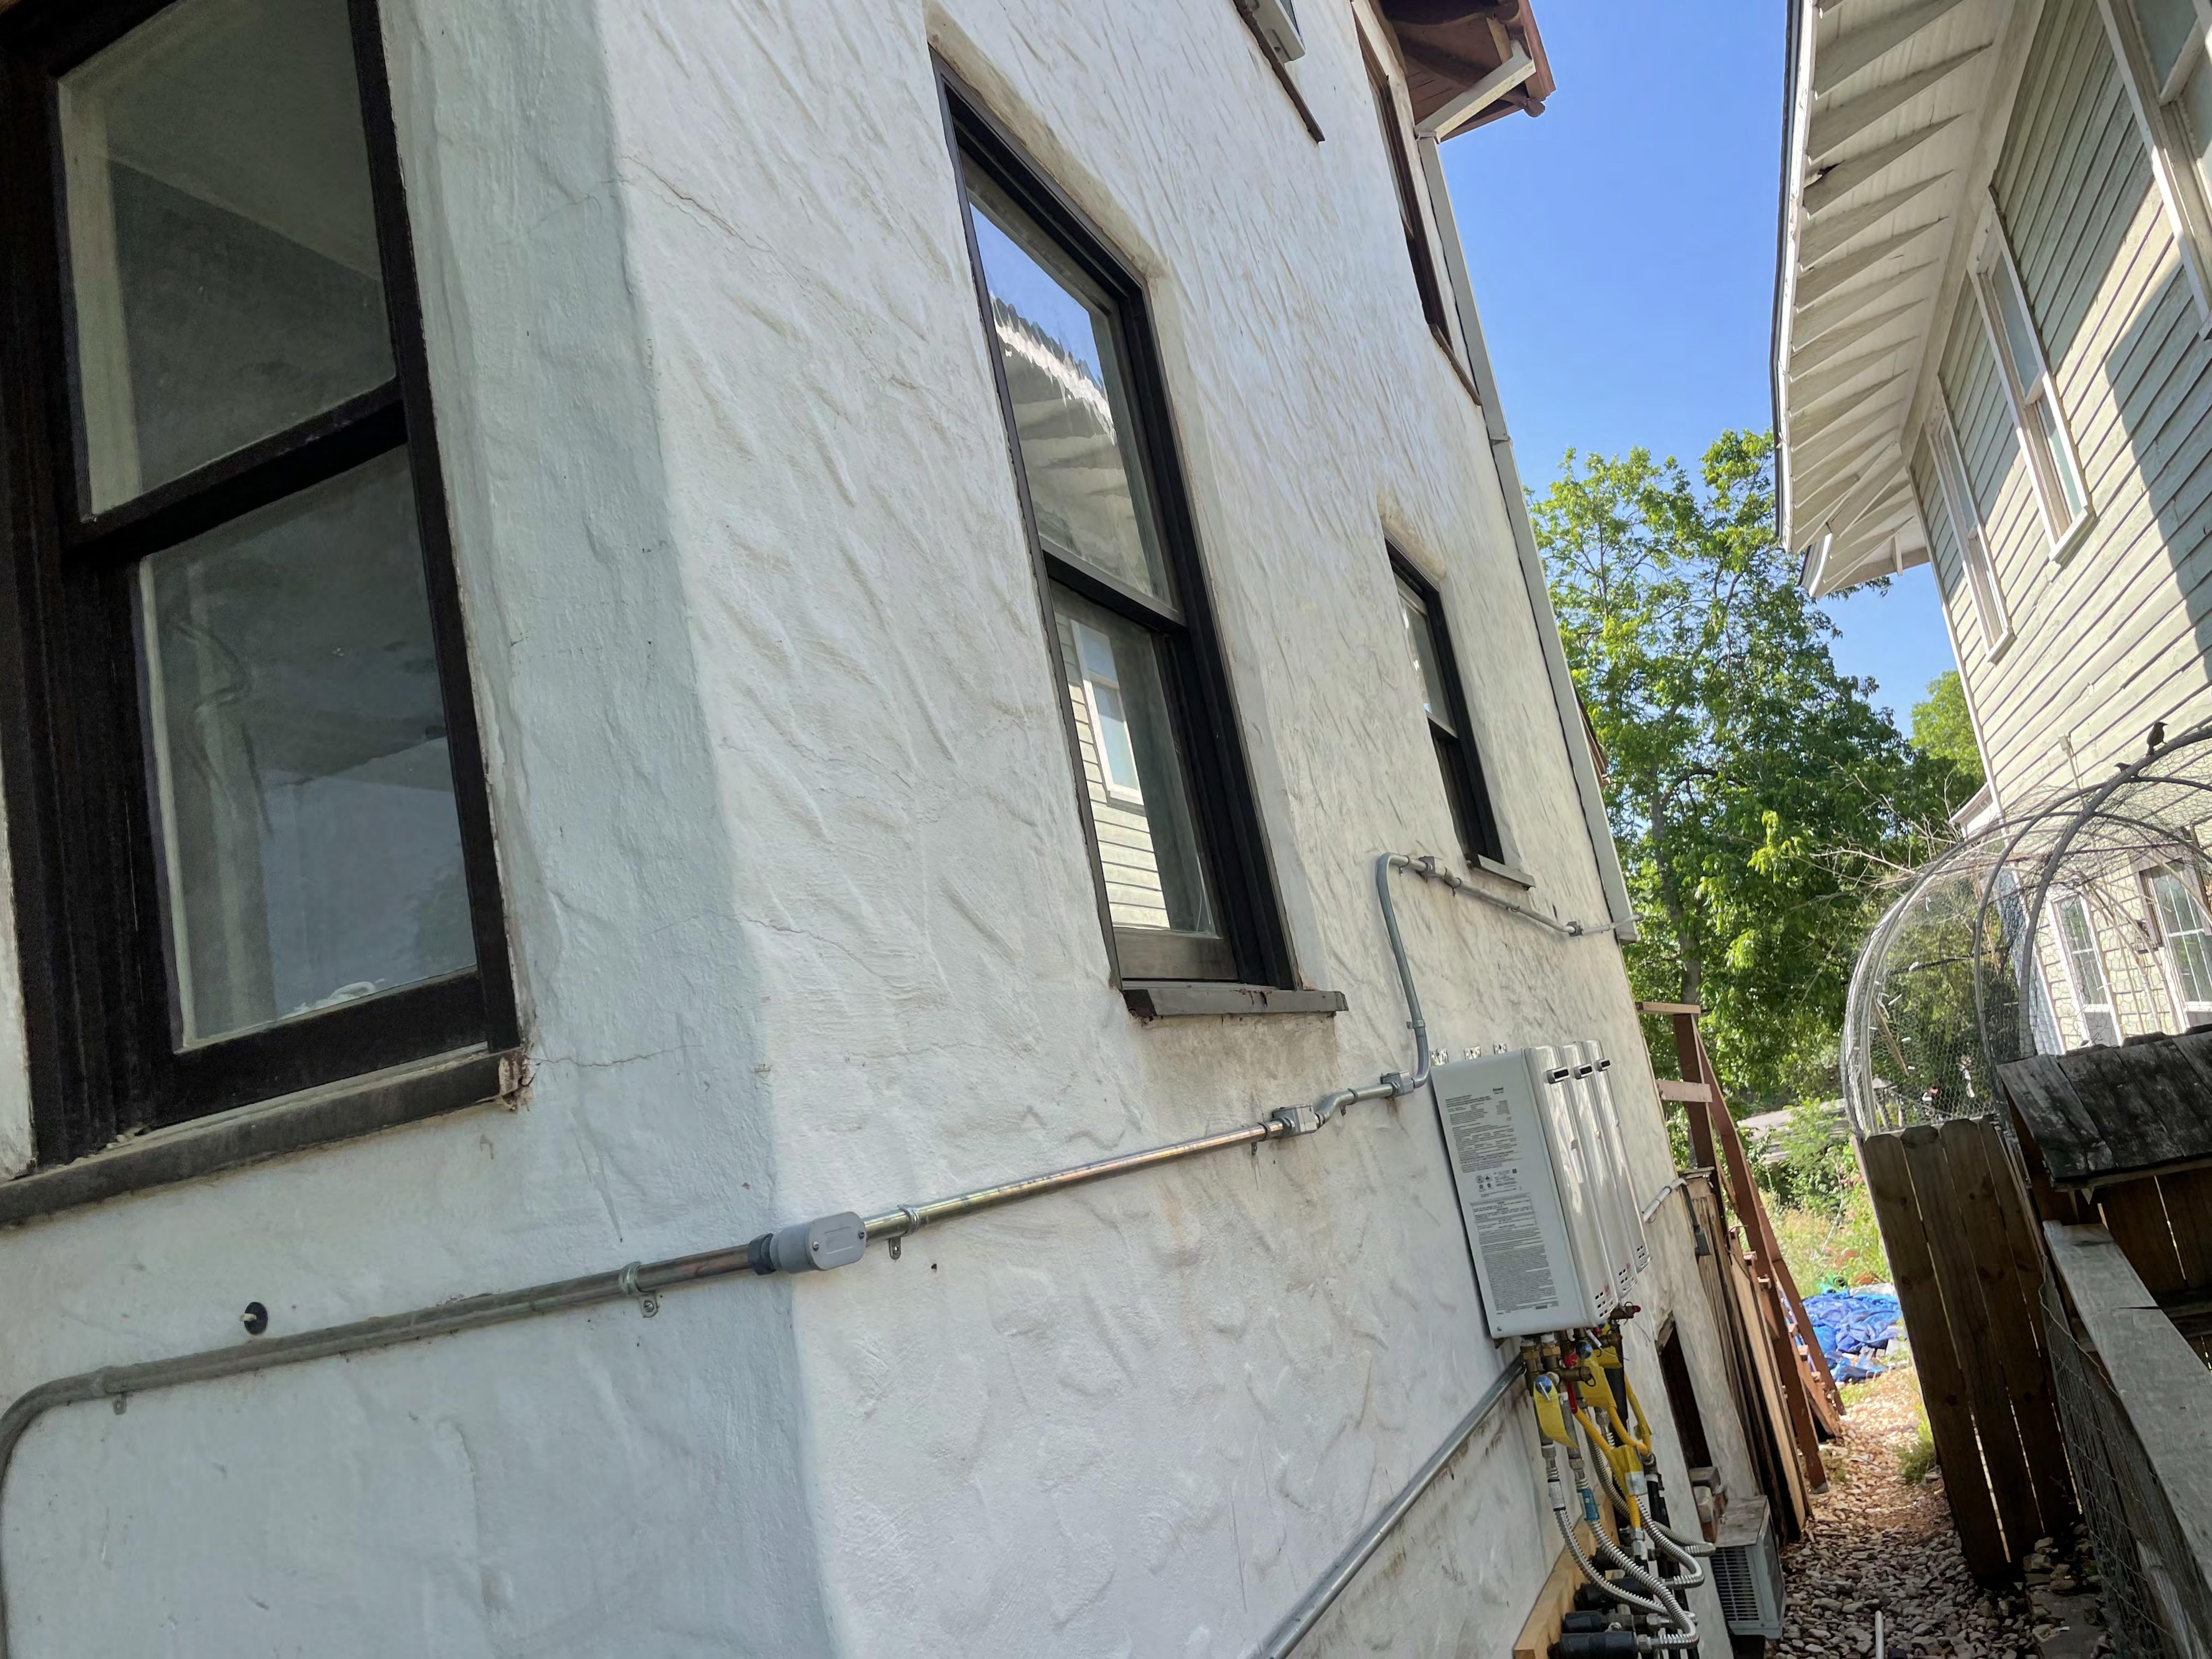
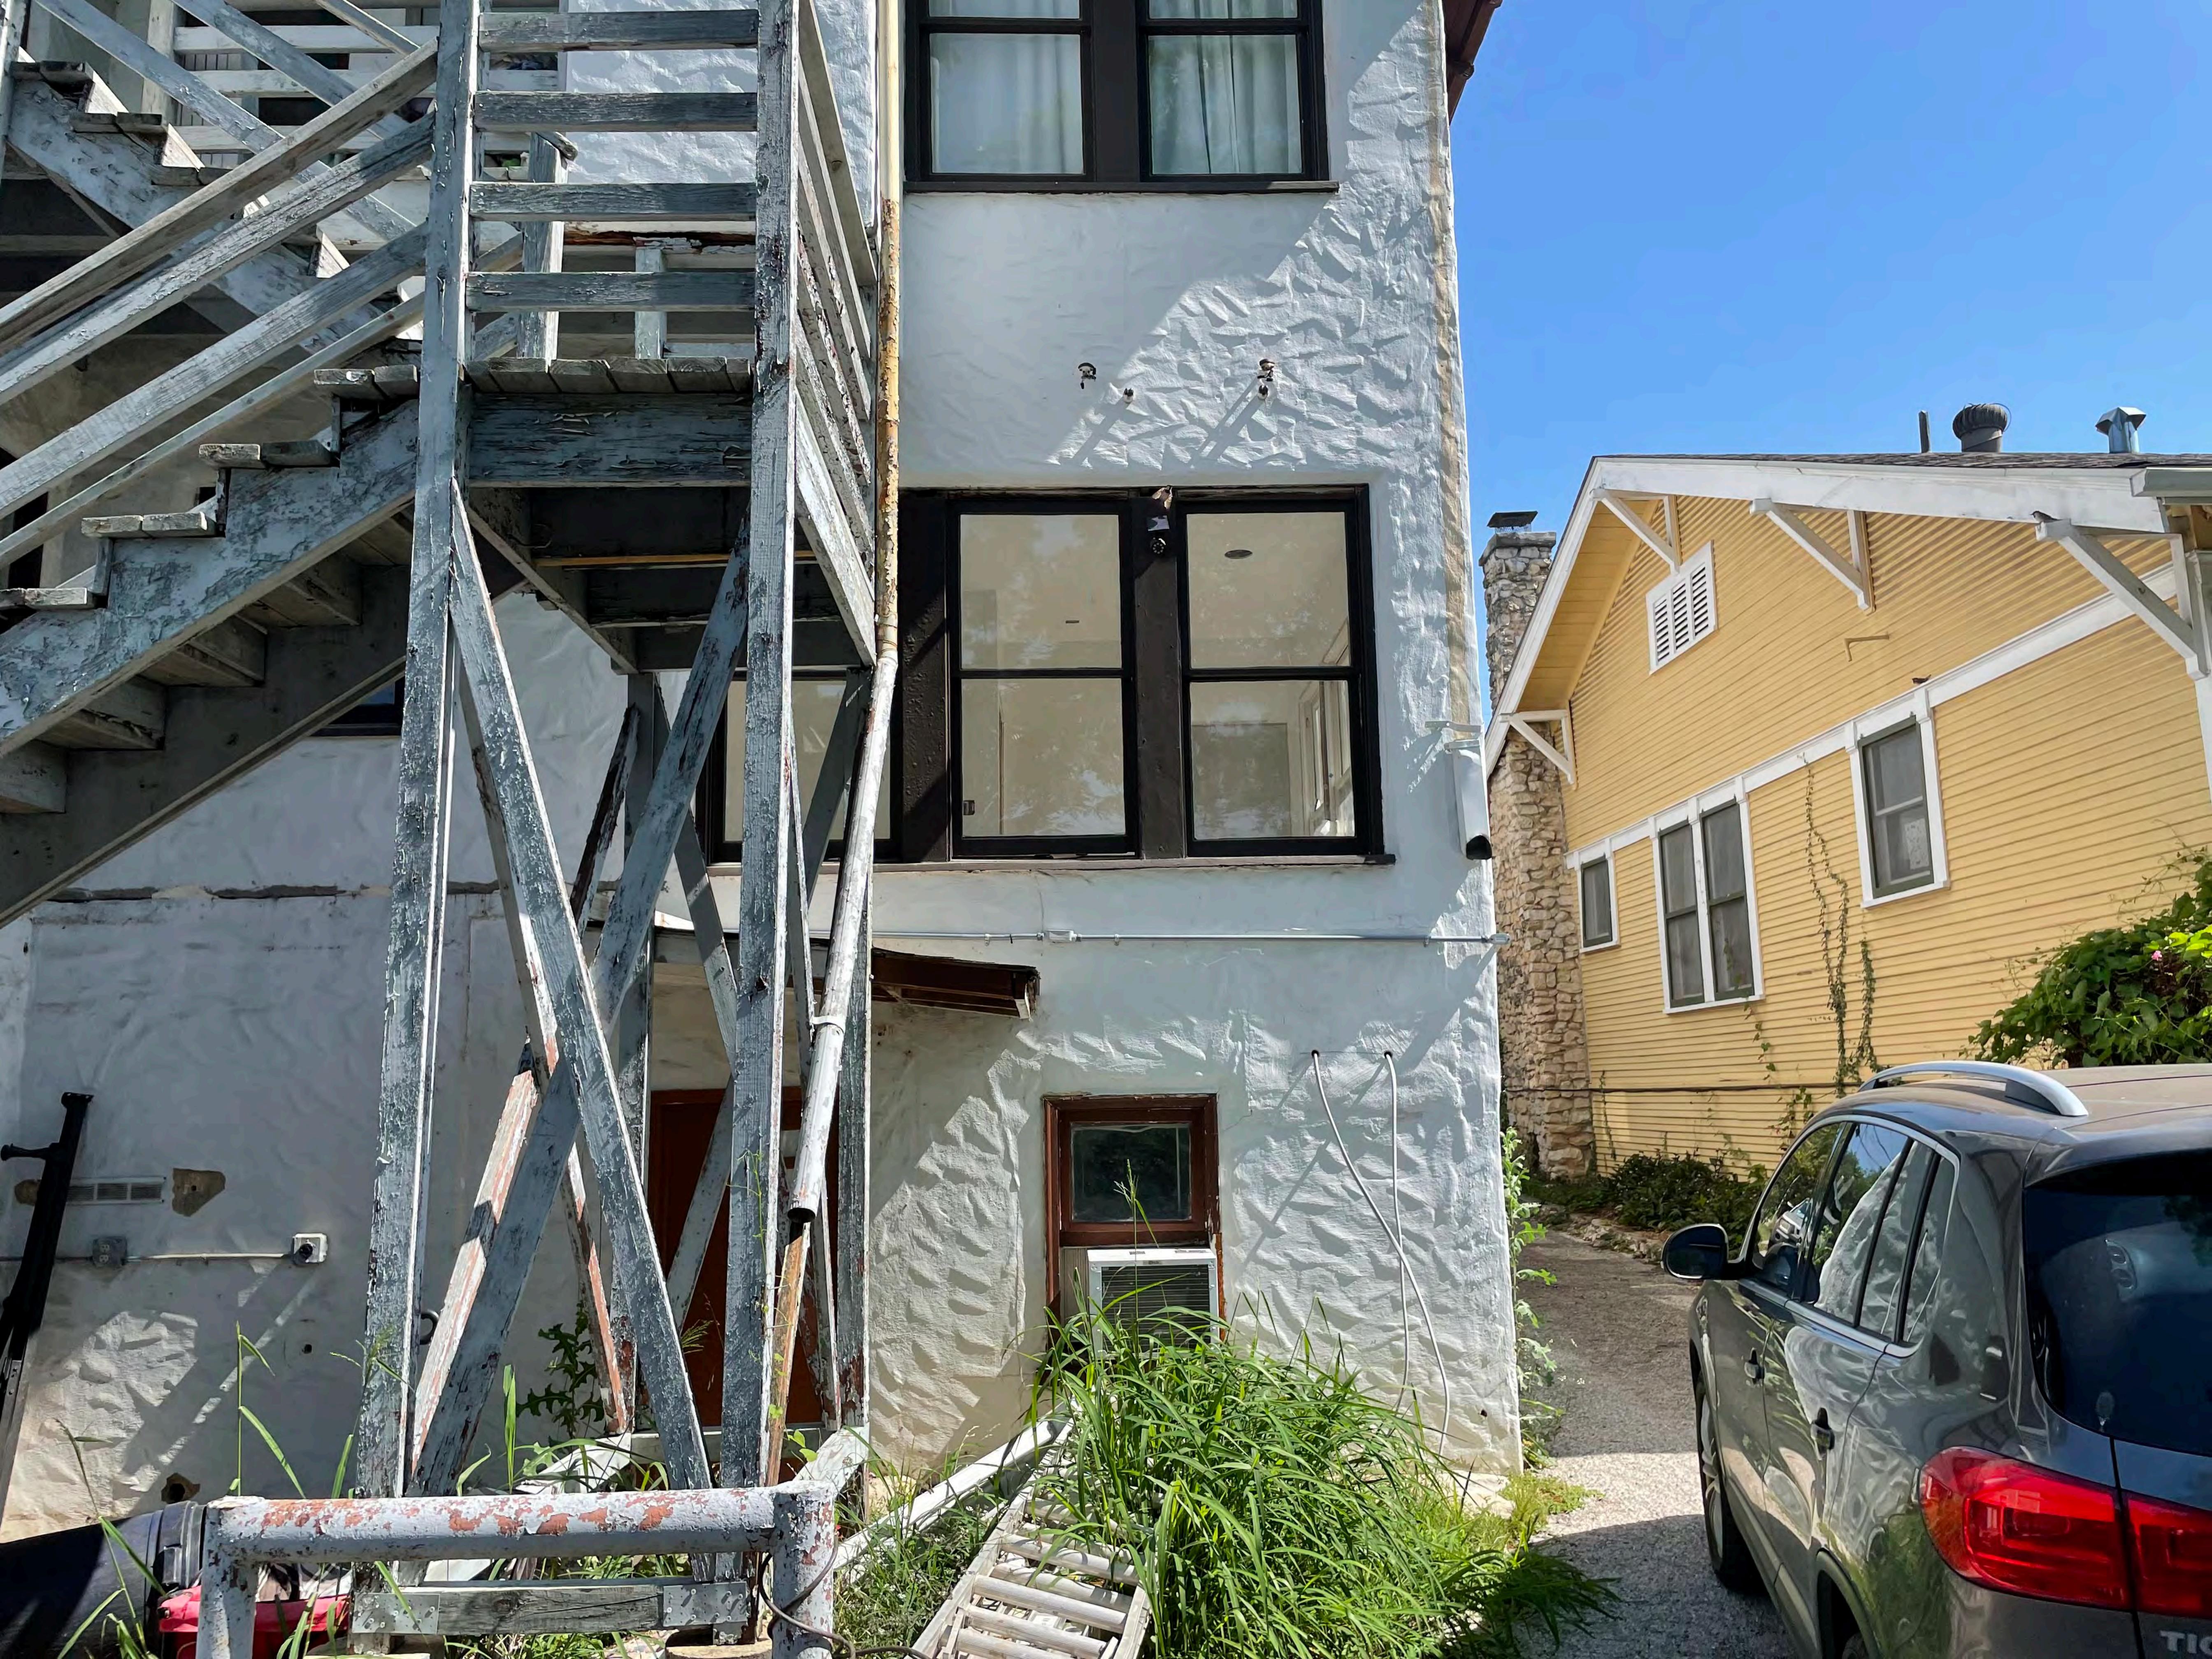
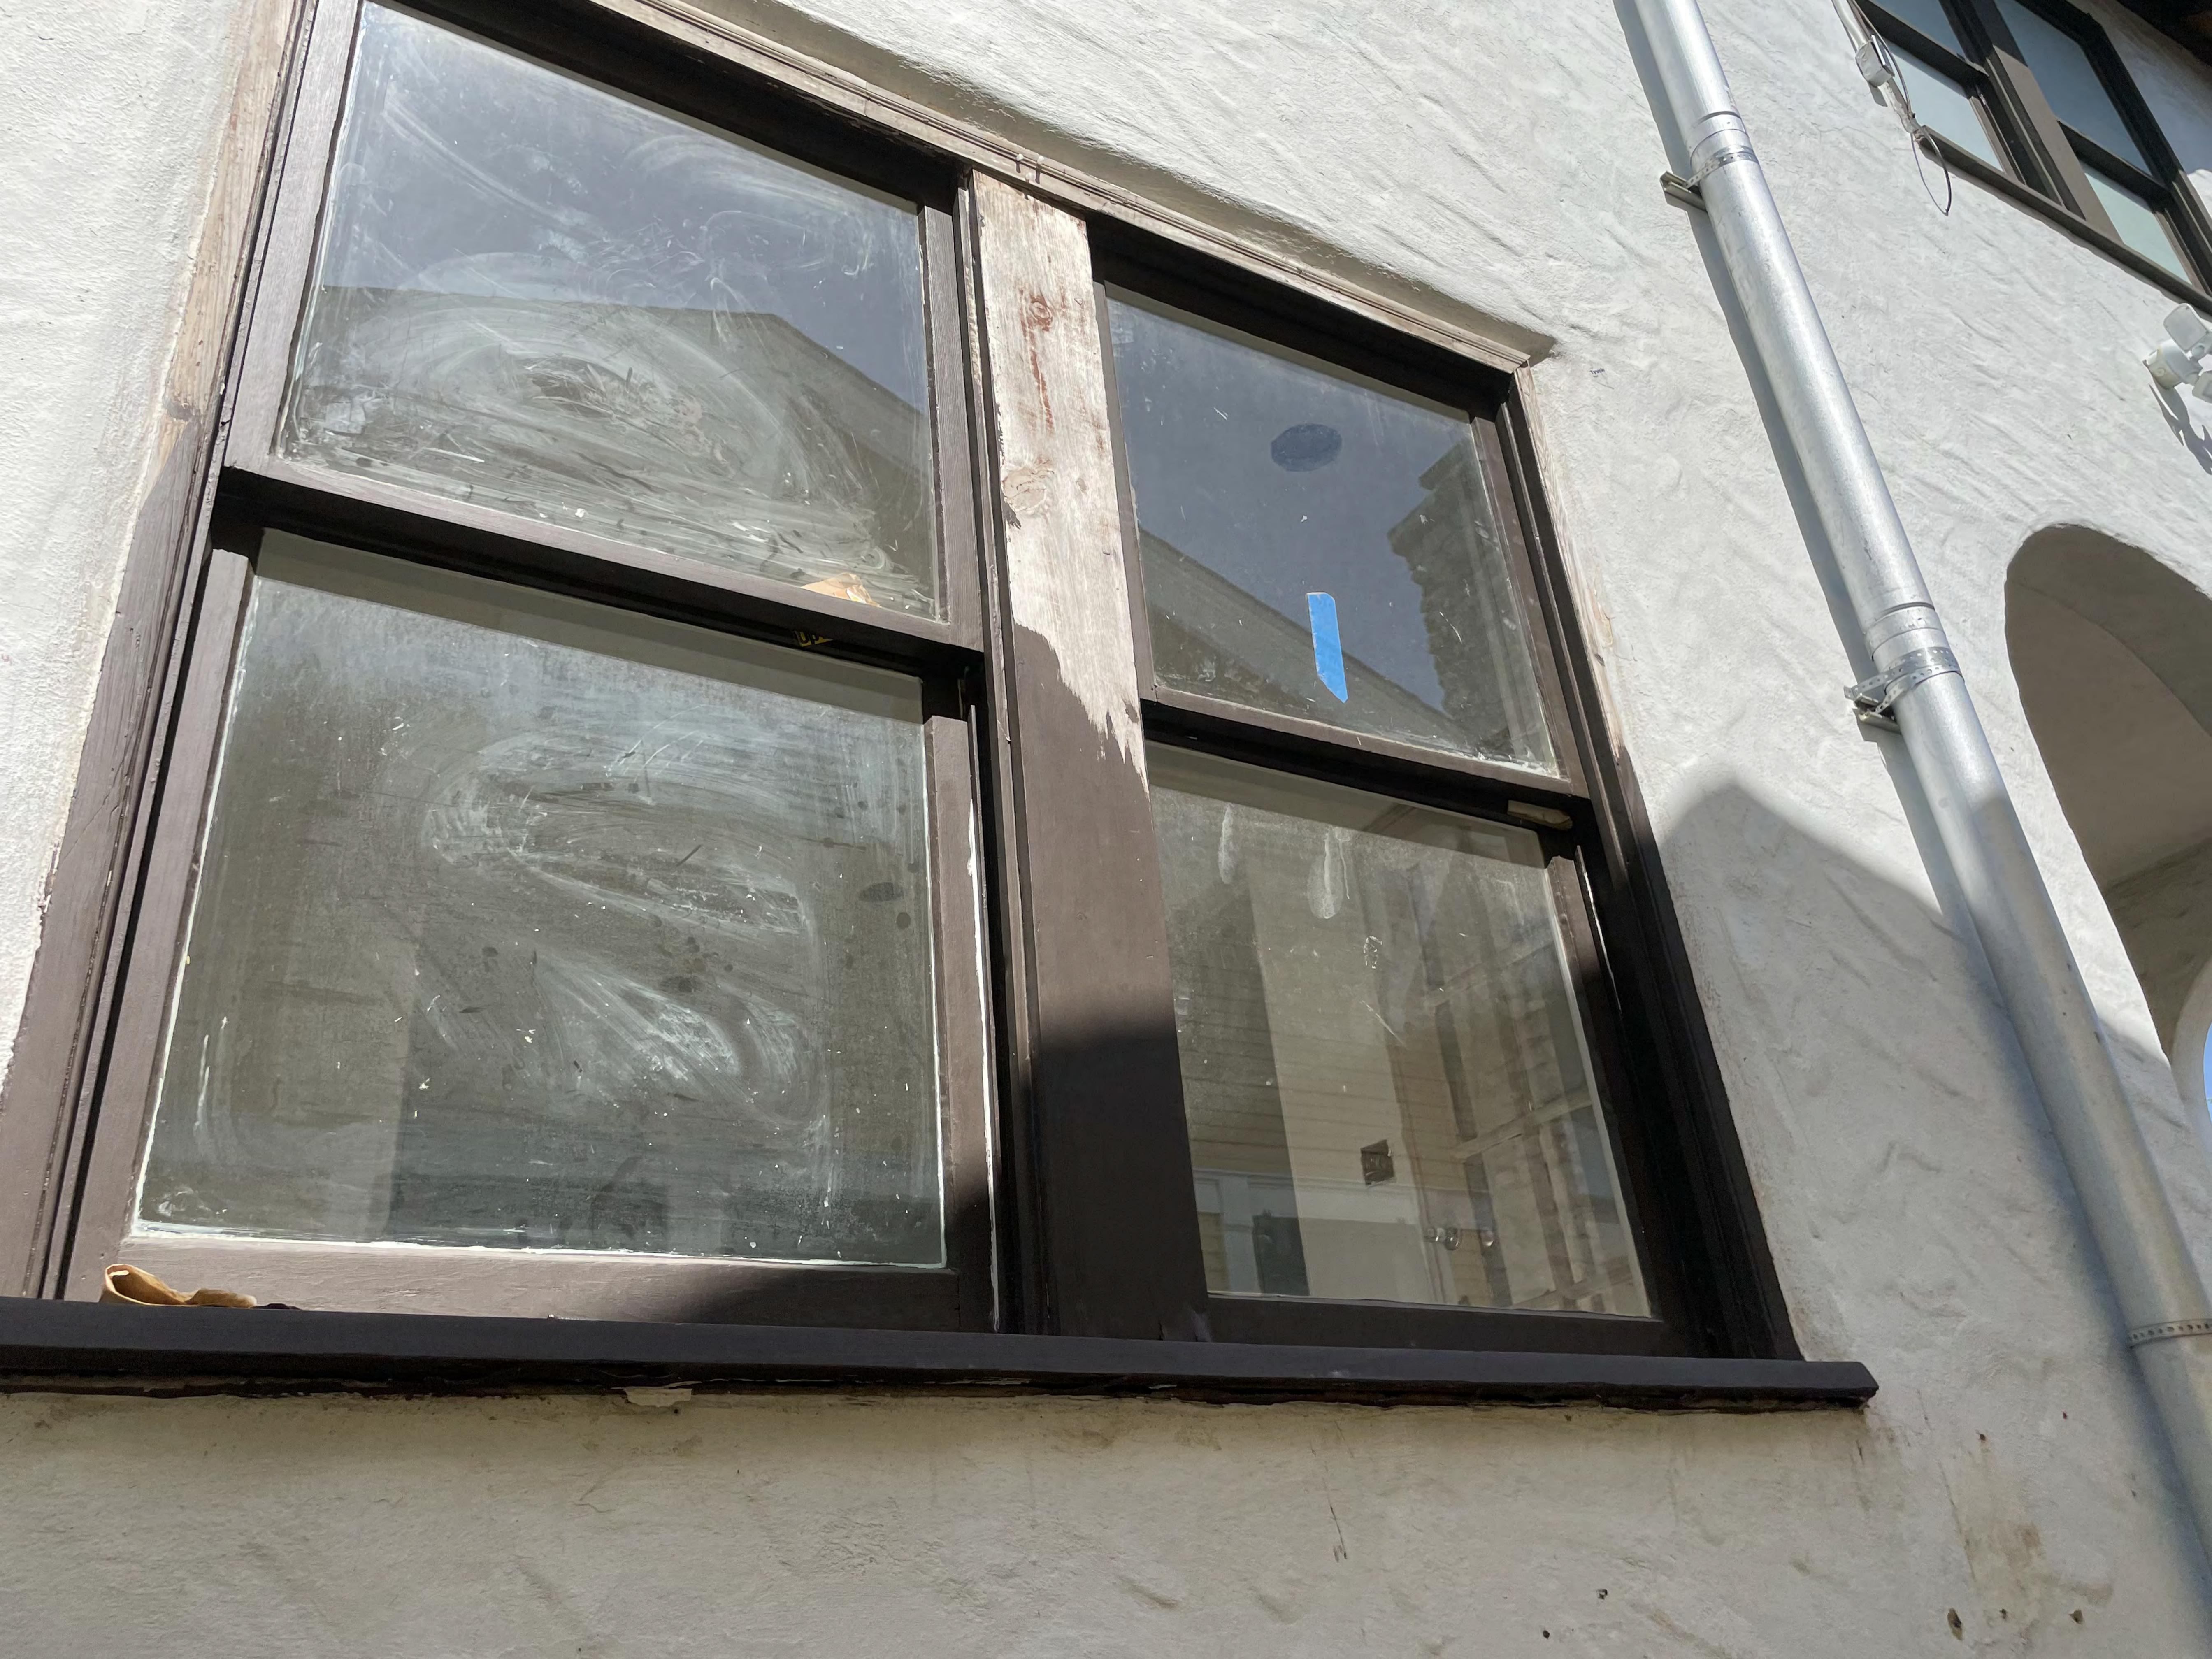
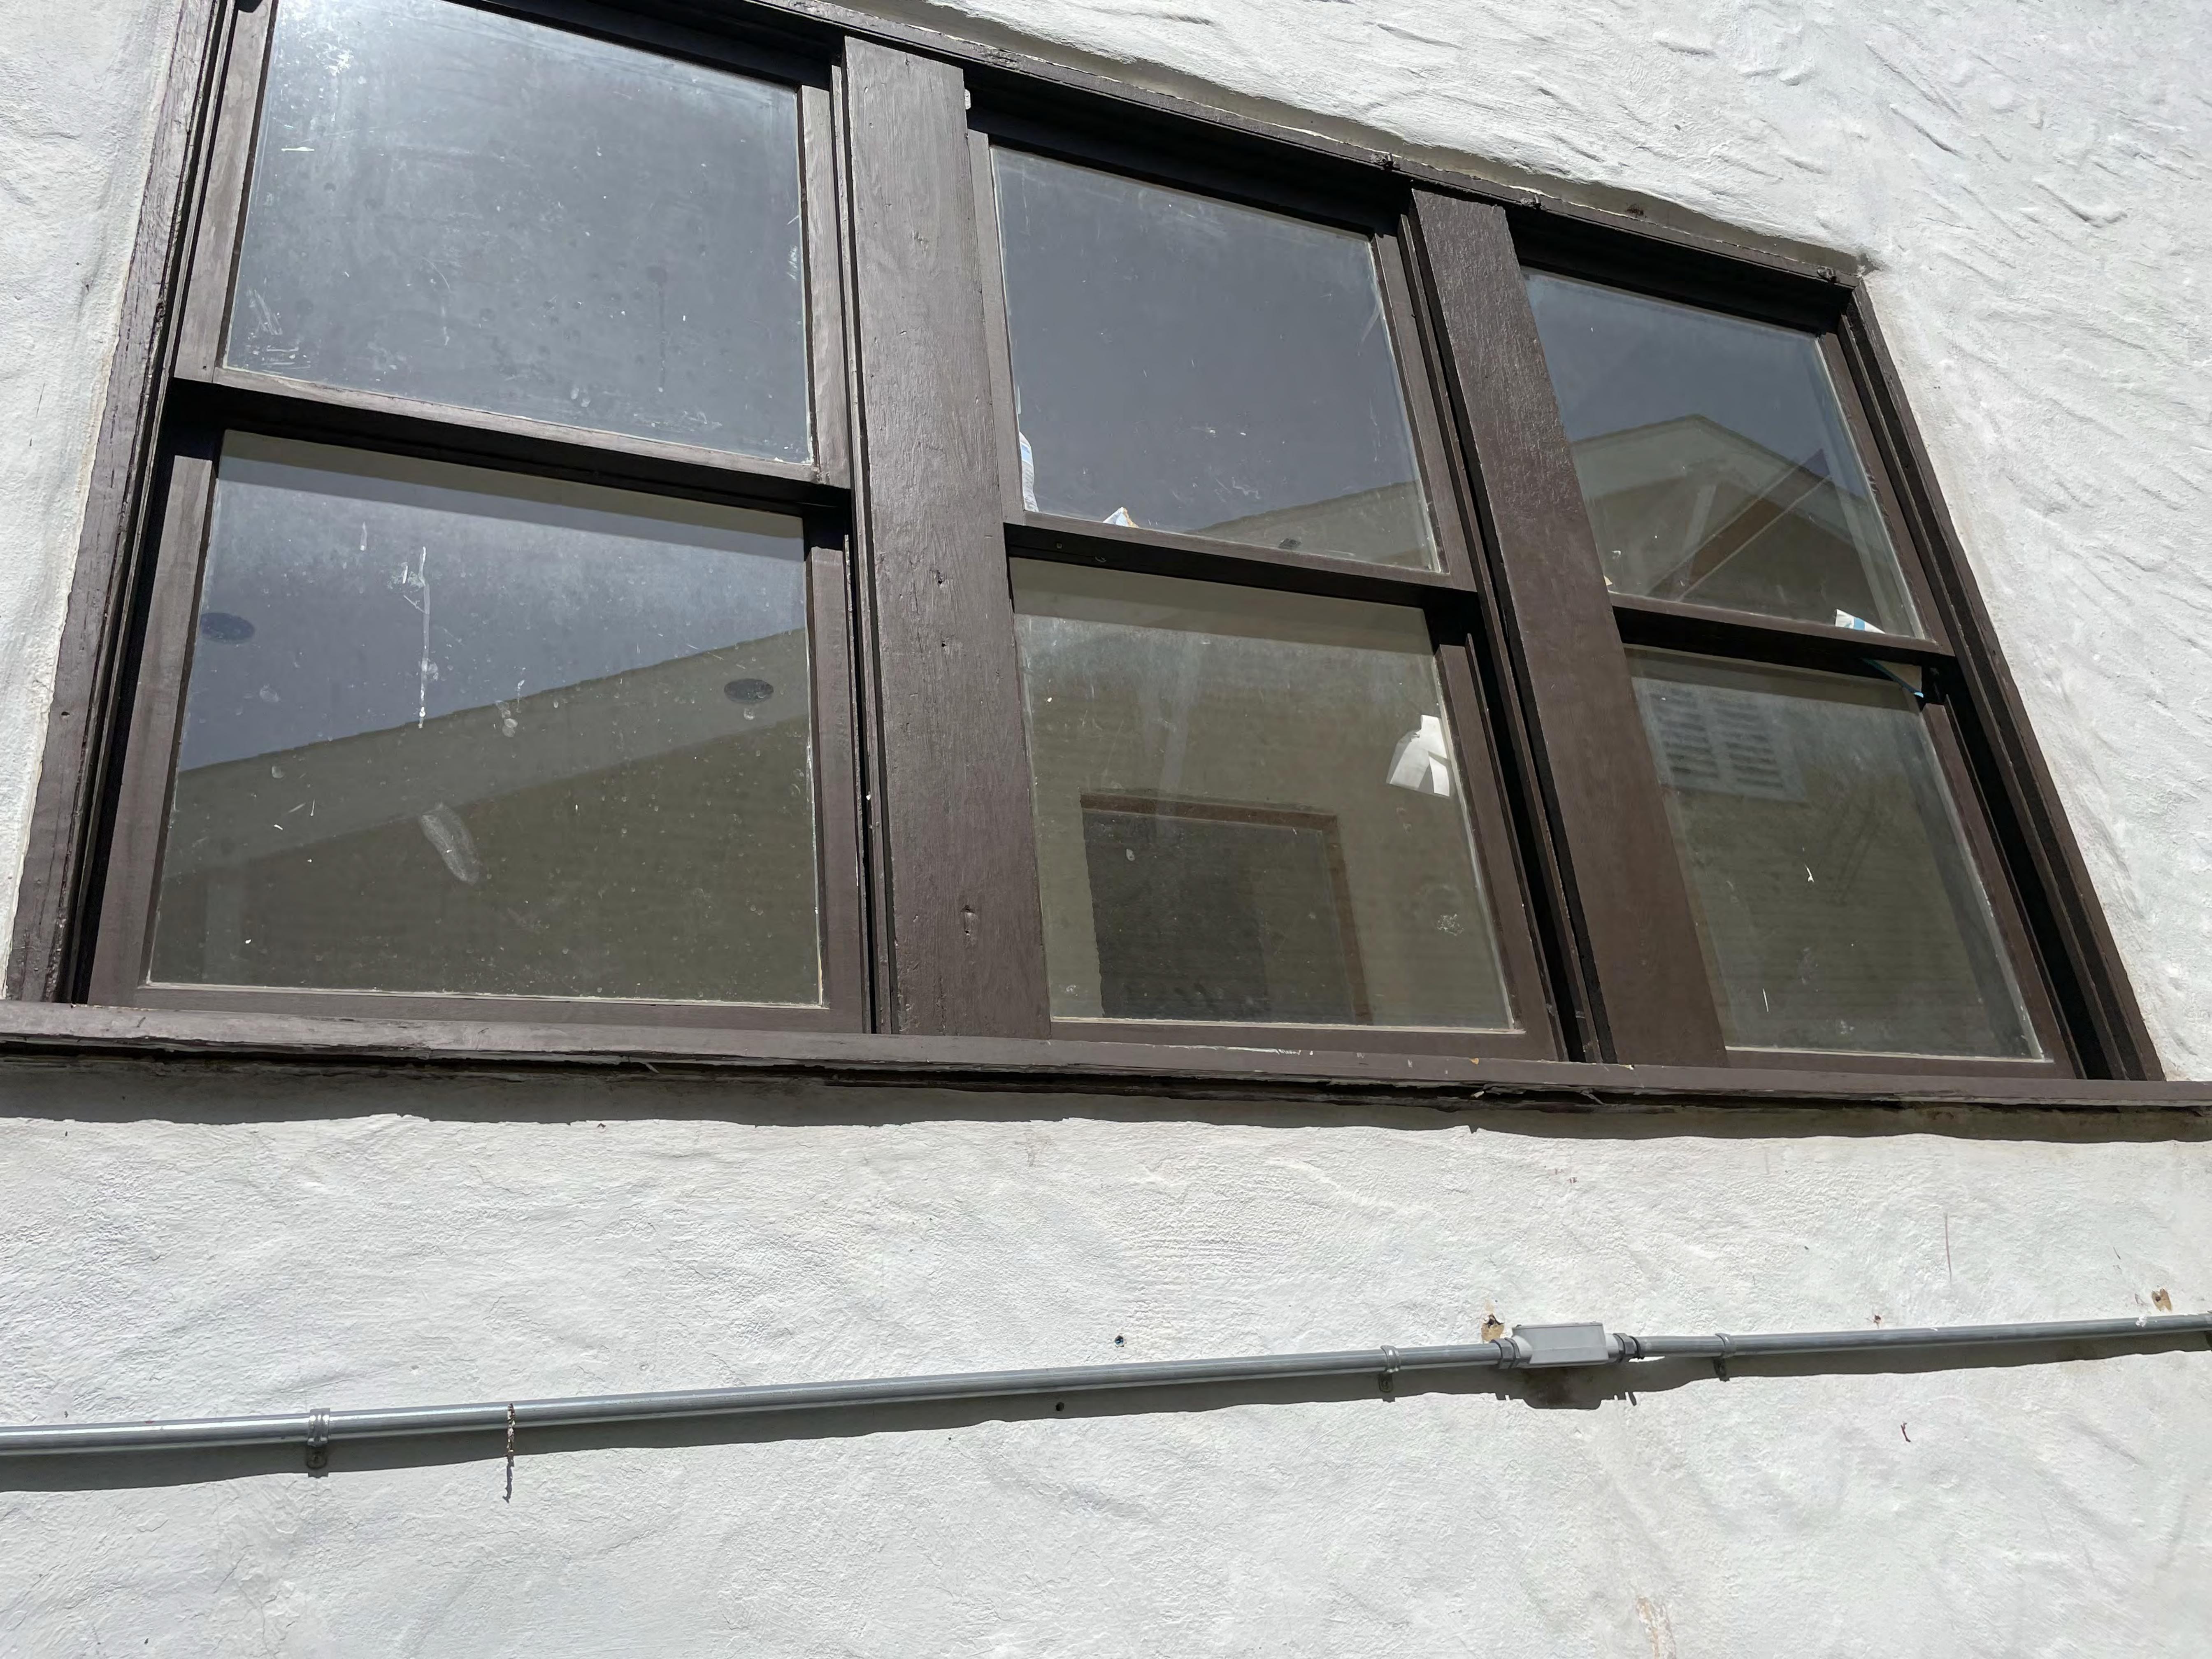
- c. WINDOW REPLACEMENT: EXISTING CONDITION From the photos submitted to date, the wood windows proposed for replacement appear to be of historic-age, fully wood one-over-one windows. The windows do not show signs of significant wood rot, wood damage, or severe deterioration. Staff finds that the wood windows are in repairable condition based on the documentation provided, with most requiring minimal repair and intervention such as the reworking of the sashes and re-glazing, along with refitting into the trim and frames. Staff has scheduled a site visit with the applicant for Monday, May 30 and may be able to report additional information at the hearing.

The current condition of the windows is such that many are unrepairable. I've had multiple contractors visit the site and have commented as such. I need to replace them with comparable Marvin windows that are approved for historic window replacement.

Staff does not recommend approval based on findings b-e. Staff recommends that the applicant restore the deteriorated wood windows and preserve all original window openings. If the HDRC is compelled to approve window replacement, staff recommends the following stipulations:
