HISTORIC AND DESIGN REVIEW COMMISSION

August 03, 2022

HDRC CASE NO: 2022-303
ADDRESS: 226 E HUISACHE AVE
LEGAL DESCRIPTION: NCB 3086 BLK 2 LOT 7
ZONING: R-4 CD, H
CITY COUNCIL DIST.: 1
DISTRICT: Monte Vista Historic District
APPLICANT: Nadav Givoni/GR-226 HUISACHE LLC
OWNER: Nadav Givoni/GR-226 HUISACHE LLC
TYPE OF WORK: Window replacement
APPLICATION RECEIVED: May 01, 2022
60-DAY REVIEW: Not applicable due to City Council Emergency Orders
CASE MANAGER: Hannah Leighner
REQUEST:

The applicant is requesting a Certificate of Appropriateness for approval to replace nineteen (19) existing wood windows with new wood windows.

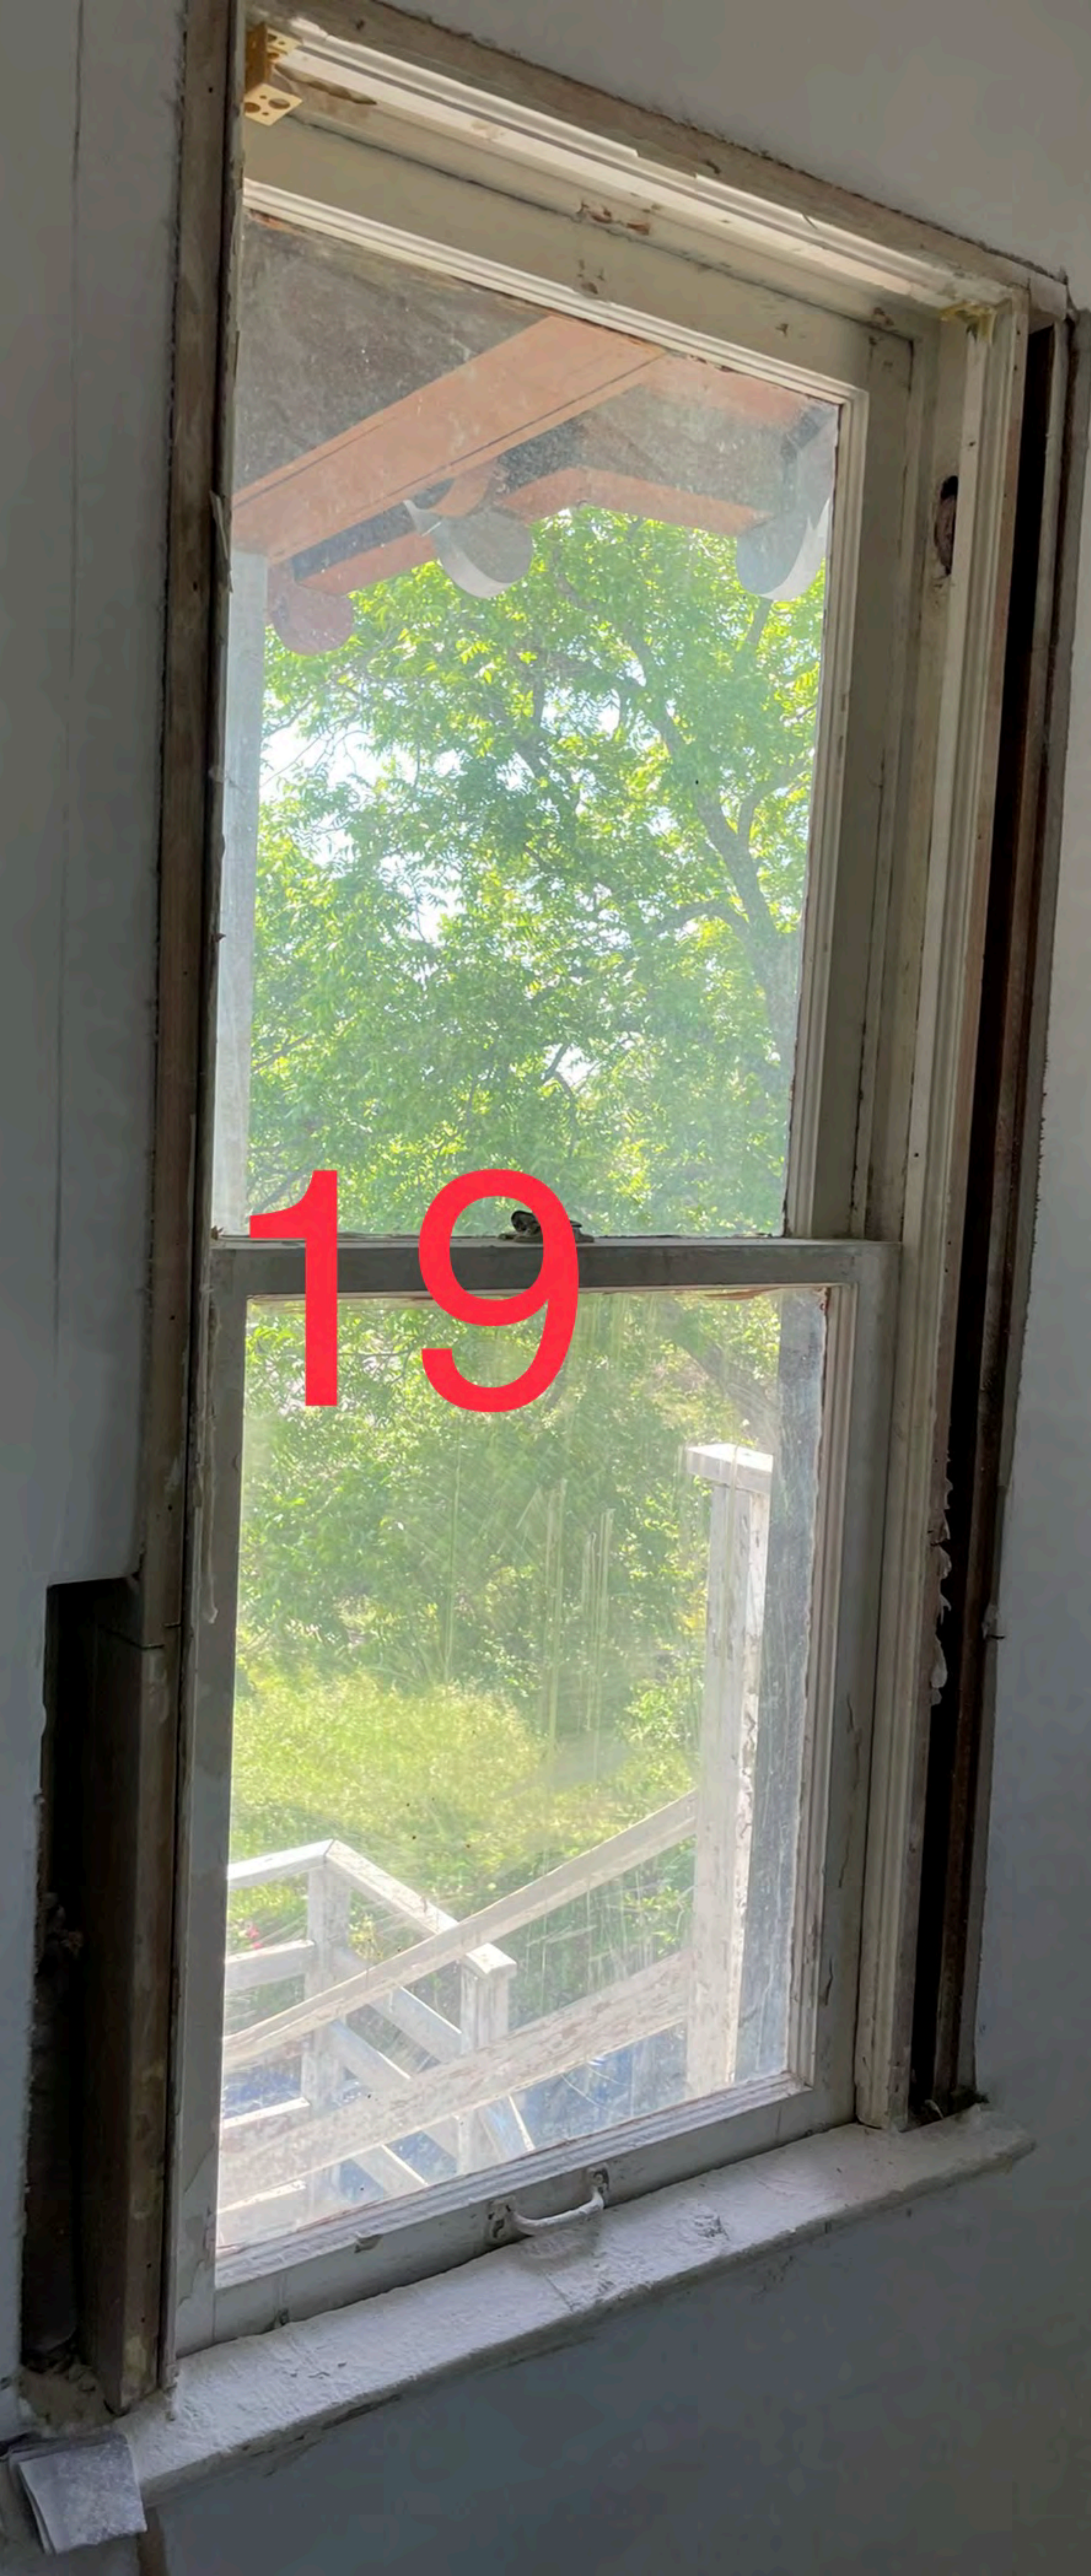
19

The current condition of the windows is such that many are unrepairable. I've had multiple contractors visit the site and have commented as such. I need to replace them with comparable Marvin windows that are approved for historic window replacement.
