HISTORIC AND DESIGN REVIEW COMMISSION

August 17, 2022

HDRC CASE NO: 2022-399
ADDRESS: 363 NORTH DR
LEGAL DESCRIPTION: NCB 7026 BLK 5 LOT 16, E11 FT OF 18
ZONING: R-6, H
CITY COUNCIL DIST.: 7
DISTRICT: Monticello Park Historic District
APPLICANT: Thomas Gandy/GANDY THOMAS R
OWNER: Thomas Gandy/GANDY THOMAS R
TYPE OF WORK: Exterior modifications, fenestration modifications
APPLICATION RECEIVED: July 24, 2022
60-DAY REVIEW: Not applicable due to City Council Emergency Orders
CASE MANAGER: Edward Hall

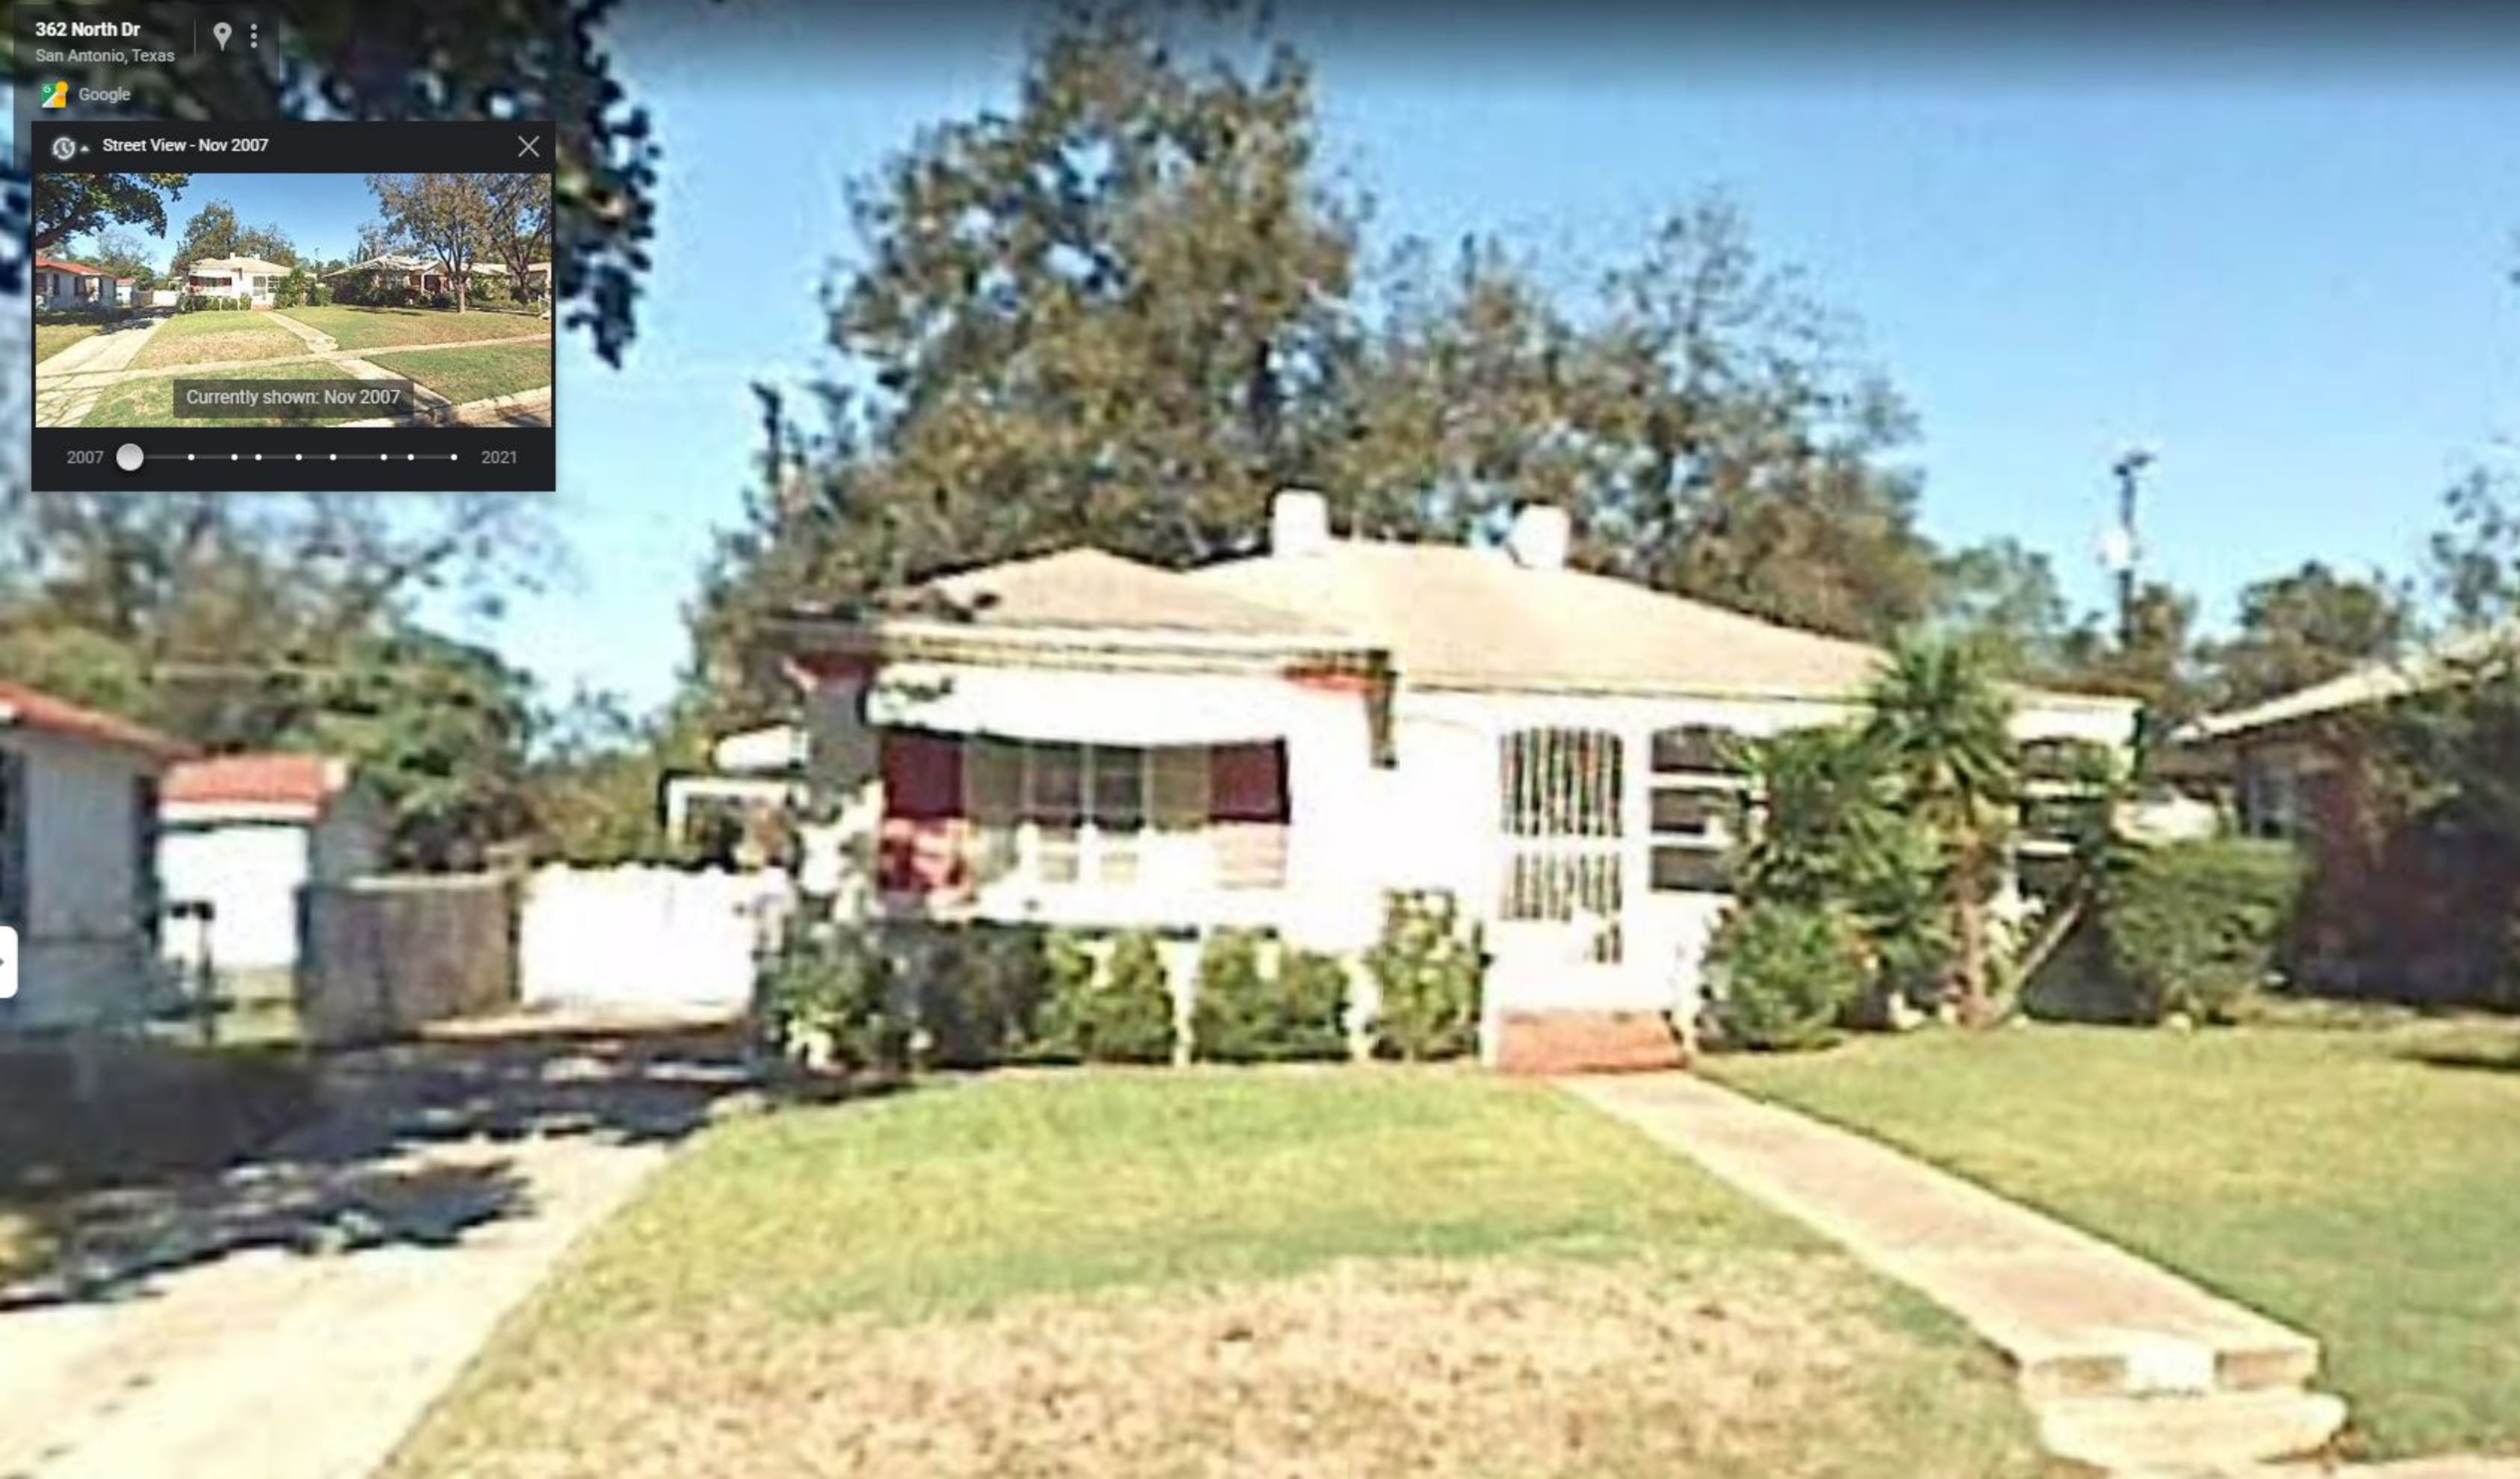
Investigation Report

Date	07/30/2021
Time	02:01 PM (-5 GMT)
Context	citizen report
Present Staff	Edward Hall
Present Individuals	Homeowner
Types of Work Observed	Exterior Maintenance and Alterations
Amount of Work Completed	50%
Description of work	Removal of side facade materials and one side door. Installation of new sheathing on side facade.
Description of interaction	OHP staff issued a Stop Work Order and spoke with the property owner. OHP advised that no further work was to occur with the exception of placing building wrap on exposed framing and building materials to prevent water damage and water infiltration into the historic structure.

Violation Type	No Certificate of Appropriateness (Code 35-451a)
OHP Action	Spoke with property owner, Posted additional "Stop Work Notice"
Will post-work application fee apply?	Yes
