#### HISTORIC AND DESIGN REVIEW COMMISSION

**January 18, 2023**

**HDRC CASE NO:** 2022-527

**ADDRESS:** 108 SCHREINER PLACE

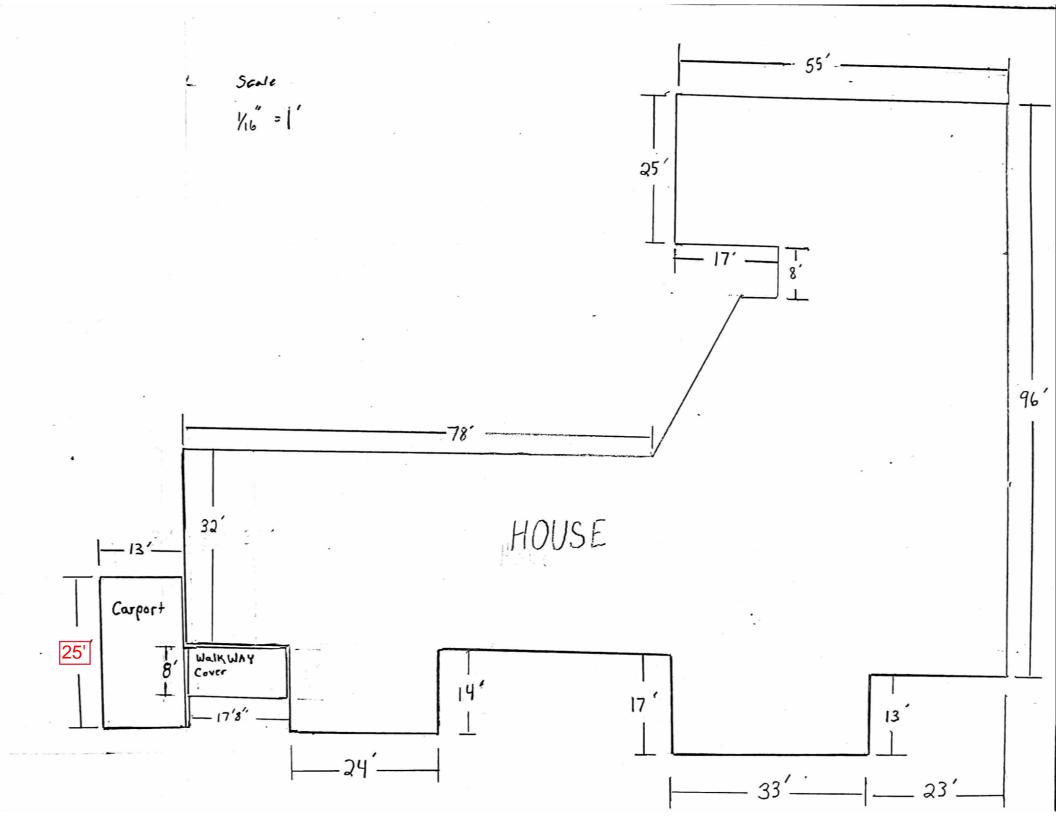
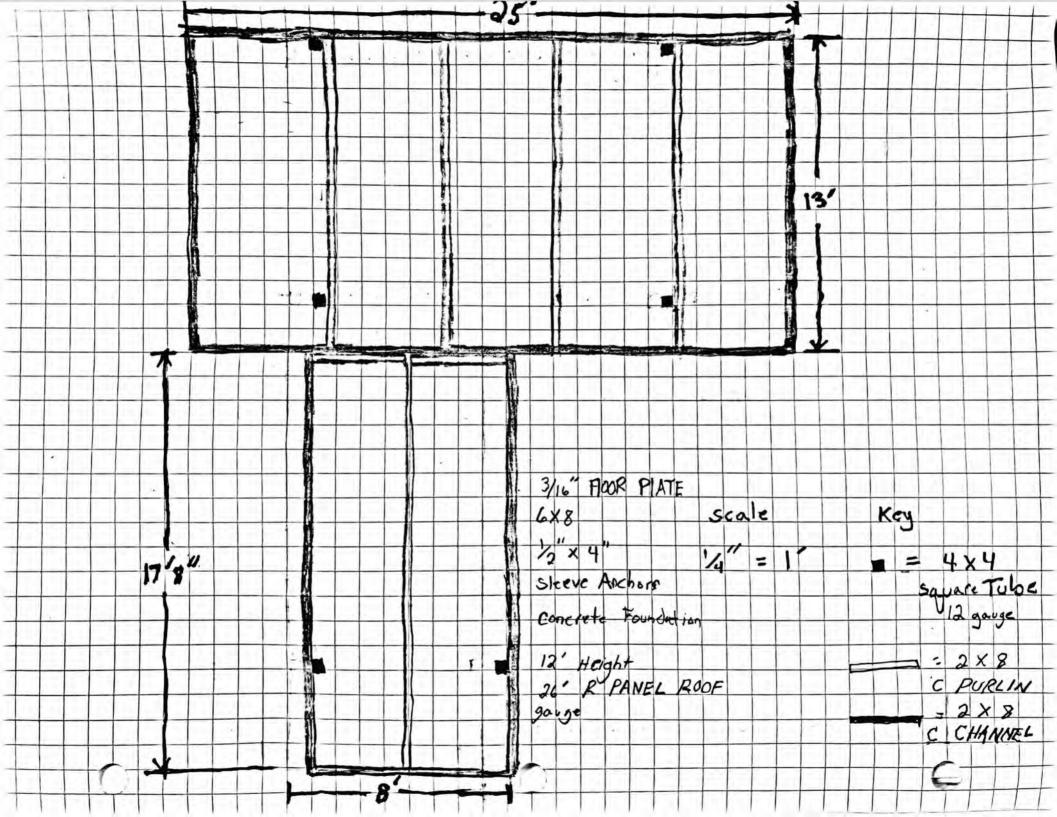
Cervantes: Is the carport touching the roof?

Savino: In terms of modifying the existing design, you could drop the height of the passageway and use a thinner profile metal for the beam.

Garza: I agree regarding lowering the walkway height.

Owner and/or contractor should reach out to Development Services regarding setback requirements for the property. Applicant should explore lowering the overall height of the carport, with particular attention to the passageway.
