HISTORIC AND DESIGN REVIEW COMMISSION

May 03, 2023

HDRC CASE NO: 2023-159
ADDRESS: 1402 FULTON AVE
LEGAL DESCRIPTION: NCB 2752 BLK 58 LOT 12
ZONING: R-4, H
CITY COUNCIL DIST.: 1
DISTRICT: Fulton Historic District
APPLICANT: Maria Luisa Cesar & Esnire Abigail Gomez
OWNER: Maria Luisa Cesar & Esnire Abigail Gomez
TYPE OF WORK: Courtyard wall modification & Historic Tax Certification
APPLICATION RECEIVED: April 25, 2023
60-DAY REVIEW: Not applicable due to City Council Emergency Orders
CASE MANAGER: Rachel Rettaliata

Application Materials: Office of Historic Preservation – Complete Plans for Restoration and Rehabilitation for 1402 Fulton Avenue, San Antonio, Texas, 78210

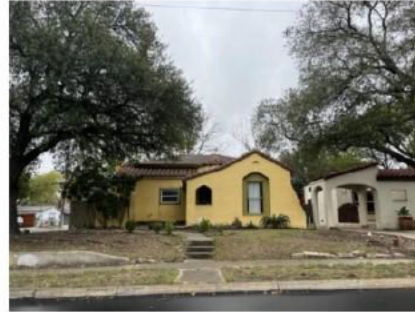
Subject: Foundation Repair
Home at 1402 Fulton Avenue
San Antonio, Texas
TBPE Registration Number: F-409
Project Number: 22611

The foundation repair for the structure located at 1402 Fulton Avenue in San Antonio, Texas was completed with the engineering guidance provided by our office. The Engineer of Record for the foundation repair is Sarah S. Hancock-Gamez having a Texas Professional Engineer License Number of 86270.

- The scope of the foundation repair did not require construction documents. Details and specifications were provided as needed to aid in the construction. New beams and concrete foundation posts were installed.

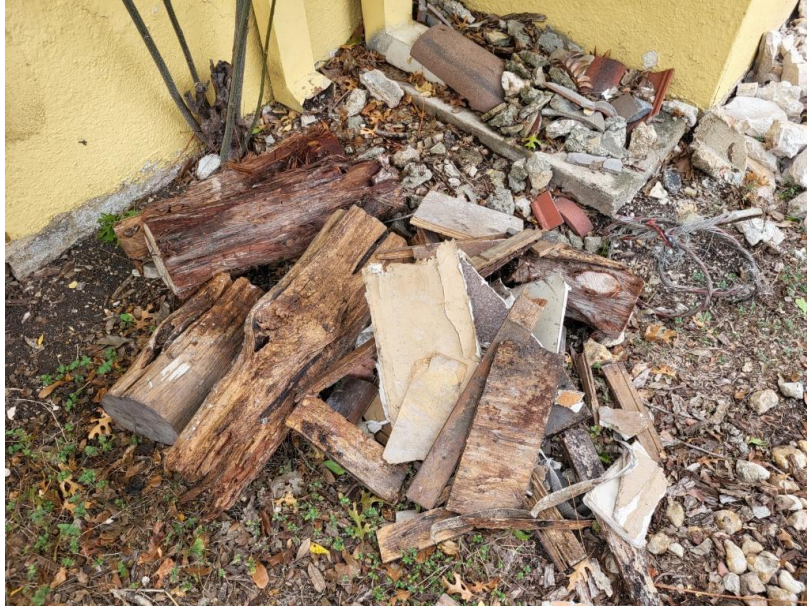
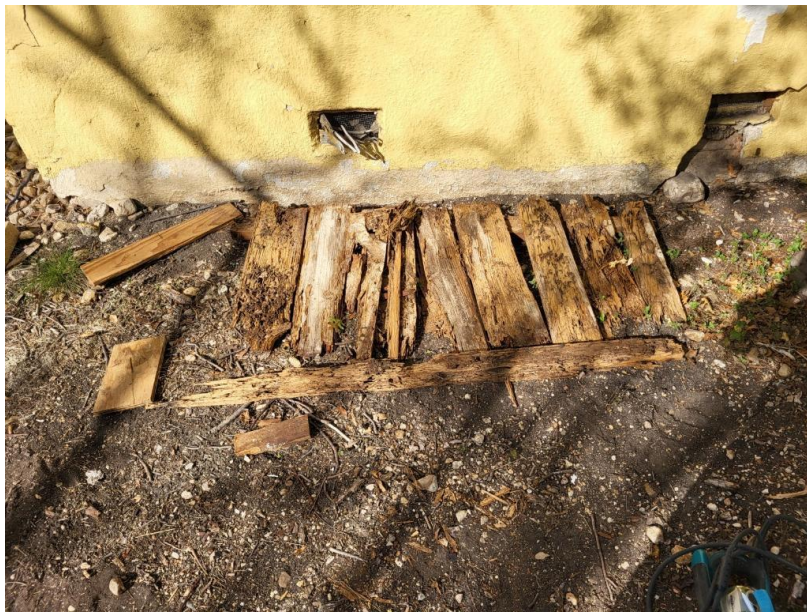
Issue: Exterior and interior cracks, wood rot on exterior windows and exterior paint chipping

Work Plan and Solution: The home had significant fractures on exterior walls that gave us structural concerns as the stucco had detached itself from the wood beams that made up the house frame. We also realized that significant wood rot across the window trim was keeping the house from being insulated from the elements and properly weatherized. Working with our contractor and his team, we sketched out a plan to repair and restore the exterior stucco, remove areas of wood rot along the window trim and replace with new wood and add sealant to ensure we were “drying” the home and protecting it from the elements. We also decided to repair all interior cracks that existed when we purchased the home and those that formed as the house settled after the foundation work. Our contractor and his team repaired shoddy interior

trim work, and added wood trim to the house where previous patchwork had failed to produce standard, up-to-code work. These repairs added structural security and insulation to the home while also restoring it. Our contracting team also took this opportunity to replace the door leading to the exterior of the house. They also repaired rotting wood trim on the interior of the house and repaired windows in each room, ensuring that at least one window in each room was functional for egress, per code and safety standards. To complete the work, we worked with our contractor to ensure that the paint we selected was approved by the Office of Historic Preservation, a task he completed on our behalf. Lastly, our contractor and his team repaired areas of the interior trim and baseboard that were damaged.

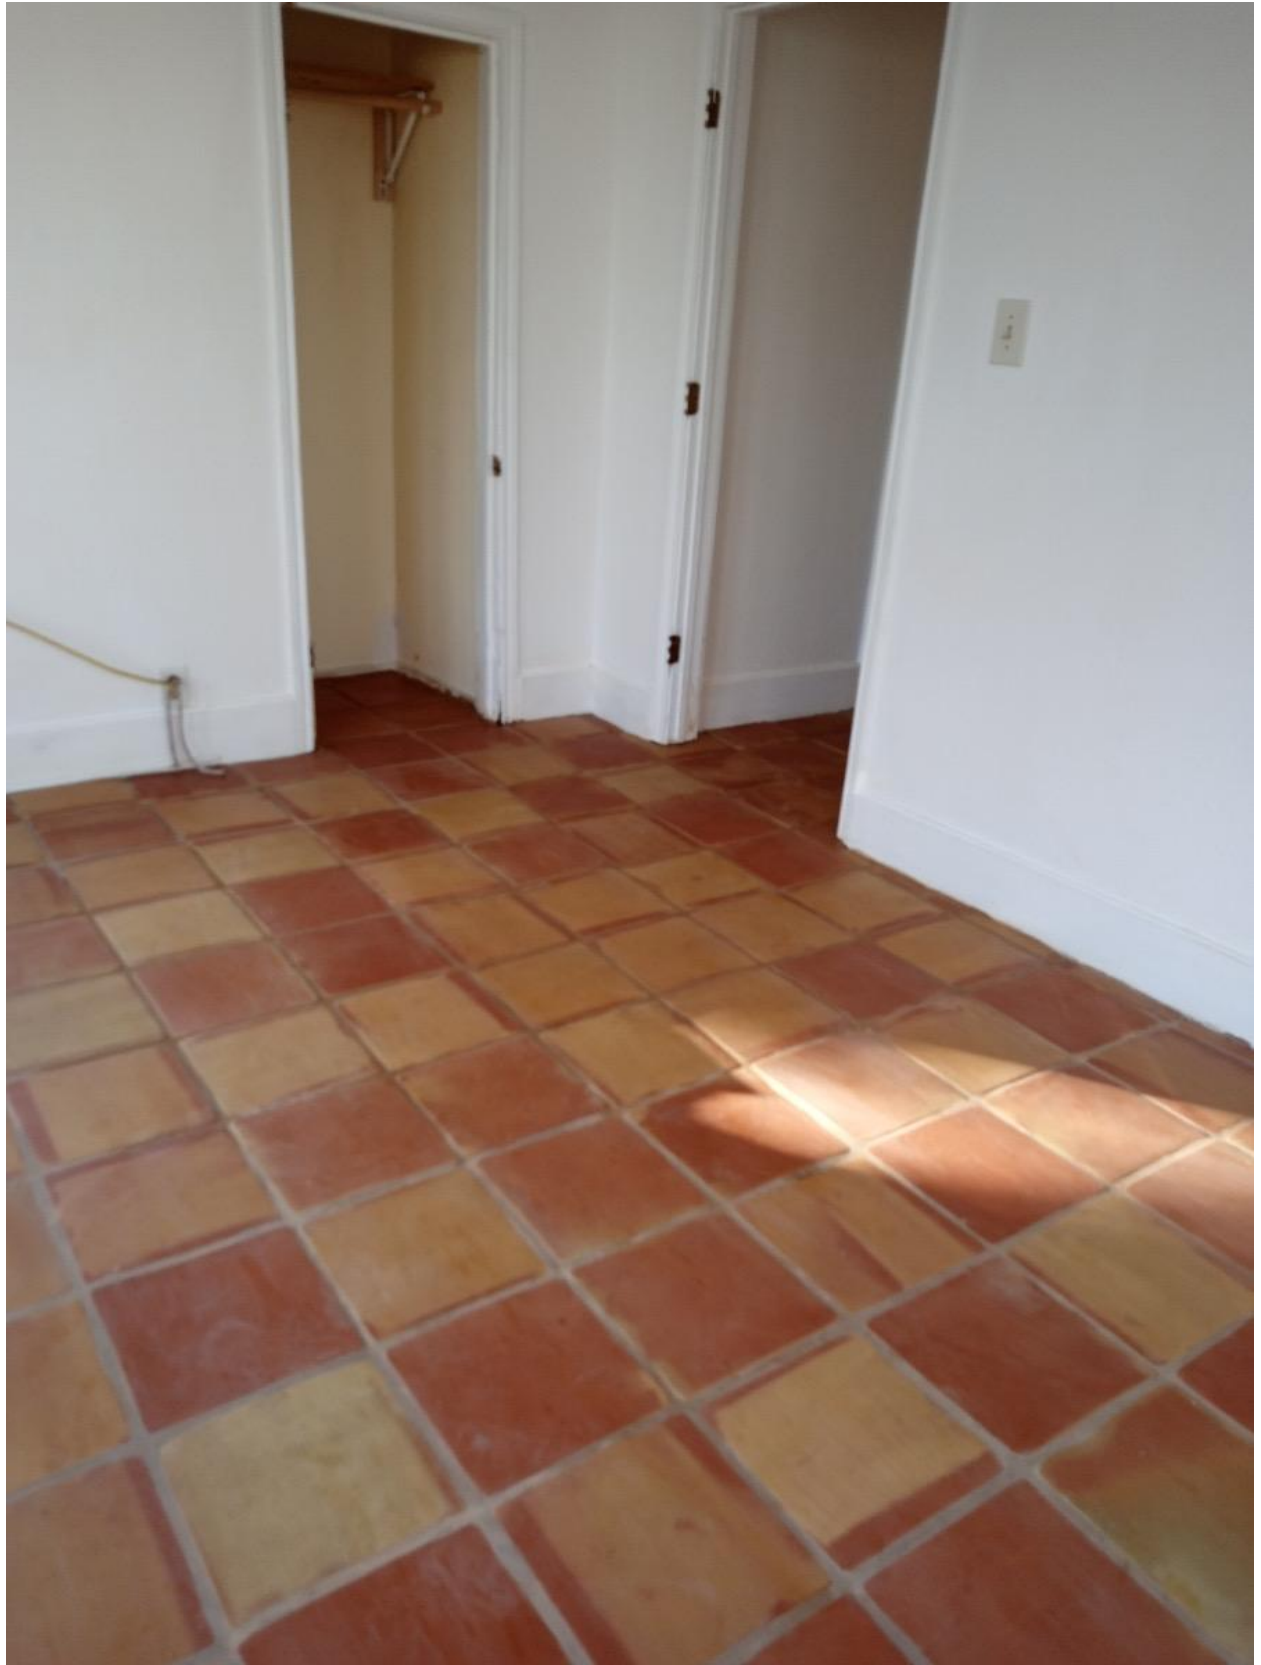
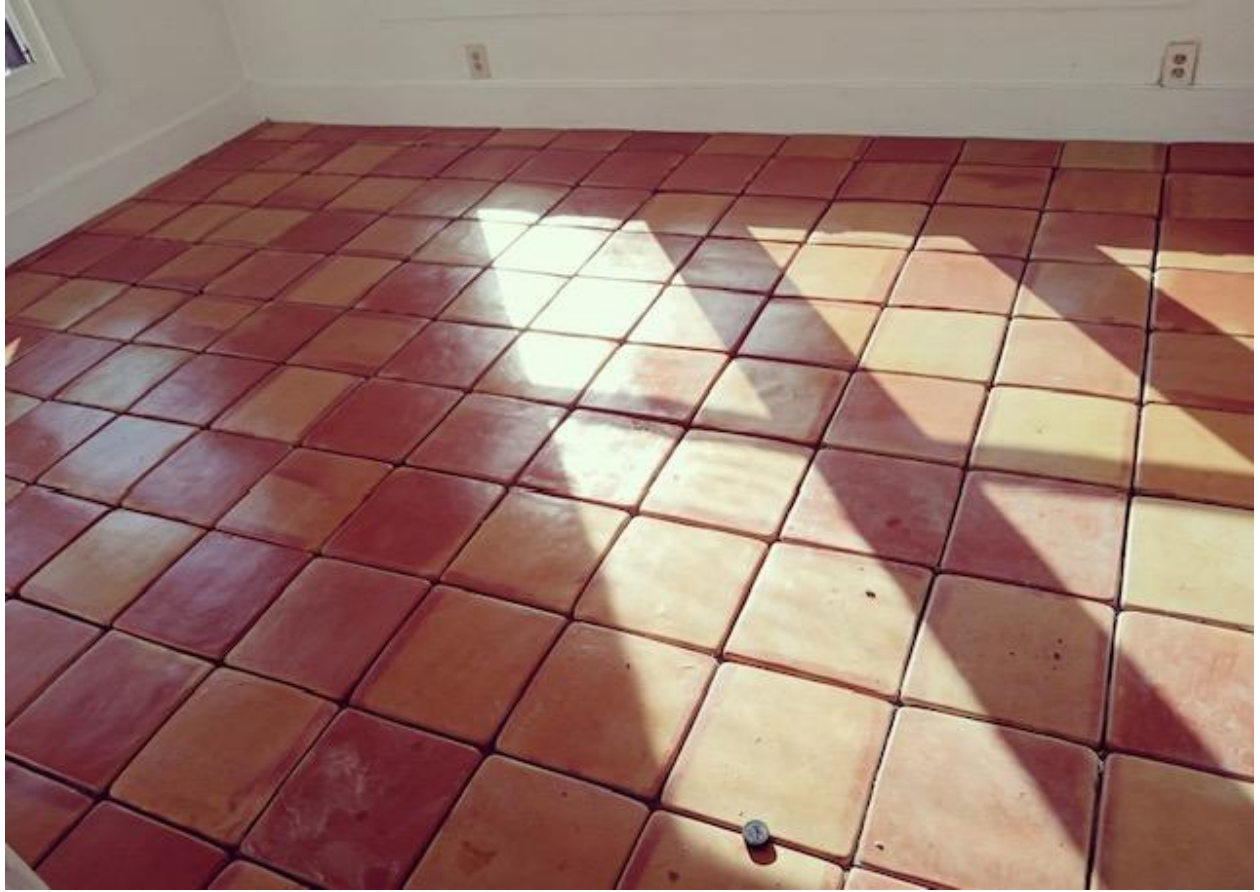
Issue: Damaged laminate flooring in hallway, bedroom and laundry room

Work Plan and Solution: When we purchased the home, there was cheap laminate faux wood flooring leading from the hallway to the two bedrooms, with moderate damage in some places and significant damage in other places. What's more, when we removed the flooring in the laundry room, where stepping over the floor would give in certain places, we found significant wood rot.

Working with our contractor, we decided to remove the laminate flooring, replace rotten floor joists where necessary and repair those pieces that could be salvaged, and then replace the laminate flooring with tile that matched the style of the house.
