# HISTORIC AND DESIGN REVIEW COMMISSION

**HDRC CASE NO:** 2023-081  
**ADDRESS:** 8623 OLD CORPUS CHRISTI RD  
**LEGAL DESCRIPTION:** NCB 10923 BLK 4 LOT N 58.17 FT OF 3A  
**ZONING:** R-6, H  
**CITY COUNCIL DIST.:** 3  
**DISTRICT:** Mission Historic District  
**APPLICANT:** ARMANDO H MARTINEZ/A D A INC.  
**OWNER:** ARCELIA SANDOVAL/SANDOVAL ARCELIA  
**TYPE OF WORK:** Review of demolition with replacement plans  
**APPLICATION RECEIVED:** February 28, 2023  
**60-DAY REVIEW:** Not applicable due to City Council Emergency Orders  
**CASE MANAGER:** Rachel Rettaliata

The applicant is requesting a Certificate of Appropriateness for approval to demolish the primary structure.

Re: Existing Structure Conditions  
8623 Old Corpus Christi Hwy.

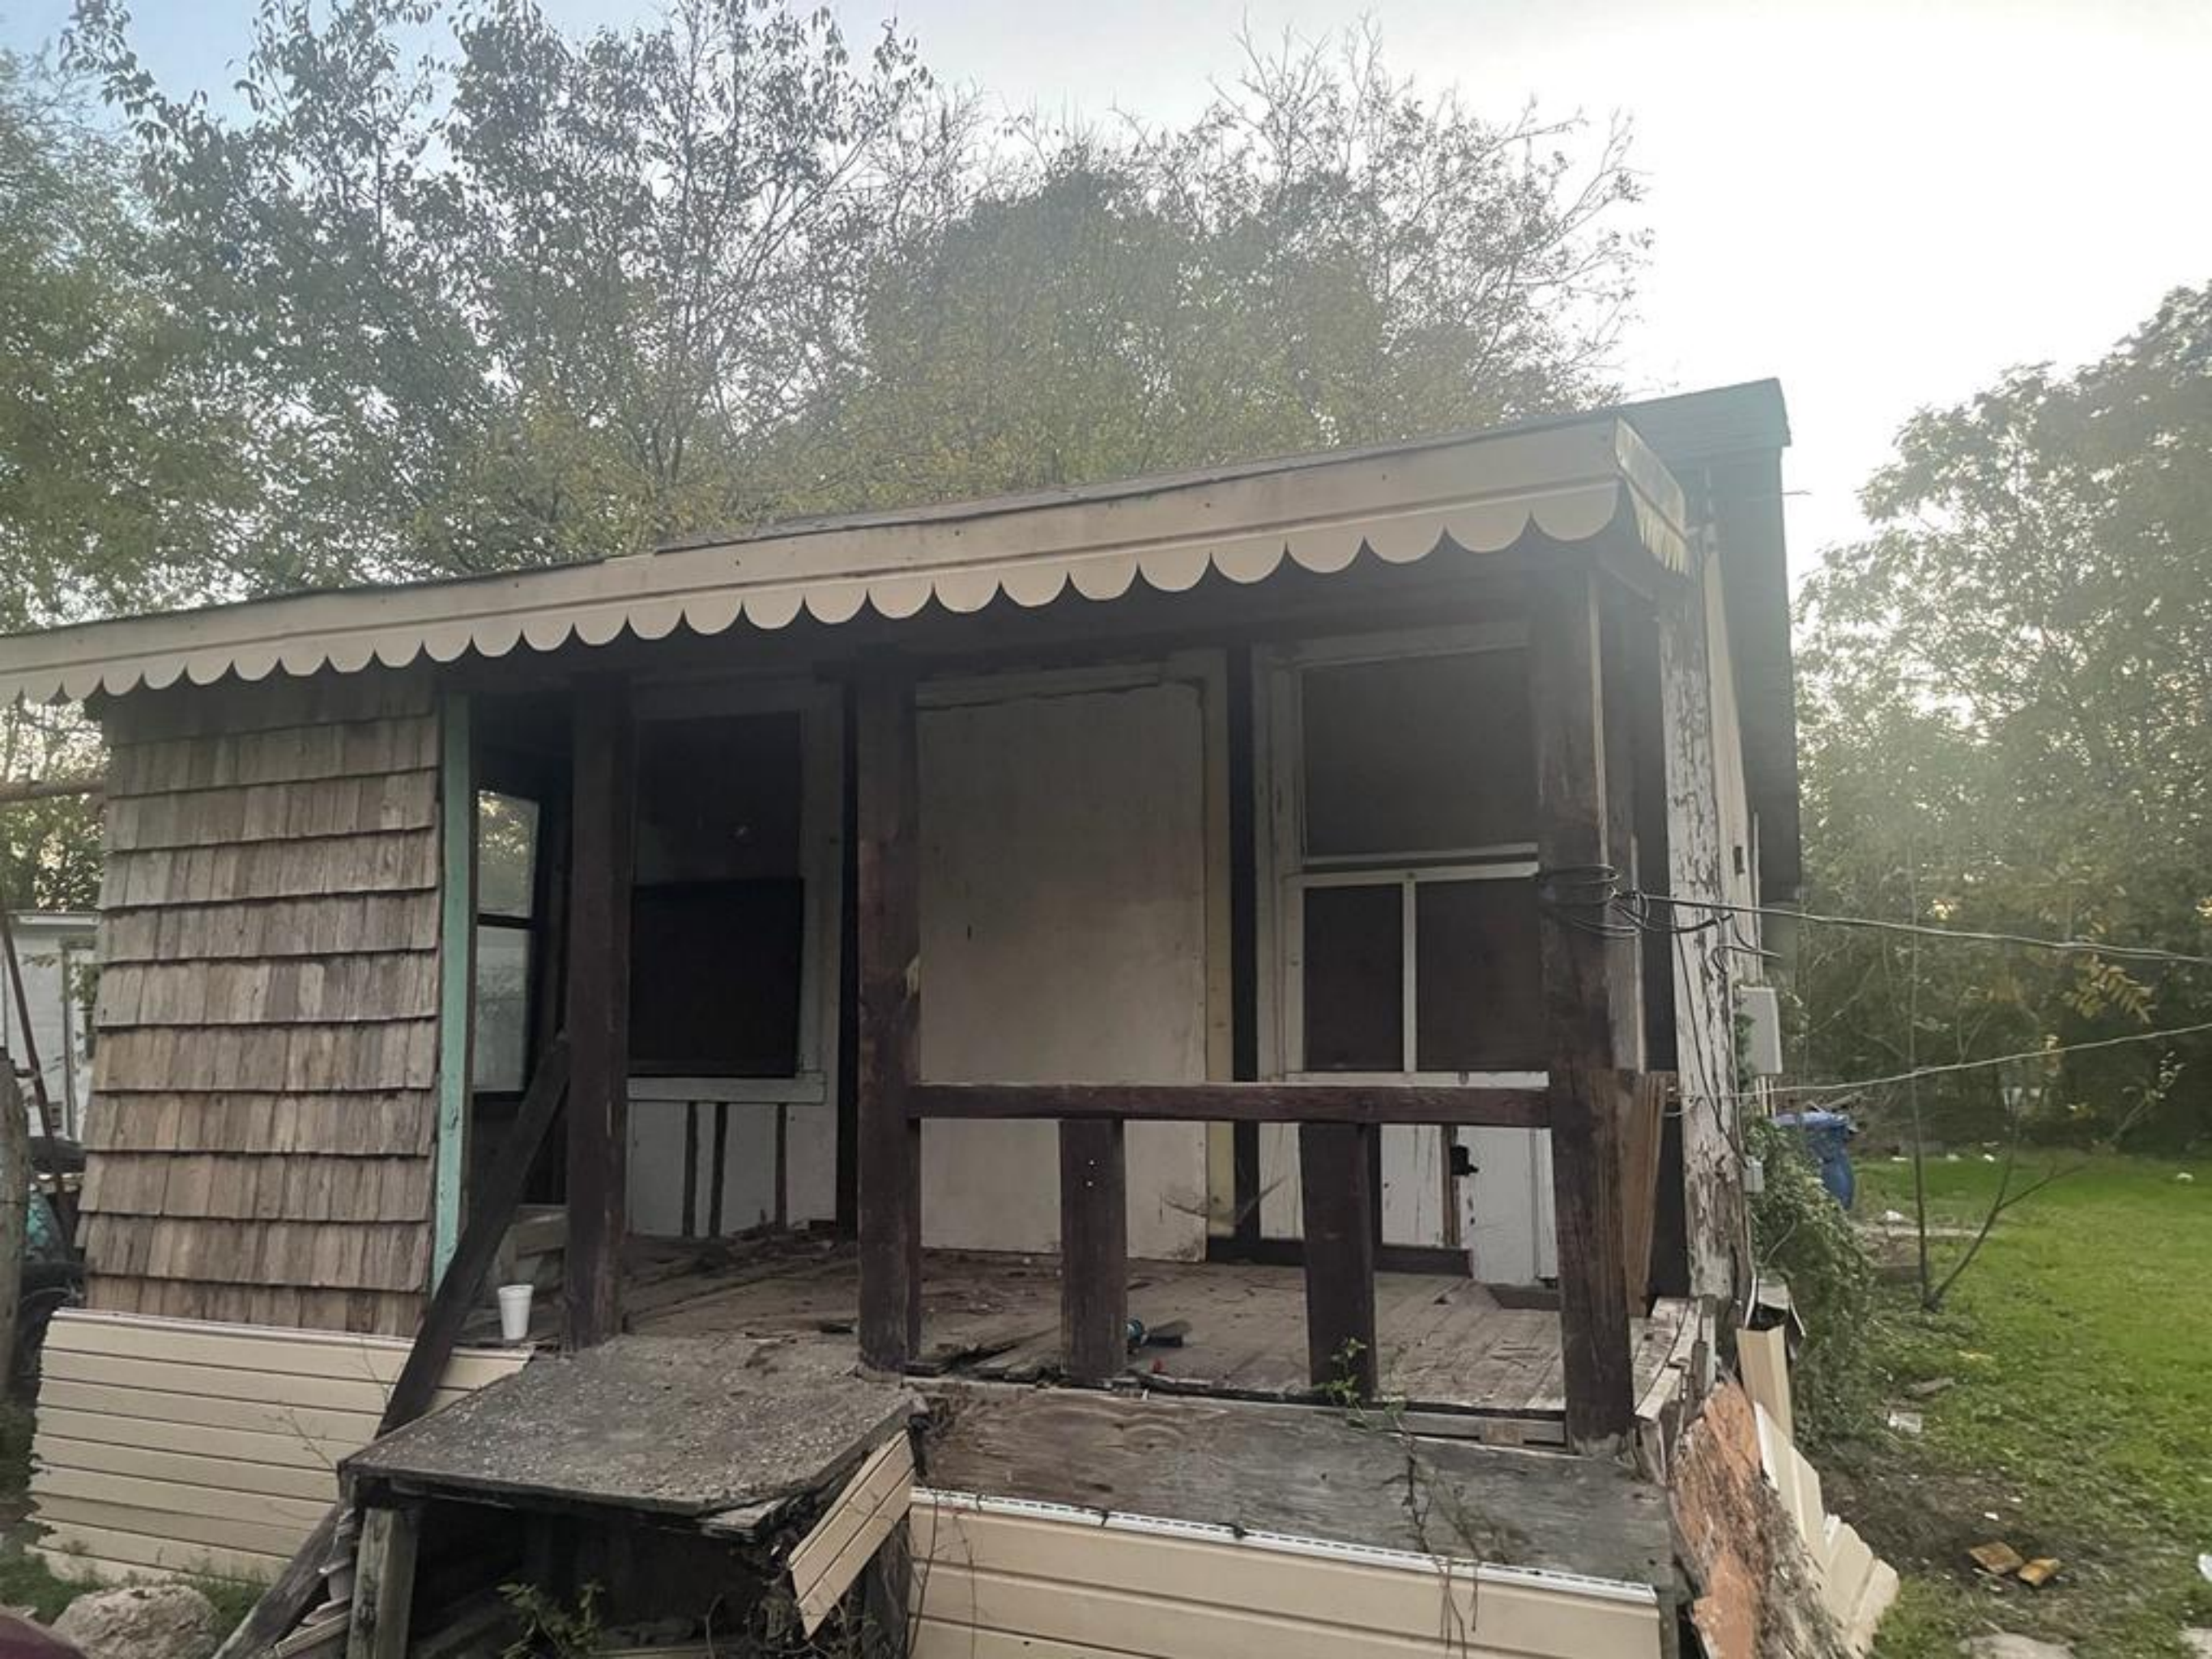
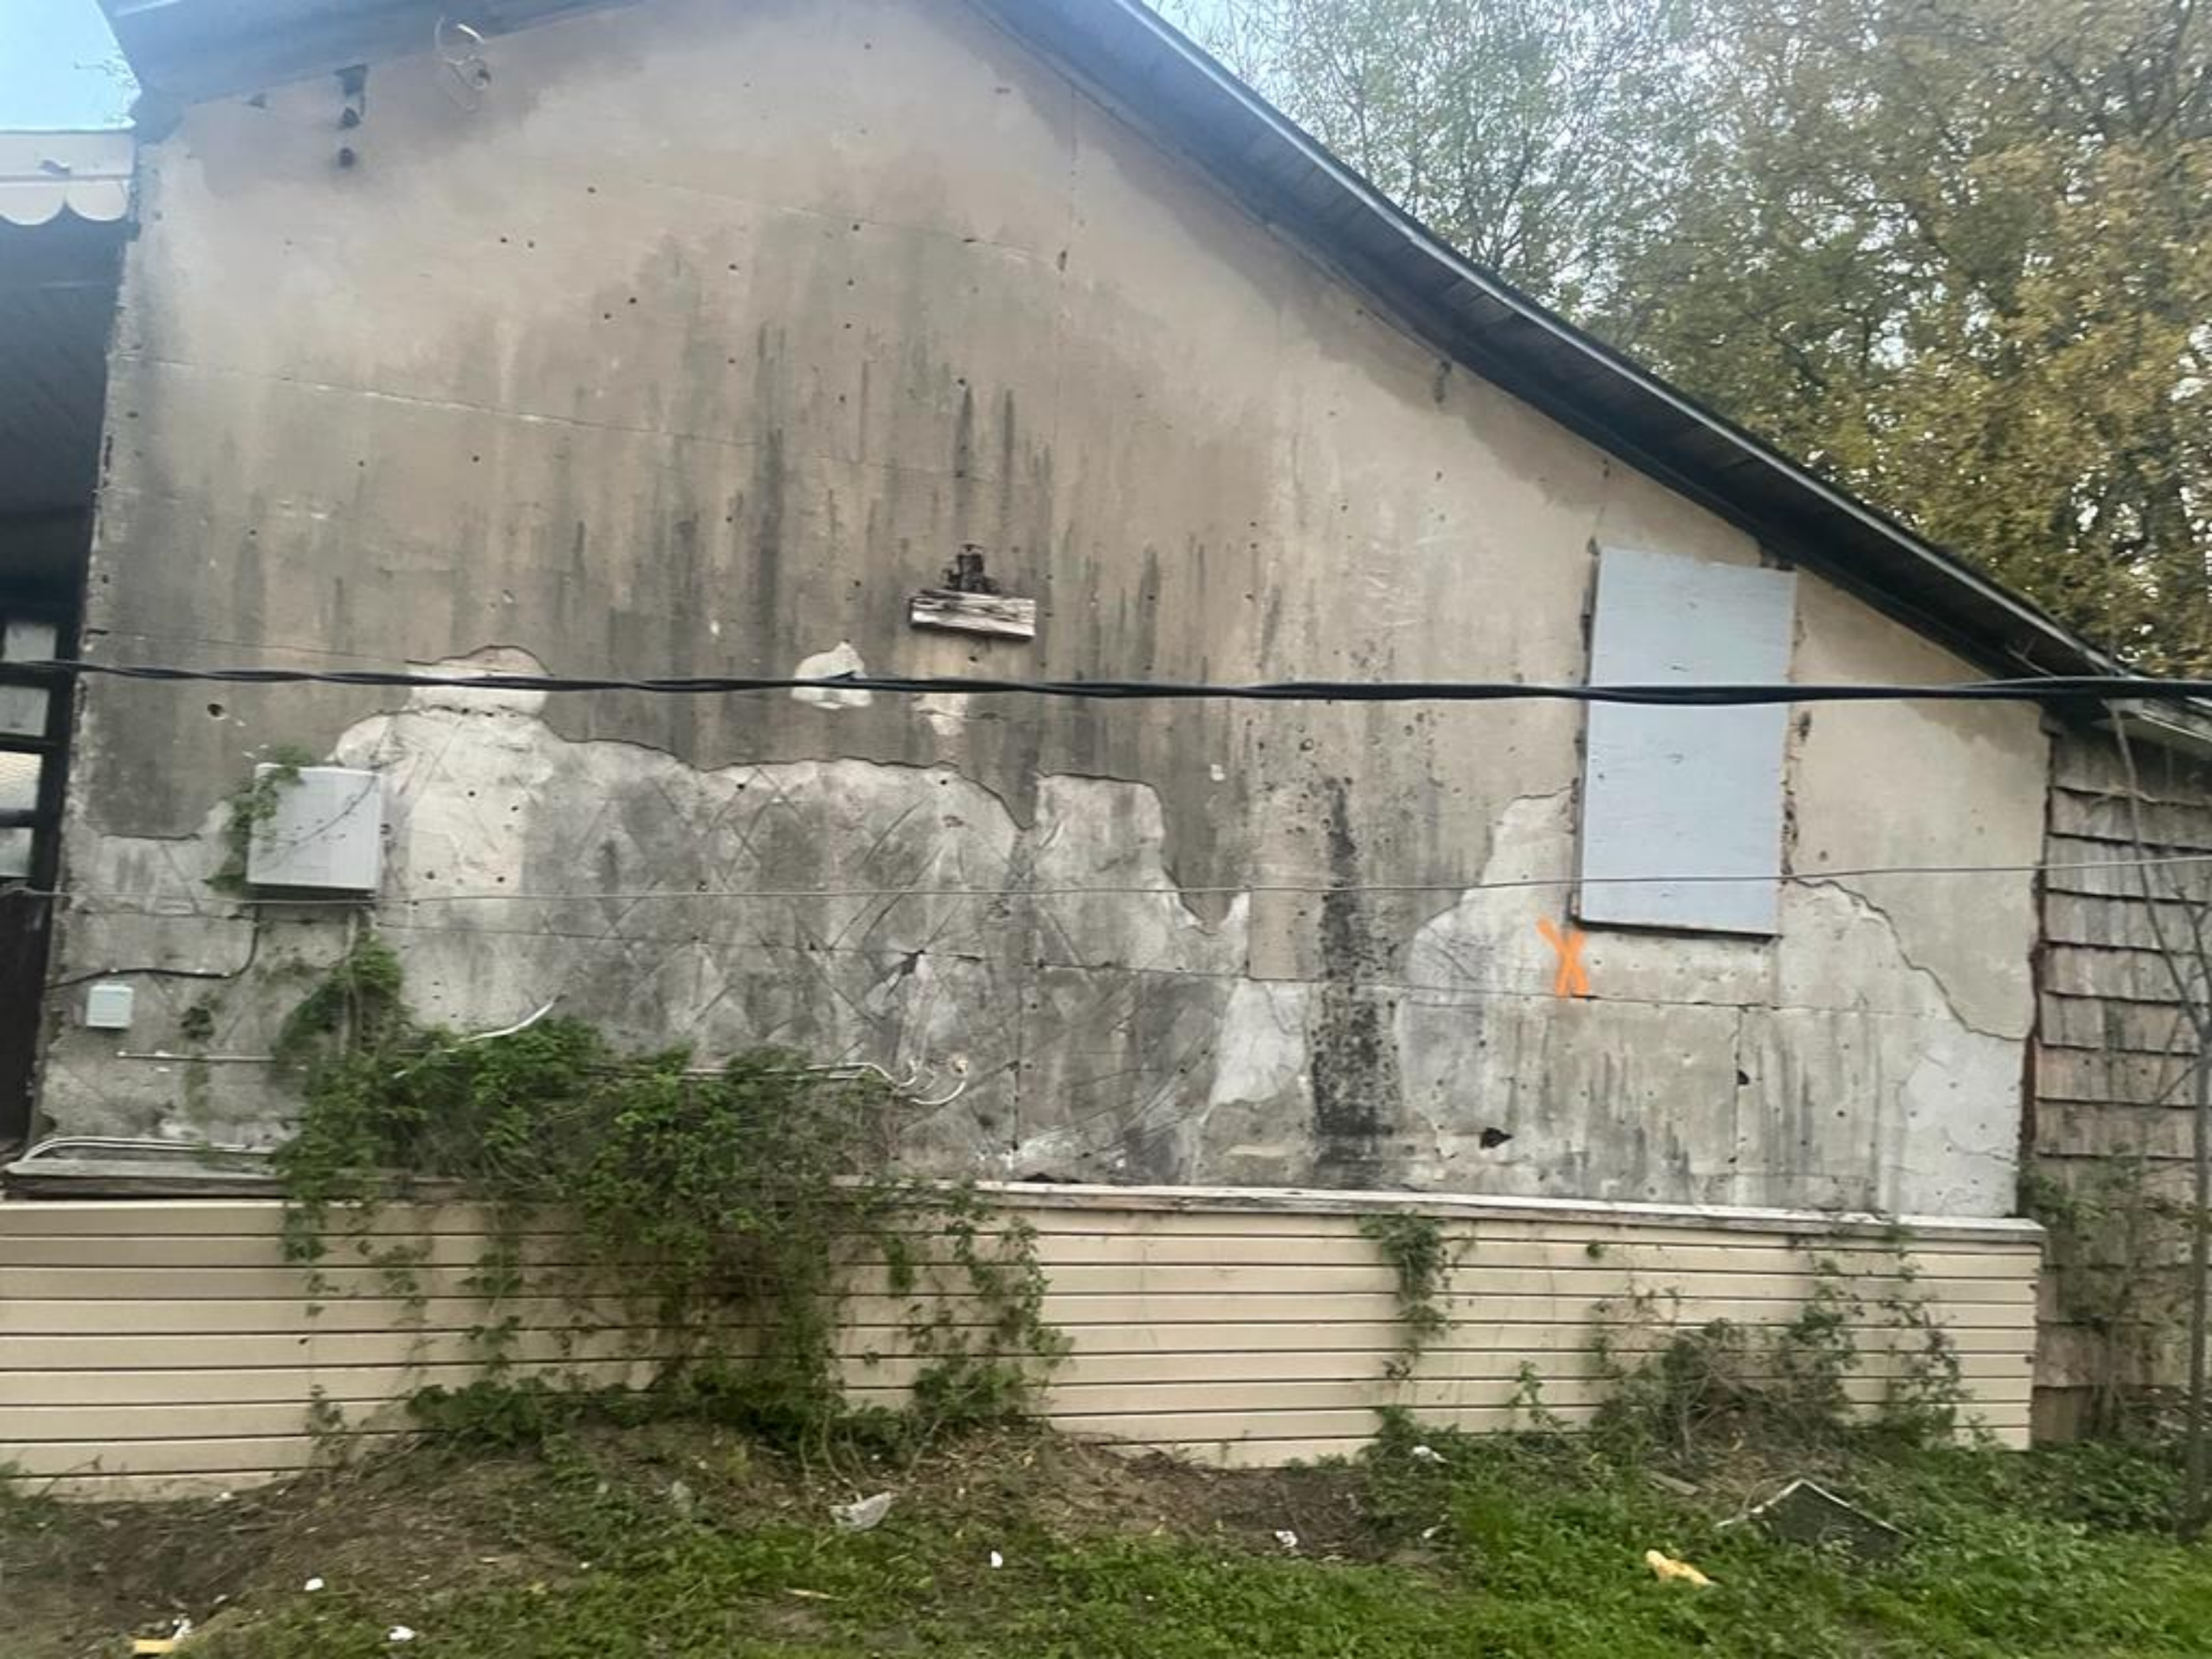
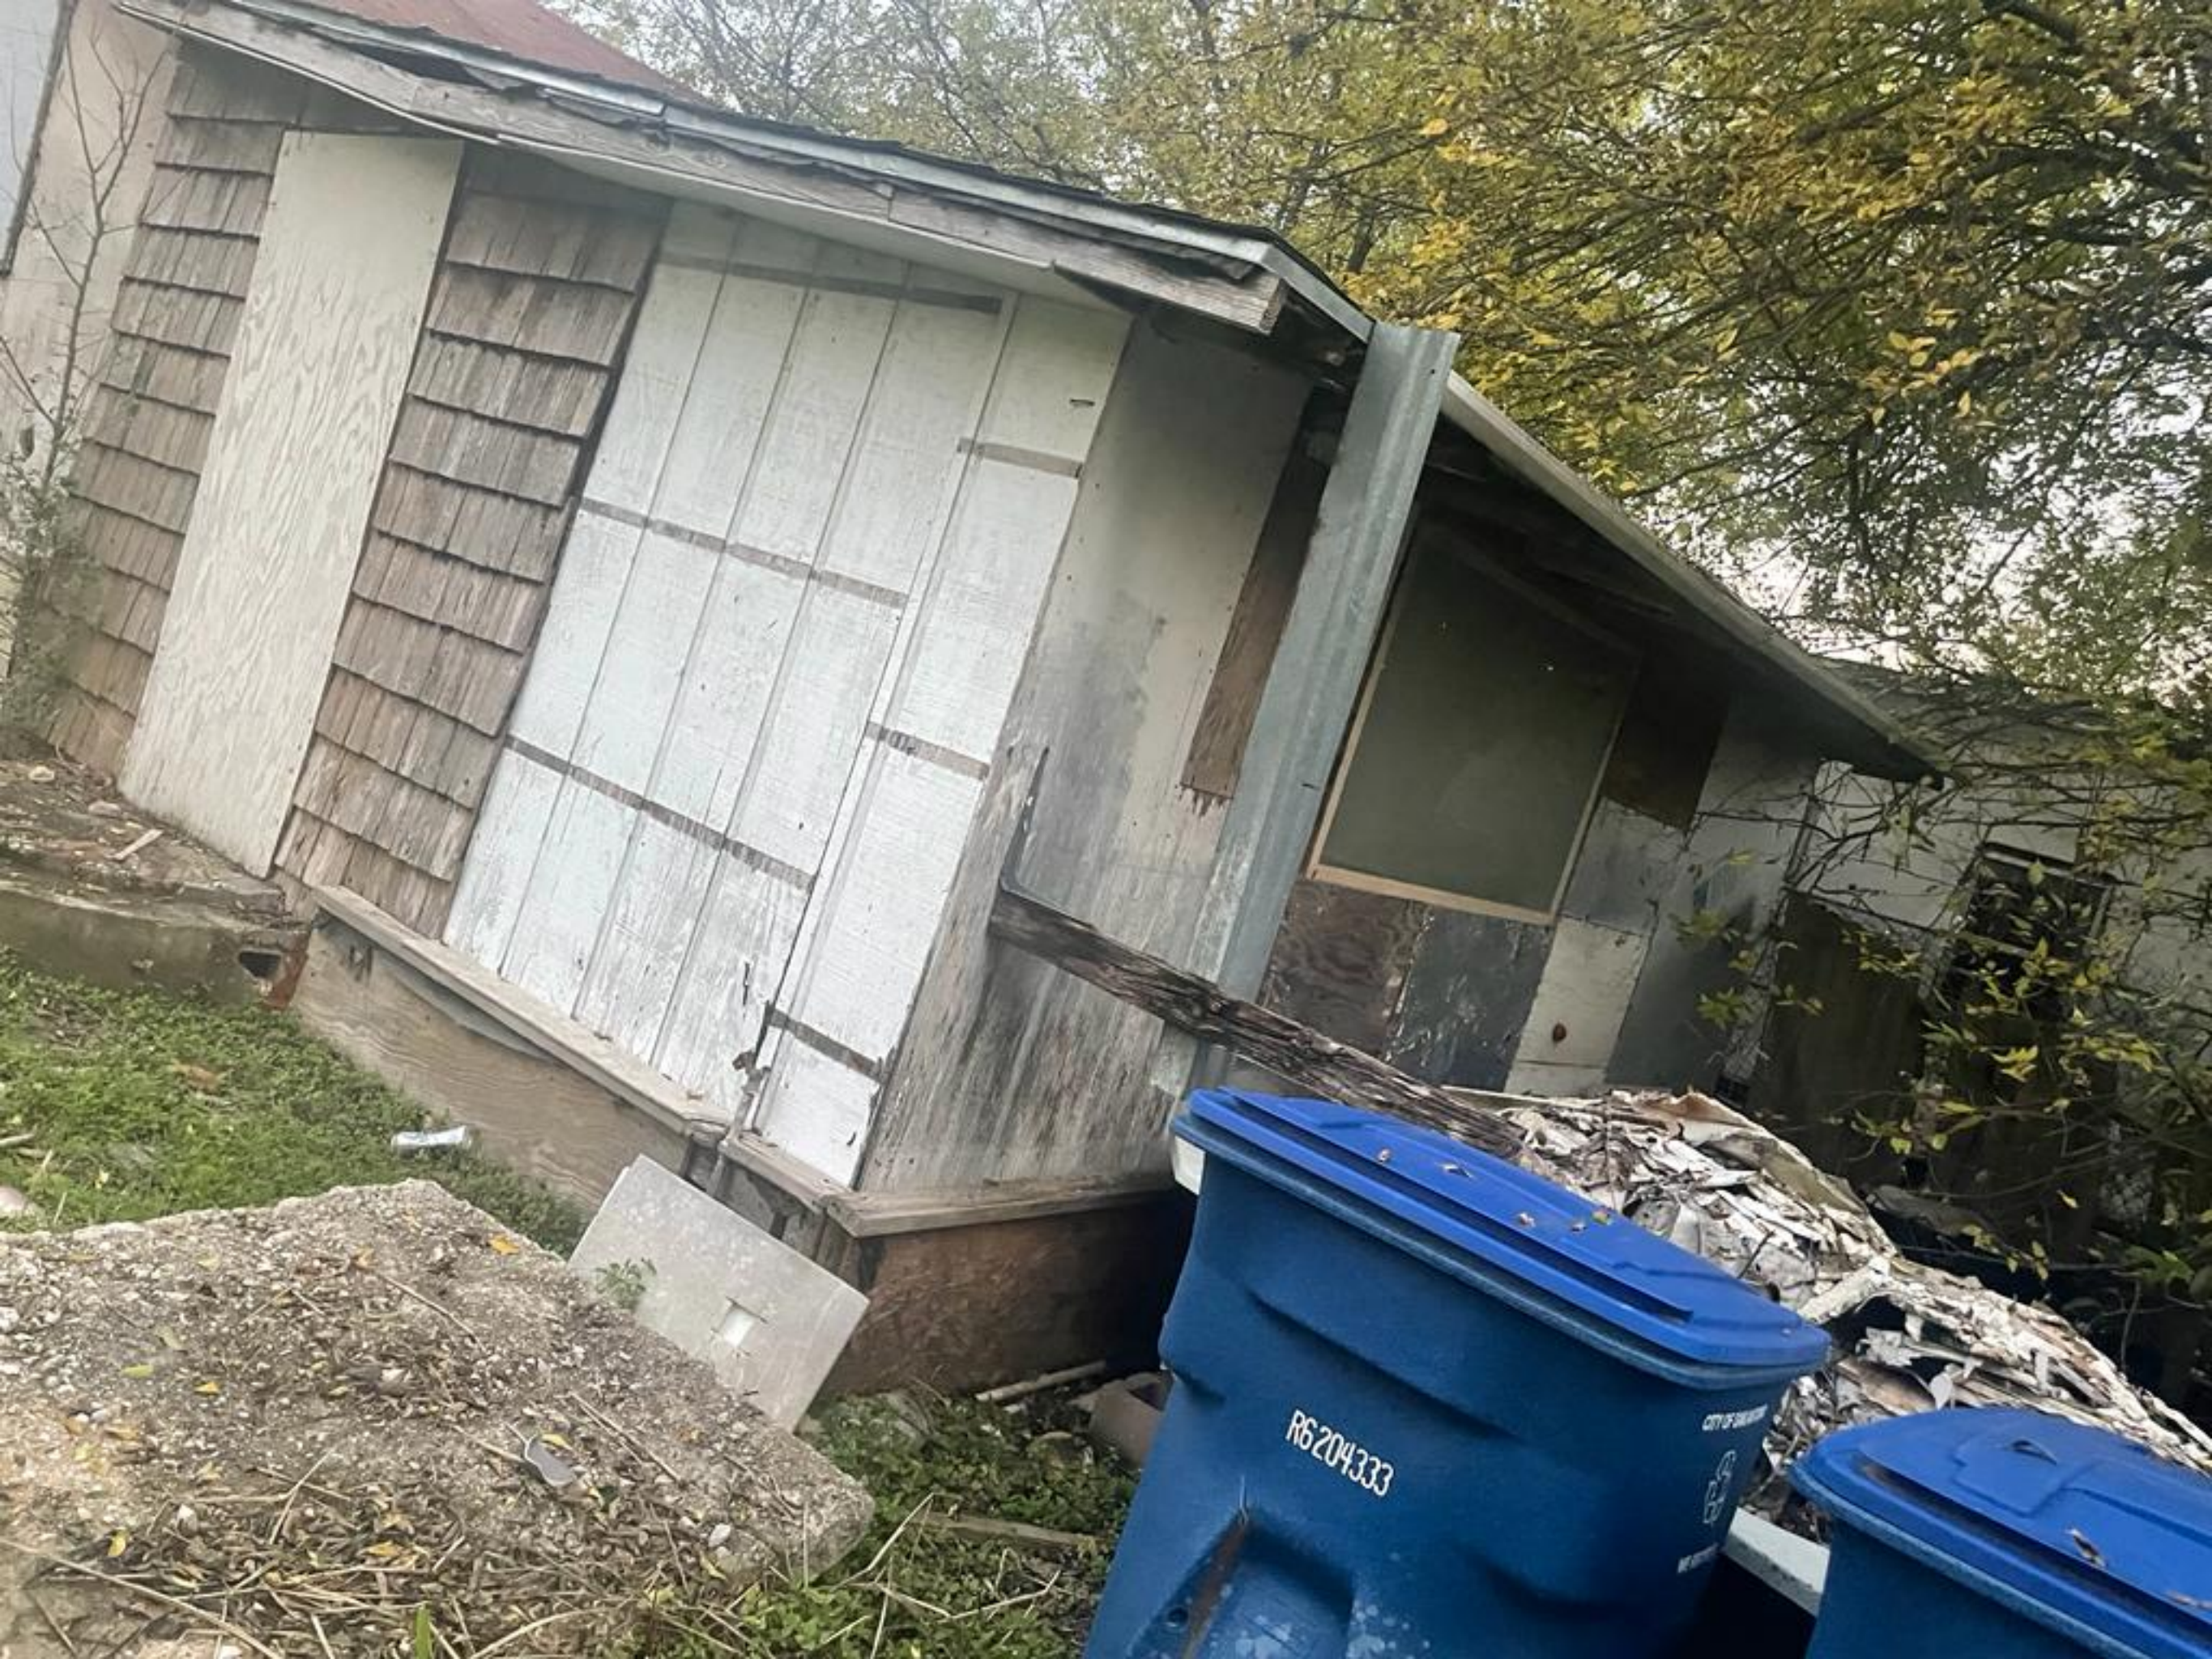
1. Existing wood deck needs to be replaced with foundation post replaced in new IBC code applicable.
2. Skirting below existing finish floor needs to be replaced.
3. Front elevation railings required to be replaced to meet code.
4. Existing siding requires to be replaced and be replaced by one pattern siding. existing siding needs to be removed.
5. Existing windows need to be removed and replaced with required windows meeting the code.
6. Existing structure has several types of roofs and requires new roof.
7. Observation of foundation footings requires replacement with new engineered design.
8. Structure requires new main framing that will meet the current code requirements.
9. Exterior fascia needs to be replaced and installed properly.

10. Existing structure does not have proper wall waterproofing barrier with base flashings. Existing porch needs new sub floor replacement.
11. Existing stucco requires replacement and to be replaced with selected siding.

12. Interior walls need to be properly spaced and plumed according to current code.
13. All existing sheet rock needs replacement with proper tape, float and texture painted.

14. Existing bathroom fixtures need replacement along with faucets and drains.
15. Existing plumbing vents and main drains do not meet current code.
16. Existing main sewer lines need to be replaced and in compliance with current plumbing code.

Note: The above observations of visual inspections, justifies the recommendation of existing residential structure to be removed and demolish. Replacement of a suitable residential structure is present for review and approval.
