HISTORIC AND DESIGN REVIEW COMMISSION

October 06, 2021

HDRC CASE NO: 2021-475
ADDRESS: 901 MASON ST
LEGAL DESCRIPTION: NCB 1267 BLK 3 LOT S 137.0 OF 9 & 10 & N 50.0 OF E 24.0 FT OF 9 ARB 9C, 10A, & 9B
ZONING: O-2, H
CITY COUNCIL DIST.: 2
DISTRICT: Government Hill Historic District
LANDMARK: Individual Landmark
APPLICANT: robert miranda/finesse construction llc
OWNER: logan fullmer/901 MASON LLC
TYPE OF WORK: Installation of a standing seam metal roof with a ridge cap
APPLICATION RECEIVED: September 03, 2021
60-DAY REVIEW: Not applicable due to City Council Emergency Orders
CASE MANAGER: Edward Hall
REQUEST:

The applicant is requesting a Certificate of Appropriateness for approval to install a standing seam metal roof with a ridge cap on the historic structure at 901 Mason, located within the Dignowity Hill Historic District.

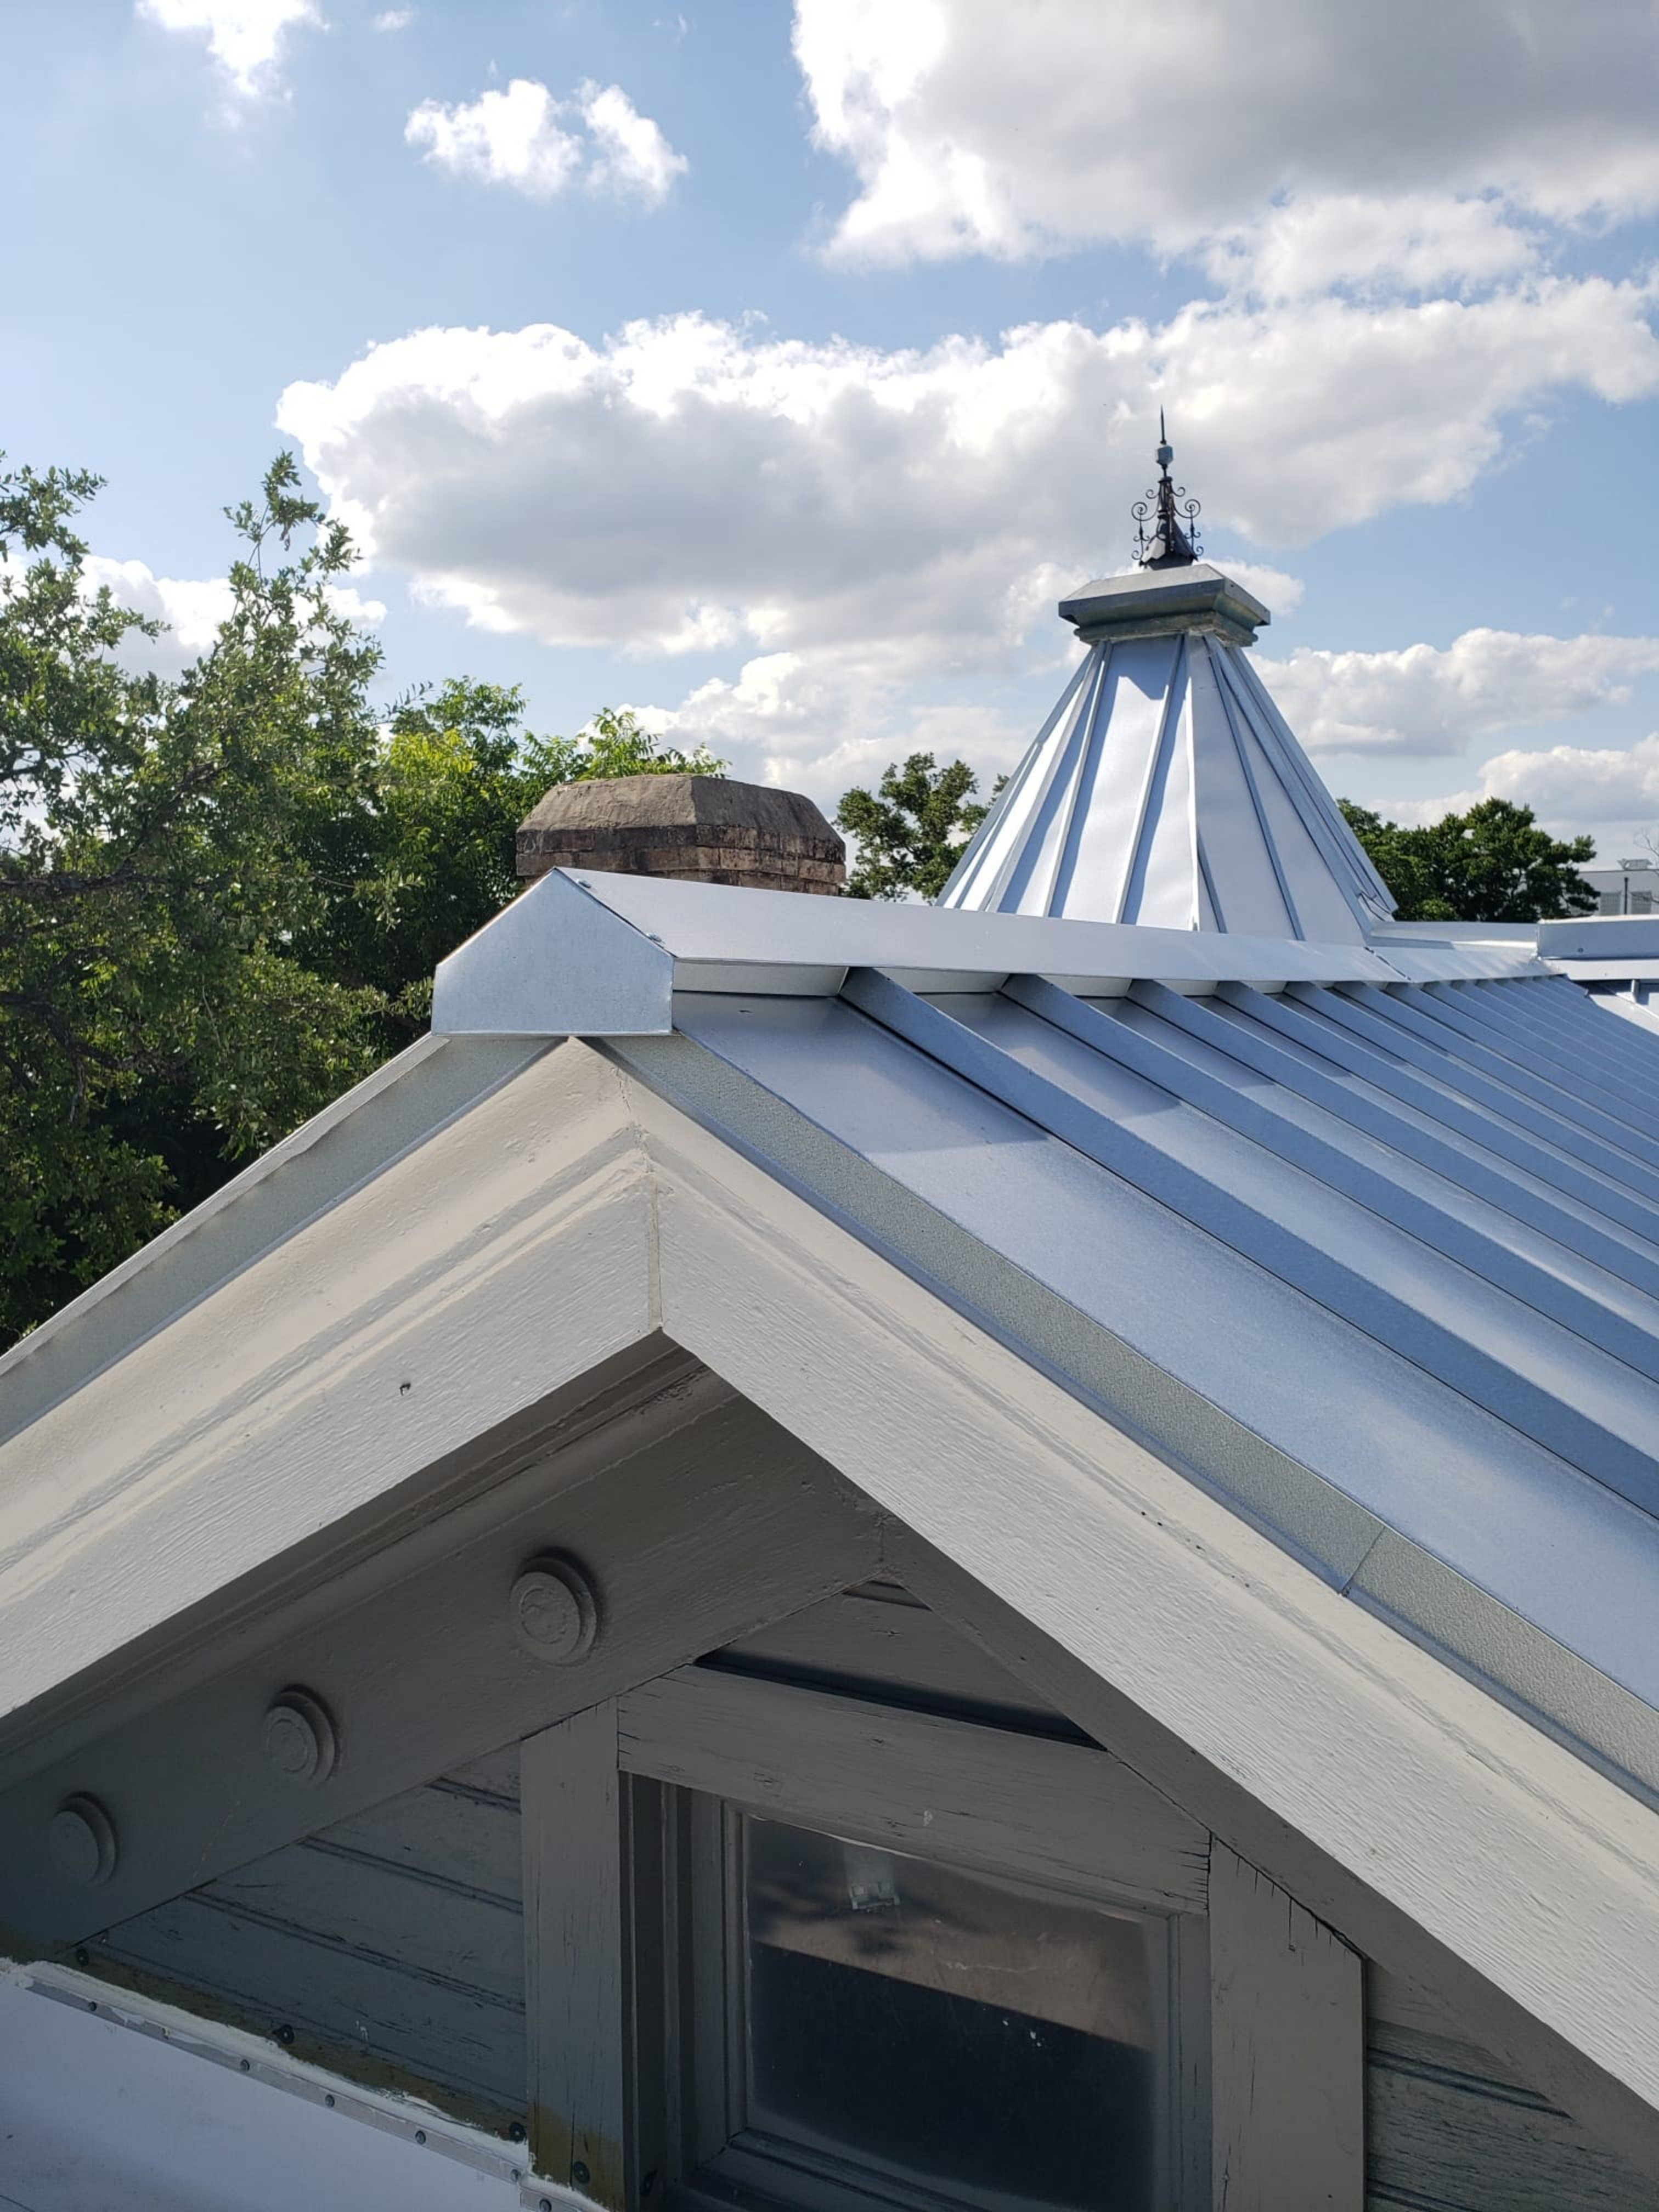
August 12, 2021 at 12:21 PM
901 Mason St
San Antonio TX 78208
United States

- b. VIOLATION – Office of Historic Preservation staff performed a site visit on August 12, 2021, to inspect the roof work that had been done to date. At that time, OHP staff found a ridge cap installed. No roofing inspection was performed to inspect materials prior to installation.

- c. ROOF REPLACEMENT – Per the Guidelines for Exterior Maintenance and Alterations 3.B.vi., metal roofs should be installed where historically found or architecturally appropriate. Additionally, the Guidelines note that new metal roofs should adhere the specifications outlined in the Guidelines; panels should be smooth and feature 18 to 21 inches in width, seams should be 1 to 2 inches tall, ridge seams should featured a crimped ridge seam, and panels should feature a standard galvalume finish. Staff finds the ridge caps to be inconsistent with the Guidelines.

Staff recommends that a standing seam metal roof that is consistent with the Guidelines regarding ridge detail (crimped/munched ridge seam or a crimped ridge sleeve) be installed in place of the installed ridge cap.
